## Fire Performance Testing of an External Cladding System BS 8414-1:2015 + A1:2017

### Test Report

Prepared for : Kingspan Insulation Ltd.  
Project : System Development  
Report No. : DLR1448 Rev.0  
Sample : Kooltherm K15 100mm - 3mm Aluminium Cassette

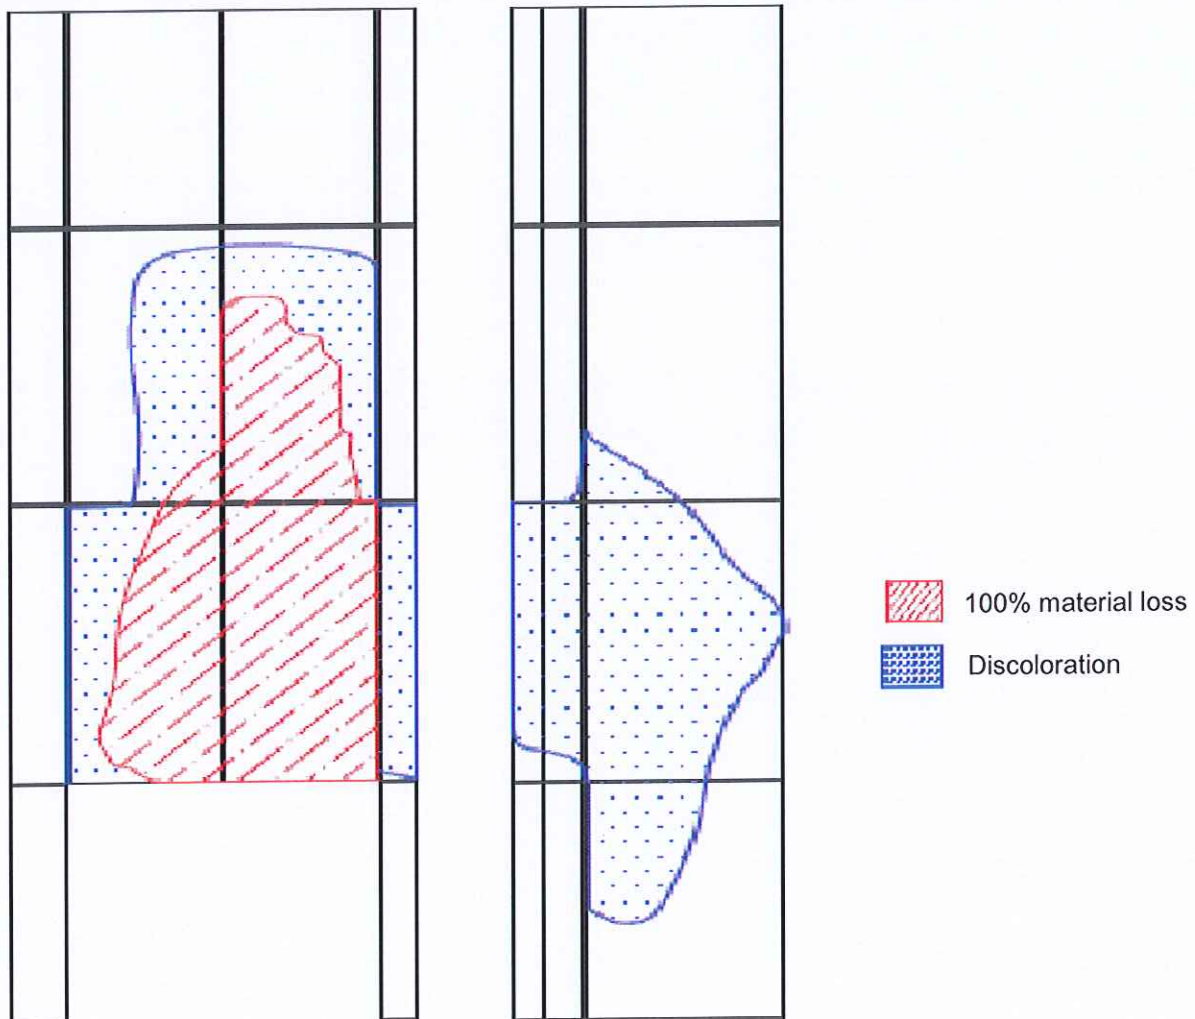
**Figure 8 Area Map Showing the Condition of the aluminium panels after the Test**

Sl. No.	Components	Observation	Photo Reference
1	Aluminium panels	<ul style="list-style-type: none"> <li>Approximately 28% (5m<sup>2</sup>) of complete material loss on main wall aluminium panels.</li> <li>No material loss on wing wall aluminium panels.</li> <li>Approximately 19% (3.4m<sup>2</sup>) of discolouration on main wall aluminium panels.</li> <li>Approximately 28% (3.6m<sup>2</sup>) of discolouration on main wall aluminium panels.</li> </ul> <p>Panels M1, M7, M11, M14-W7 corner &amp; W8 - No damage was observed.</p> <p>Panel M2-W1 corner – Minor discolouration.</p> <p>Panel M3 - Minor discolouration at the corner. No other damage was observed</p> <p>Panel M4 - Approximately 50% of the panel was consumed in fire, the remaining was distorted, discoloured and buckled.</p> <p>Panel M5 - 100% of the panel was consumed in fire.</p> <p>Panel M6-W3 corner - 90% of the panel was discoloured and the 1<sup>st</sup> coating was burned.</p> <p>Panel M8 - Approximately 10% of the panel was consumed in fire, the remaining was distorted, discoloured and buckled.</p> <p>Panel M9 - Approximately 60% of the panel was consumed in fire, the remaining was distorted, discoloured and buckled.</p> <p>Panels M10-W5 corner, M12 &amp; M13 – Minor discolouration.</p> <p>Panel W2- Approximately 25% of the top coating was burned and discoloured.</p> <p>Panel W4 - Approximately 85% top coating was burned and discoloured and buckled.</p> <p>Panel W6 - Minor discolouration.</p>	<p>DLP C2753B/0005</p> <p>See Figure 8 in this section for area details.</p>

- Approximately 5m<sup>2</sup> of the total aluminium panels was completely consumed by fire.
- Approximately 7m<sup>2</sup> of the total aluminium panels was discoloured.

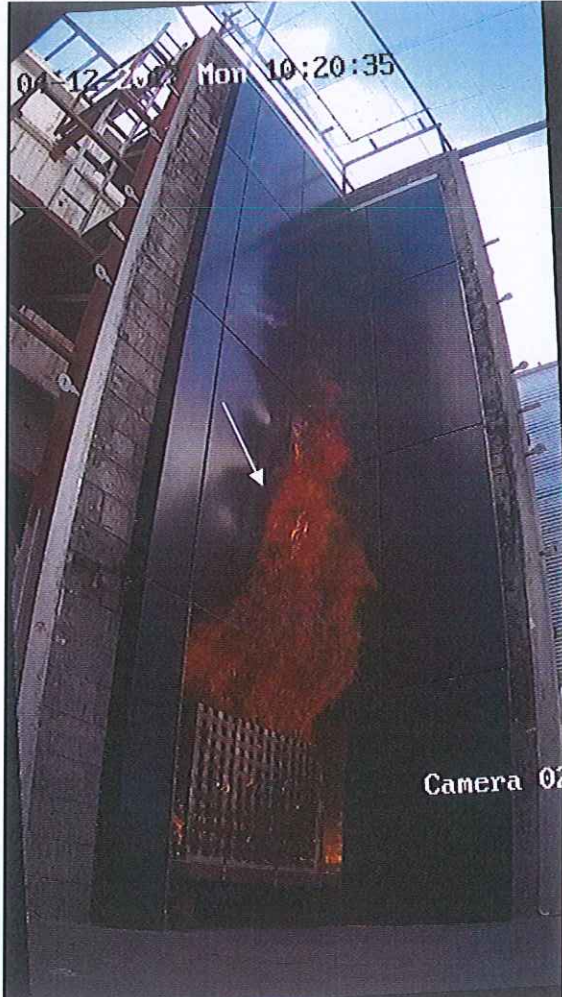
10:20:21	190	Flames reached 2000mm above the combustion chamber.	-
10:20:35	152	1 <sup>st</sup> layer of coating of panels M4 & M5 started to burn.	DLP C2753B/0001

1<sup>st</sup> layer of coating started to burn.

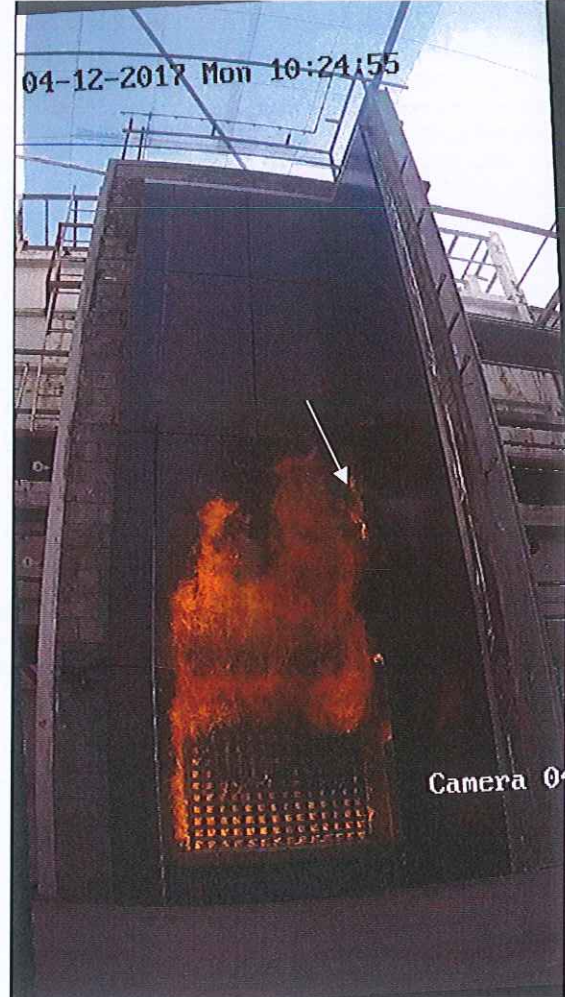
10:24:54	463	Sustained flame observed on panels M5 & M6 vertical joint.	DLP C2753B/0002
10:25:40	509	Panels M4 & M5 melted.	-
10:26:33	562	Railings behind panels M4 & M5 melted.	-

Continuous flame observed on panels M5 & M6 vertical joint.

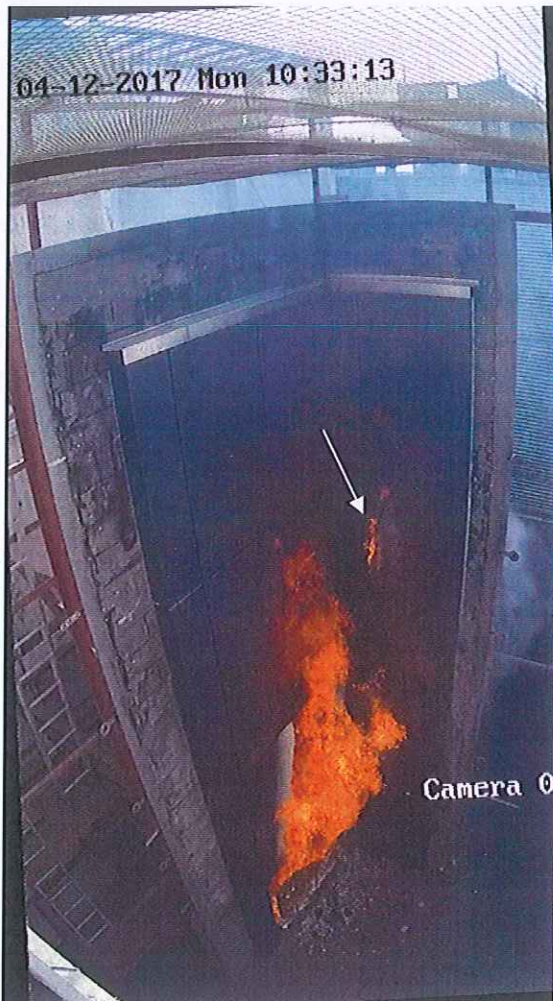
Time	Seconds	Observation	Photo Reference
10.31.39	868	Flames observed between panes W2 & W3 horizontal joint.	-
10.33.13	962	Sustained flame observed on panels W5 & W6 vertical joint.	DLP C2753B/0003

Continuous flame  
observed on W5 &  
W6 vertical joint.

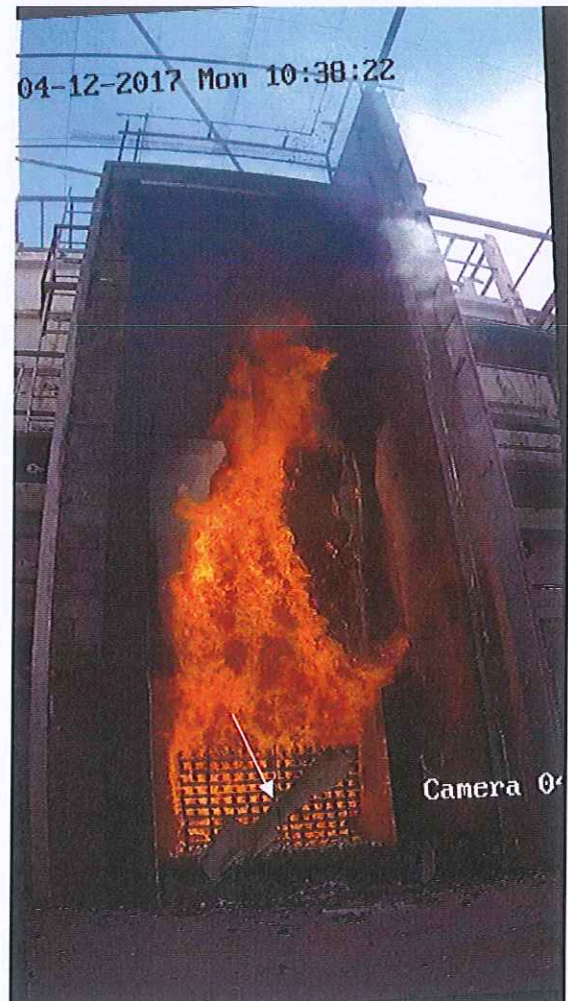
10.38.22	1271	Panel M5 fell from the main wall.	DLP C2753B/0004
10.39.38	1347	Kooltherm K15 insulation behind panels M4, M5, M8 & M9 was exposed as charcoal.	-

Panel M5 fell from  
the main wall.

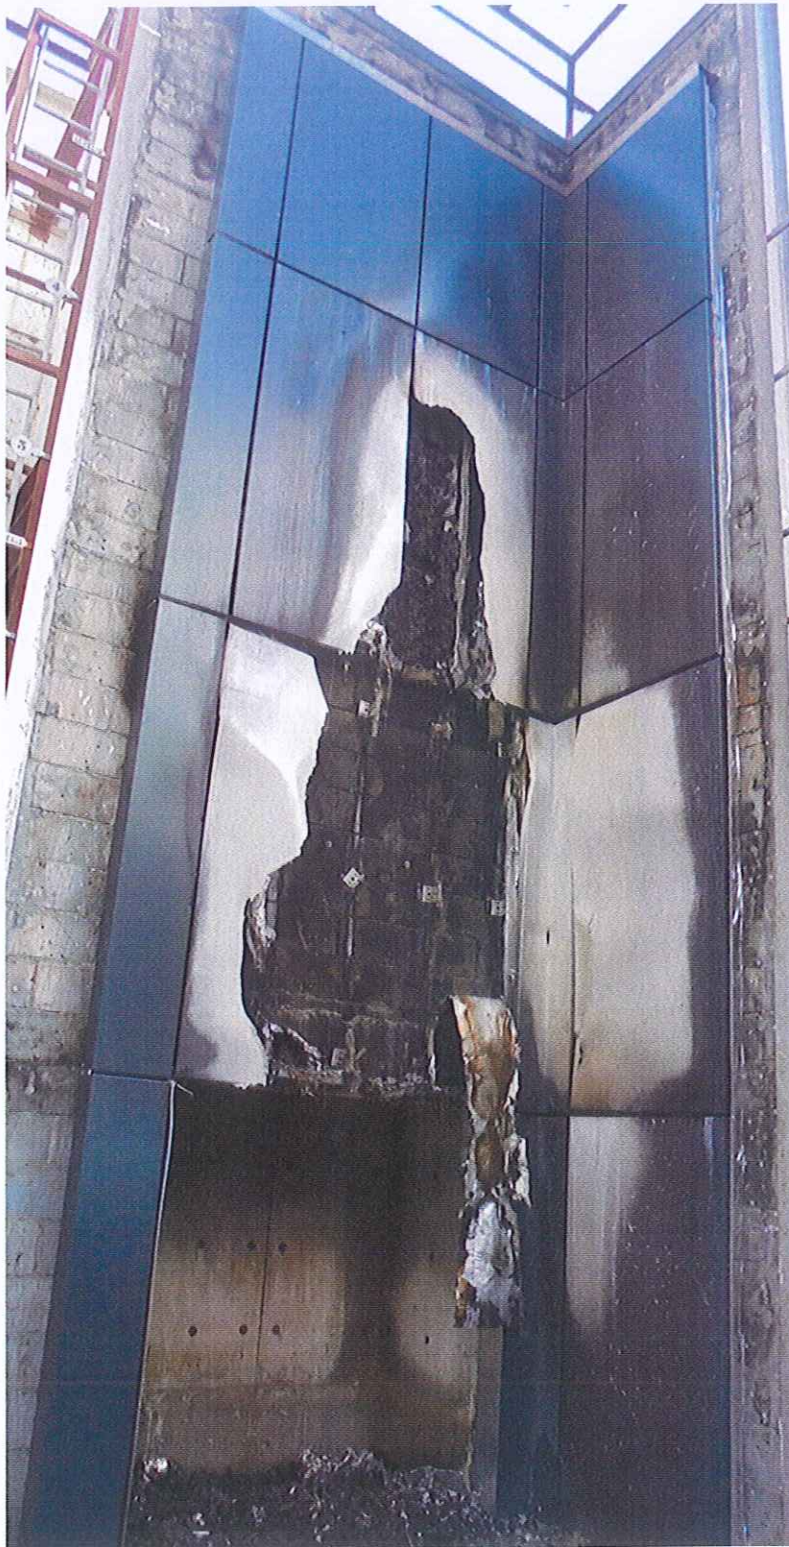
DLP C2753B/0005

View of the sample after the test completion

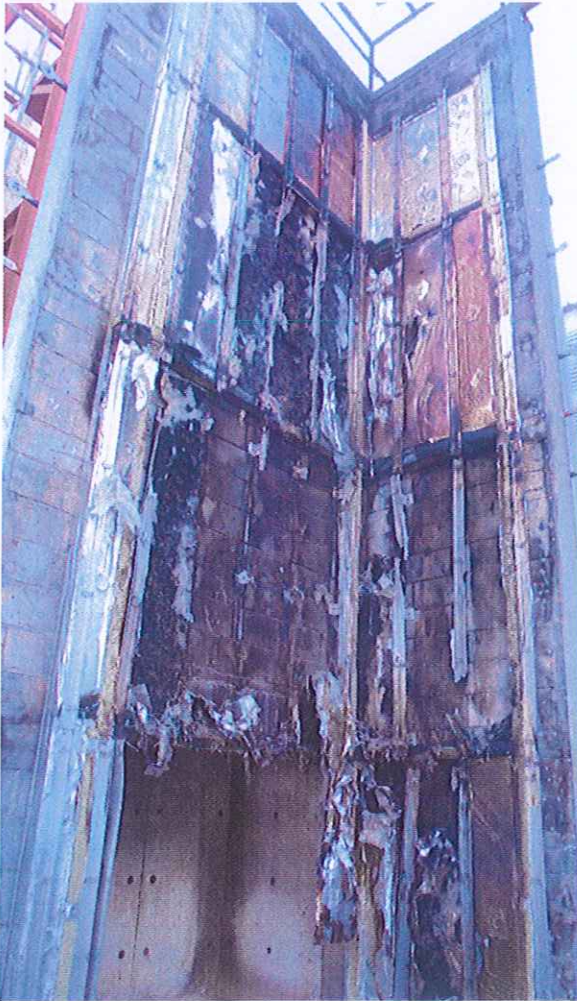
3	Insulation	<p>100% damage on Kooltherm K15 insulations and core wall was exposed behind panels M4, M5, M6-W3, M9 &amp; M10-W5.</p> <p>Insulation behind panels W2, W4 &amp; W6 were charred and exposed as charcoal.</p> <p>Discoloration was observed to insulations behind panels M1, M3, M7, M11, M12, M14-W7 &amp; W8.</p>	DLP C2753B/0007
4	Railing	<p>Railings behind panels M4, M5, M6-W3, W4, M8 &amp; M9 were melted. Railings behind panels M1, M3, M7, M11, M12, M13, M14-W7 and W8 were discoloured.</p> <p>Railings behind panels M2-W1 &amp; W2 were buckled and discoloured.</p>	DLP C2753B/0007

Sl. No.	Components	Observation	Photo Reference
5	Bracket	100% of the brackets behind panels M4, M5 & M6-W4 were damaged. All other brackets were discoloured and were in place without damage.	DLP C2753B/0007.

View of the sample  
without panels

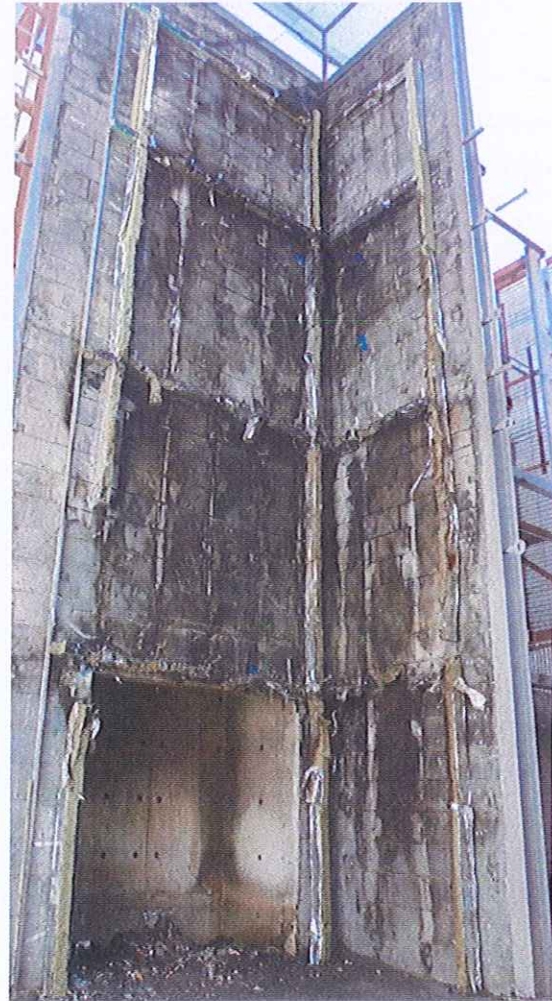
DLP C2753B/0008

Sl. No.	Components	Observation	Photo Reference
2	Cavity barrier	<p><b>Horizontal intumescent cavity barrier:</b></p> <p>The 1<sup>st</sup> horizontal cavity barrier above the combustion chamber was activated. Melted aluminium and middle core of the panel debris fell onto the barrier and was compressed by its weight. Material loss and damage was observed.</p> <p>The 2<sup>nd</sup> horizontal cavity barrier at 2330mm above the combustion chamber was activated. The expanded intumescent layer was not present on the main wall during dismantling.</p> <p>The 3<sup>rd</sup> horizontal cavity barrier at 4660mm above the combustion chamber on main wall and wing wall was activated. No material loss was observed.</p> <p>The 4<sup>th</sup> horizontal cavity barrier at 6274mm above the combustion chamber on main wall and wing wall was activated. No material loss was observed.</p> <p><b>Vertical cavity barrier:</b></p> <p>Minor discolouration to the vertical cavity barrier extending between panel M1 and the combustion chamber.</p> <p>Buckling and minor material loss on vertical cavity barrier extending between the combustion chamber and panel M2.</p> <p>Minor discolouration to the vertical cavity barrier on wing wall.</p>	DLP C2753B/0006, DLP C2753B/0007 & DLP C2753B/0008.

View of the cavity  
barriers

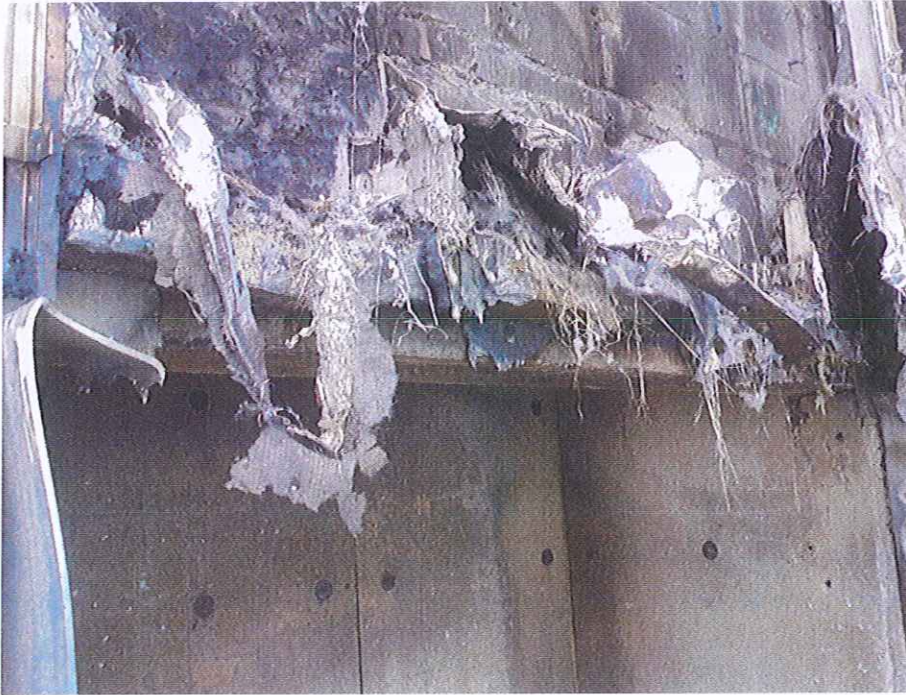
DLP C2753B/0006

Cavity barrier at the top of combustion chamber
