Fire Performance Testing of an External Cladding System BS 8414-1:2015 + A1:2017

Test Report

Prepared for : Kingspan Insulation Ltd.
Project : System Development
Report No. : DLR1453 Rev.0
Sample : Kooltherm K15 –Alpolic/fr - BML100

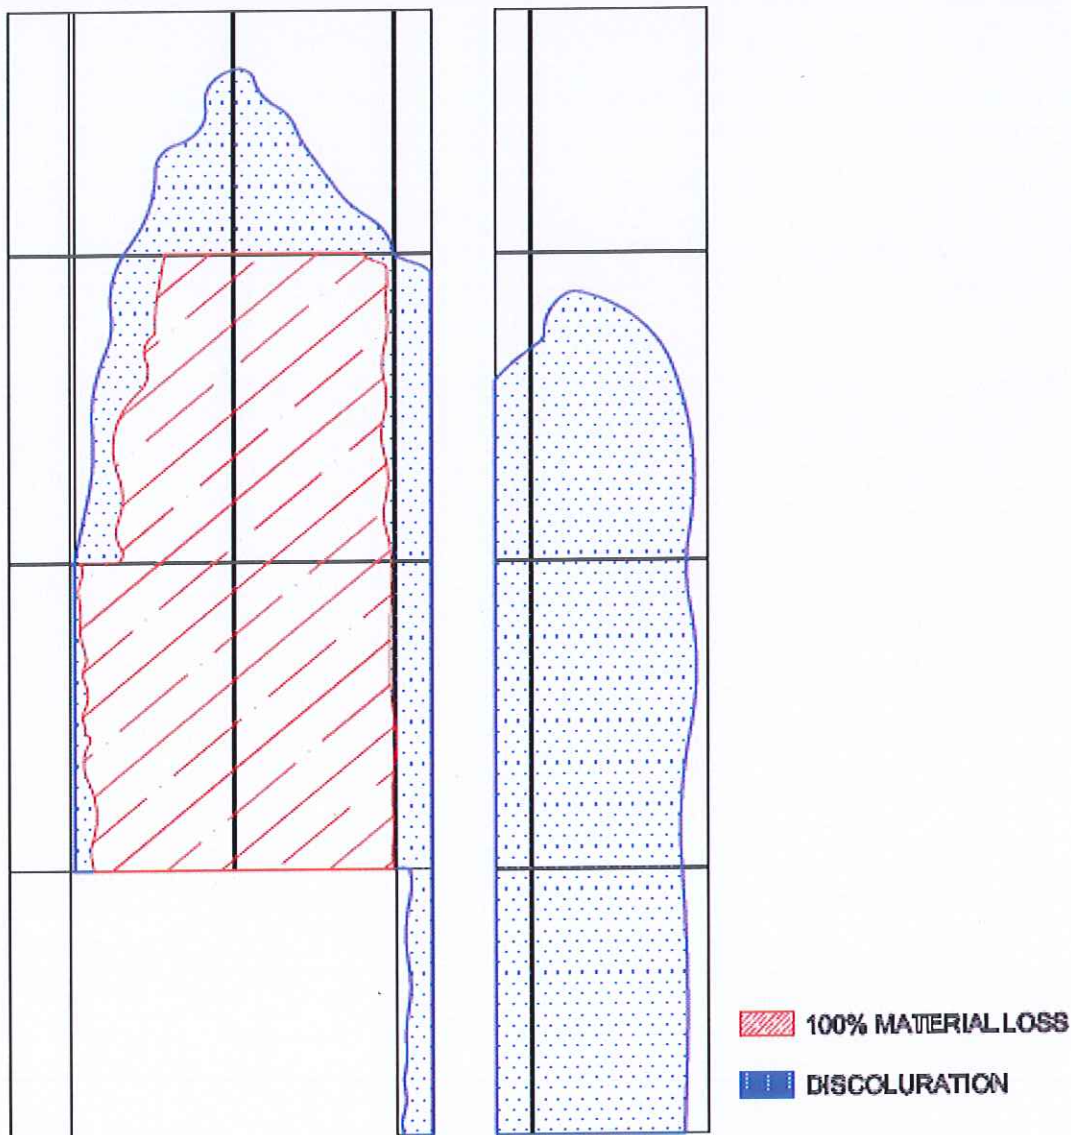
Figure 8 ACM panel damaged area

- Approximately 8m² of the total panel was completely consumed by fire.
- Approximately 10m² of the total panel was discoloured.

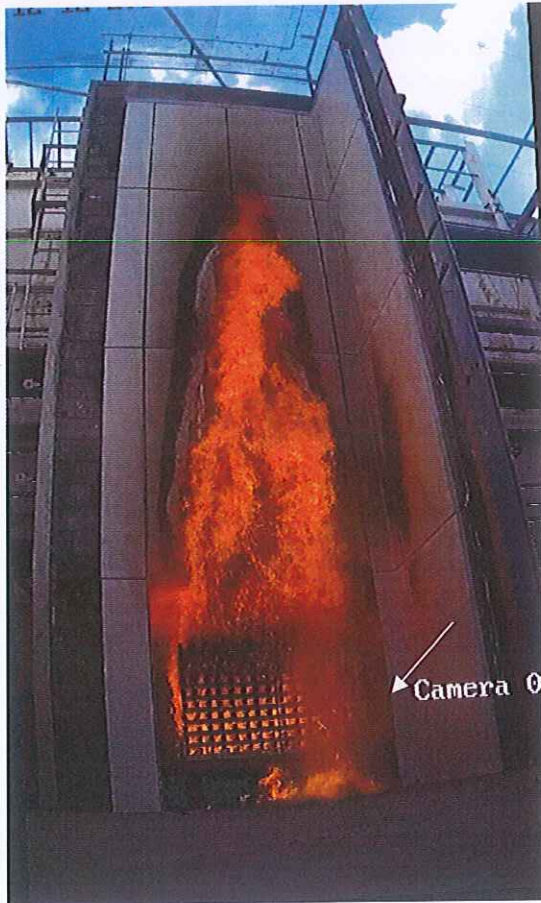
DLP C2753C /0001

09:18:00	427	Melted aluminium dripped from main wall.	-
09:18:20	447	Flame on top of flashing above combustion chamber	-
09:18:57	484	Flaming debris fell down from main wall.	DLP C2753C/0001

Flaming debris fell down from main wall.

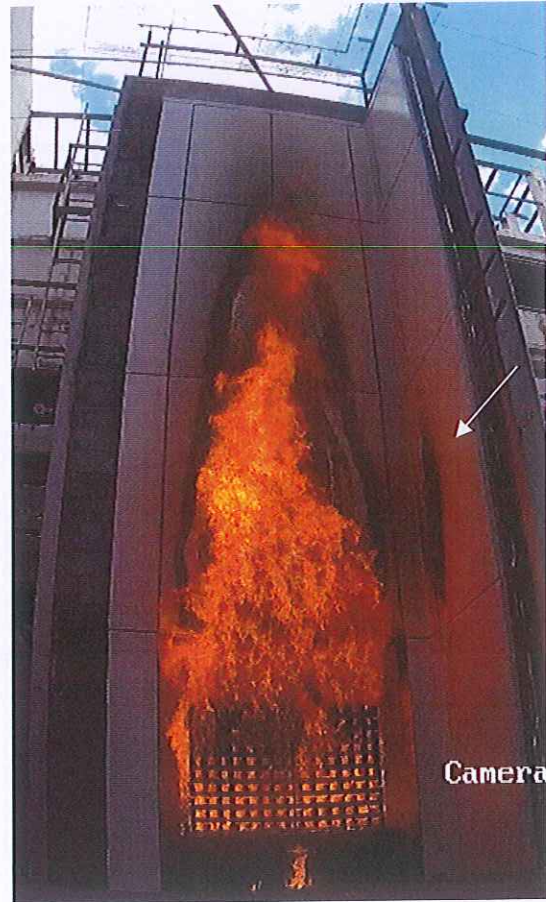
DLP C2753C /0002

09:20:06	718	Discolouration on panel W2	DLP C2753C/0002
09:20:23	570	Discolouration on panels M12 and M13	-
09:20:30	577	Sustained flame observed on M4 & M5 vertical joint.	DLP C2753C/0003

Discolouration on W2

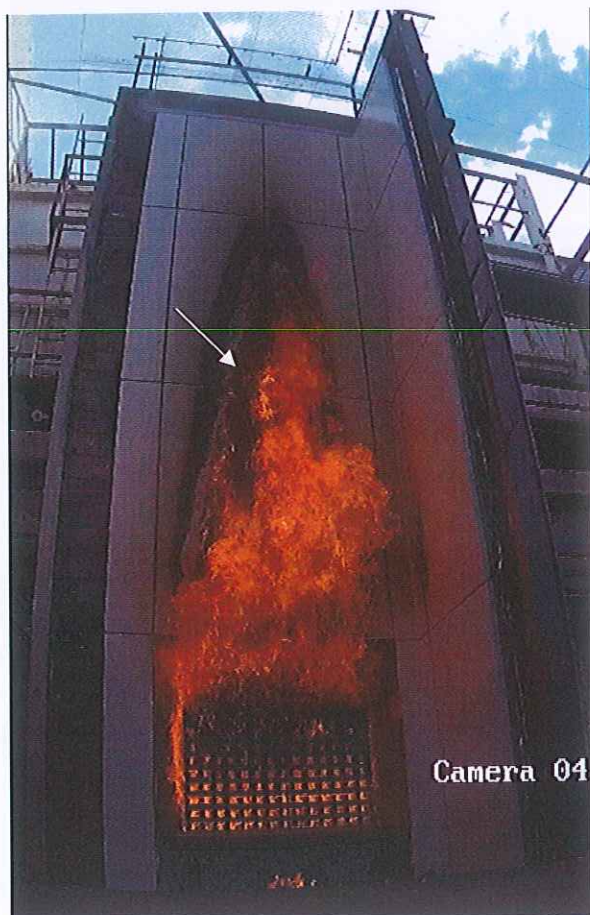
DLP C2753C/0003 Self sustained flame on M4 & M5

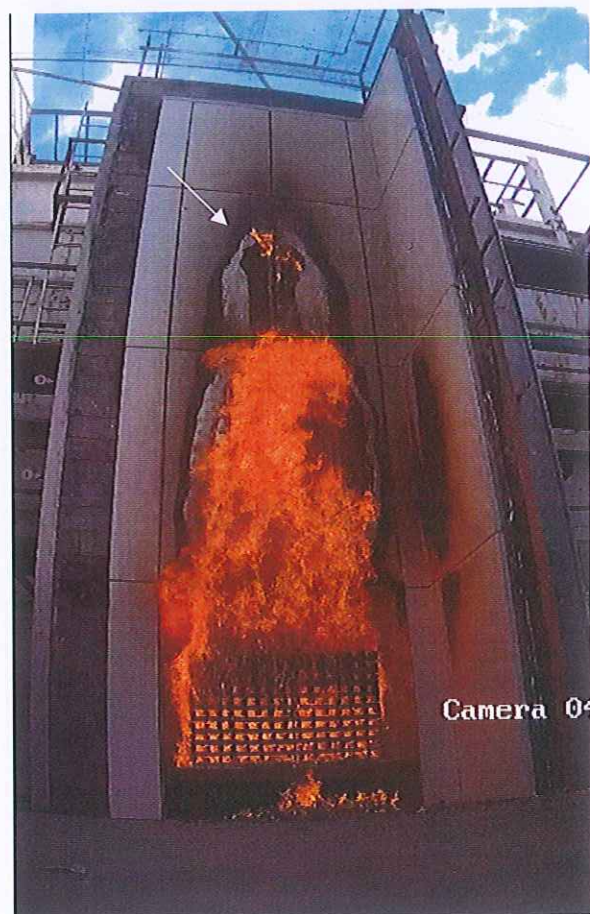
09:21:00	607	Flames observed in around burned edges of panel M4	-
09:21:28	635	Sustained flame observed on M8 & M9 vertical joint.	DLP C2753C/0004
09:22:53	720	Burning debris fell off the main wall.

DLP C2753C/0004 Self sustained flame between M8 & M9

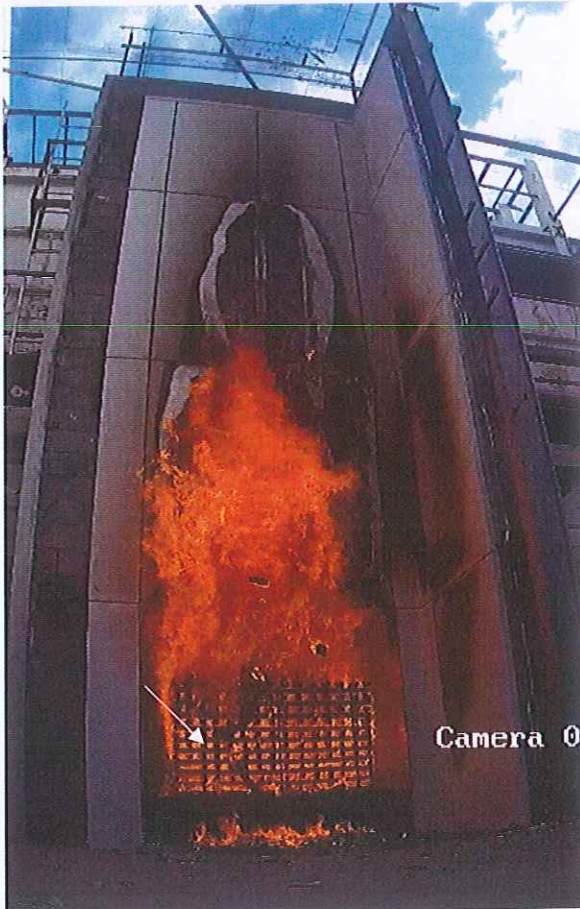
09:28:14	1041	Aluminium railings behind panel M4 and M5 melted	-
09:28:44	1071	Debris fell off the main wall.	DLP C2753C/0005
09:30:38	1185	Sustained flame at corners of panels M4 & M5.	-

DLP C2753C/0005 Debris fell off the main wall

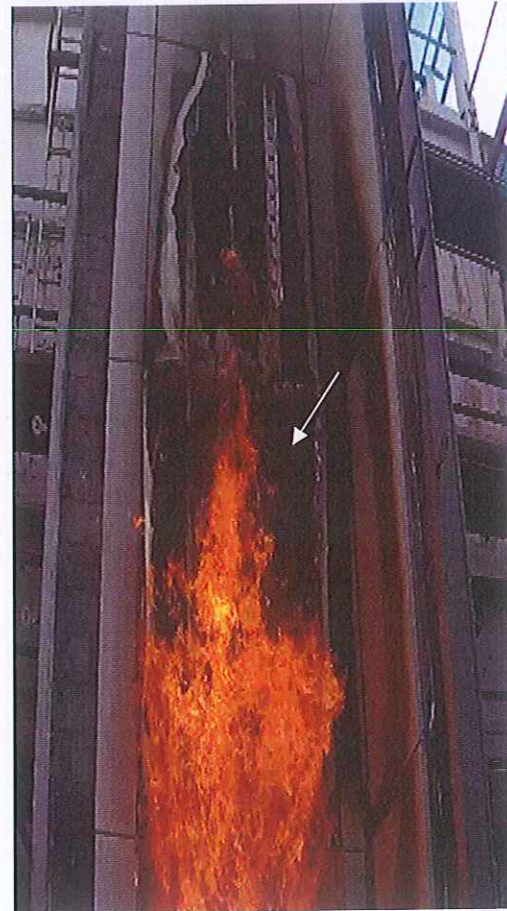
09:32:26	1293	100% of the panels M4 and M5 were consumed by fire.	DLP C2753C/0006
09:33:00	1327	Insulation behind burned panels were exposed as char.	-
09:35:39	1486	Burned insulation behind the panel M4 & M5 fell off.	-

DLP C2753C/0006 M4 & M5 panels consumed by fire

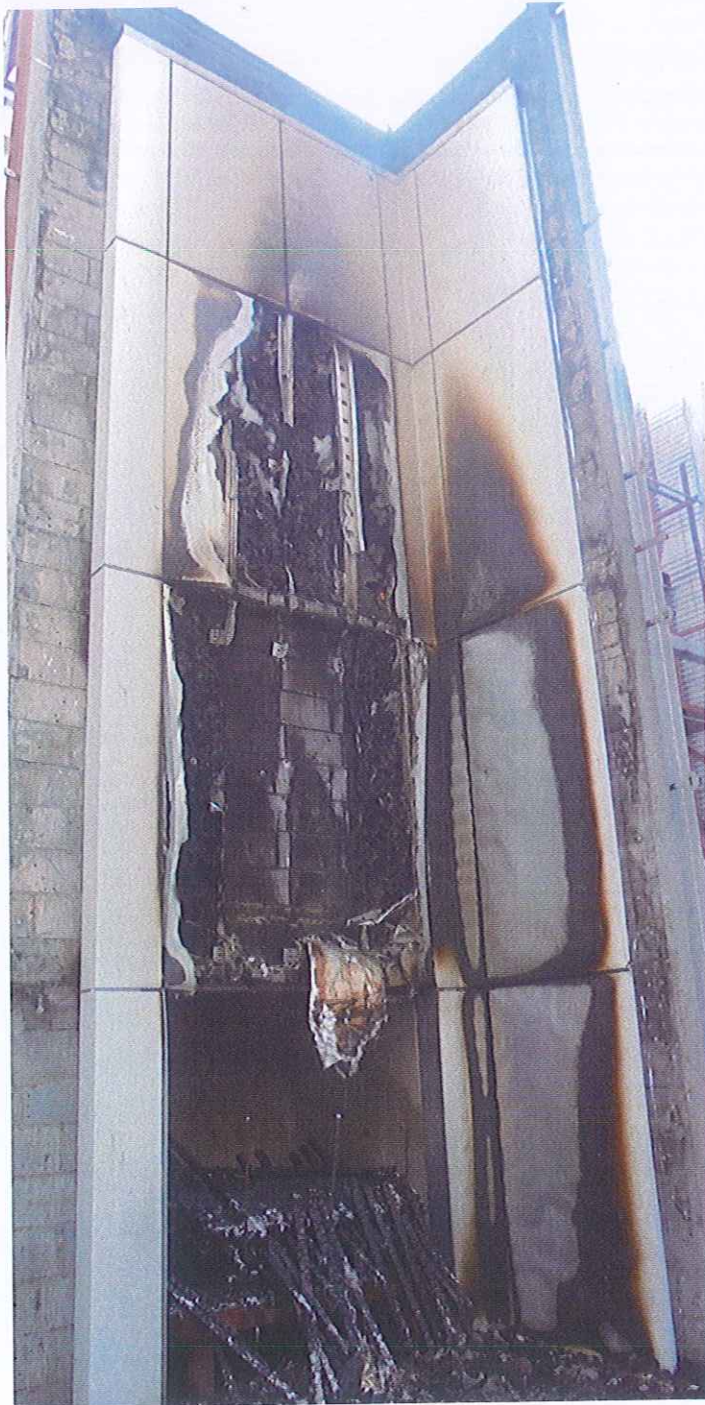
DLP C2753C/0007

Sl. No.	Components	Observation	Photo Reference
1	Aluminium composite panels	<p>Approximately 27% of material loss on the panels.</p> <p>Approximately 37% of panel was discoloured.</p> <p>Panels M1, M7, M11 and M14-W7 corner, W8 - No damage was observed.</p> <p>Panel M2-W1 corner – 100% discolouration on W1. Minor discolouration on M2.</p> <p>Panel M3 - Minor discolouration was observed at edge. No other damage was observed</p> <p>Panels M4, M5 - 100% of the panel was consumed by fire.</p> <p>Panel M6-W3 corner - 100% of the panel was discoloured and 1st layer of coating was burned from panel W3.</p> <p>Panel M8 - Approximately 60% of the panel was consumed by fire, the remaining was distorted, discoloured and buckled.</p> <p>Panel M9 - Approximately 90% of the panel was consumed by fire, the remaining was distorted, discoloured and buckled.</p> <p>Panel M10-W5 corner - Minor discolouration was observed.</p> <p>Panels M12, M13 – Top coating was burned at the vertical joint, discolouration was observed</p> <p>Panels M12, M13 – Top coating was burned at the vertical joint.</p> <p>W2- Approximately 80% top coating was burned and discoloured.</p> <p>W4- Approximately 75% top coating was burned, discoloured and buckled.</p> <p>W6- Approximately 50% discolouration was observed.</p>	<p>DLP C2753C/0007</p> <p>See Figure 8 in this section for area details.</p>

Sl. No.	Components	Observation	Photo Reference
5	Brackets	100% of brackets behind panels M4, M5, M6-W4, M8 and M9 were damaged. All other brackets were discoloured and were in place without any damage.	DLP C2753C/0007.

View of the sample after the test completion

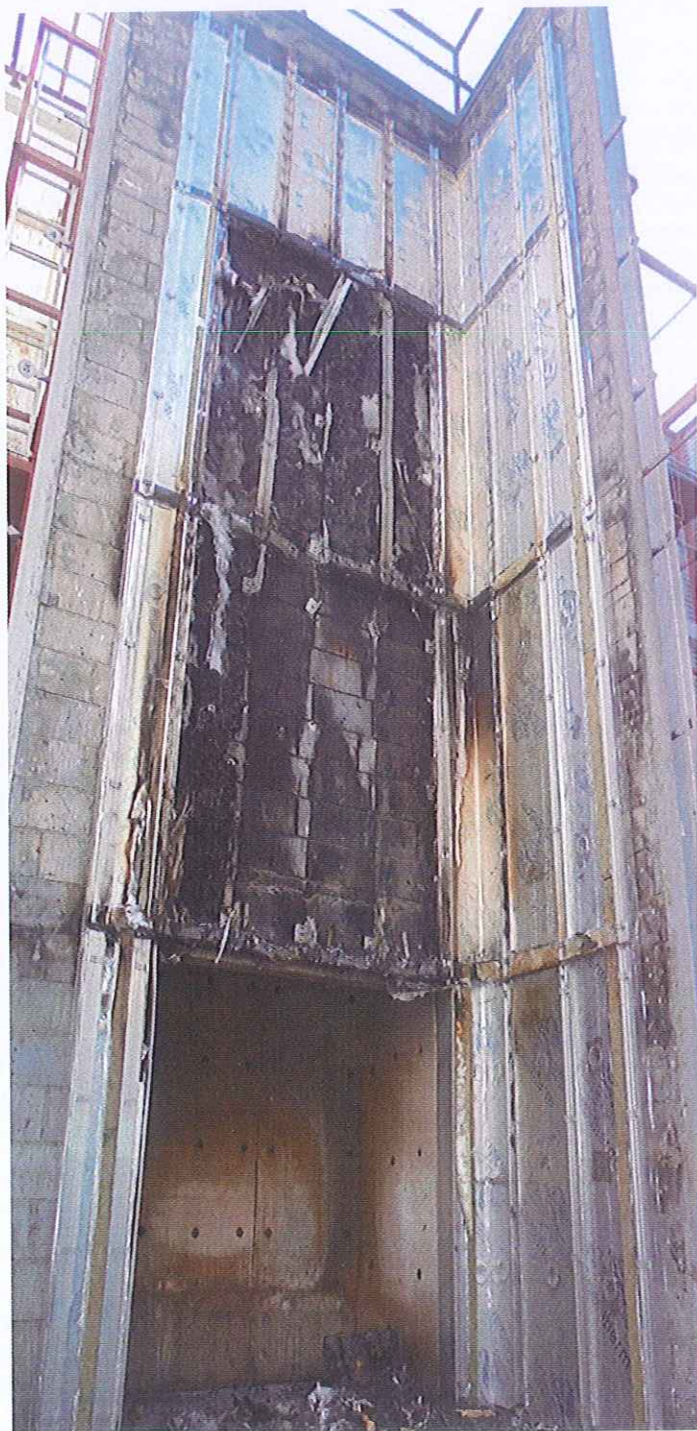
Sl. No.	Components	Observation	Photo Reference
2	Cavity barrier	<p>Horizontal intumescent cavity barrier:</p> <p>The 1st horizontal cavity barrier at 150mm above the combustion chamber was activated. Melted aluminium debris fell onto the barrier and was compressed by its weight. Material loss and damage was observed.</p> <p>The 2nd horizontal cavity barriers at 2480mm was activated. The expanded intumescent layer was not present on the main wall during dismantling.</p> <p>The 3rd horizontal cavity barriers at 4810mm on main wall was activated and on wing wall was not activated. No material loss were observed.</p> <p>The 4th horizontal cavity barriers at 6425mm on main wall and was partially activated on main wall and on wing wall was not activated. No material loss was observed.</p> <p>Vertical cavity barrier:</p> <p>Minor discolouration and buckling to the vertical cavity barriers extending between panel M1 and combustion chamber.</p> <p>Buckling and minor material loss on vertical cavity barriers extending between combustion chamber and panel M2. No damage to the vertical cavity barrier on wing wall.</p>	DLP C2753C/0008, DLP C2753C/0009 & DLP C2753C/0010.

3	Insulation	<p>100% damage on Kooltherm K15 insulations and core wall was exposed behind panels M4, M5.</p> <p>Insulation behind W3 was discoloured.</p> <p>Insulation behind M8, M9 was damaged and exposed as charcoal.</p> <p>All other insulations were in place without any damage.</p>	DLP C2753C/0008 & DLP C2753C/0009
4	Railing	<p>All railings behind panels M4 & M5 were melted off.</p> <p>Railings behind panels M3, M7, M11, M12 and M13 were discoloured.</p> <p>Railings behind M2-W1 and W2 were buckled and discoloured. All other railings were in place without any damage.</p>	DLP C2753C/0009

DLP C2753C/0008 Cavity barrier and insulation

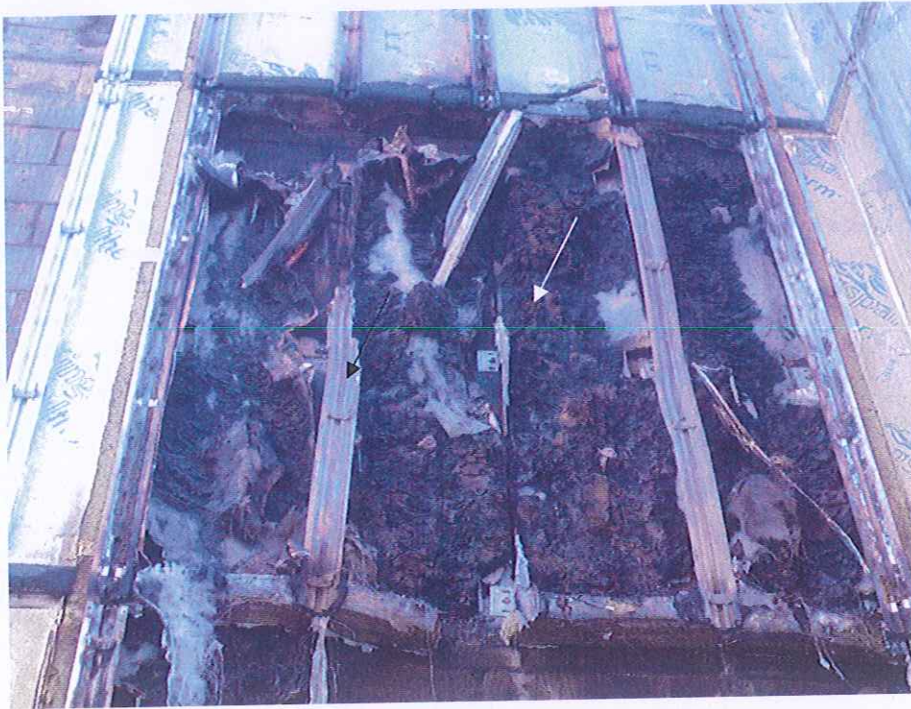
DLP C2753C/0009

Burned Kooltherm K15 insulation and railings

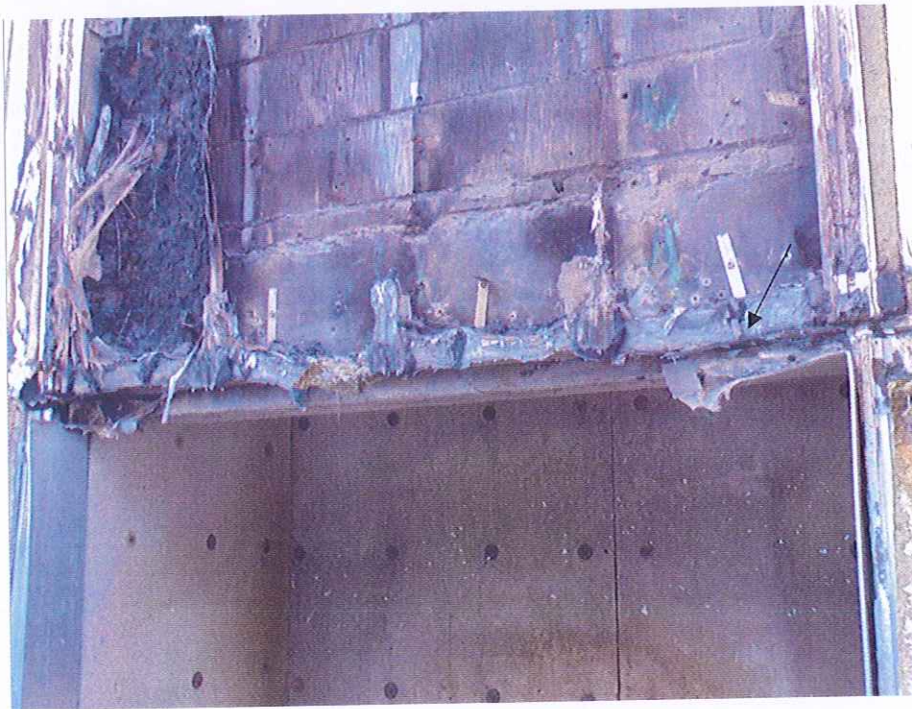
DLP C2753C/0010

Cavity barrier at the top of combustion chamber
