**BS 8414-2:2005 test on a
150mm BENCHMARK
Evolution Panel.**

Prepared for:
Kingspan Ltd
Greenfield Business Park No 2,
Holywell,
Flintshire.
CH8 7GJ.

15th May 2014

Test report number 293939

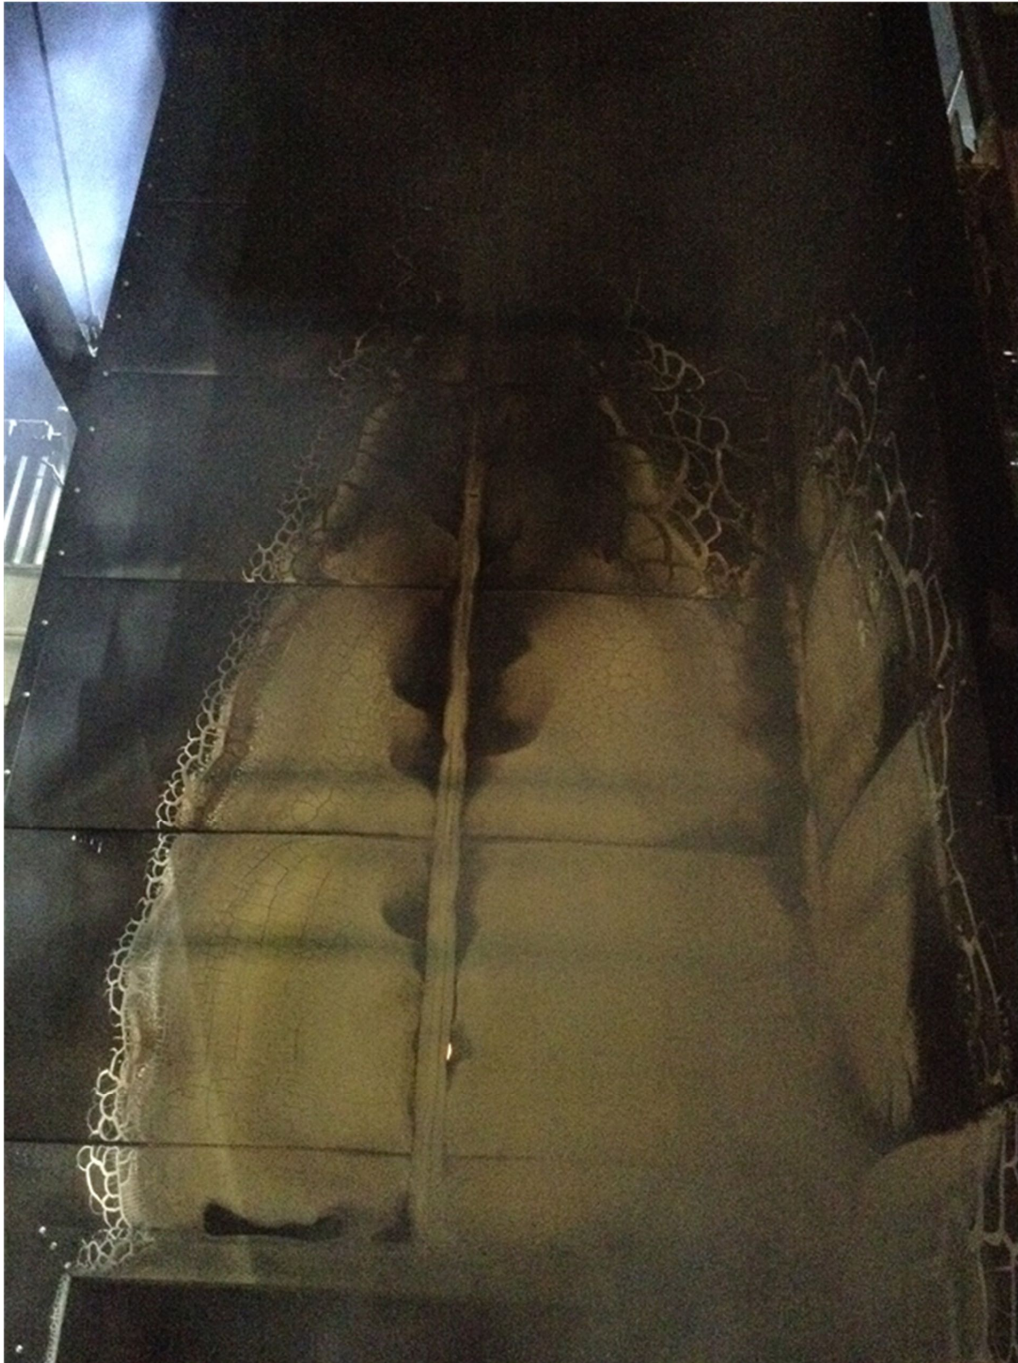
Figure 14. Photograph showing the condition of the cladding system post-test (Decorative Layer Full height).

A schematic illustration of the damage to the system is shown in Figure 16. The condition of the cladding system after the test is shown in Figure 14 and Figure 15.

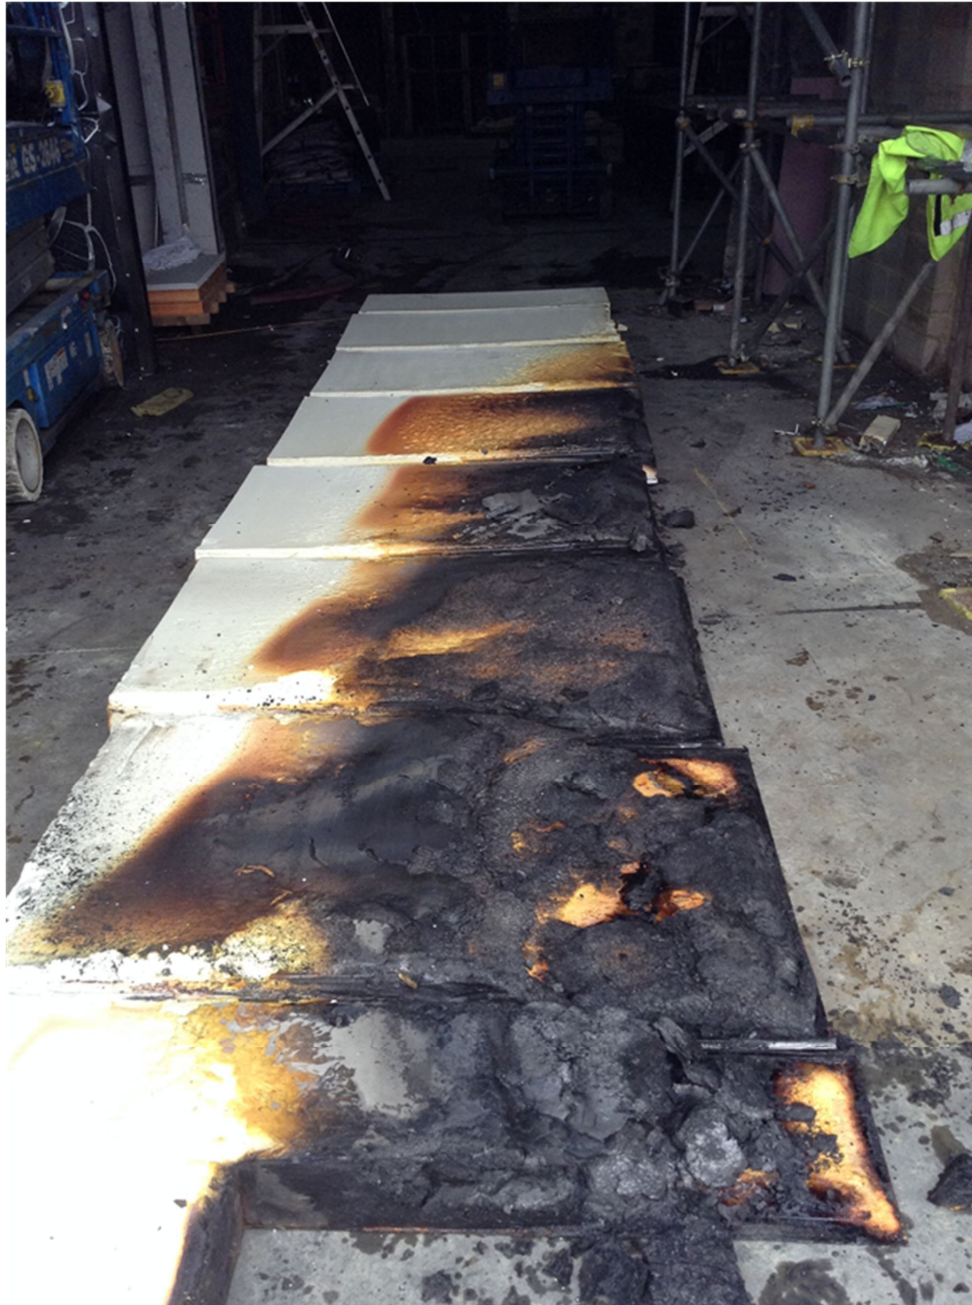
Figure 17. Photograph showing the condition of the insulation layer post-test (Insulation Layer removed from cladding wall).

The condition of the panels after the test is shown in Figure 17 and Figure 18.
