BRE Global Test Report

BS 8414-2: 2005 Test on a Kingspan BENCHMARK 220mm QuadCore™ Wall liner panel with a Corium brick system.

Prepared for: Kingspan Ltd
Date: 7th November 2016
Report Number: P102340-1000 issue 1

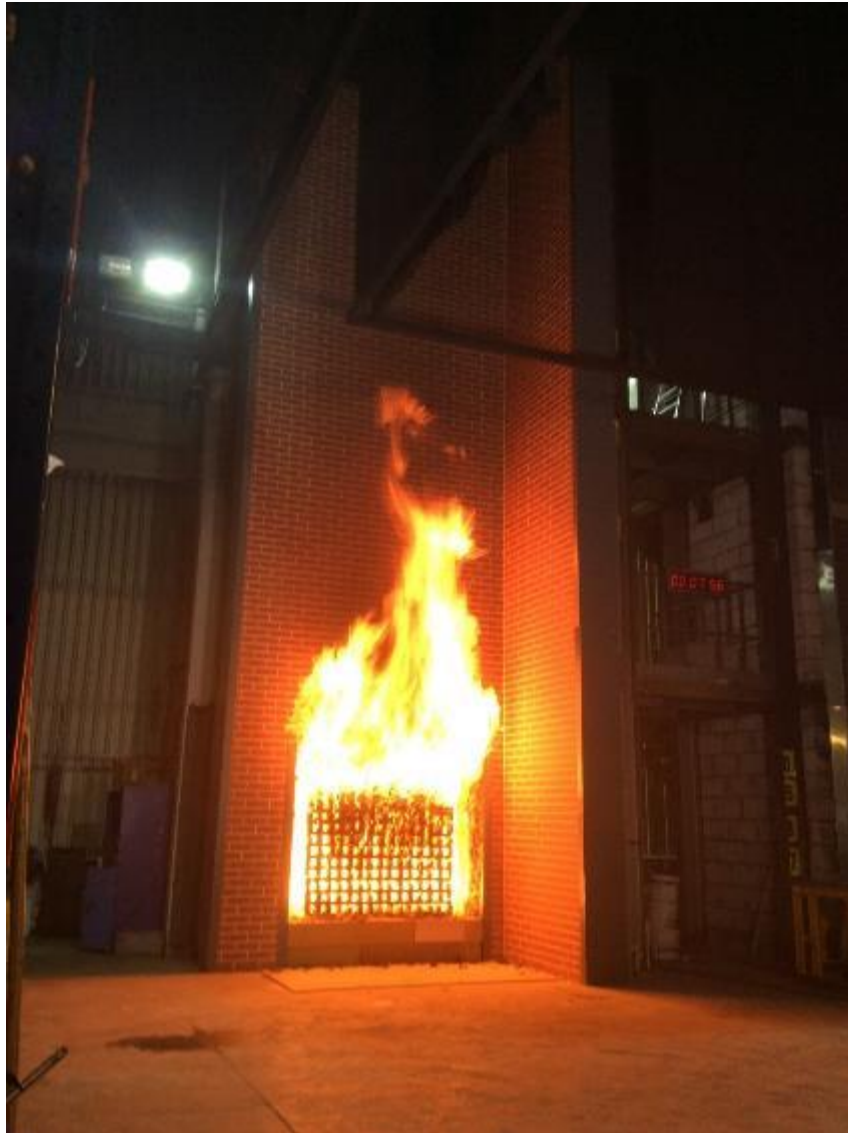
Time (mins:secs)	Description
-5:00	logger start.
0:00	Ignition of crib.
2:08	Flames out of hearth.
4:23	Flames to 2.0m cladding wall main face centreline.
7:20	Spalling of brick small bits outside area. Rapid spalling from the Corium bricks.
12:40	Spalling of brick, small bits outside area flames to 2m cladding wall main face.
15:30	Spalling of brick, small bits falling outside of impact area.
21:45	Crib starts to collapse. Flames 2.5 m cladding wall main face.

Figure 13. Cladding system during the test.

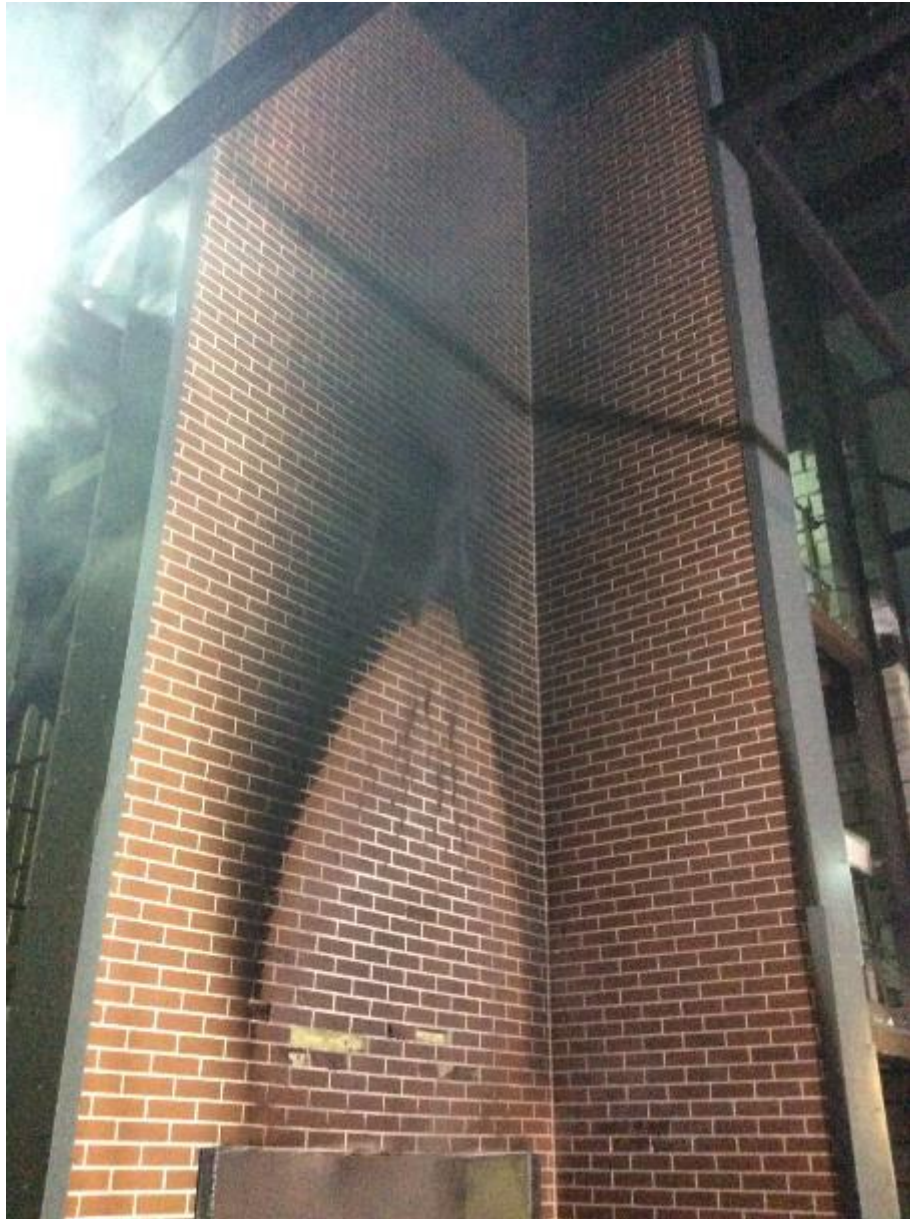
Damage to the outer layer of Corium brick was limited to the area within the flame plume and was limited to the loss of three full Corium brick on the main wall and five half bricks. The remaining damage consisted of minor spalling of the surface of seven bricks.

Figure 18. Damage to upper main wall (Corium bricks).

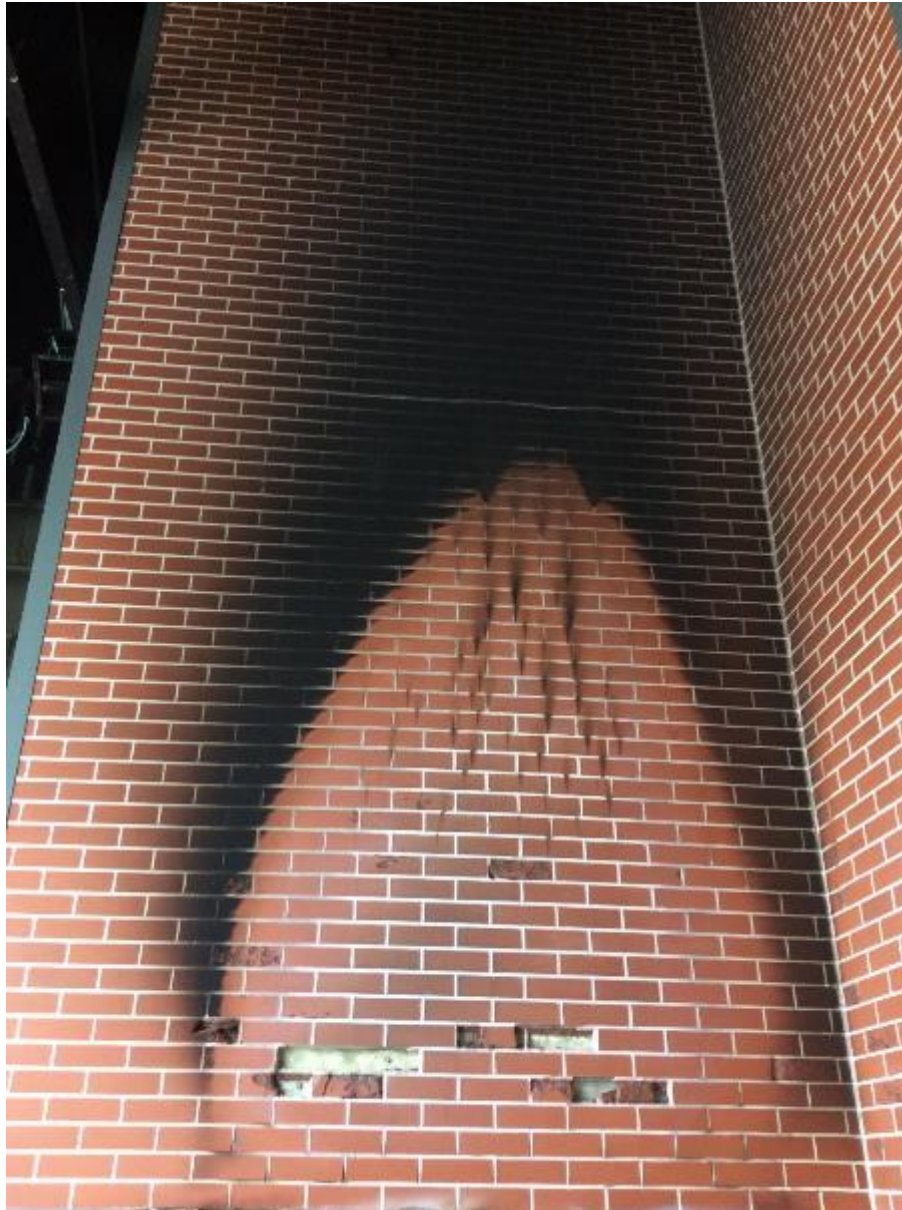
Figure 19. Damage to lower main wall (Corium bricks).

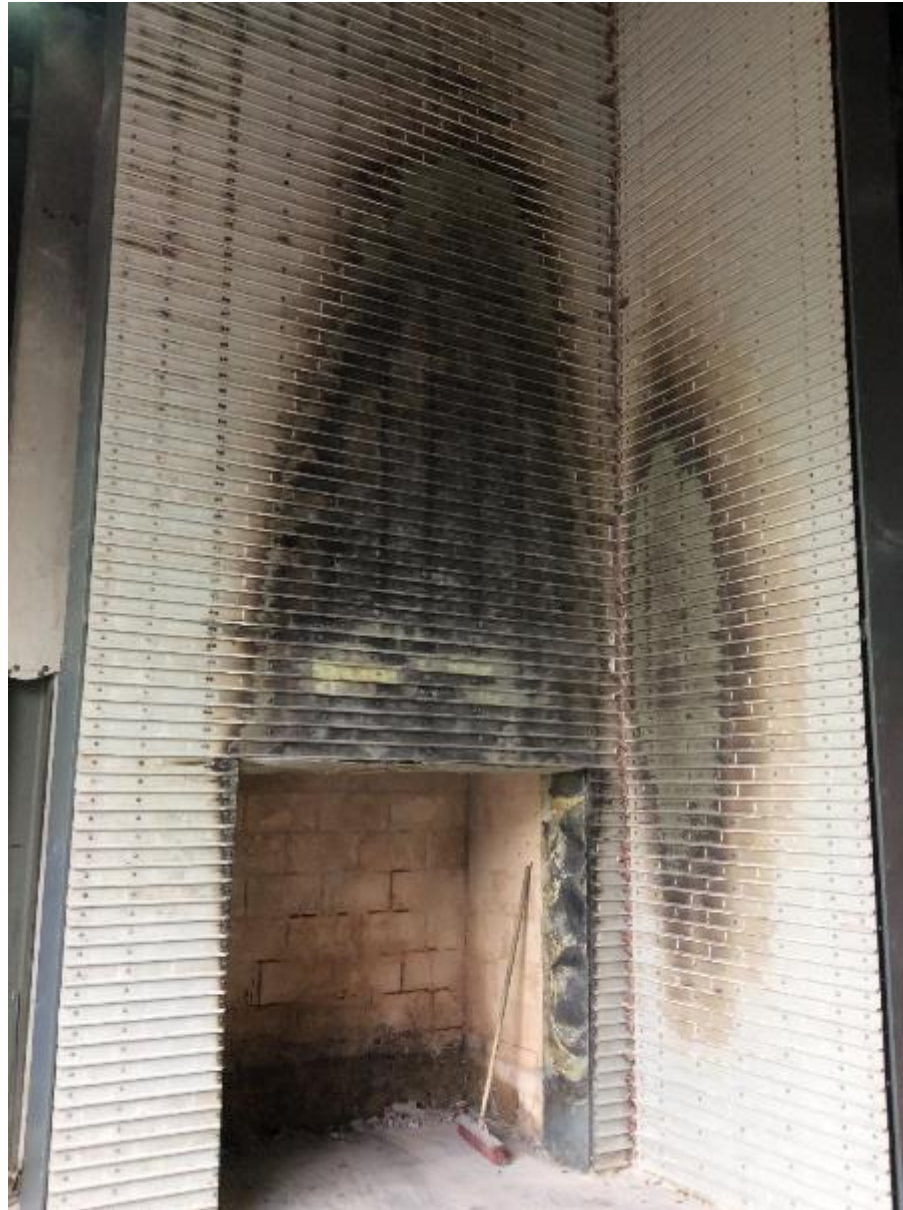
Damage to this area was consistent in extent to that seen on the Corium bricks and did not extend beyond the area of damage caused by heat transfer from the direct heating of the Corium bricks within the flame plume area. On the wing wall an area with a width of around 0.5 m and a height of 2m was damaged. Again this was caused by heat transfer from the direct heating of the Corium bricks.

Figure 20. Damage to lower main and wing walls (Corium brick rail system).

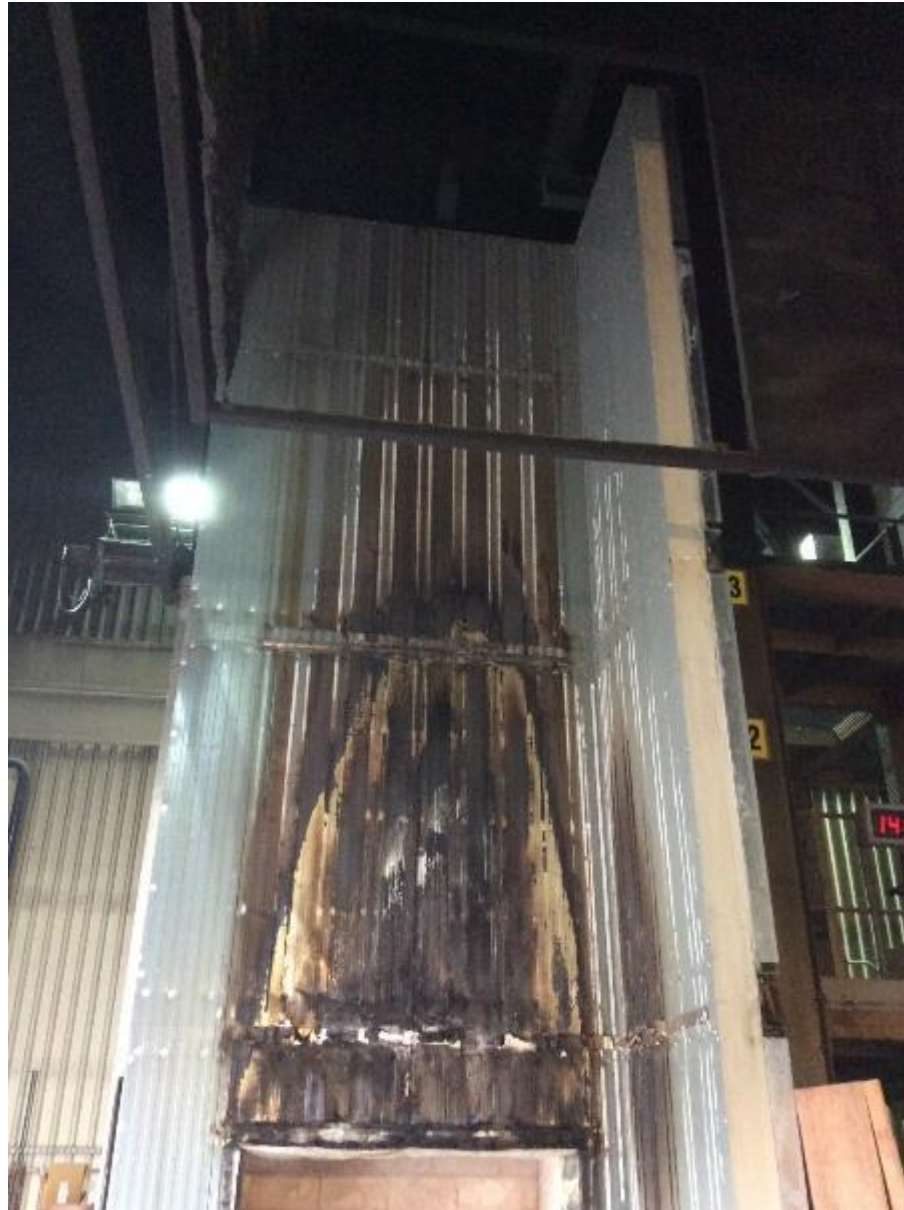
Damage to this area was consistent with the damage to the Corium bricks and the Corium brick rails and did not extend beyond the area of damage caused by heat transfer from the direct heating of the Corium bricks within the flame plume area. On the wing wall an area with a width of around 0.5 m and a height of 1.5m was damaged. Again this was caused by heat transfer from the direct heating of the Corium bricks and through the Corium brick rails.

Figure 21. Damage to upper main wall (insulation layer).

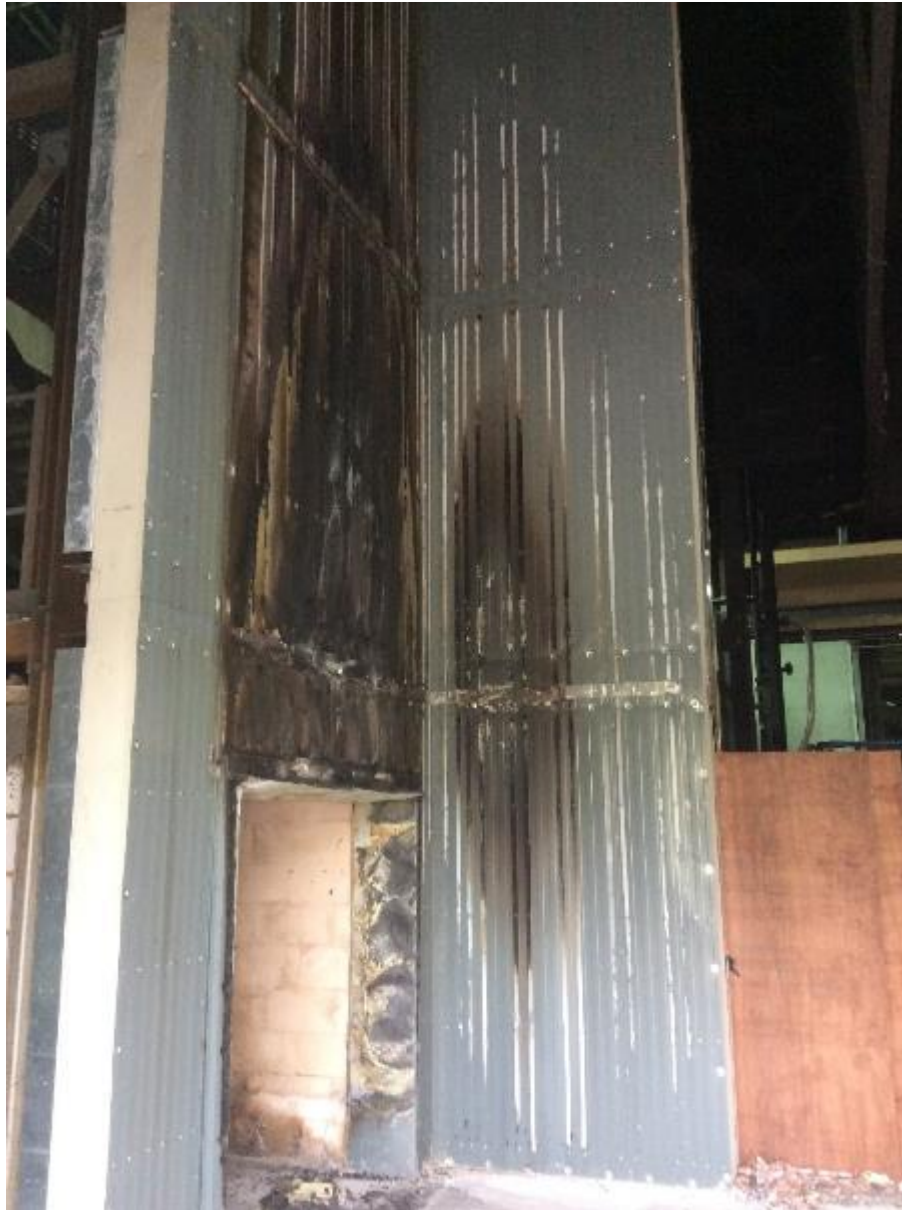
Figure 22. Damage to lower wing wall (insulation layer).
