BRE Global Test Report

BS 8414-2 : 2005 Test on a Gebrik Rainscreen Cladding System

Date: 21 September 2015

Report Number: P100838-1000 Issue 2

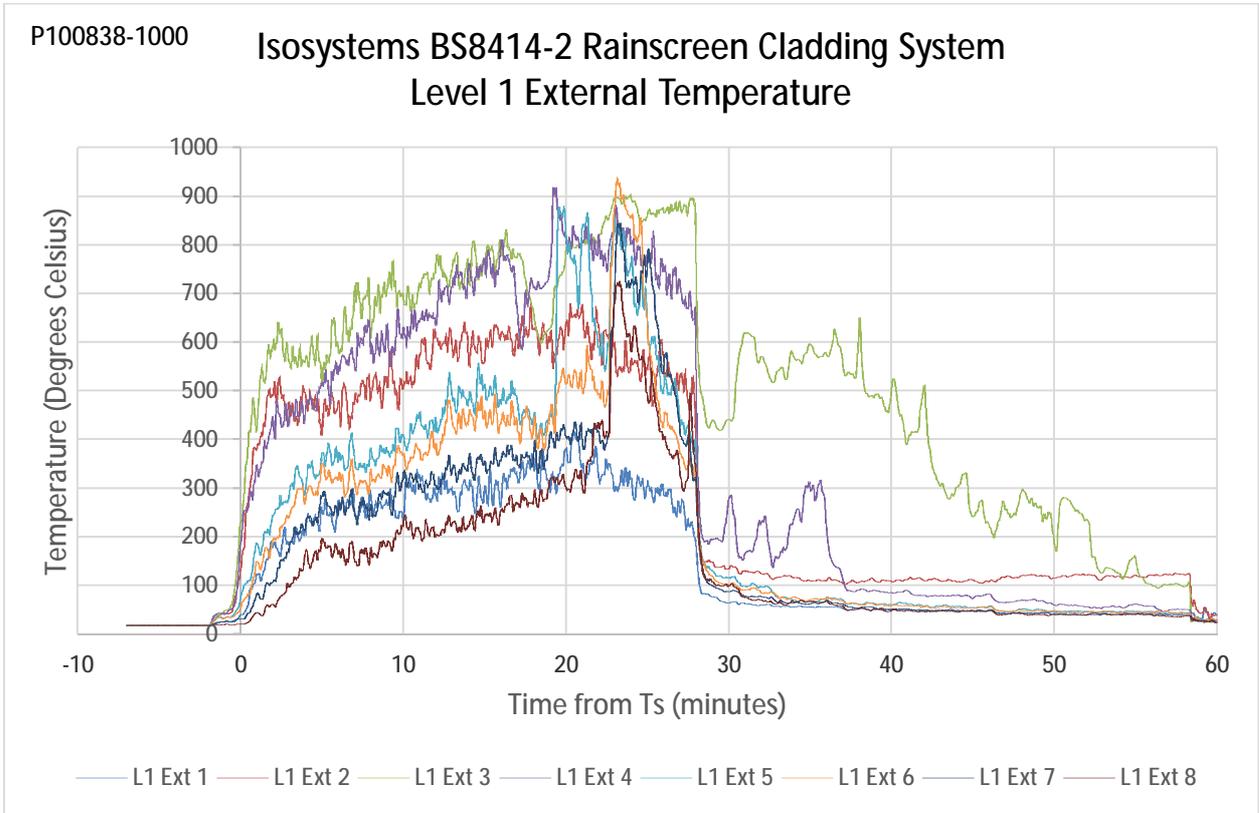
Figure 10. Temperatures Level 1 External

Parameter	Result
T _s , Start Temperature	221.7°C
Peak Temperature in first 15 minutes of test	770.5°C 15 minutes after ignition of the crib at thermocouple "Level 1 Ext 3"
t _s , Start time	2 minutes; 1 second after ignition of the crib
Peak temperature/time at Level 2, 50mm external	651.2°C 23 minutes; 8 seconds after ignition
Peak temperature/time at Level 2, Cavity 1	154.6°C 60 minutes after ignition
Peak temperature/time at Level 2, Insulation Layer	295.6°C 57 minutes; 30 seconds
Peak temperature/time at Level 2, cement particle board	84.1°C 58 minutes; 48 seconds
Peak temperature/time at Level 2, cavity 2	27.5°C 41 mins; 15 seconds
Peak temperature/time at Level 2, Plasterboard	20.9°C 58 minutes; 12 seconds

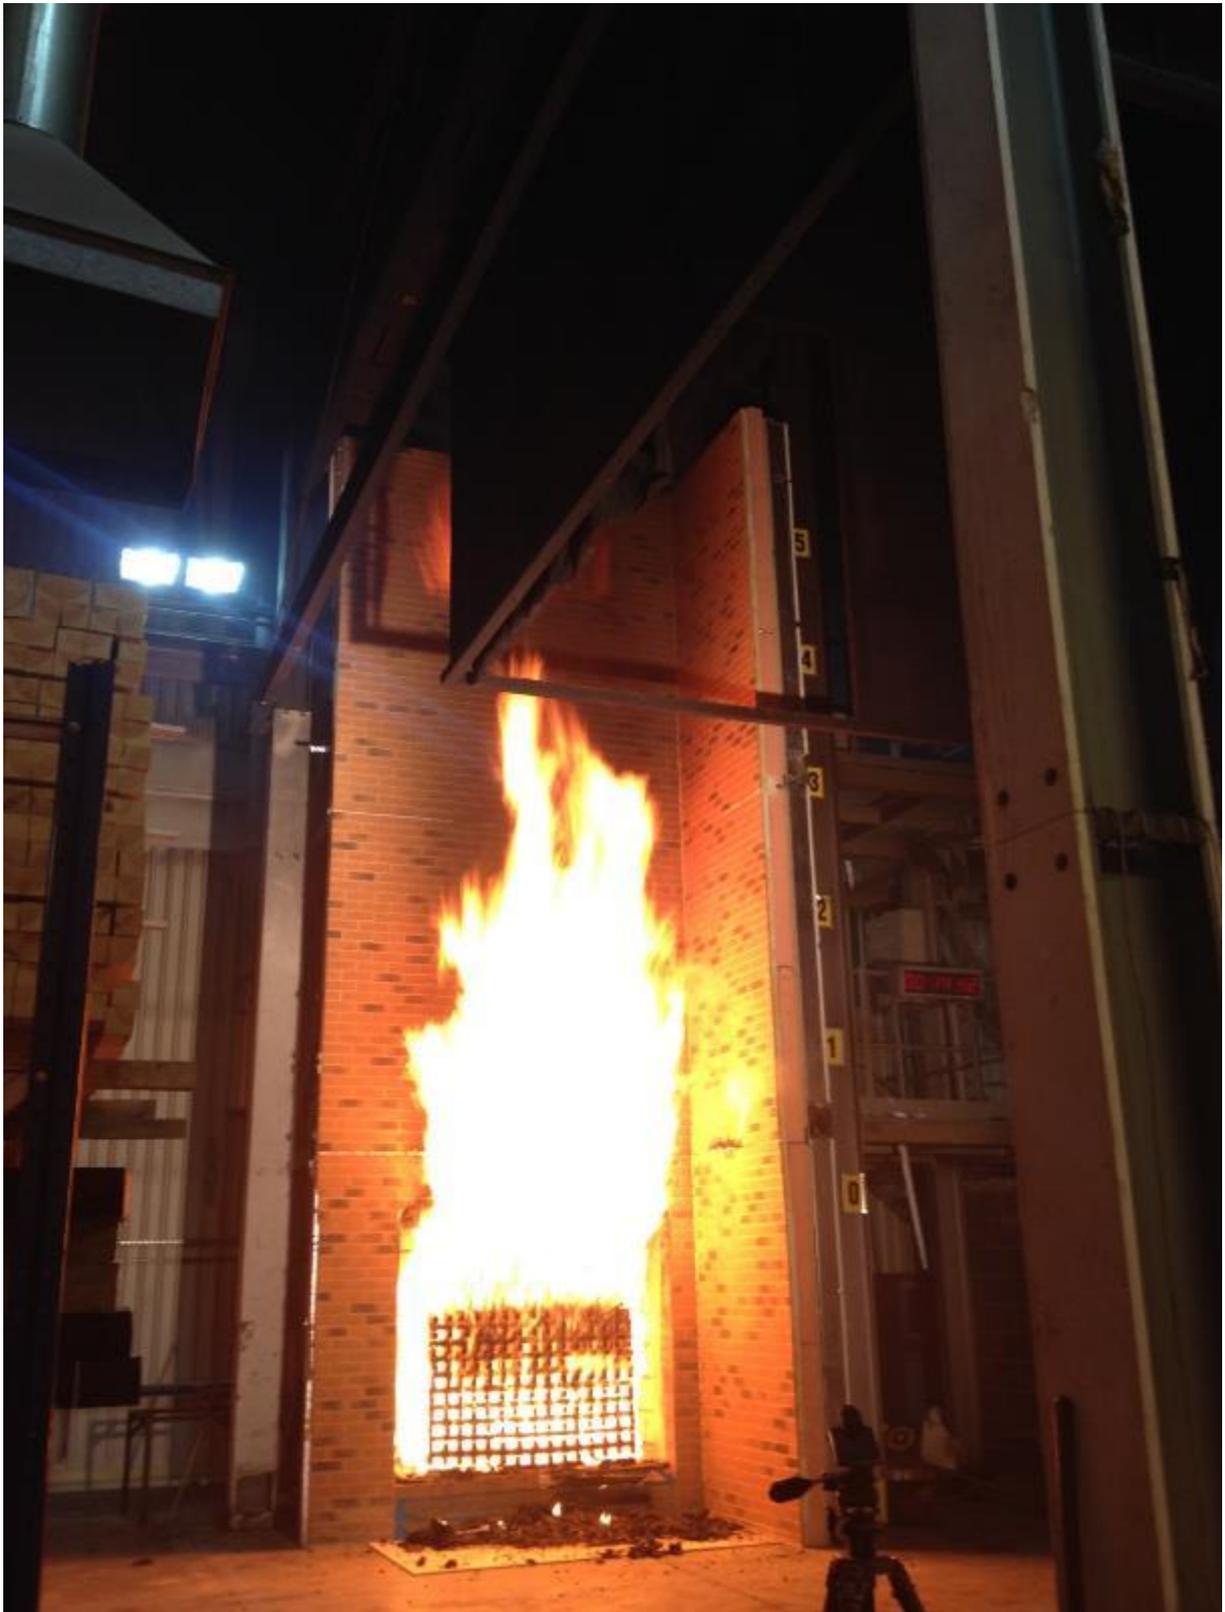
Figure 15. Cladding system during the test.

Time (mins:secs)	Description
-5:00	Logger start
0:00	Ignition of crib
2:17	Flames out of hearth
2:59	Flames to 1.5m on main face
6:08	Flames to 2.5m on main face

8:15	Brick fallen from hearth surround
8:56	Brick fallen from 0.5m main face
9:15	Combustion within flame plume
10:10	Flaming on floor for more than 10 seconds

11:00	Flames to 3.5m
11:58	Bricks fallen from 1m
12:35	Pool fire on floor
13:07	Ignition of joint on wing wall 0.5m
15:56	Intermittent flaming at 4m
17:57	Bricks falling from 1.5m

19:27	Bricks falling from 2.5m Flames to 4.5m
20:09	Flaming on surface of wing wall 0.5m
21:18	Bricks falling from 3m. Flaming to 4.5m consistent
21:40	Large pool fire on floor

21:55	Flaming in corner to 3.5m
23:25	Bricks falling from 3.5m main face
23:54	Wing wall flaming from 0.5m to 2.5m
24:49	Bricks falling from wing wall 2.5m

26:00	Bricks falling from 4m main face
26:28	Wing wall flaming to 3m
26:48	Corner flaming to 4.5m
29:30	Wing wall flaming to 4m
30:00	Crib extinguished

Time (mins:secs)	Description
35:21	Wing wall bricks falling from 4m
60:00	Continued burning of insulation where brick slips had fallen away till end of test on main wall

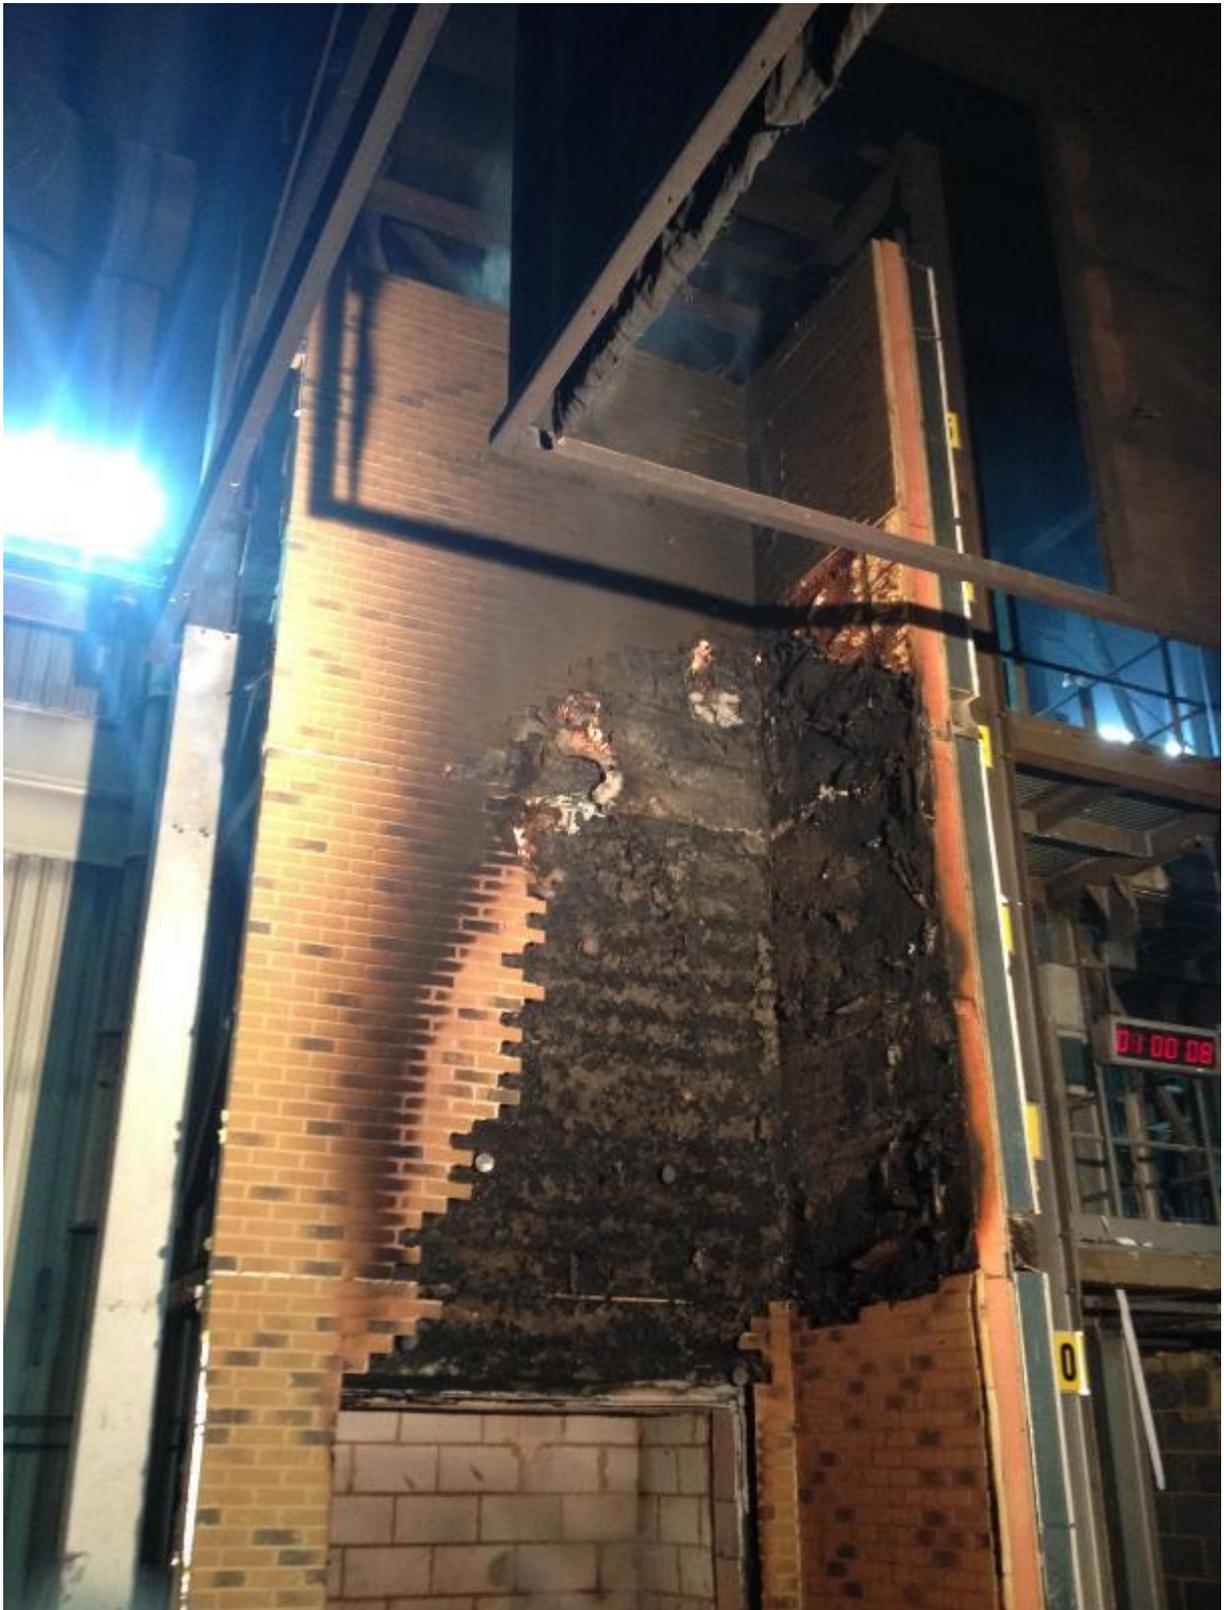
Figure 16. System on completion of the test

Figure 16 shows the condition of the system following completion of the test. The following sections comprise a summary of visual observations made following the test.

Brickslip sections had detached from the system and fallen to the floor at the following locations:

- On the main face of the wall, between the centreline and the right side of the face, up to ~4m above the hearth level
- On the wing face of the wall, across the full width of the wall from ~0.5m up to ~4.5m above the hearth.

Sections of Brickslip were cracked (or beginning to detach) out-with these detached areas, above the fallen panels on the wing and main faces of the system.

On the main face of the system, insulation was charred beneath all of the areas where brickslip sections had fallen away up to the level 2 fire break (~4m above the hearth opening).

On the wing face of the system, the insulation had charred across the full width of the wall up to ~4m above the hearth opening height.

There was an area of non-charred insulation where the bricks had fallen away without flames impinging on the insulation surface. This area was on the wing face of the wall immediately below the second level fire break at ~4.5m, as evidenced in Figure 16.
