BRE Global Test Report

BS8414-2: 2005 Test on a Kingspan K15 insulated system with a ventilated Terracotta tile rainscreen

Prepared for: Kingspan Insulation Ltd

Report Number: 303930 Issue: 3

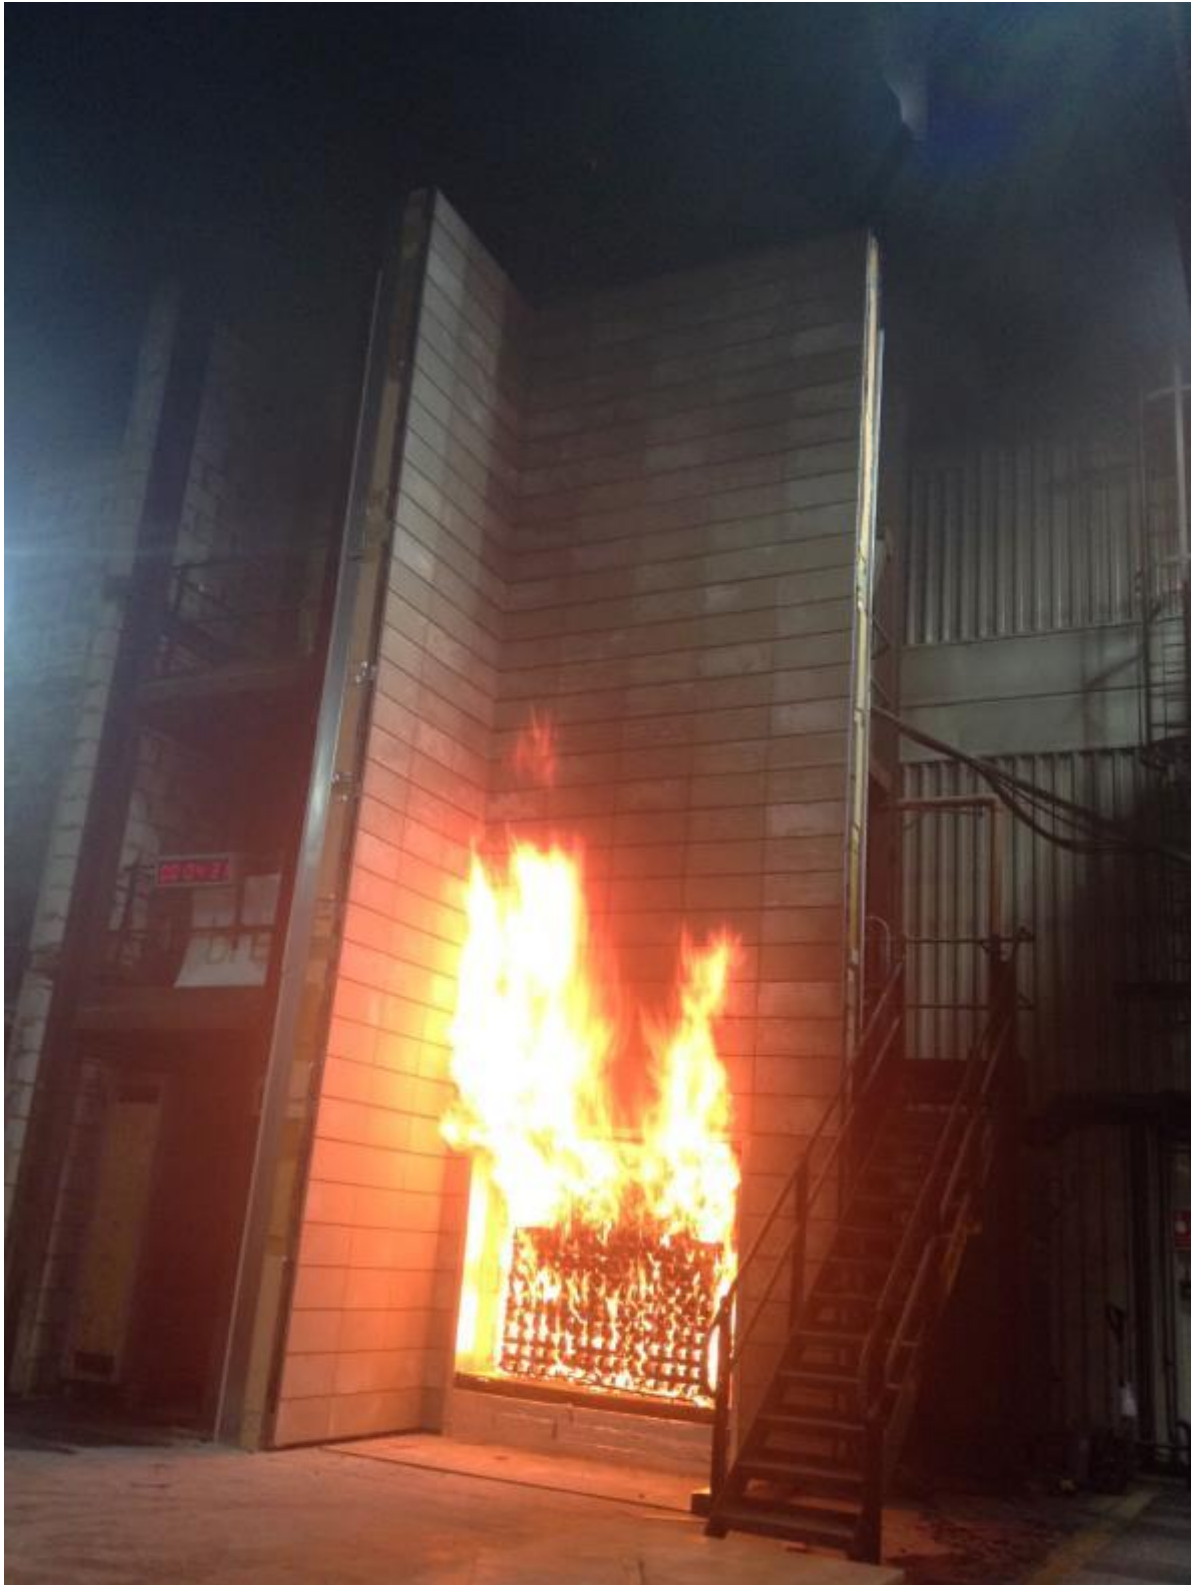
Figure 15. Cladding system during the test.

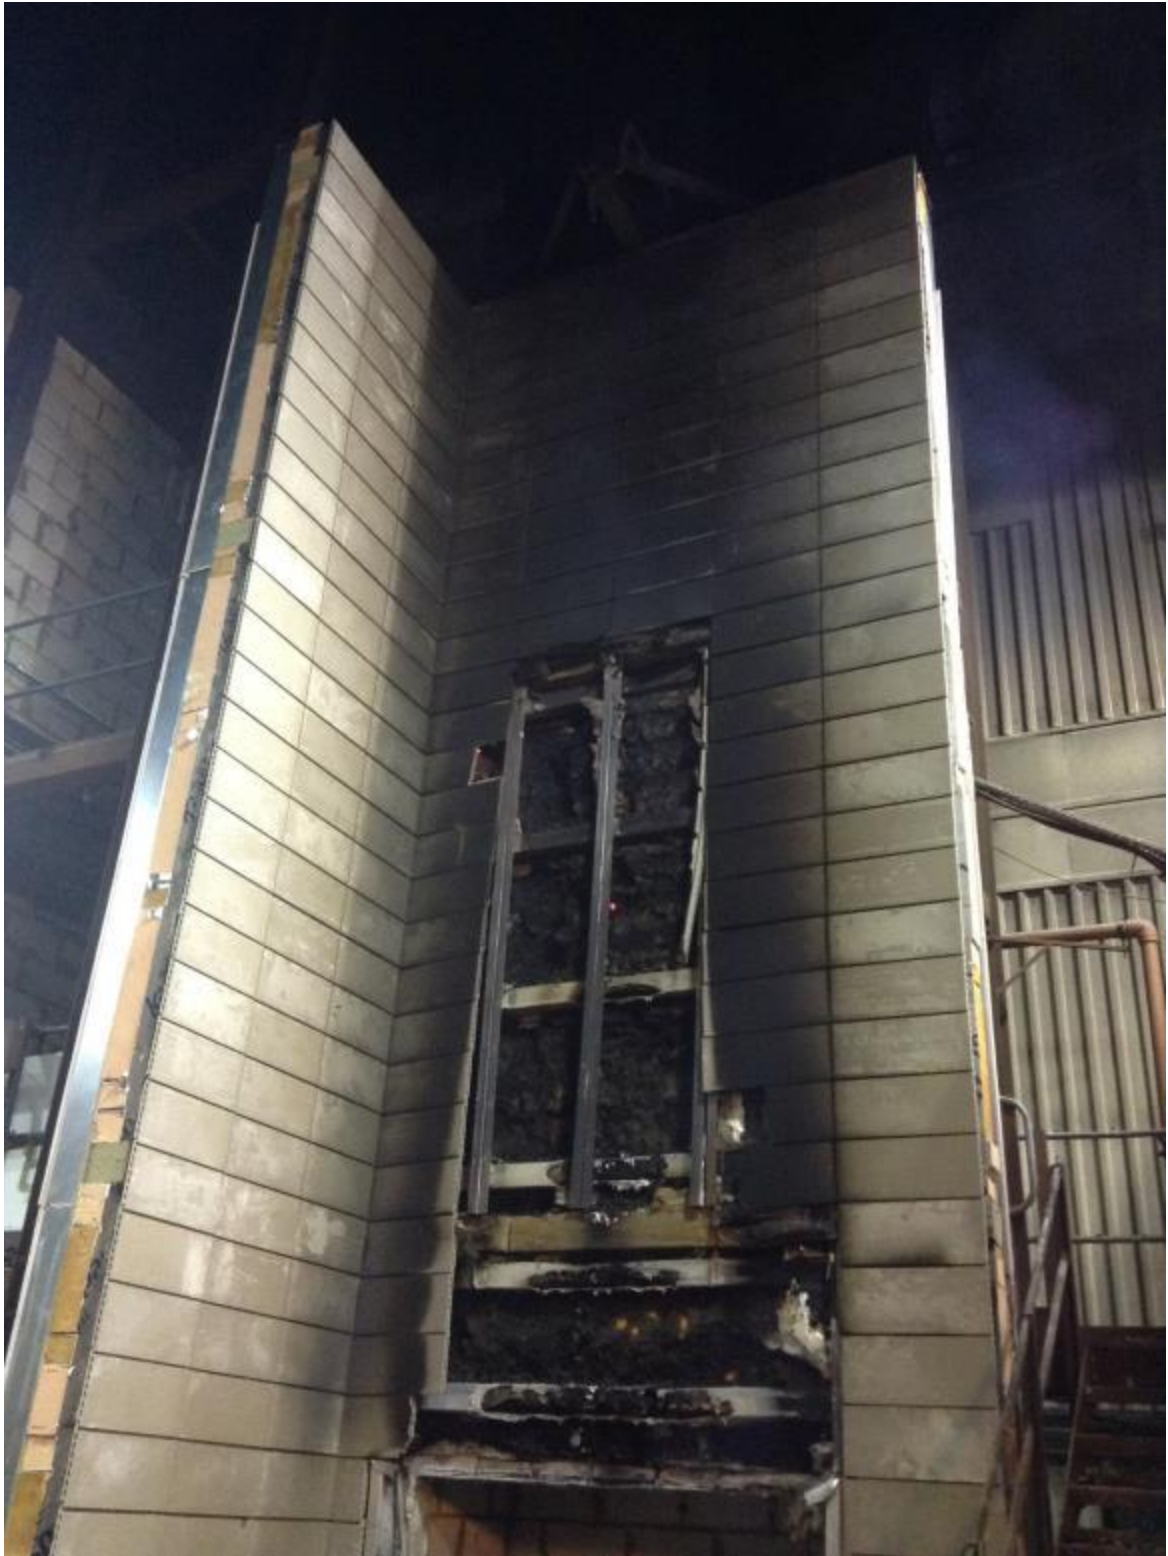
A photograph of the damage to the system is shown in Figure 16.

Figure 16. Photograph showing the condition of the cladding system post-test (Decorative Layer Full height).

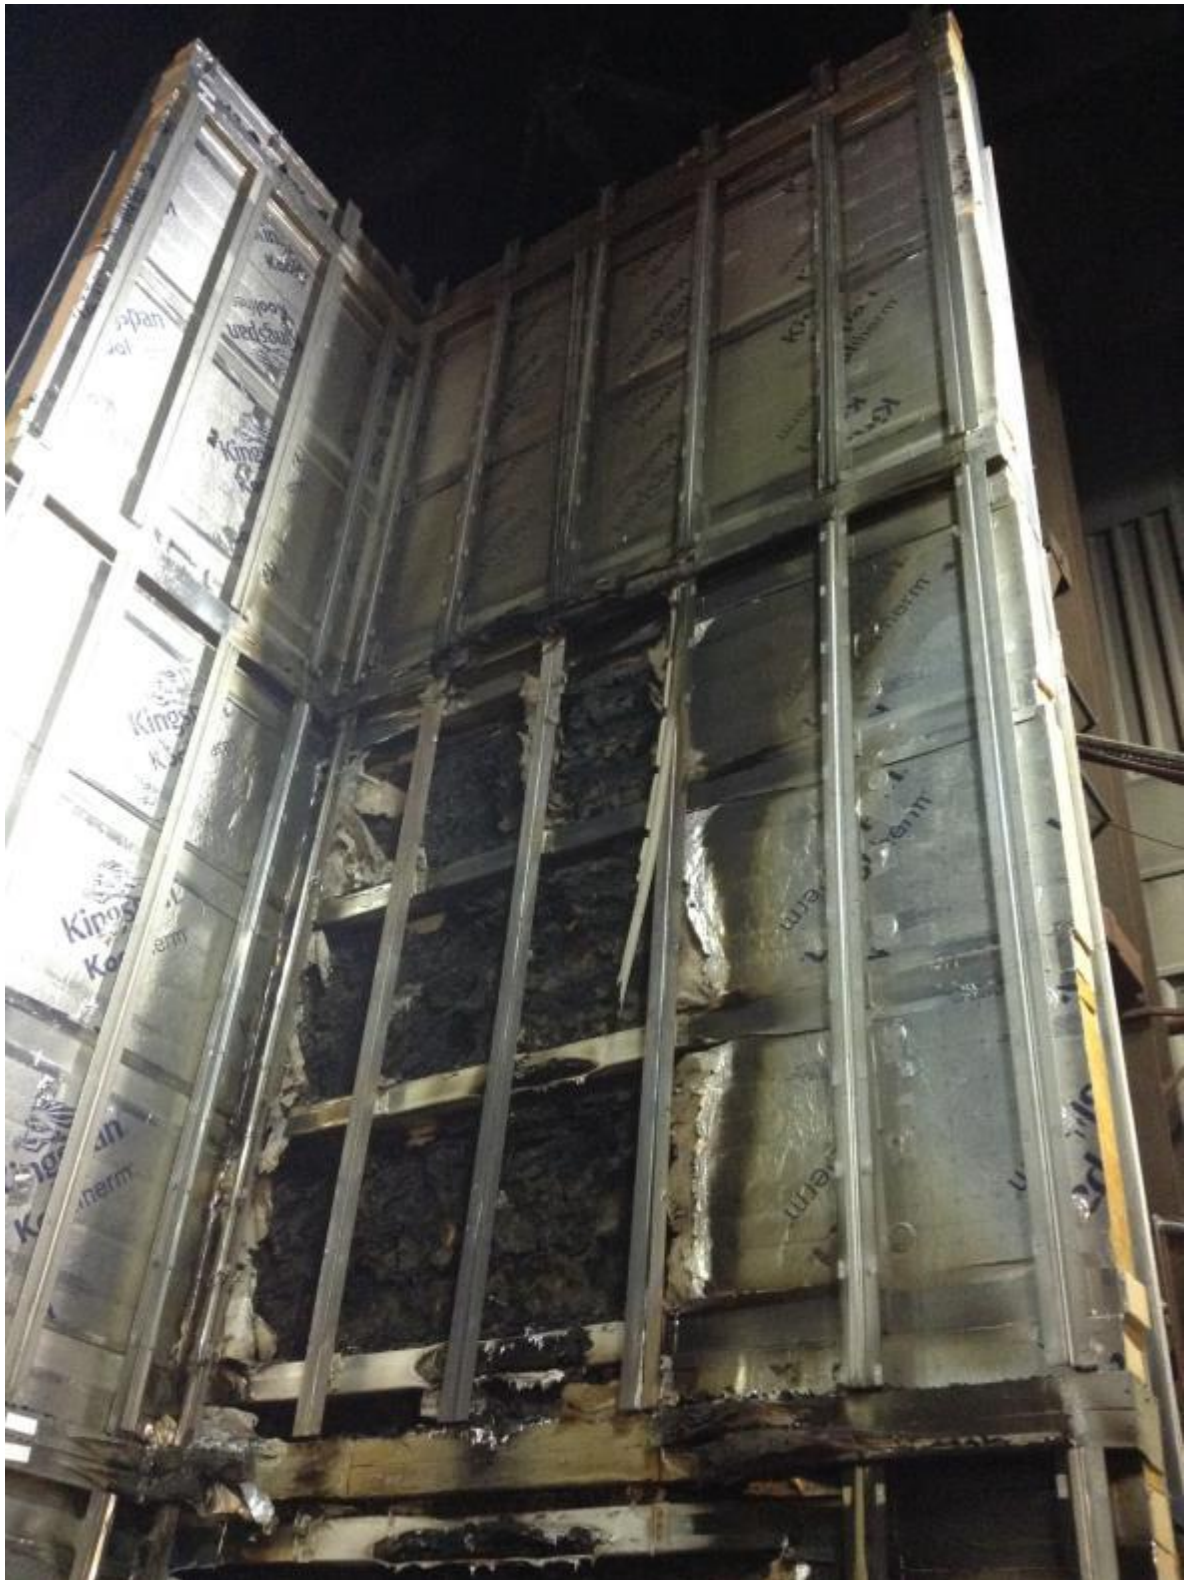
The condition of the insulation beneath the terracotta rainscreen after the test is shown in Figure 17. There was heat damage to the majority of the tiles between the first and second level fire breaks on the main face of the wall, as can be seen in the figure, and there was slight damage to the tiles above the second level fire break. It was noted that the insulation layer continued to burn past after the crib was extinguished with combustion reaching the fire barrier at the second level of the construction.

Figure 17. Photograph showing the condition of the insulation layer of the System post-test (Decorative layer removed)
