BRE Global Test Report

BS 8414-2:2015 + A1:2017 Test on a ventilated façade system with Kingspan Kooltherm insulation (100mm-thick) and Alpolic A2 panels (4mm-thick).

Prepared for: Kingspan Insulation Limited

Report Number: P109938-1000 **Issue:** 2

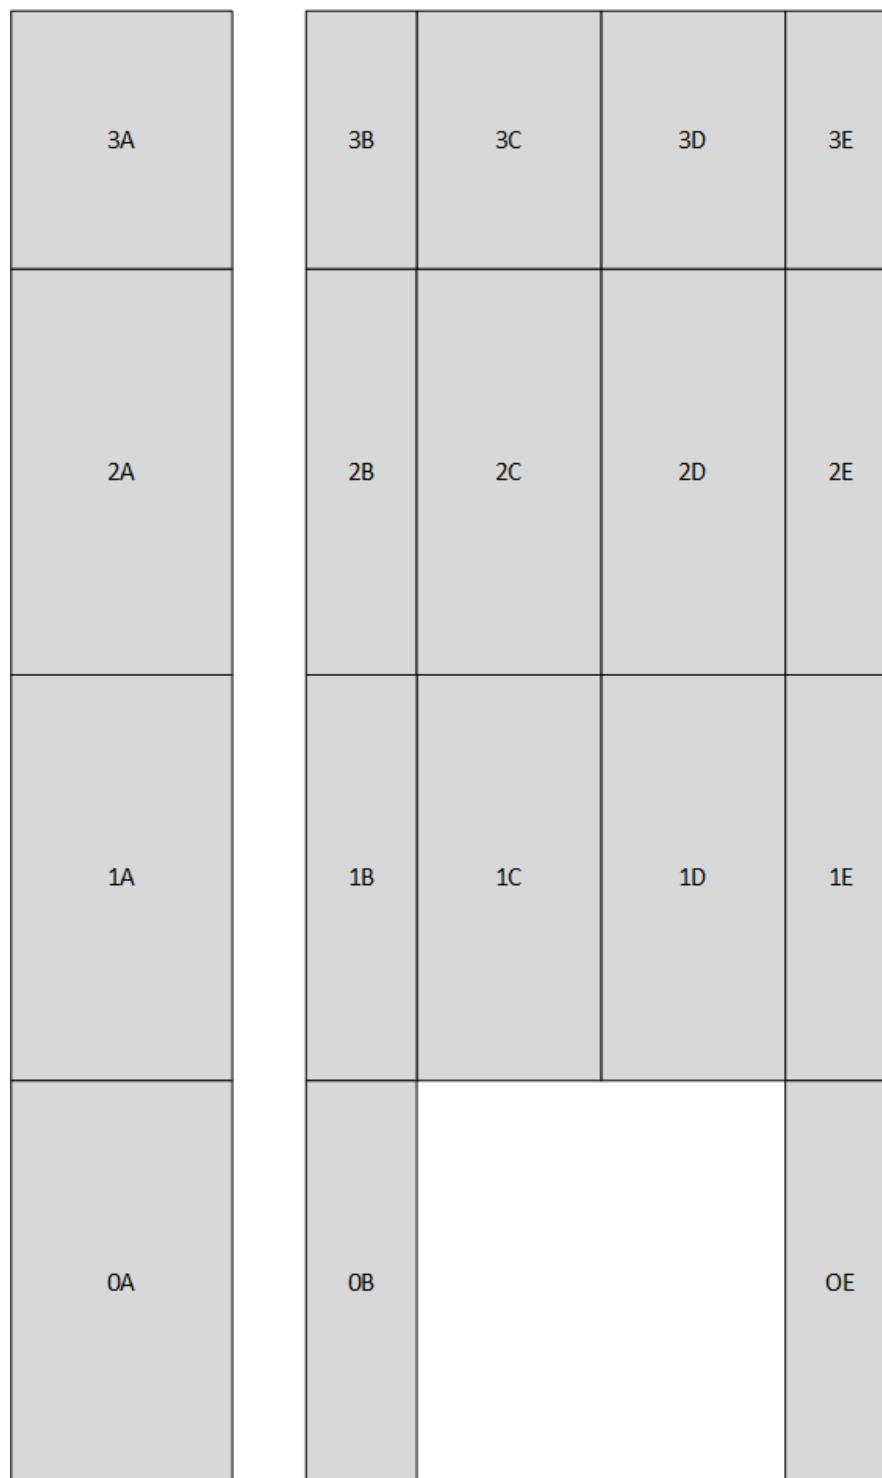
Figure 2. Layout of panels and numbering system used for reporting. Not to scale.

With reference to *Figure 2* the damage to the ACM panels was as follows:

Panel 0A – 70% of coating removed and 20% dark discolouration and panel distorted.

Panel 1A – 70% coating removed and 20% dark discolouration, panel distorted.

Panel 1B – 90% dark discolouration with distortion.

Panel 1C – 80% consumed. 80% of coating removed and 20% dark discolouration on the remainder of the panel.

Panel 1D – 80% consumed. 60% of coating removed and 30% dark discolouration on the remainder of the panel.

Panel 2C – 40% consumed. 60% of coating removed and 20% dark discolouration on the remainder of the panel.

Panel 2D – 40% consumed. 40% coating removed and 20% dark discolouration on the remainder of the panel.

Panel 3C – slight consumption at base of panel ($<0.01\text{m}^2$). 30% dark discolouration and 10% of coating removed.

Panel 3D – 20% dark discolouration with 10% of coating removed. Heavy distortion at base with slight distortion throughout panel.

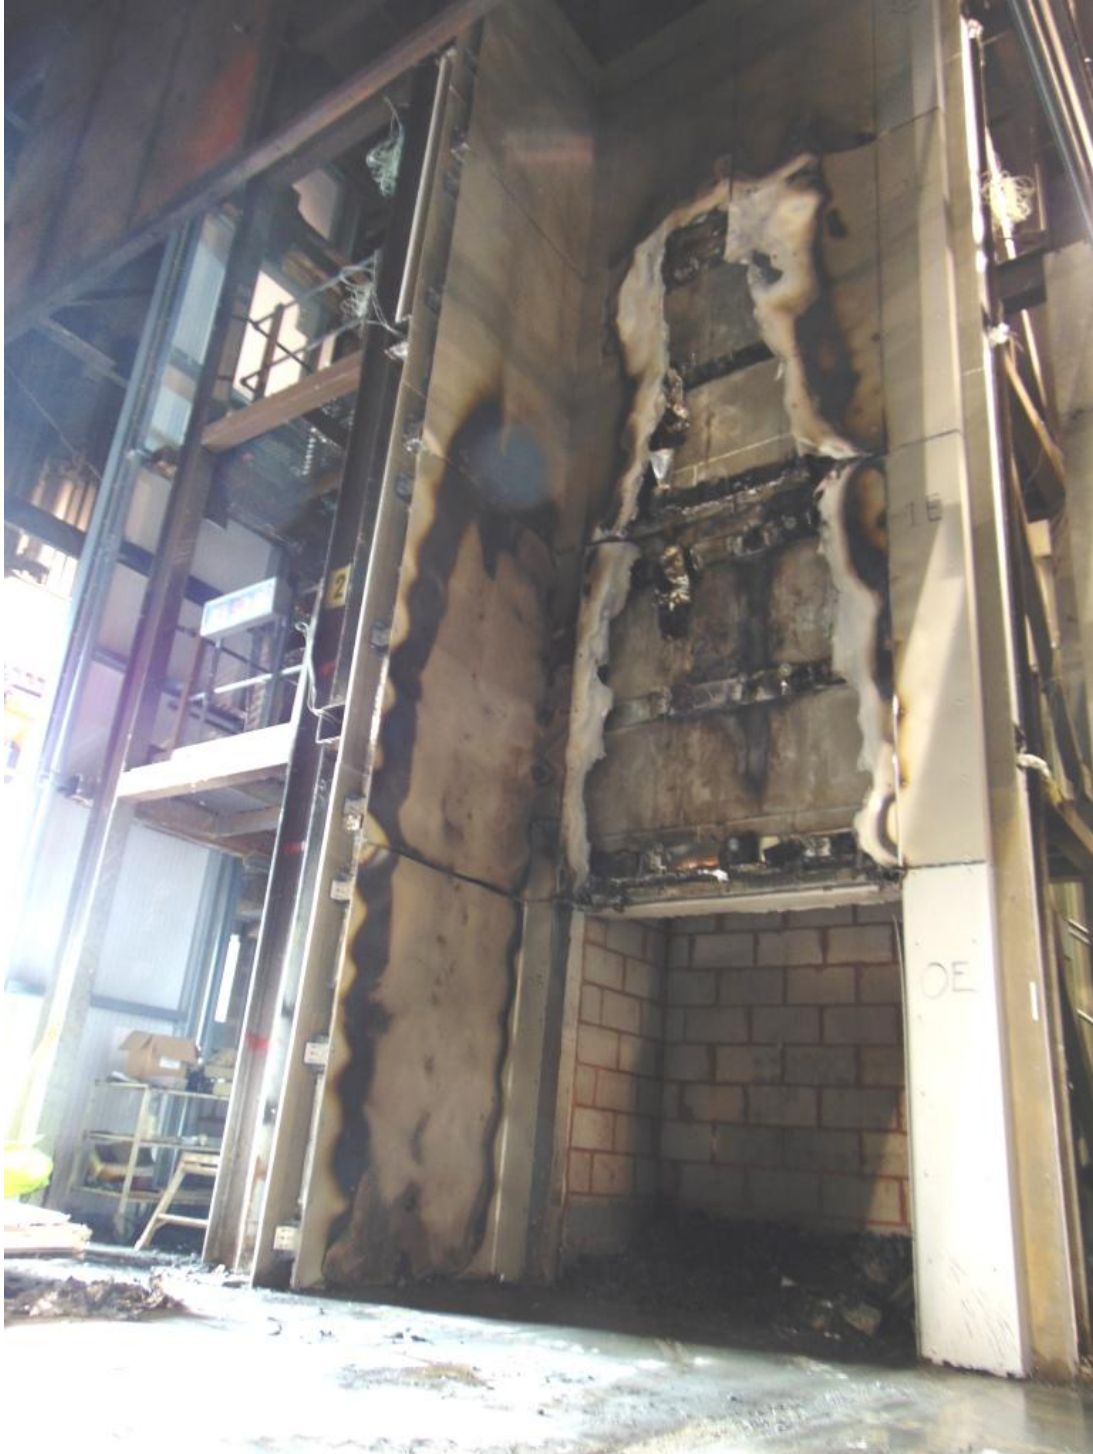
Flaming debris was observed from the cladding system from 12 minutes 5 seconds until approximately 19 minutes 25 seconds. A small fire formed at the base of the cladding system as a result. Consumption of ACM panels was observed tapering up to a height of approximately 5m above the top of the combustion chamber. Detachment of insulation and horizontal cavity barriers was also observed.

Figure 20. Full-height photograph of cladding system immediately after test.

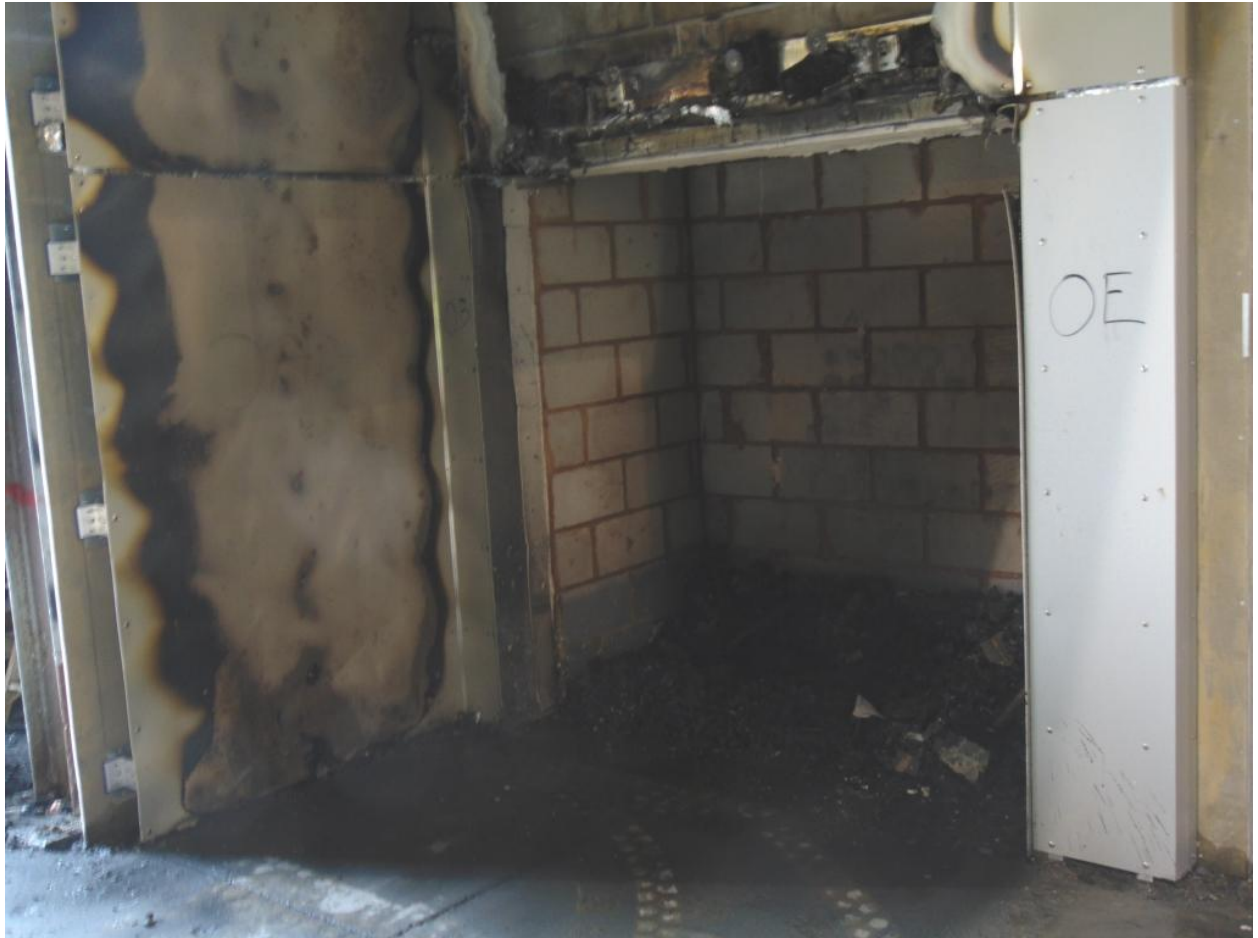
Figure 21. Damage to panels between ground and top of combustion chamber opening.

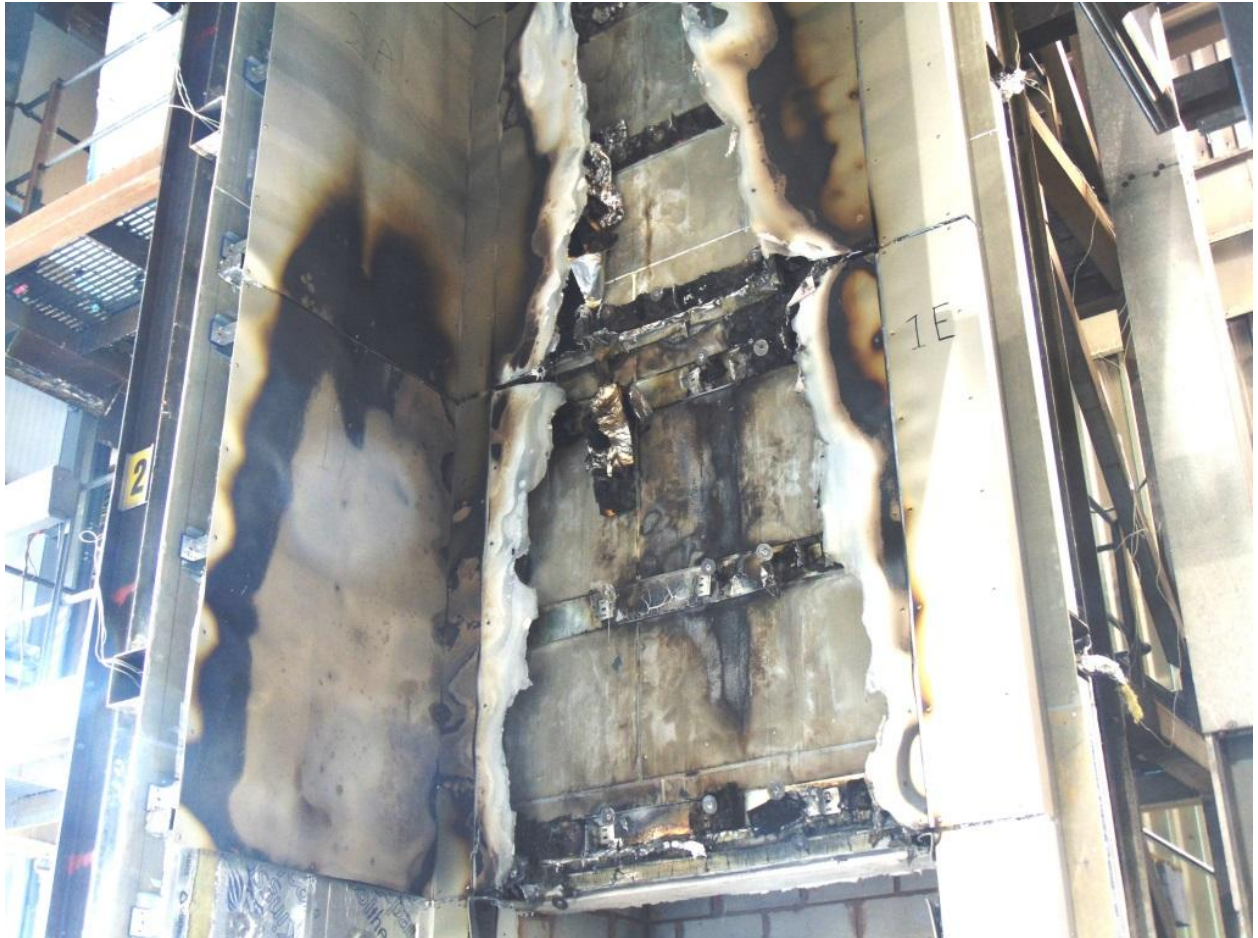
Figure 22. Damage to panels between top of combustion chamber and a height of approximately 5000mm above the top of the combustion chamber.

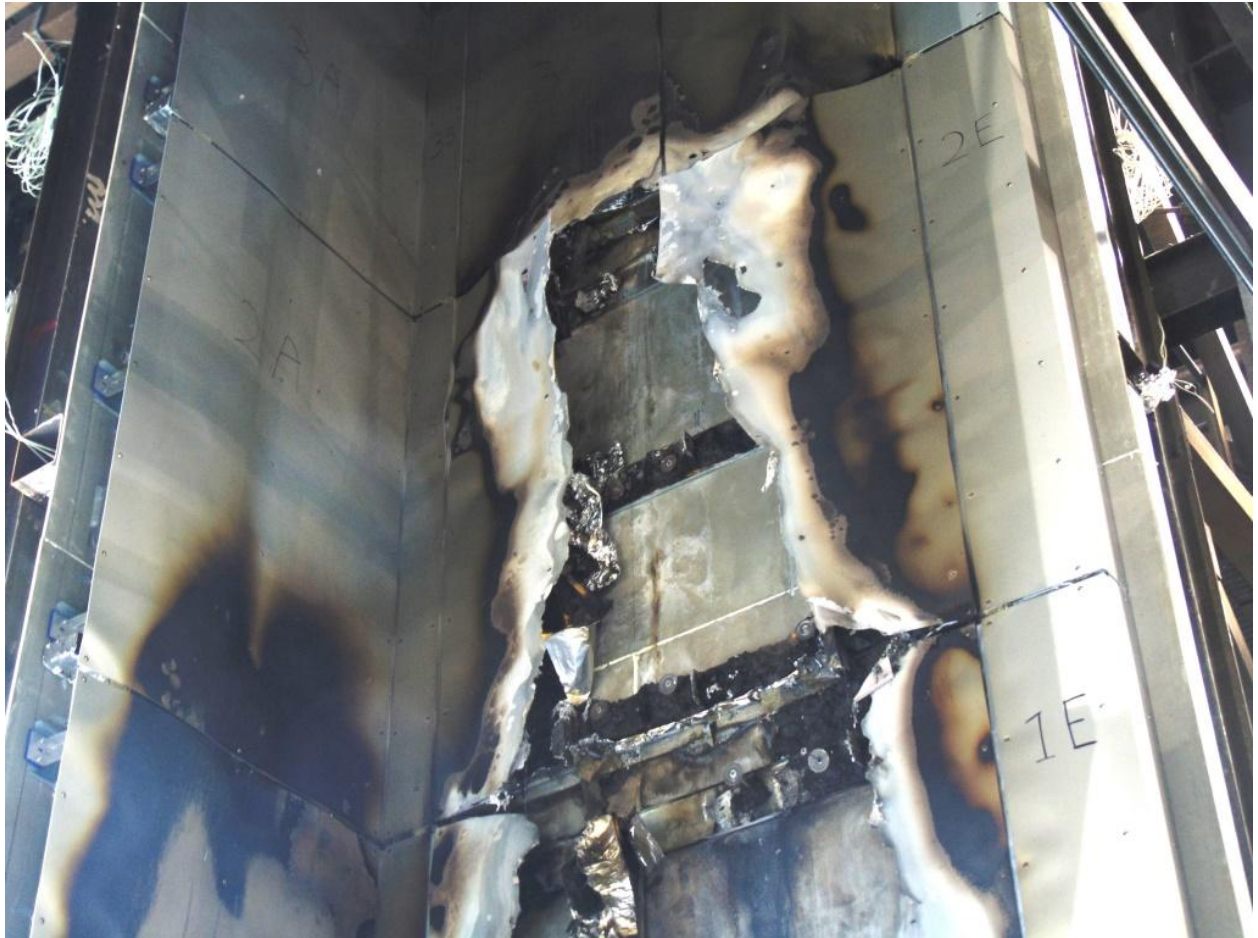
Figure 23. Damage to panels between a height of approximately 4000mm and 6000mm above the top of the combustion chamber.

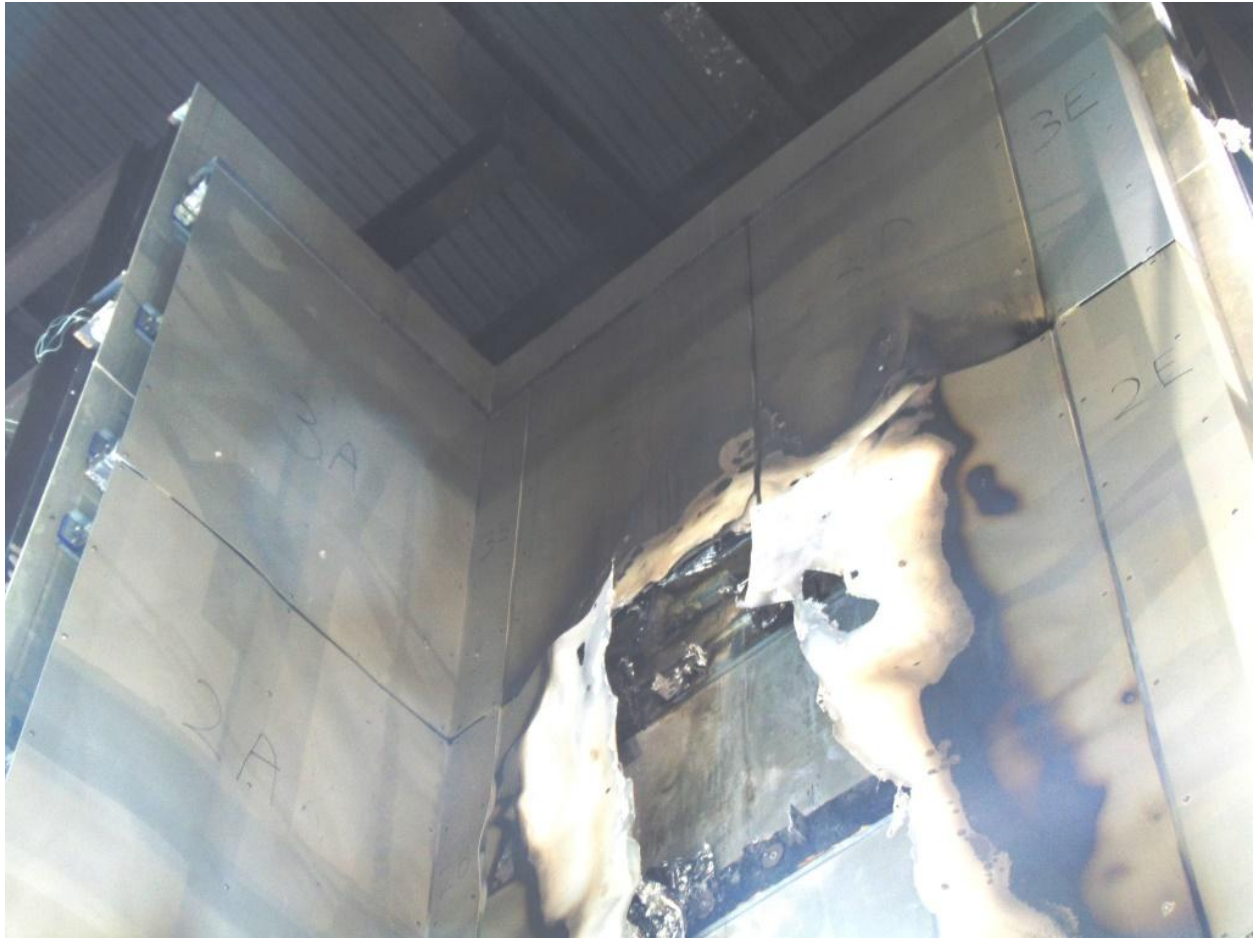
Figure 24. Damage to panels between a height of approximately 6000mm above the top of the combustion chamber and the top of the cladding system.

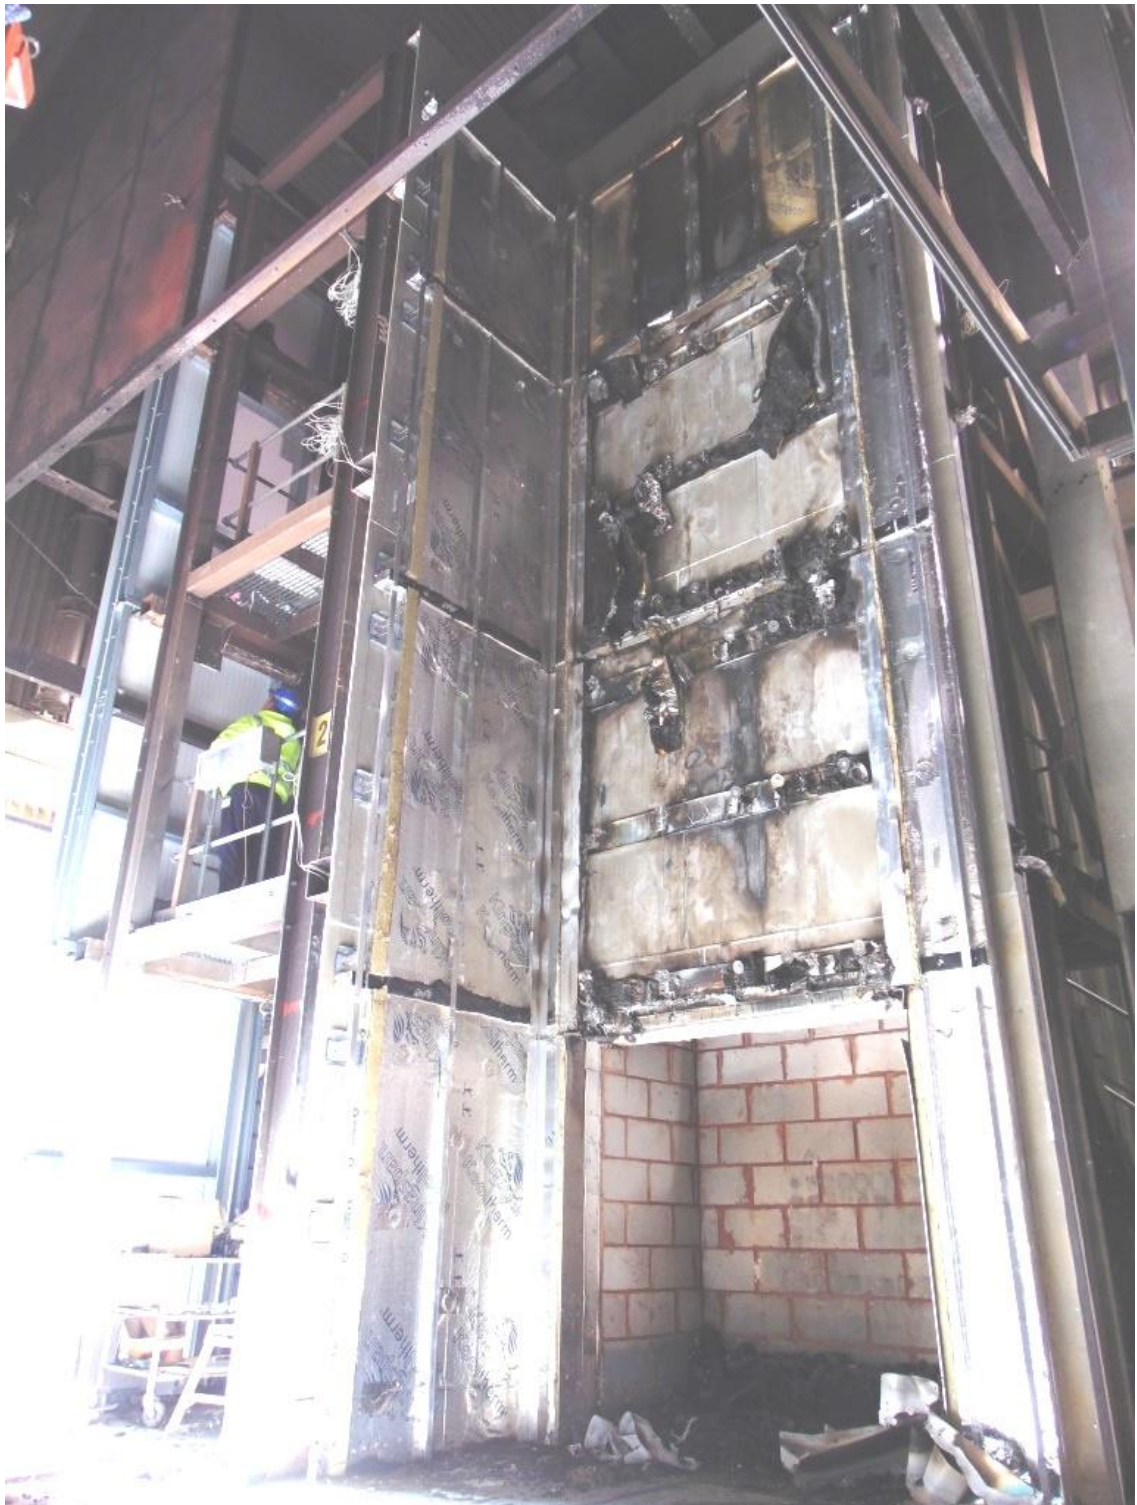
Figure 25. Full-height photograph of damage to insulation.

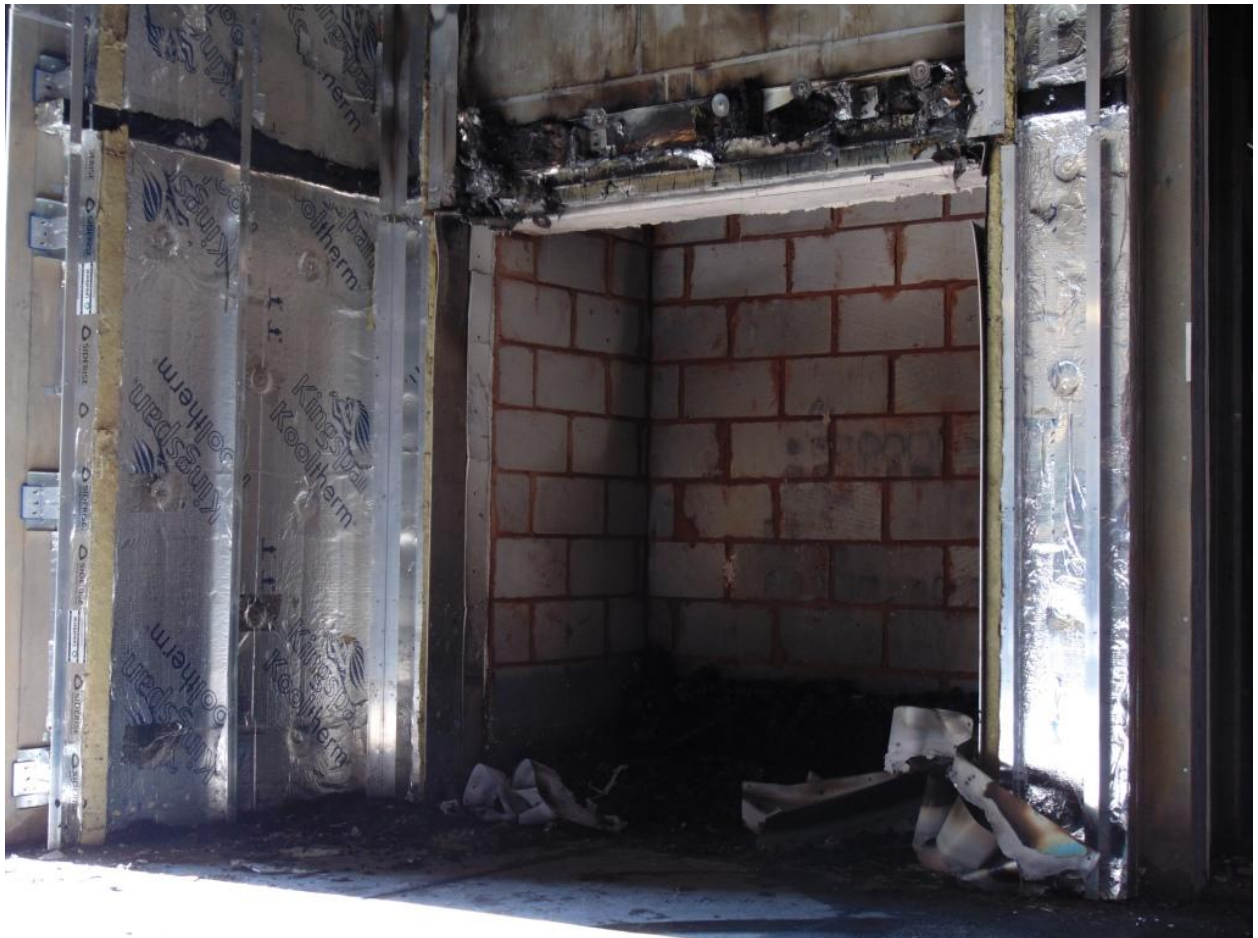
Figure 26. Damage to insulation between ground and top of combustion chamber opening.

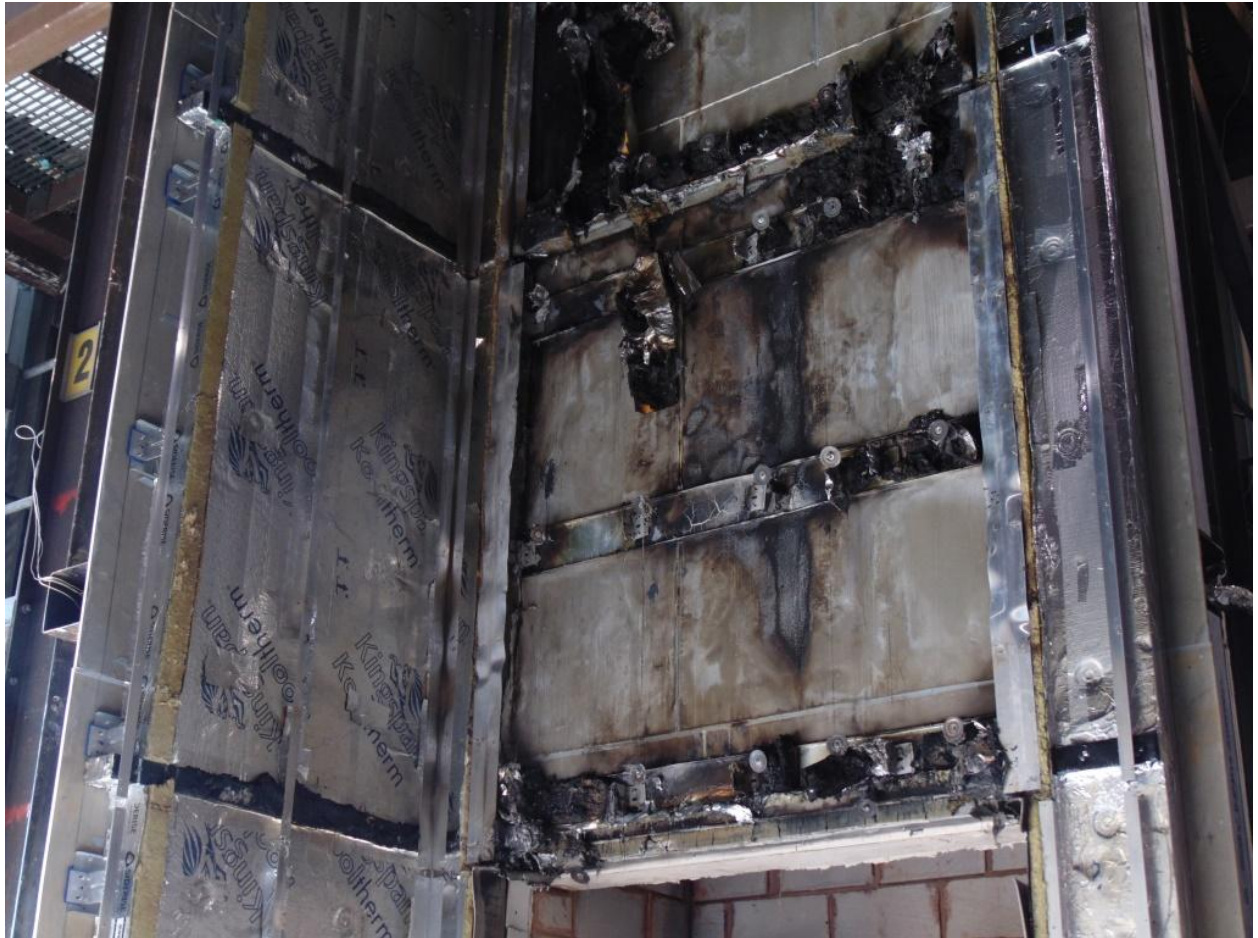
Figure 27. Damage to insulation between top of combustion chamber and a height of approximately 4500mm above the top of the combustion chamber.

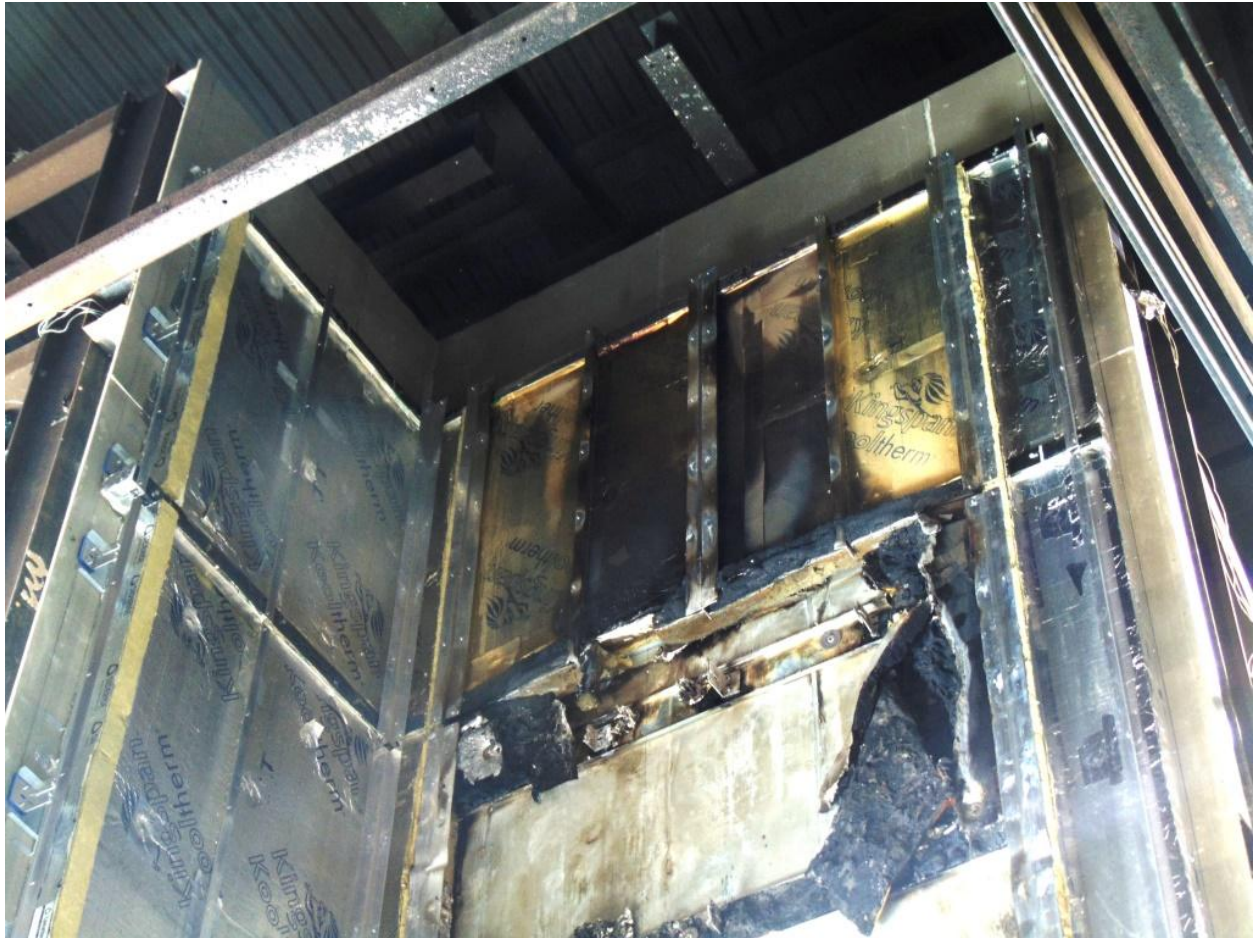
Figure 28. Damage to panels between a height of approximately 5000mm above the top of the combustion chamber and the top of the cladding system.

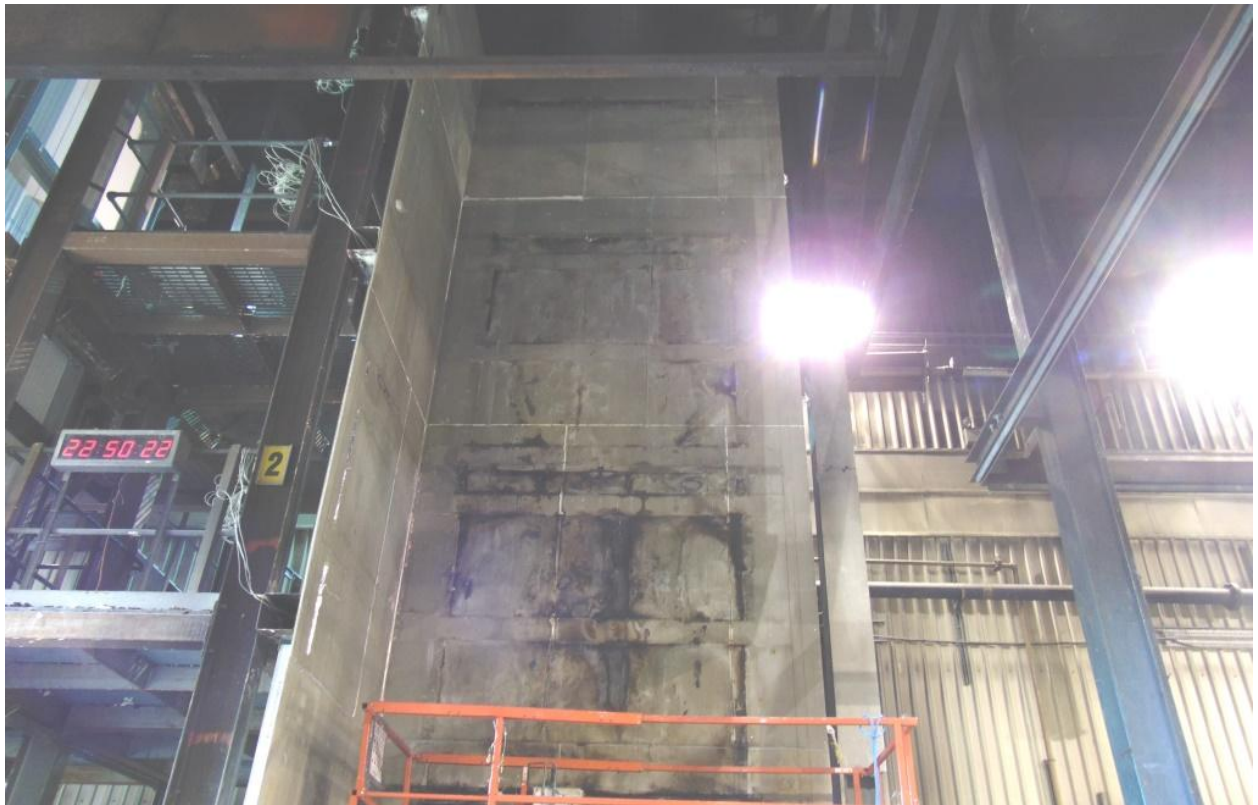
Figure 29. Damage to cement board from the top of the combustion chamber to the top of the cladding system.
