Fire Performance Testing of an External Cladding System BS 8414-2:2015 + A1:2017

Test Report

Prepared for : Kingspan Insulation Ltd.
Project : System Development
Report No. : DLR1547 Rev.0
Sample : 100mm Kingspan Kooltherm K15 with Dri-Design
Aluminium Cassette

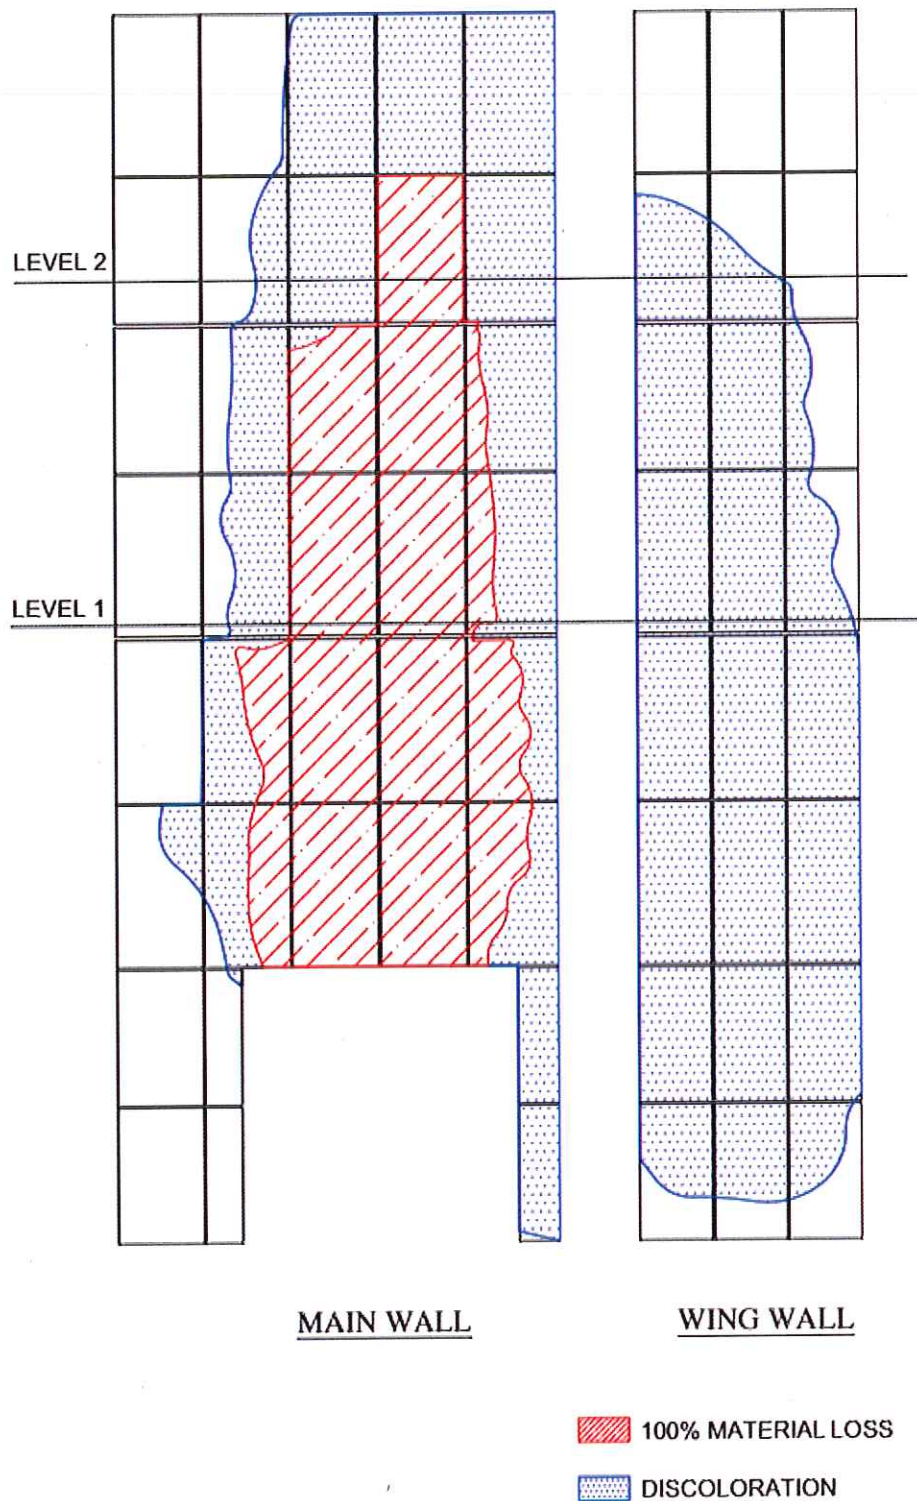
Figure 12 Area Map Showing the Condition of the Sample After the Test

- Approximately 9m² of the total external visible area was completely consumed.
- Approximately 19m² of the total external visible area was discoloured.

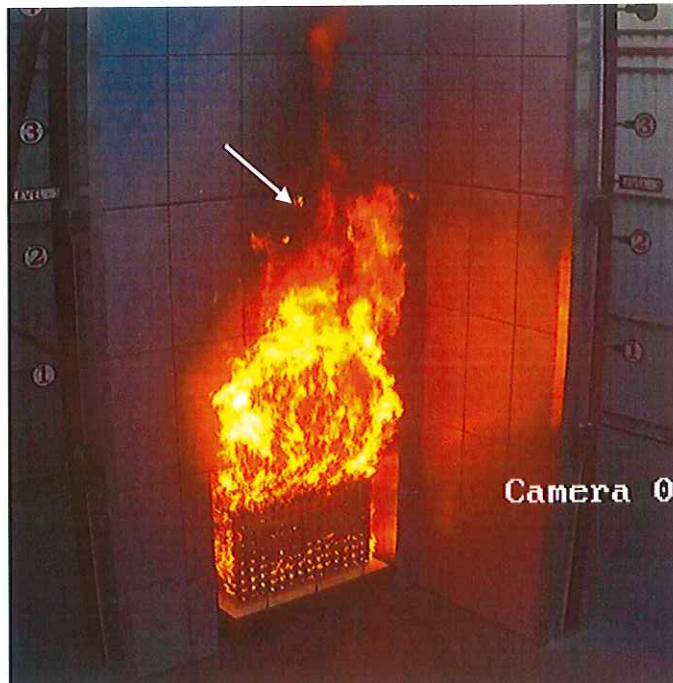
06:17:45	66	Flame tip at 3m above the combustion chamber.	-
06:18:25	106	Coating of panels M9, M10, M14 & M15 started to burn off.	-
06:19:23	164	Coating of panels M19 & M20 started to burn off.	DLP C2753J/0001

DLP C2753J/0001 Coating of panels M19 & M20 started to burn off.

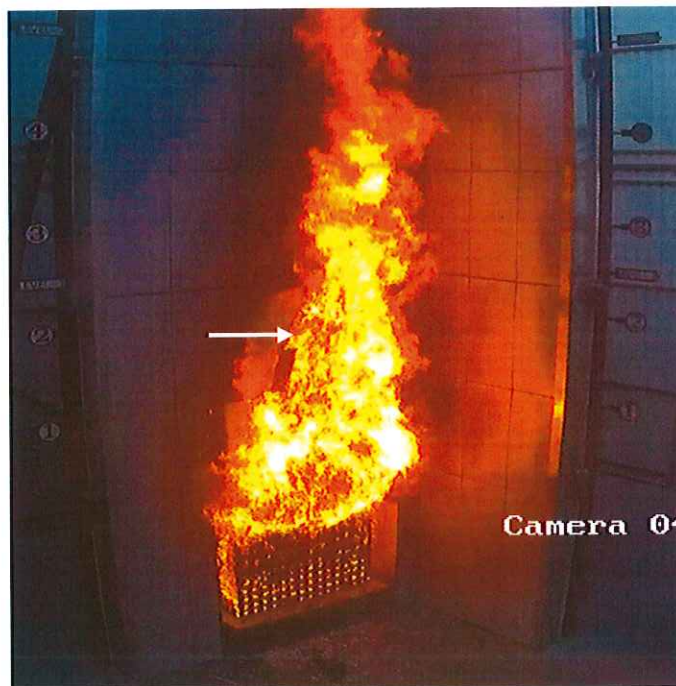
06:22:35	356	Self-sustained flames on the surface of panel M8.	-
06:23:17	398	Continuous falling of aluminium debris from the main wall.	-
06:23:22	403	Panels M9, M10, M14 & M15 partially melted and insulation behind the panels burning.	DLP C2753J/0002

DLP C2753J/0002 Panels M9, M10, M14 & M15 partially melted and insulation behind the panels burning.

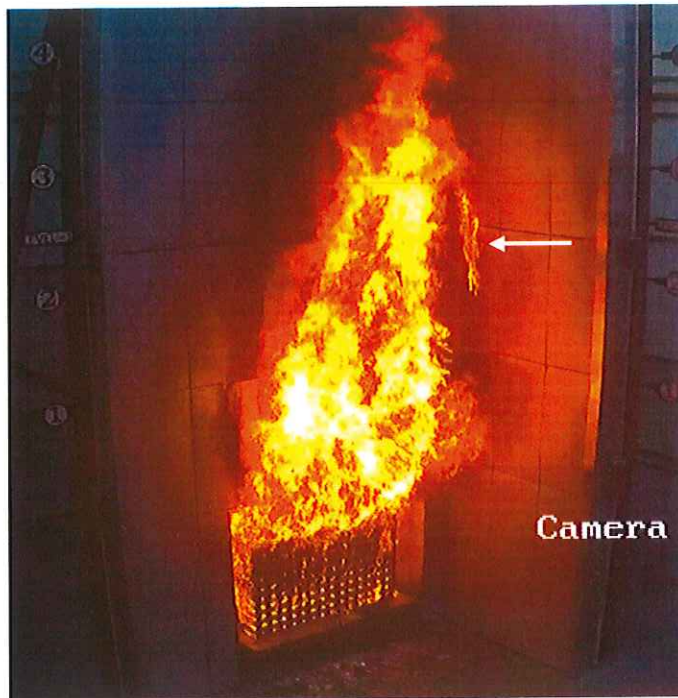
06:23:34	415	Debris of insulation behind panel M14 fell off.	-
06:23:49	430	Self-sustained flames on the surface of panel W7.	DLP C2753J/0003
06:23:59	440	Self-sustained flames on the surface of panel W10.	-

DLP C2753J/0003 Self-sustained flames on the surface of panel W7.

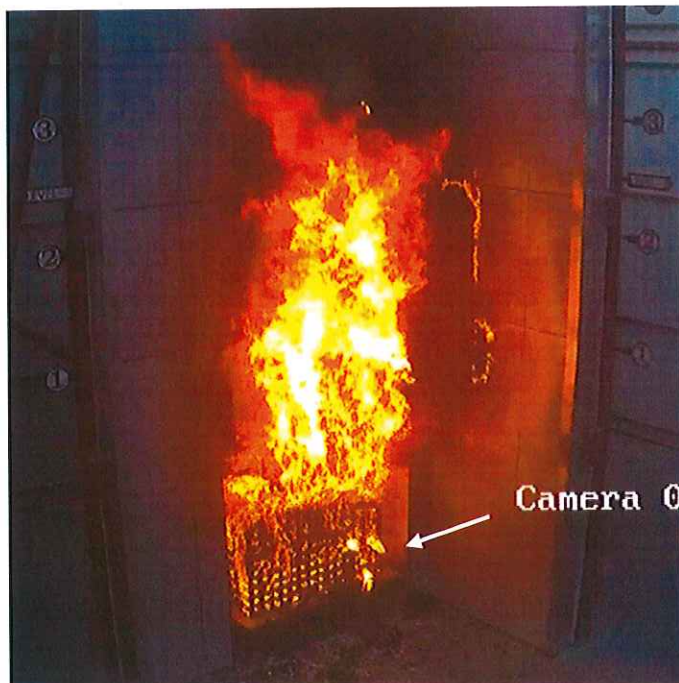
06:24:38	479	Flaming debris fell off the main wall.	DLP C2753J/0004
06:25:22	523	Coating of panel M30 started to burn off.	-
06:25:43	544	Self-sustained flames on the surface of panel M24.	-

DLP C2753J/0004 Flaming debris fell off the main wall.

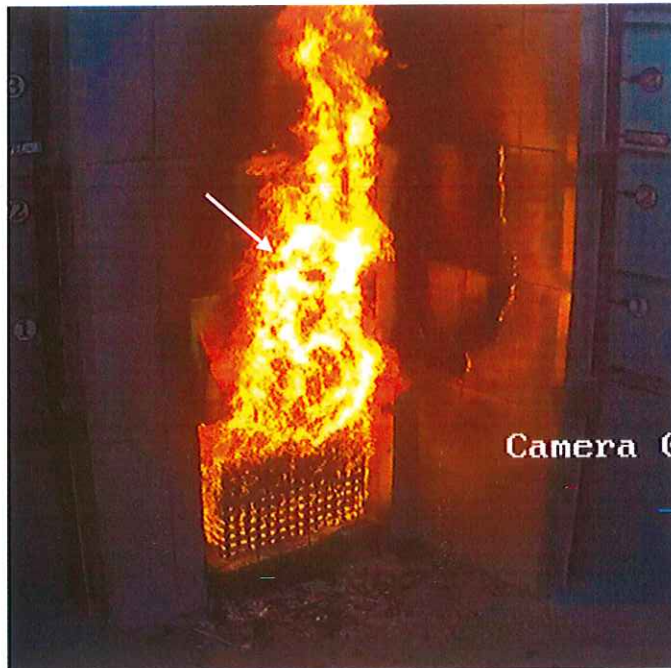
Time	Seconds	Observation	Photo Reference
06:26:05	566	Approximately 90% of panels M9, M10, M14 & M15 melted.	DLP C2753J/0005
06:27:12	633	Self-sustained flames at panels M7 & M8 vertical joint.	-

DLP C2753J/0005 Approximately 90% of panels M9, M10, M14 & M15 melted.

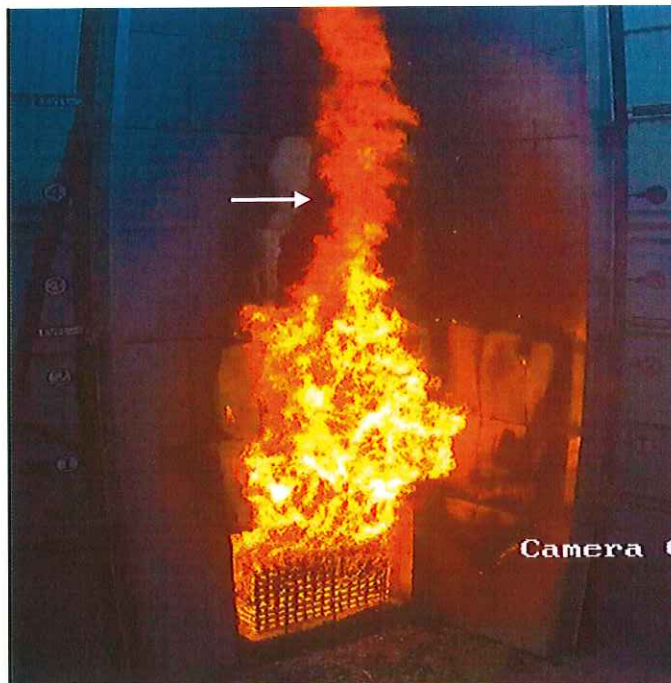
06:27:43	664	Self-sustained flames on the surface of panels W8 & W11.	-
06:28:39	710	Panels M24 & M25 partially melted and insulation behind the panels burning.	DLP C2753J/0006

DLP C2753J/0006 Panels M24 & M25 partially melted and insulation behind the panels burning.

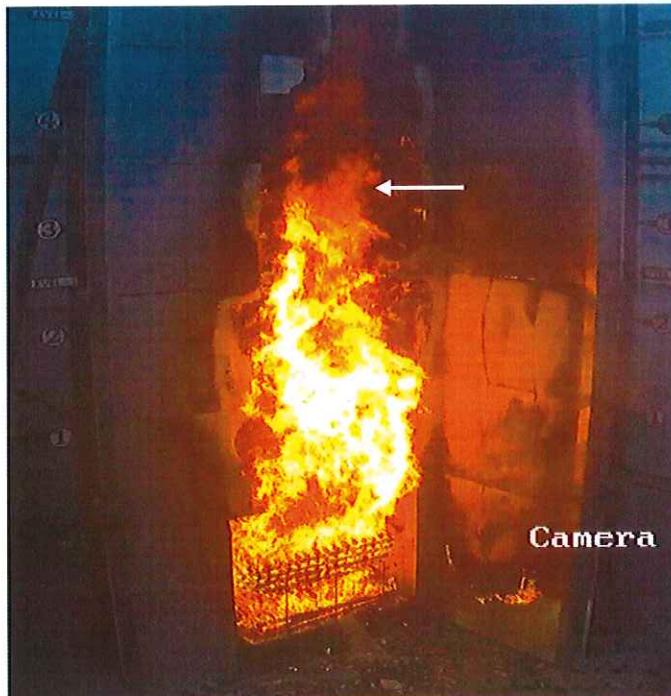
06:33:59	1040	Coating of panel M35 started to burn off.	-
06:34:58	1099	100% of the panels M19, M20, M25 & M30 consumed.	DLP C2753J/0008
06:35:17	1118	Self-sustained flames on the surface of panels W2 & W6.	-

DLP C2753J/0008 100% of the panels M19, M20, M25 & M30 consumed fell off.

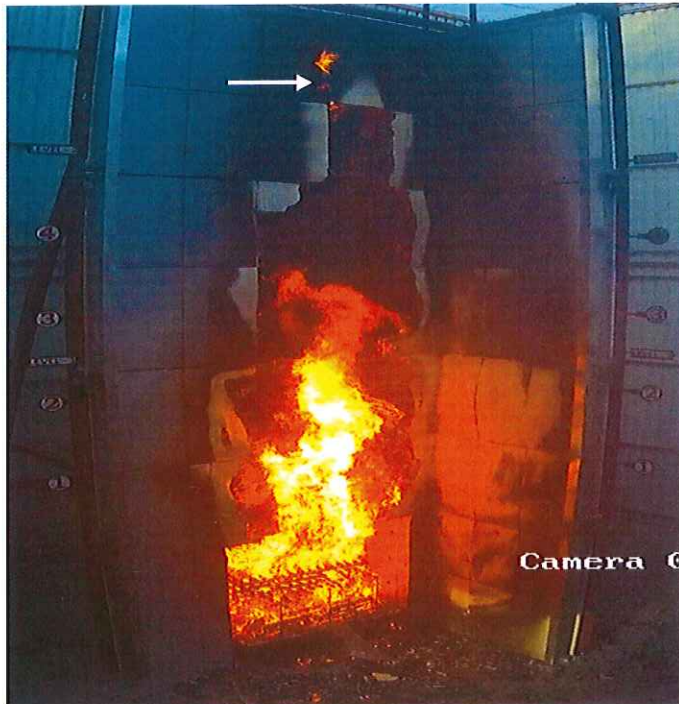
06:36:27	1188	Self-sustained flames at panels M34 & M35 vertical joint.	-
06:38:07	1288	Flames behind panel M35.	DLP C2753J/0009
06:40:35	1436	Continuous falling of debris of insulation.	-

DLP C2753J/0009 Flames behind panel M35.

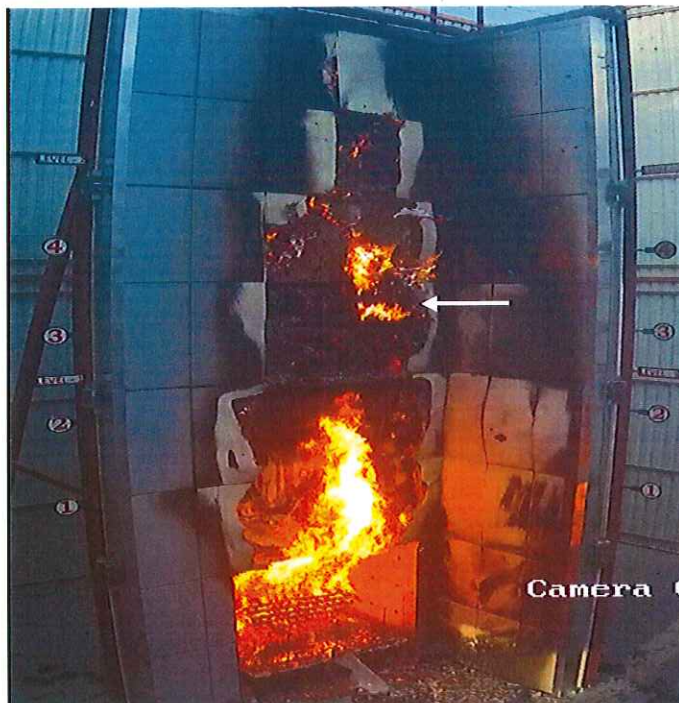
06:41:56	1517	Panel M35 discoloured.	-
06:42:00	1521	Flaming debris of the insulation behind panel M24 fell off.	DLP C2753J/0010
06:45:33	1734	Heat source was extinguished. Observations continued for another 30 minutes.	-

DLP C2753J/0010 Flaming debris of the insulation behind panel M24.

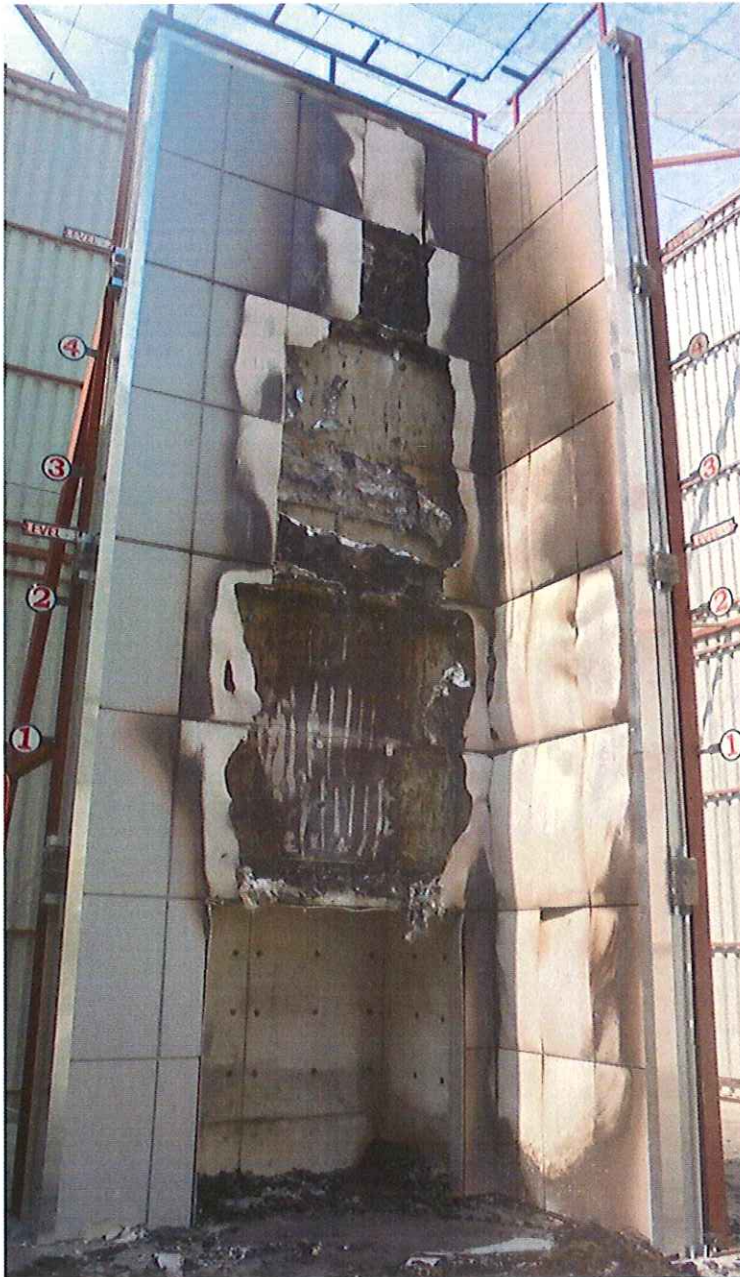
DLP C2753J/0011

Sl. No.	Components	Observation	Photo Reference
1	2mm Aluminium Cassette panels	<p>Panels M1, M2, M4, M4, M12, M17, M22, M27 & M32 - No changes on the panels.</p> <p>Panels M3, M6, M11, M21, M29, M31, M34, M35 & M36 - 100% discoloration on the panels.</p> <p>Panels M5, M7, M28 & M33 - Minor discoloration on the panels.</p> <p>Panels M8, M11, M13, M16, M21 & M26 - Approximately 50% material loss observed. Remaining area was buckled and discoloured.</p> <p>Panels M9, M10, M14, M15, M19, M20, M25 & M30 - 100% material loss observed.</p> <p>Panels M18 & M23 - Approximately 50% of the panel was discoloured.</p> <p>Panels W1, W2, W3, W4, W5, W6, W7, W8, W9, W10, W11, W12, W13 & W14 - Panels were discoloured.</p> <p>Panels W15, W16, W17, W18, W19, W20, W21, W22, W23 & W24 - Minor discoloration on the panels.</p>	<p>DLP C2753J/0011.</p> <p>Please see Figure 13 in this section for damaged areas</p>

View of the sample after the test

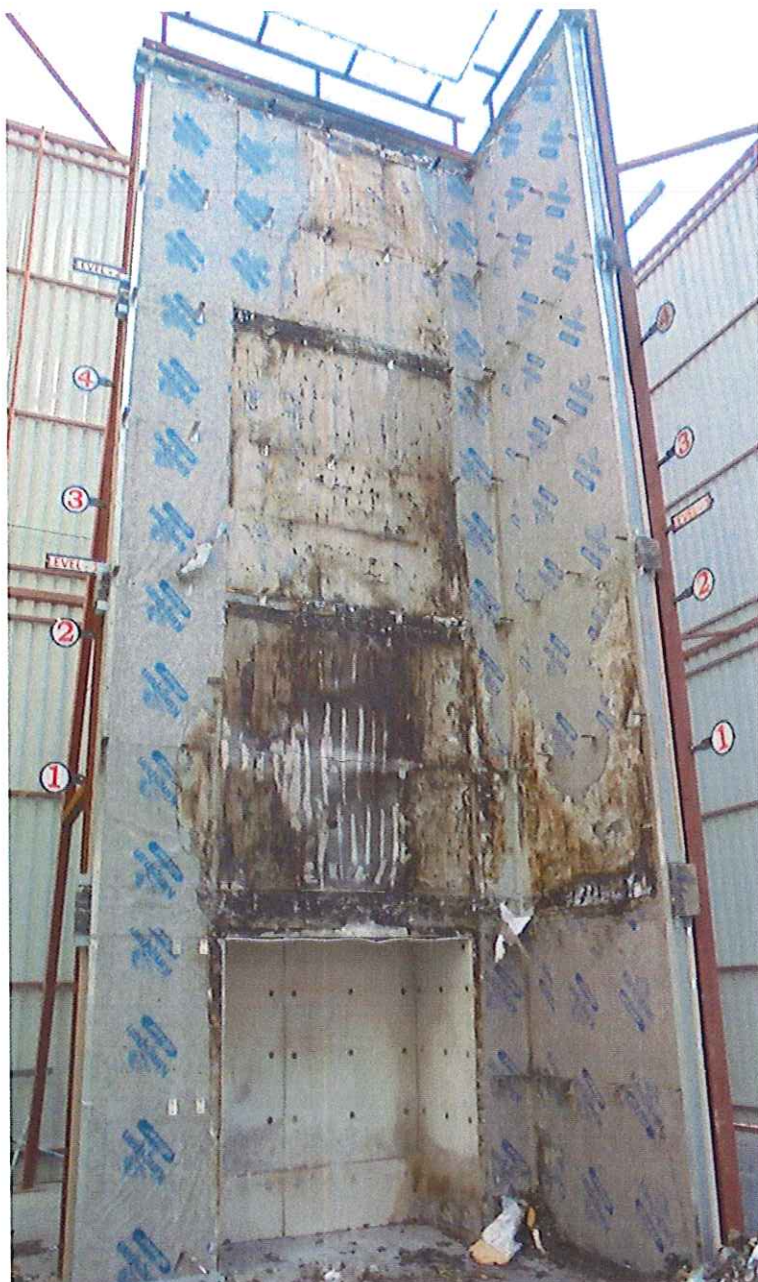
DLP C2753J/0013

Sl. No.	Components	Observation	Photo Reference
5.	Brackets and Breather membrane	<p>Brackets:</p> <p>Approximately 10% of the Helping Hand brackets on the main wall were partially melted.</p> <p>All other brackets on the main wall and wing wall were in place and no damage was observed.</p> <p>Breather membrane:</p> <p>Material loss and discolouration to the Nilvent breathable membrane on the main wall and wing wall.</p>	DLP C2753J/0013, & DLP C2753J/0018.
6.	12mm Versapanel cement particle board	Minor damages and discolouration to the Versapanel cement particle board on the main wall and no significant changes to the Versapanel cement particle board on wing wall.	DLP C2753J/0013, & DLP C2753E/0018.
7.	Kingframe SFS and plaster boards	No significant changes.	DLP C2753J/0014.

Breather membrane and brackets

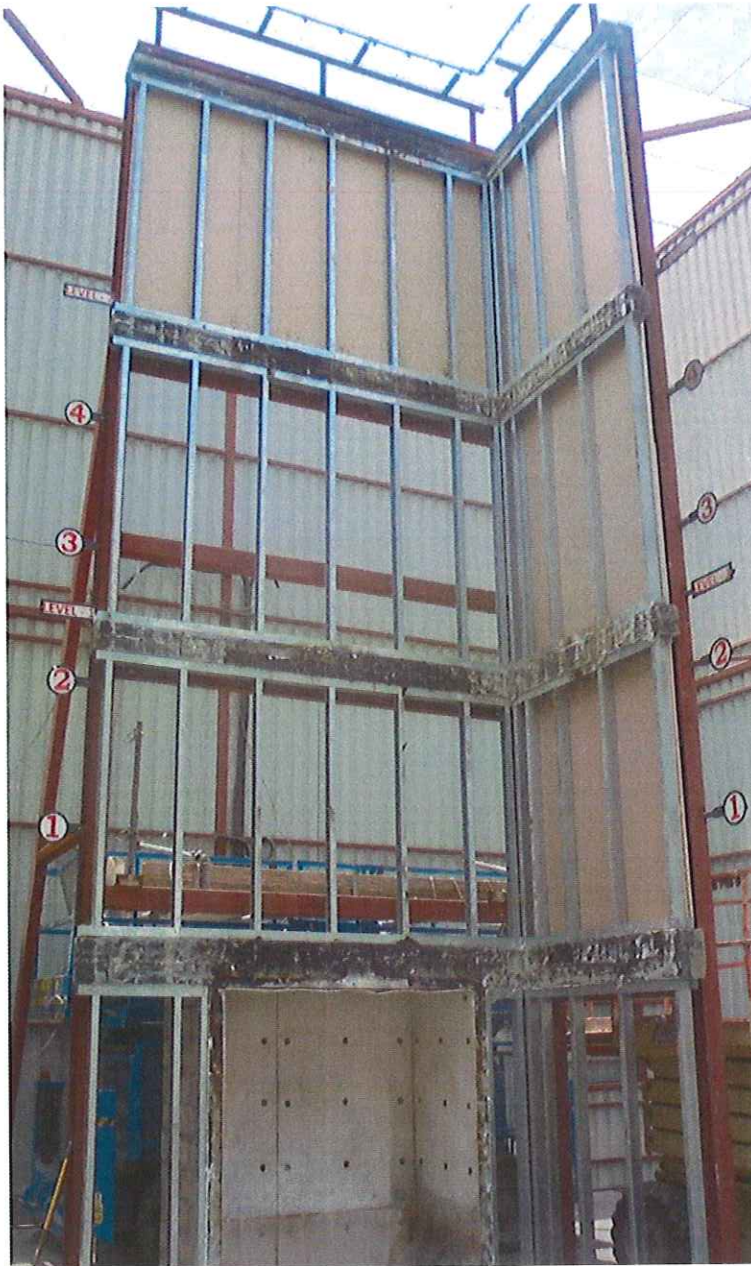
DLP C2753J/0014

Kingframe SFS and plaster board

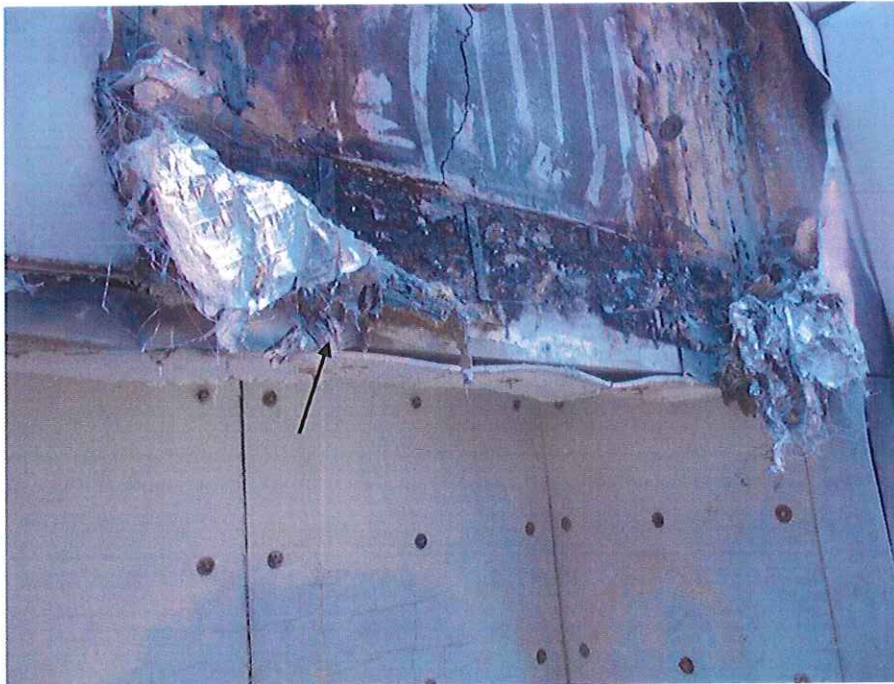
DLP C2753J/0015

Sl. No.	Components	Observation	Photo Reference
3.	Cavity barrier	<p>Horizontal intumescent cavity barrier:</p> <p>Main wall:</p> <p>The 1st horizontal cavity barrier at 150mm above the combustion chamber was activated except the cavity barrier behind panel M7. Intumescent layer was not present during dismantling. Material loss observed.</p> <p>The 2nd horizontal cavity barrier at 2375mm above the combustion chamber was activated. Intumescent layer was partially present during dismantling. Cavity barrier was in place and material loss observed.</p> <p>The 3rd horizontal cavity barrier at 4875mm above the combustion chamber was activated except the cavity barrier behind panel M27. Intumescent layer was partially present during dismantling. Cavity barrier was in place and minor material loss observed.</p> <p>The 4th horizontal cavity barrier at 6890mm above the combustion chamber was activated except the cavity barrier behind panel M32. Intumescent layer was present during dismantling. Cavity barrier was in place and minor material loss observed.</p> <p>Wing wall:</p> <p>All the cavity barriers on the wing wall were activated. Intumescent layer was present during dismantling. Minor material loss observed.</p> <p>Vertical cavity barrier:</p> <p>Buckling and discoloration on the vertical cavity barrier on the main wall and wing wall.</p>	DLP C2753J/0012, DLP C2753J/0015, DLP C2753J/0016 & DLP C2753J/0017.

Cavity barrier above the combustion chamber

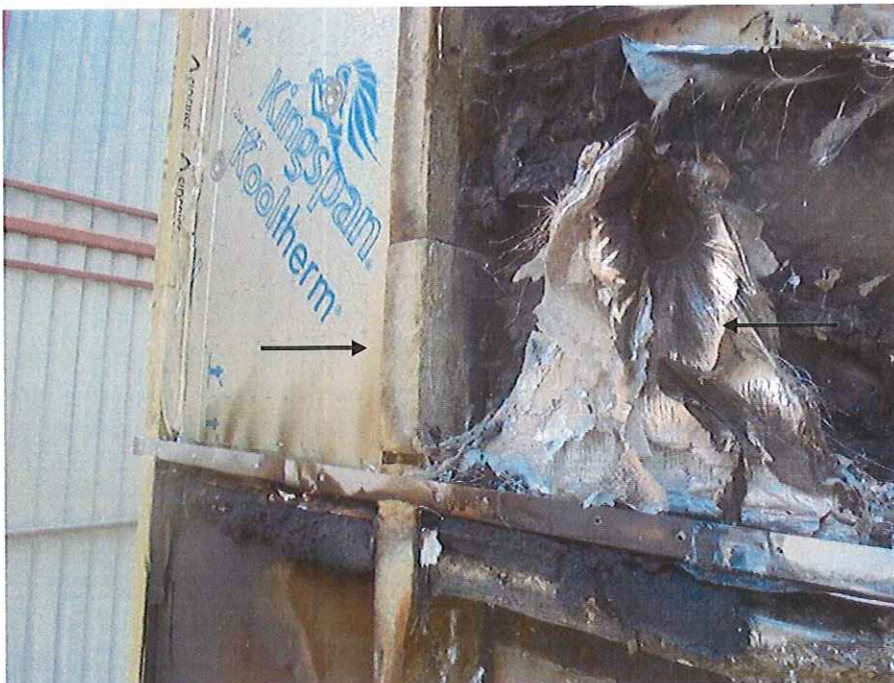
2.	Kingspan Kooltherm K15 insulation	<p>Main wall:</p> <p>Insulation behind panels M8, M9, M10, M13, M14, M15, M19, M20, M24 & M25 was completely burned and fell off.</p> <p>Insulation behind panels M11, M16, M18, M21, M23, M26, M28, M29, M30, M31, M33, M34, M35 & M36 was burned and left as char.</p> <p>Insulation behind panels M3, M6, M7 & M12 was discoloured.</p> <p>All other insulation on the main wall was in place and no changes observed.</p> <p>Wing wall:</p> <p>Insulation behind panels W7, W8, W9, W10, W11 & W12 was burned and left as char.</p> <p>All other insulation on the main wall was discoloured.</p> <p>Material loss observed.</p>	<p>DLP C2753J/0012, DLP C2753J/0016, & DLP C2753J/0017.</p>

4.	Railings	<p>Railings:</p> <p>Railings behind panels M8, M9, M10, M11, M13, M14, M15 M16, M18, M19, M20, M21, M23, M24, M25 & M26 were melted completely.</p> <p>Railings behind panels M28, M29, M30, M31, M33, M34, M35 & M36 were discoloured and buckled.</p> <p>All other railings on the main wall were in place and no damage was observed.</p> <p>All the railings on the wing wall were discoloured.</p>	DLP C2753J/0012, DLP C2753J/0016 & DLP C2753J/0017.

Vertical cavity barrier, insulation and railings on main wall

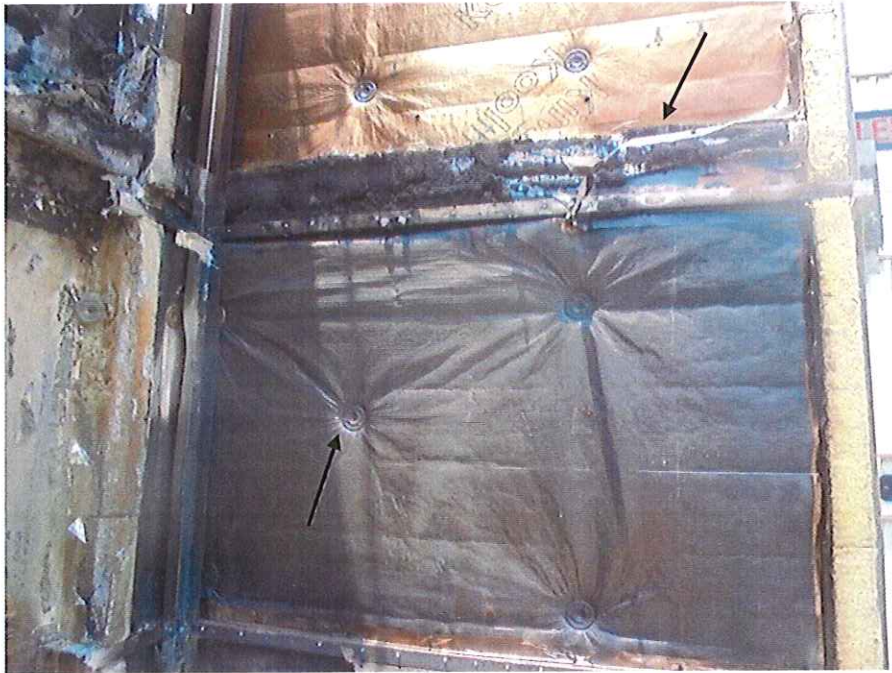
DLP C2753J/0017

Cavity barrier, insulation and railings on wing wall
