## Fire Performance Testing of an External Cladding System BS 8414-2:2015 + A1:2017

### Test Report

Prepared for : Kingspan Insulation Ltd.  
Project : System Development  
Report No. : DLR1515 Rev.0  
Sample : 100mm Kingspan Kooltherm K15 - Alpollic A2 ACM -  
BML400

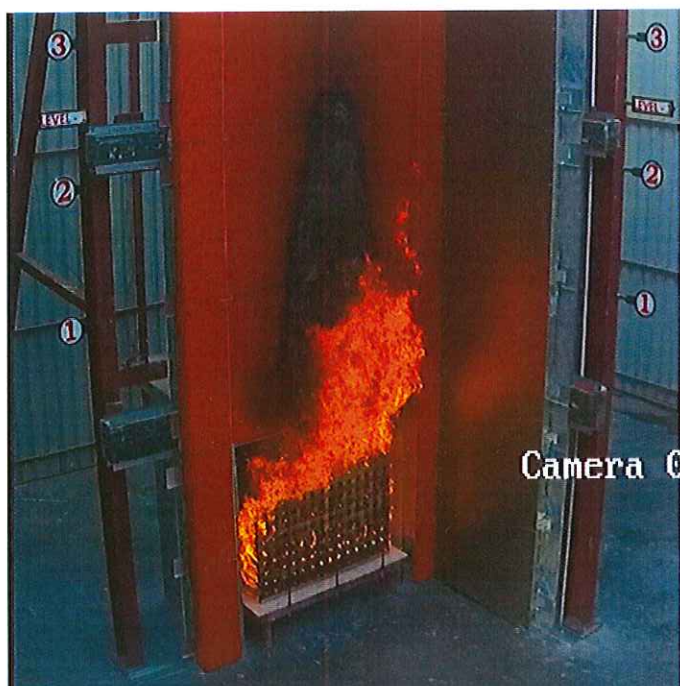
07:17:10	63	Minor buckling on panels M6, M7, M10 & M11.	-
07:17:32	85	Coating of panels M6, M7, M10 & M11 started peeling off.	-
07:18:22	135	Coating of panels M14 & M15 started peeling off.	DLP C2753E/0001

DLP C2753E/0001 Coating of panels M14 & M15 started peeling off.

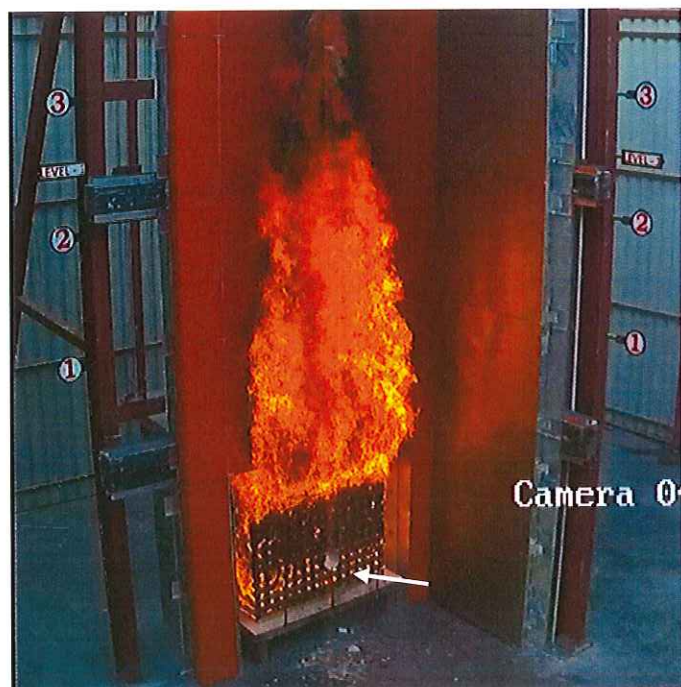
07:22:25	378	Aluminium debris fell off the main wall.	DLP C2753E/0002
07:22:43	396	Aluminium skin of panels M6 & M10 partially melted and insulation behind the panels was burning.	DLP C2753E/0003

DLP C2753E/0002 Aluminium debris fell off the main wall.

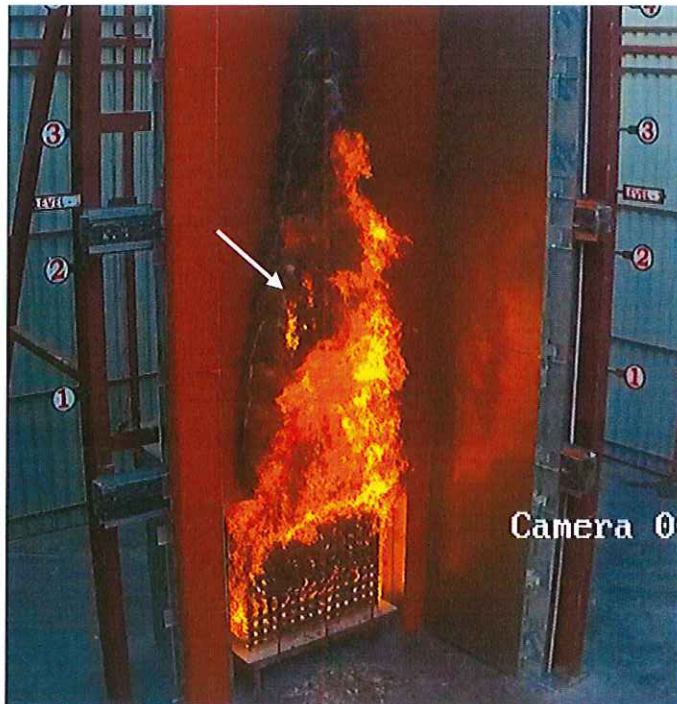
DLP C2753E/0003 Aluminium skin of panels M6 and M10 partially melted and insulation behind the panels burning.

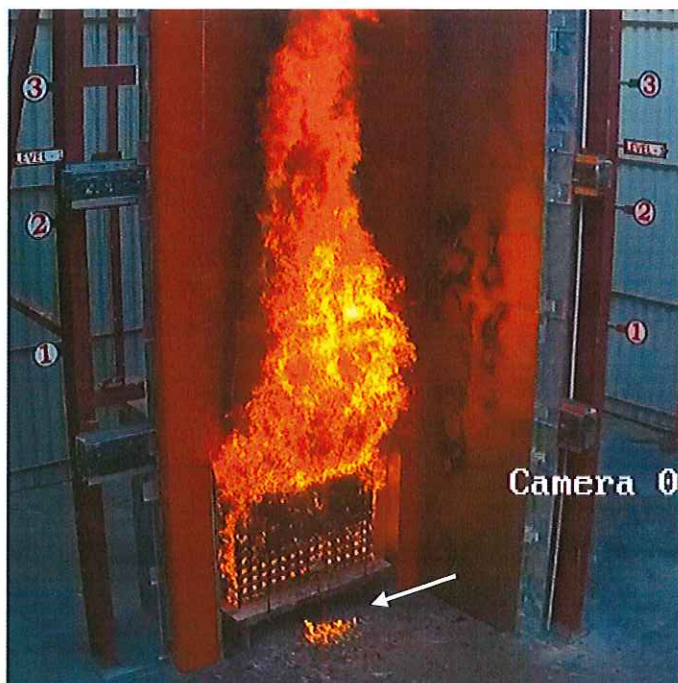
07:23:37	450	Flame impinged on wing wall and coating of panel W2 started peeling off.	-
07:24:36	509	Coating of panel W3 started peeling off.	-
07:25:01	534	Flaming debris observed on the floor.	DLP C2753E/0004

DLP C2753E/0004 Flaming debris observed on the floor.

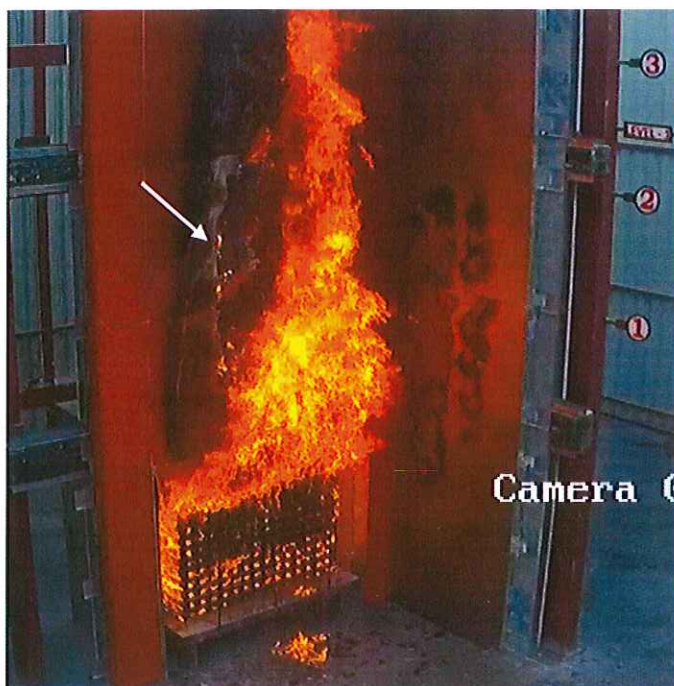
Time	Seconds	Observation	Photo Reference
07:25:31	564	Approximately 50% of panels M6, M7, M10 & M11 melted.	DLP C2753E/0005
07:26:05	598	Debris of insulation fell off the main wall.	-

DLP C2753E/0005 Approximately 50% of panels M6, M7, M10 & M11 melted.

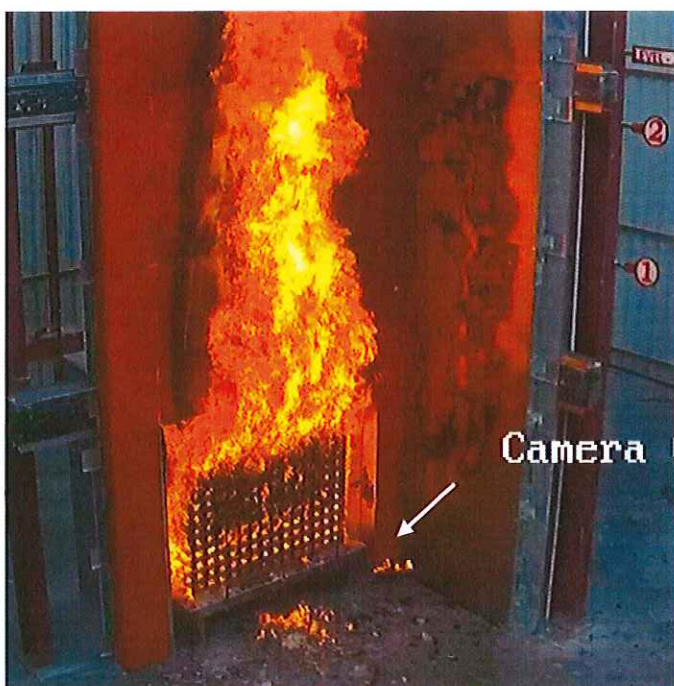
07:26:58	651	Aluminium skin of panels M14 and M15 partially melted and insulation behind the panels was burning.	-
07:27:07	660	Flaming debris of insulation behind the panel M6 fell off.	DLP C2753E/0006

DLP C2753E/0006 Flaming debris of insulation behind panel M6 fell off.

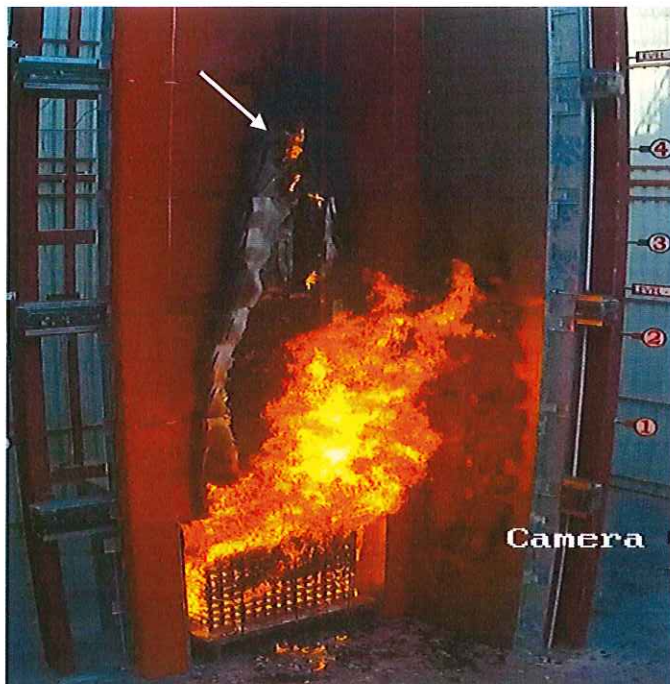
07:28:49	762	Self-sustained flames behind panels M18 & M19.	DLP C2753E/0007
07:29:07	780	Piece of mineral core of panel M19 fell off.	-
07:29:45	818	Debris of panels M18 & M19 fell off.	-

DLP C2753E/0007 Self-sustained flames behind panels M18 & M19.

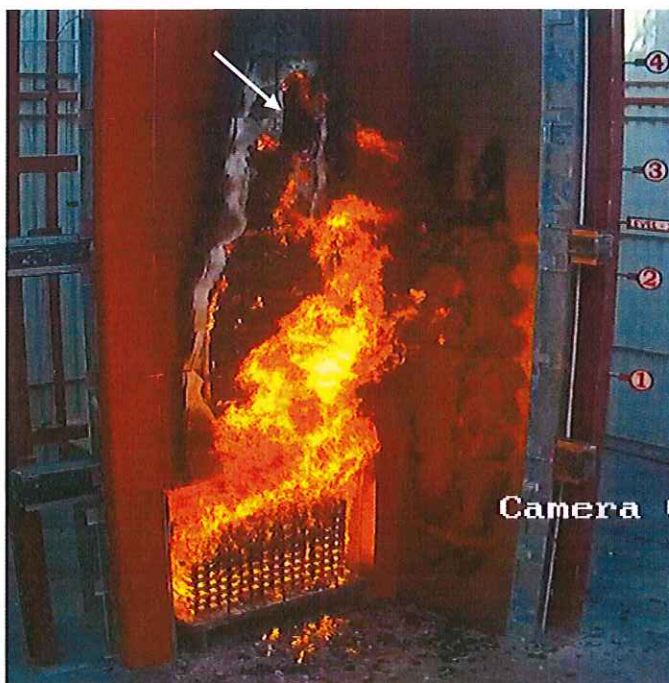
07:30:24	857	Panels M14, M15 and M19 partially consumed and flames on the insulations behind the panels.	DLP C2753E/0008
07:33:39	1052	Coating of panels M22 & M23 started peeling off.

DLP C2753E/0008 Panels M14, M15 and M19 partially consumed and flames on the insulation behind the panels.

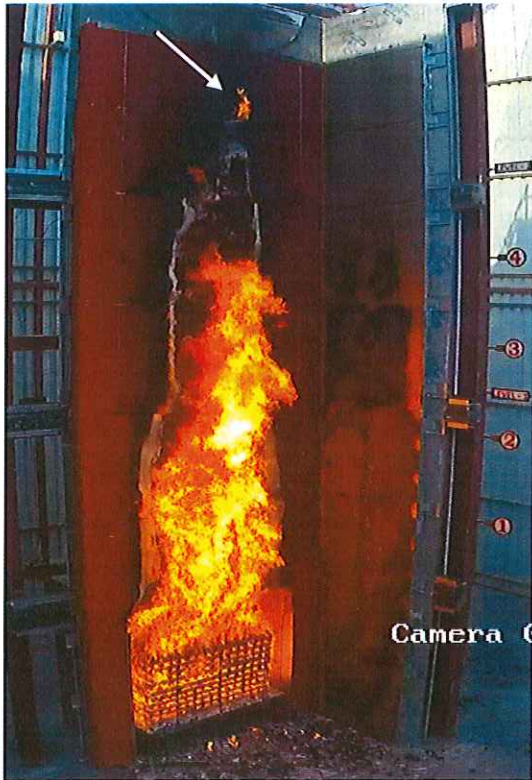
07:35:12	1145	Aluminium skin of panel M23 started to melt.	
07:35:48	1181	Self-sustained flames at panels M23 & M27 horizontal joint.	DLP C2753E/0009
07:35:59	1192	Continuous falling of debris of aluminium and insulation.	-

DLP C2753E/0009 Self-sustained flames at panels M23 & M27 horizontal joint.

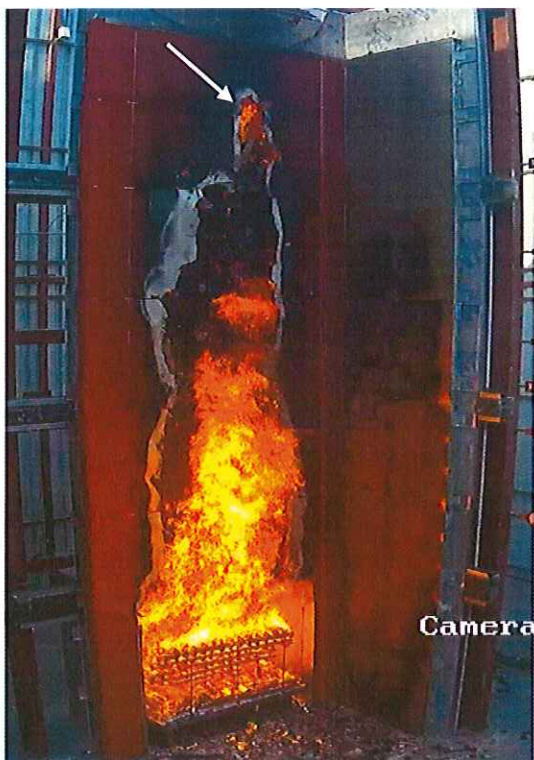
07:36:52	1245	Aluminium skin of panel M27 started to melt.	-
07:38:08	1321	Self-sustained flames on the insulations behind panels M23 & M27.	DLP C2753E/0010

DLP C2753E/0010 Self-sustained flames on the insulation behind panels M23 & M27.

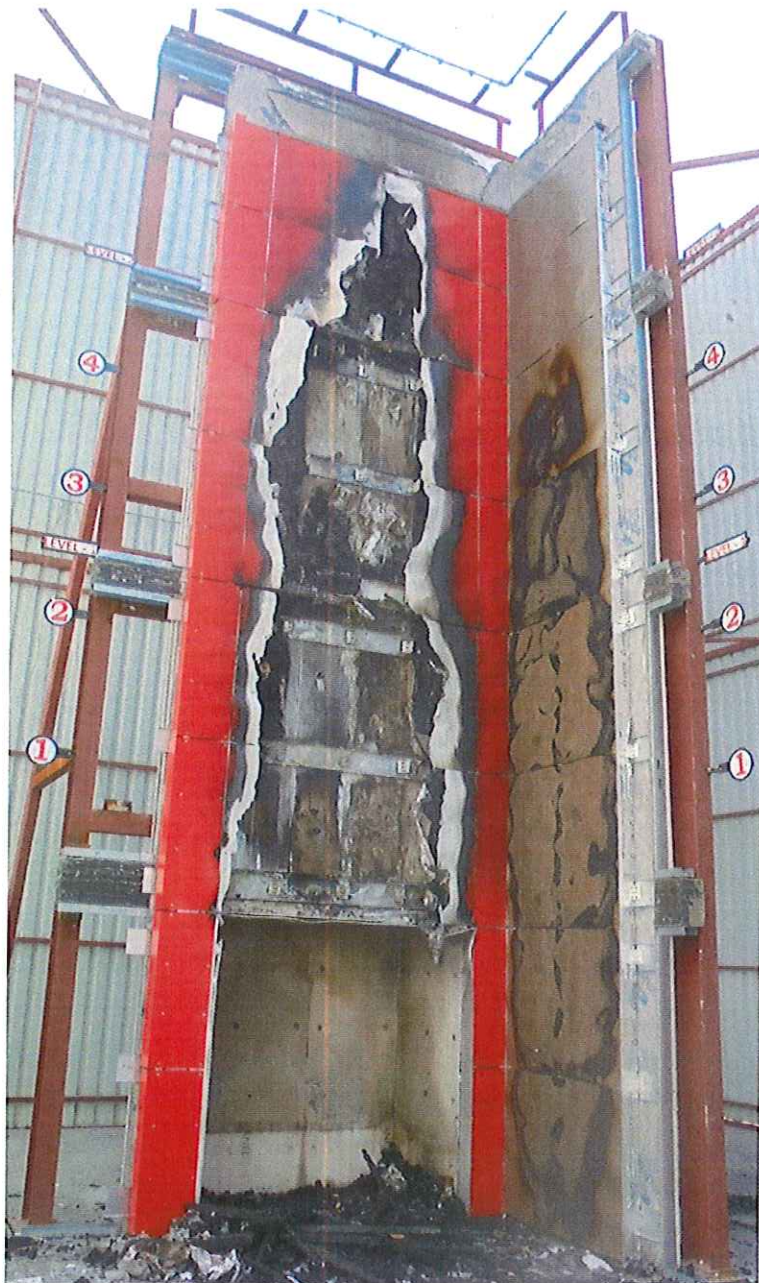
DLP C2753E/0011

Sl. No.	Components	Observation	Photo Reference
1	4mm ACM panels	<p>Panels M1, M2, M3, M4, M21, M24, M25 &amp; M28 – No significant changes to the panels.</p> <p>Panels M5, M8, M9, M12, M13, M16, M17 &amp; M20 – Minor buckling and discoloration on the panels.</p> <p>Panel M6, M7, M10 &amp; M14 – Approximately 80% material loss observed. Remaining area was buckled and discoloured.</p> <p>Panels M11, M15, M18 &amp; M19 – Approximately 60% material loss observed. Remaining area was buckled and discoloured.</p> <p>Panels M22 &amp; M23 – Approximately 40% material loss observed. Remaining area was discoloured.</p> <p>Panel M26 – Approximately 50% of the panel was discoloured.</p> <p>Panel M27 – Approximately 25% material loss observed. Remaining area was buckled and discoloured.</p> <p>Panels W1, W2, W3, W4 &amp; W5 – Panels were discoloured.</p> <p>Panel W6 – Approximately 40% of the panel was discoloured.</p> <p>Panels W7 &amp; W8 – No damage to the panels. Minor buckling observed.</p>	DLP C2753E/0011.

View of the sample after the test

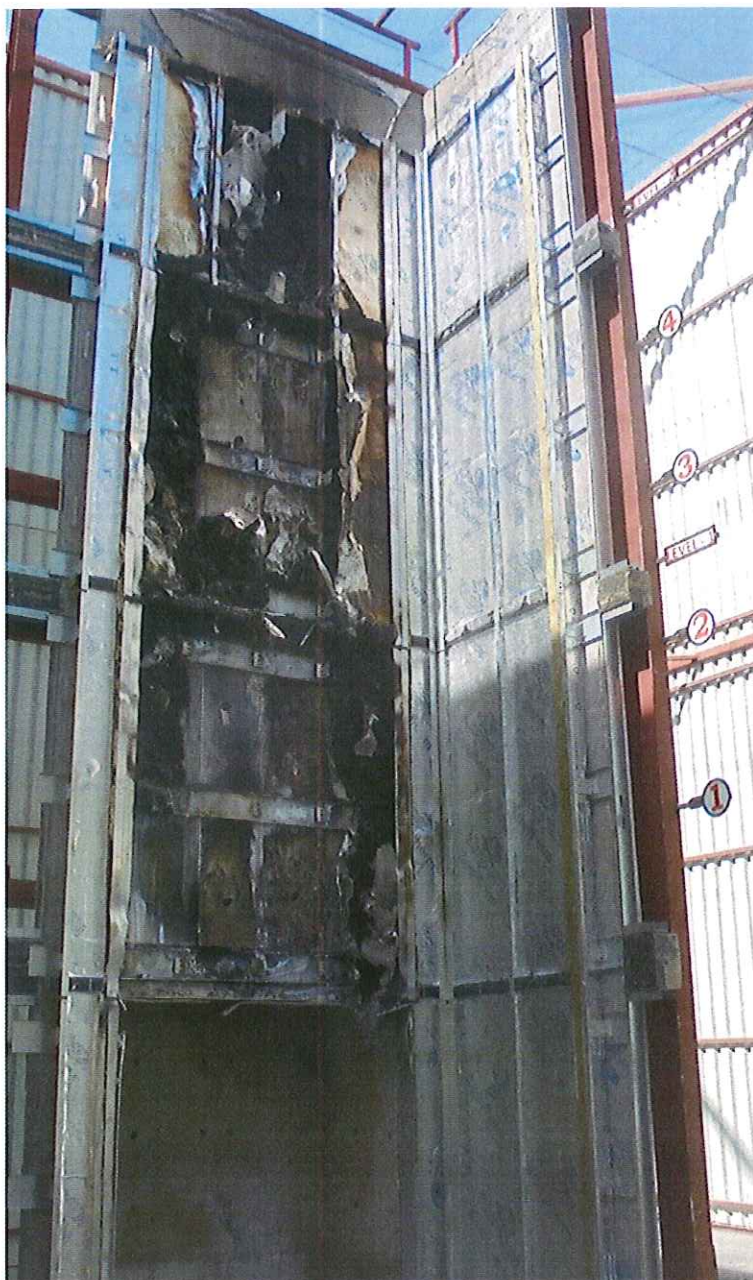
2.	Kingspan Kooltherm K15 insulation	<p>Insulation behind the panels M5 was completely burned and fell off.</p> <p>50% insulation behind panels M7, M10, M11, M14 &amp; M18 was completely burned and fell off. Remaining insulation was burned and left as char.</p> <p>50% insulation behind panels M15 &amp; M19, were completely burned and fell off. Remaining insulation was discoloured.</p> <p>50% insulation behind panels M22, M23, M26 &amp; M28 was completely burned and left as char. Remaining insulation was discoloured.</p> <p>All other insulation on the main wall and wing wall was in place and no changes observed.</p>	DLP C2753E/0012 & DLP C2753E/0018.

Sl. No.	Components	Observation	Photo Reference
3.	Cavity barrier	<p><b>Horizontal intumescent cavity barrier:</b></p> <p>Main wall:</p> <p>The 1<sup>st</sup> horizontal cavity barrier at 25mm above the combustion chamber was activated and consumed except the cavity barrier behind panels M5 &amp; M8.</p> <p>The 2<sup>nd</sup> horizontal cavity barrier at 2375mm above the combustion chamber was activated except the cavity barrier behind panels M13 &amp; M16. Intumescent layer was not present during dismantling. Cavity barrier was in place and material loss observed.</p> <p>The 3<sup>rd</sup> horizontal cavity barrier at 4725mm above the combustion chamber was activated except the cavity barrier behind panels M21 &amp; M24. Intumescent layer was partially present during dismantling. Cavity barrier was in place and minor material loss observed.</p> <p>The 4<sup>th</sup> horizontal cavity barrier at 6395mm above the combustion chamber was activated except the cavity barrier behind panels M24 &amp; M28. Intumescent layer was partially present during dismantling. Cavity barrier was in place and minor material loss observed.</p> <p>Wing wall:</p> <p>The 1<sup>st</sup> horizontal cavity barrier at 2025mm above the combustion chamber was not activated. No material loss observed.</p> <p>The 2<sup>nd</sup> horizontal cavity barrier at 4375mm above the combustion chamber was activated. Intumescent layer was not present during dismantling. Cavity barrier was in place and no material loss observed.</p> <p>The 3<sup>rd</sup> horizontal cavity barrier at 6725mm above the combustion chamber was activated. Intumescent layer was not present during dismantling. Cavity barrier was in place and no material loss observed.</p> <p>The 4<sup>th</sup> horizontal cavity barrier at 8395mm above the combustion chamber was activated. Intumescent layer was not present during dismantling. Cavity barrier was in place and no material loss observed.</p> <p><b>Vertical cavity barrier:</b></p> <p>Buckling and discoloration on the vertical cavity barrier on the main wall.</p> <p>No significant changes on the vertical cavity barrier on wing wall.</p>	DLP C2753E/0012, DLP C2753E/0016 & DLP C2753E/0018.

Sl. No.	Components	Observation	Photo Reference
4.	Railings	<p>Railings:</p> <p>Railings behind panels M6, M7, M10, M11, M14, M15, M18 &amp; M19 were melted completely.</p> <p>Railings behind panels M22, M23, M26 &amp; M27 were melted partially. Remaining areas were discoloured and buckled.</p> <p>All other railings on the main wall and wing wall were in place and no damage was observed.</p>	DLP C2753E/0012 & DLP C2753E/0018.

Kingspan Kooltherm K15 insulation, cavity barrier and railings

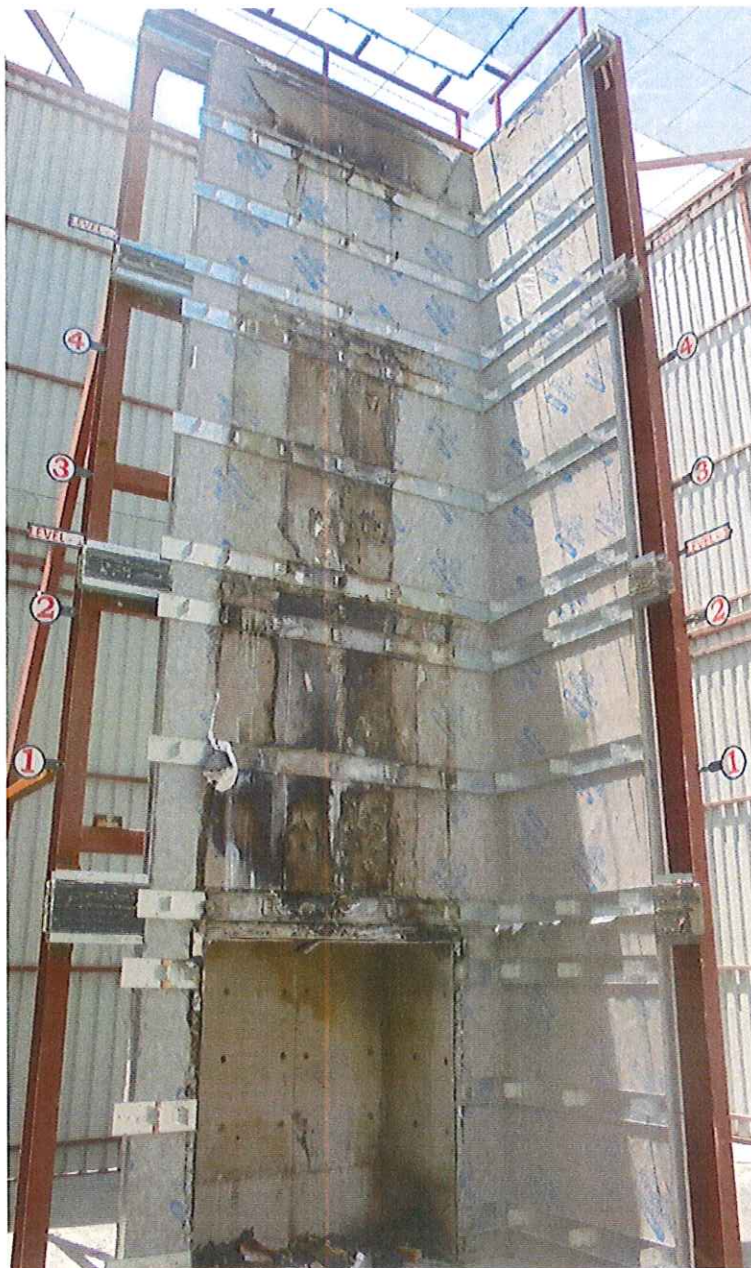
5.	Brackets, galvanized steel 'C' channel and breather membrane	<p>Brackets:</p> <p>Approximately 15% of the Helping Hand brackets on the main wall were partially melted. Remaining brackets were in place. Discoloration and buckling on the aluminium 'C' channels were observed.</p> <p>All the brackets on the wing wall were in place and no damage was observed.</p> <p>Breather membrane:</p> <p>Material loss and discolouration to the Nilvent breathable membrane on the main wall and no significant changes to the Nilvent breathable membrane on the wing wall.</p>	DLP C2753E/0013 & DLP C2753E/0019.

Breather membrane and brackets

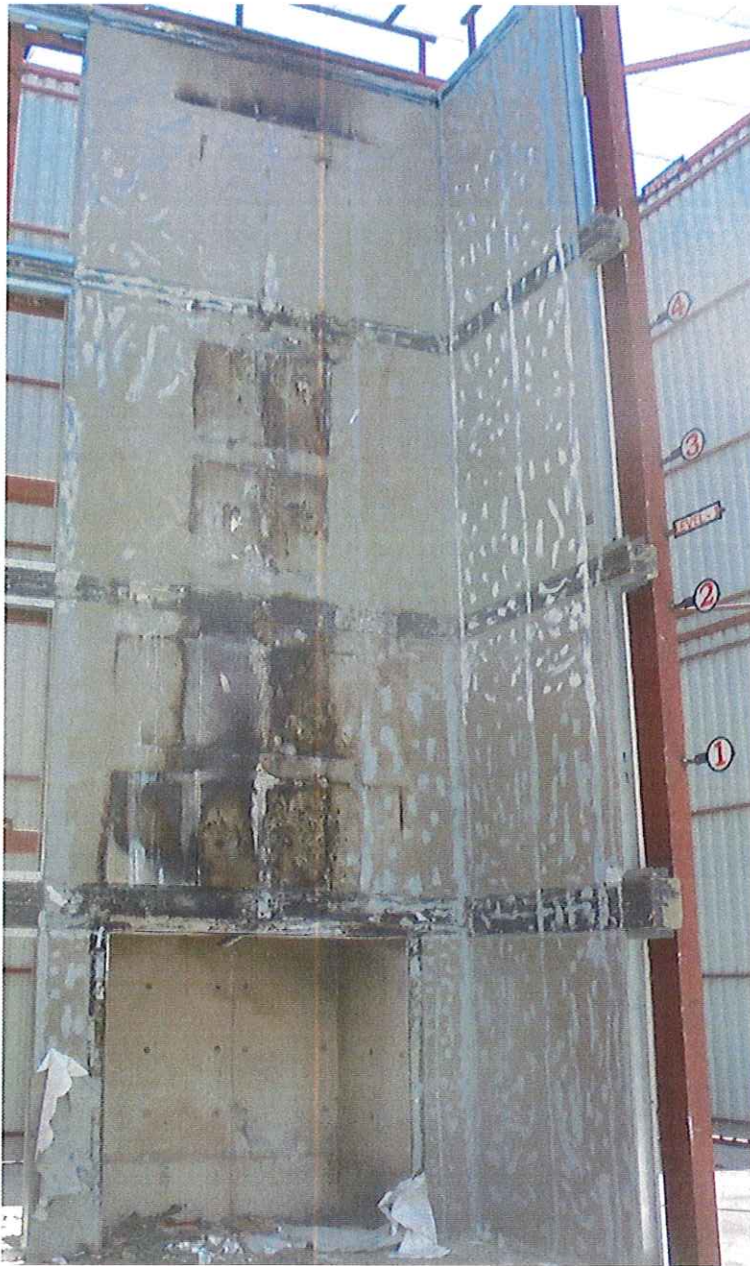
6.	12mm Versapanel cement particle board	Minor damages and discolouration to the Versapanel cement particle board on the main wall and no significant changes to the Versapanel cement particle board on the wing wall.	DLP C2753E/0014 & DLP C2753E/0020.

Versapanel cement particle board

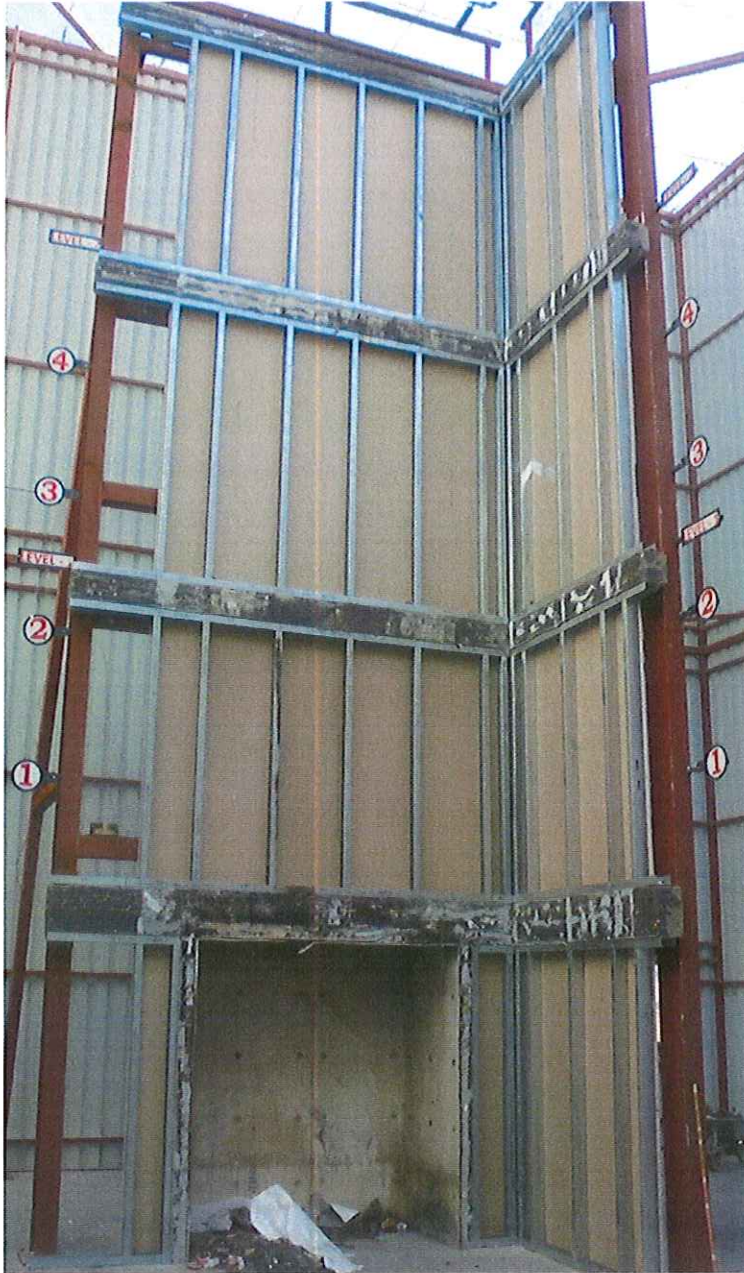
7.	Kingframe SFS and plaster boards	No significant changes.	DLP C2753E/0015.

DLP C2753E/0015 SFS and plaster board

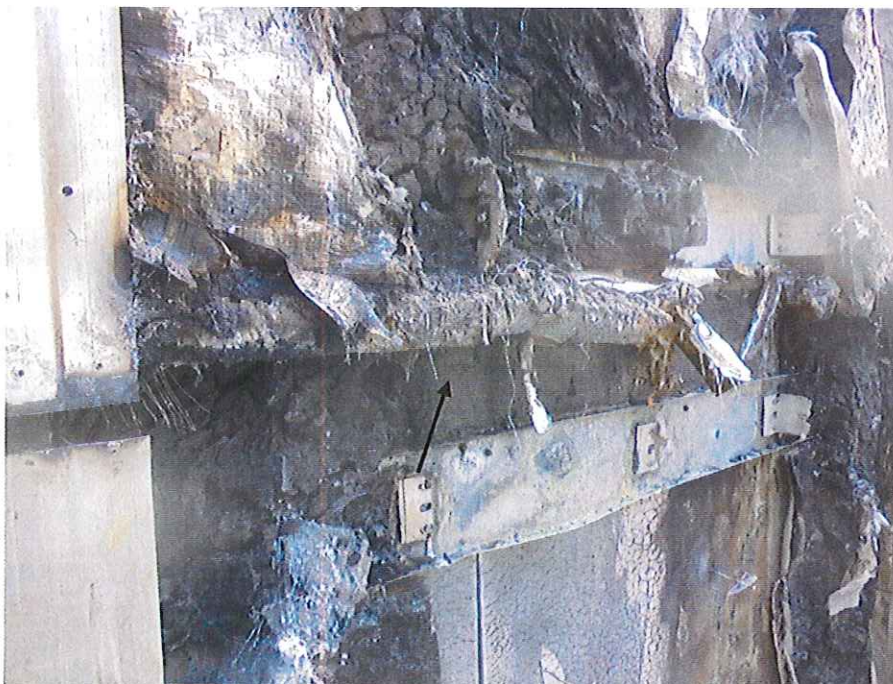
DLP C2753E/0016 Cavity barrier at level 1 main wall

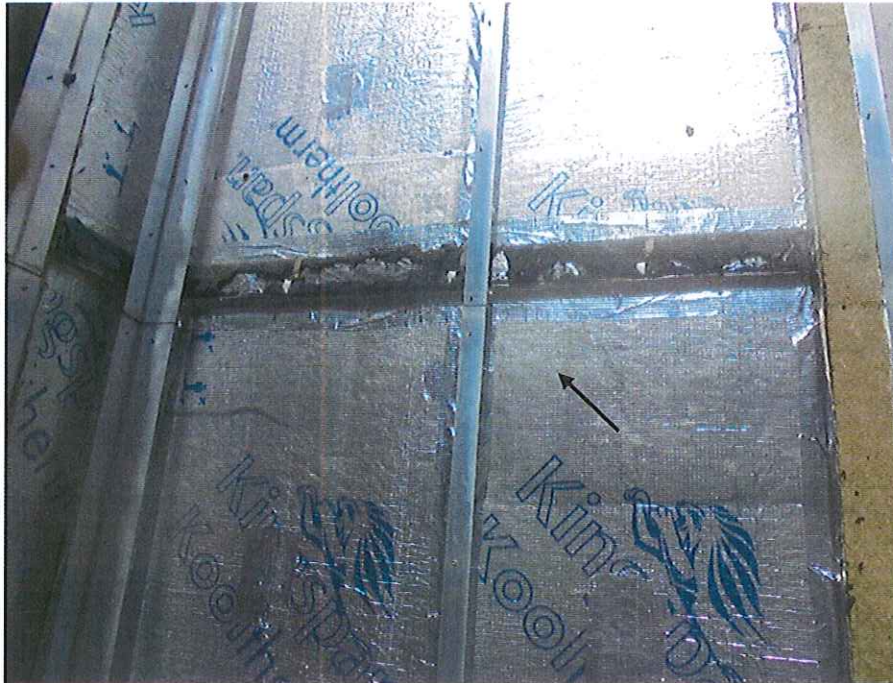
DLP C2753E/0018

Cavity barrier, insulation and railings on wing wall.

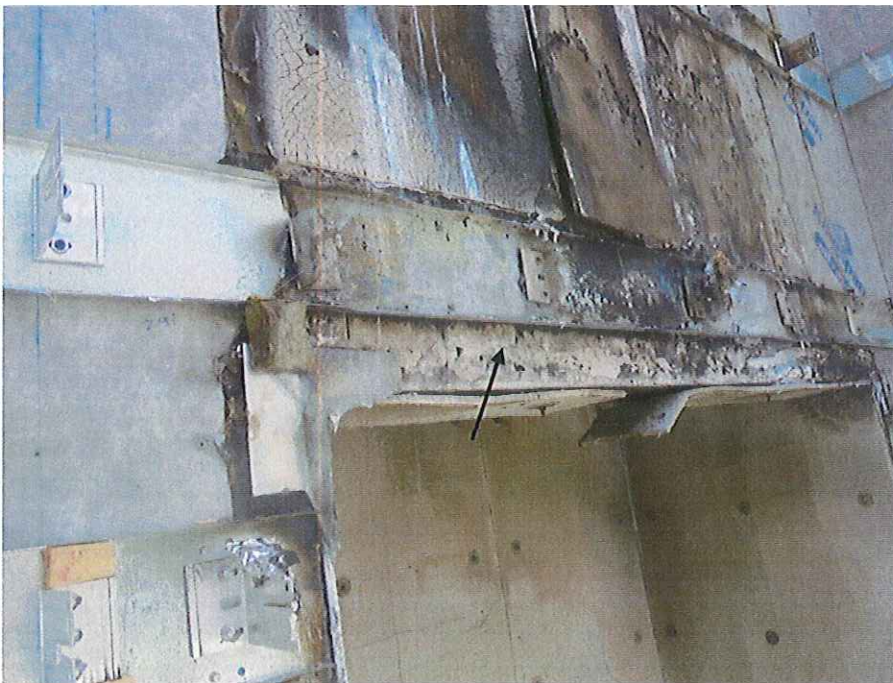
DLP C2753E/0019

Brackets

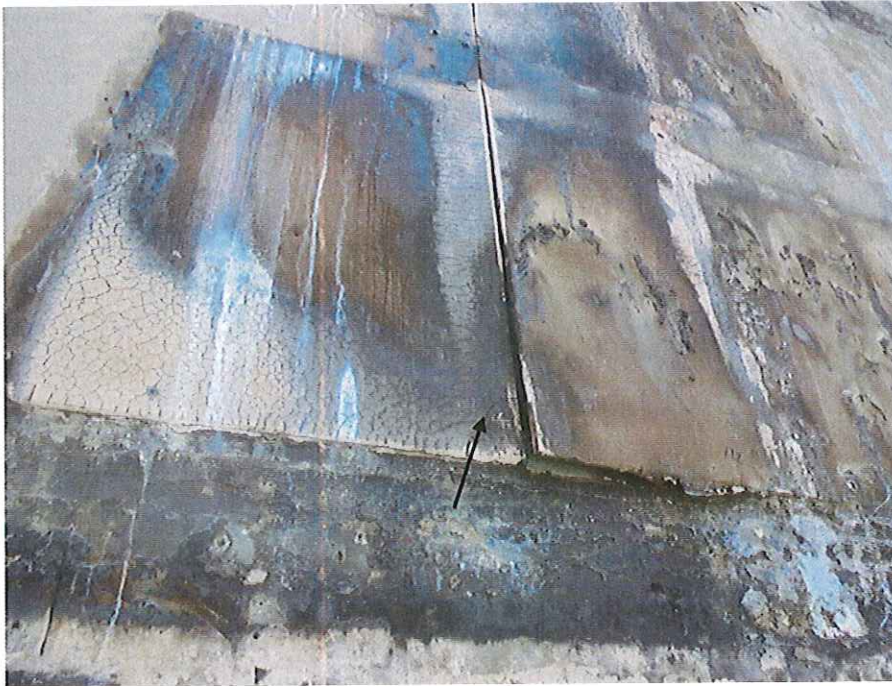
DLP C2753E/0020

Versapanel cement particle board
