Fire Performance Testing of an External Cladding System BS 8414-2:2015 + A1:2017

Test Report

Prepared for : Kingspan Insulation Ltd.
Project : System Development
Report No. : DLR1558 Rev.0
Sample : 160mm Kingspan Kooltherm K15 - Alpolic A2 ACM - BML400

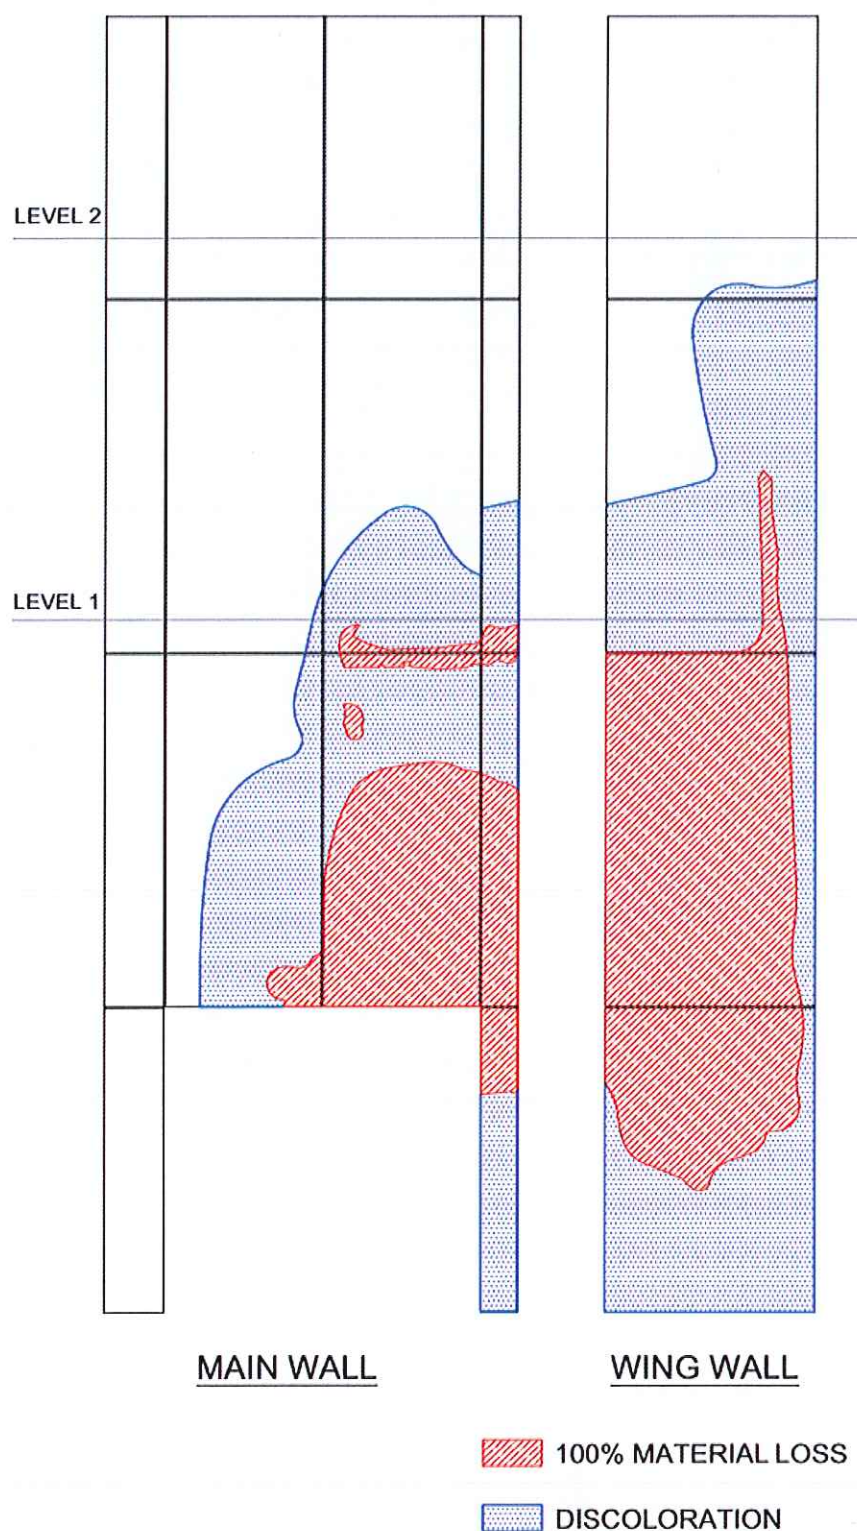
Figure 13 Area Map Showing the Condition of the Sample After the Test

- Approximately 6m² of the total external visible area was completely consumed.
- Approximately 7m² of the total external visible area was discoloured.

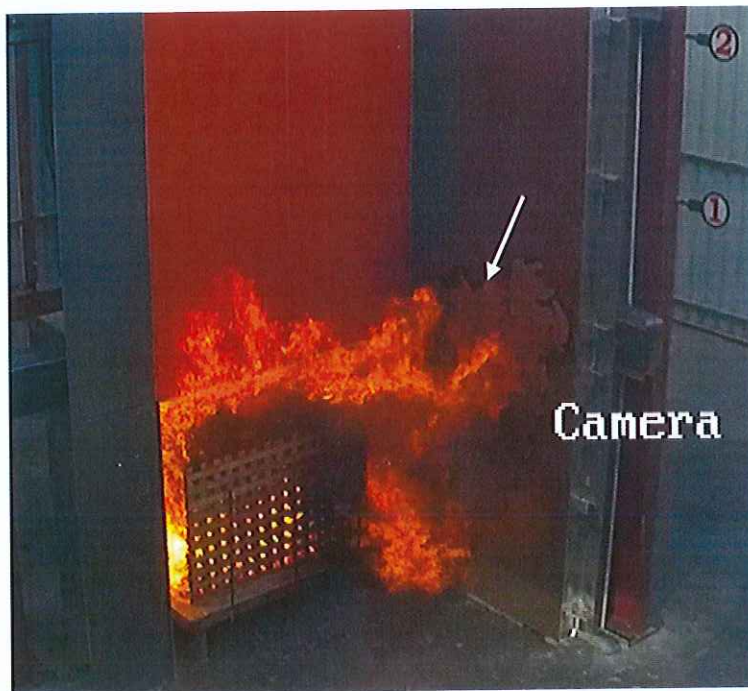
06:43:10	N/A	Self-sustained flames on the surface of panel W1.	-
06:43:56	N/A	Coating of panel W2 started to peel off.	DLP C2753E/0001
06:45:56	N/A	Coating of panel M5 started to peel off.	-

DLP C2753E/0001 Coating of panel W2 started to peel off.

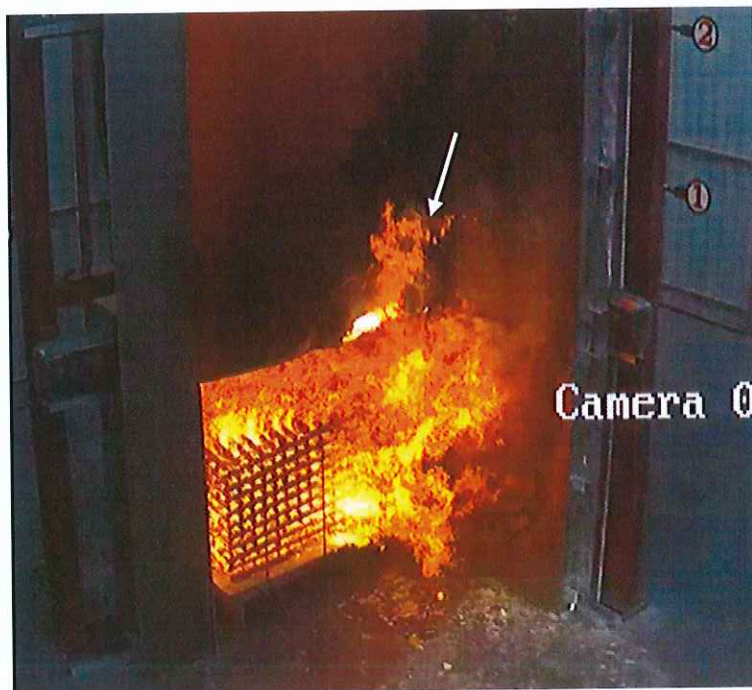
06:55:26	554	Debris of panel M5 fell off.	-
06:55:51	579	Panel M6 partially melted.	-
06:56:20	608	Self-sustained flames behind panel M5.	DLP C2753E/0002

DLP C2753E/0002 Self-sustained flames behind panel M5.

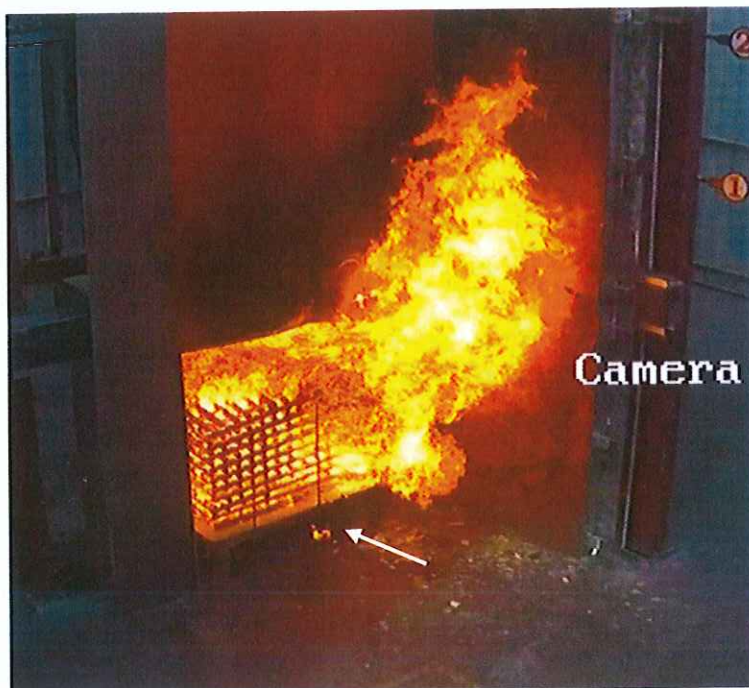
Time	Seconds	Observation	Photo Reference
06:56:27	615	Coating of panel W3 started to peel off.	-
06:56:31	619	Flaming debris fell off the main wall.	DLP C2753E/0003

DLP C2753E/0003 Flaming debris fell off the main wall.

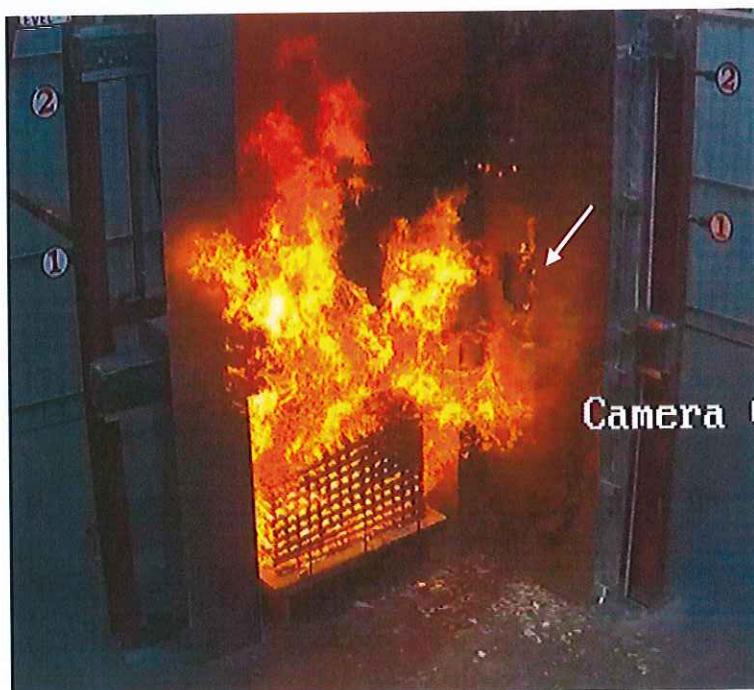
06:57:07	655	Continuous falling of debris.	
06:57:17	665	Panel W2 partially melted.	DLP C2753E/0004
06:57:38	686	Aluminium debris of panel M5 fell off.	DLP C2753E/0005

DLP C2753E/0004 Panel W2 partially melted.

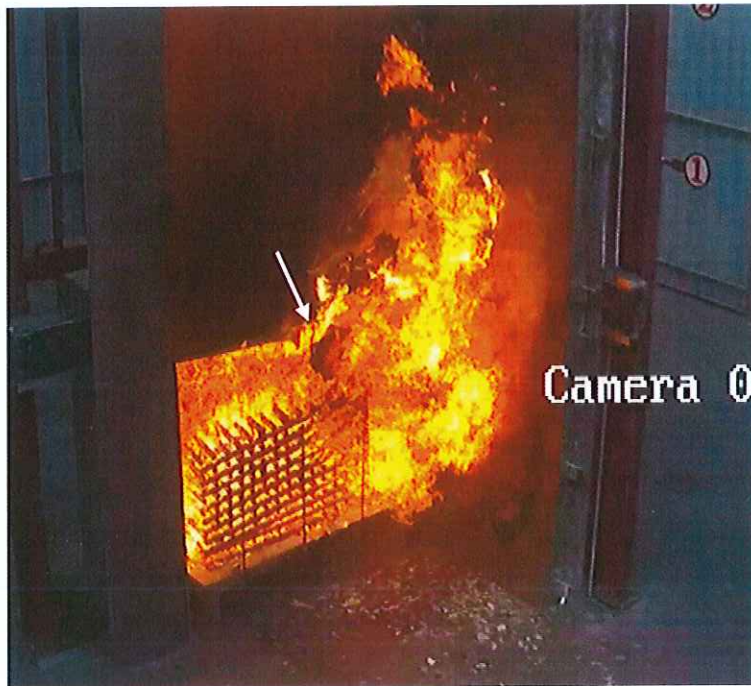
DLP C2753E/0005 Aluminium debris of panel M5 fell off.

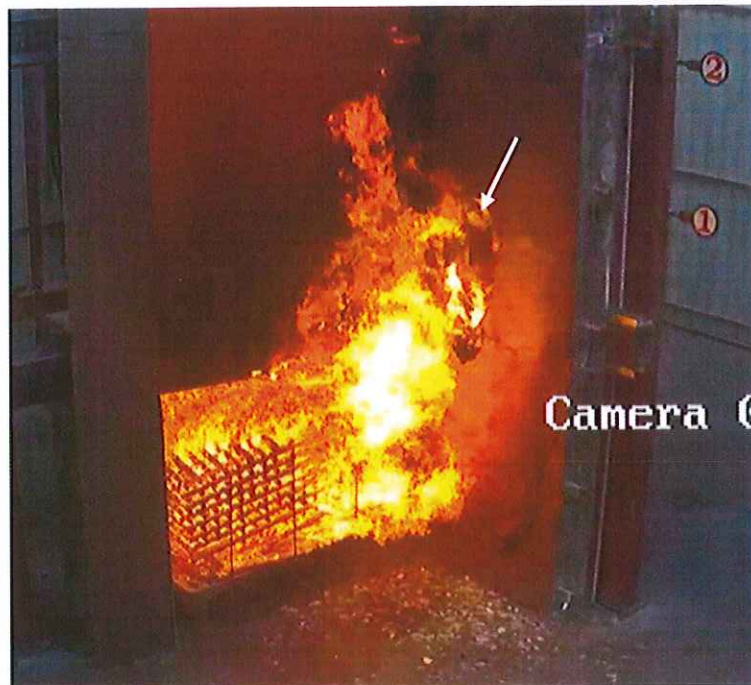
06:58:01	709	Panel W2 partially melted and flames on the insulations behind the panel.	DLP C2753E/0006
06:58:22	730	Panels M5 & M6 partially melted and flames behind the panels.	DLP C2753E/0007

DLP C2753E/0006 Panel W2 partially melted and flames on the insulation behind the panel.

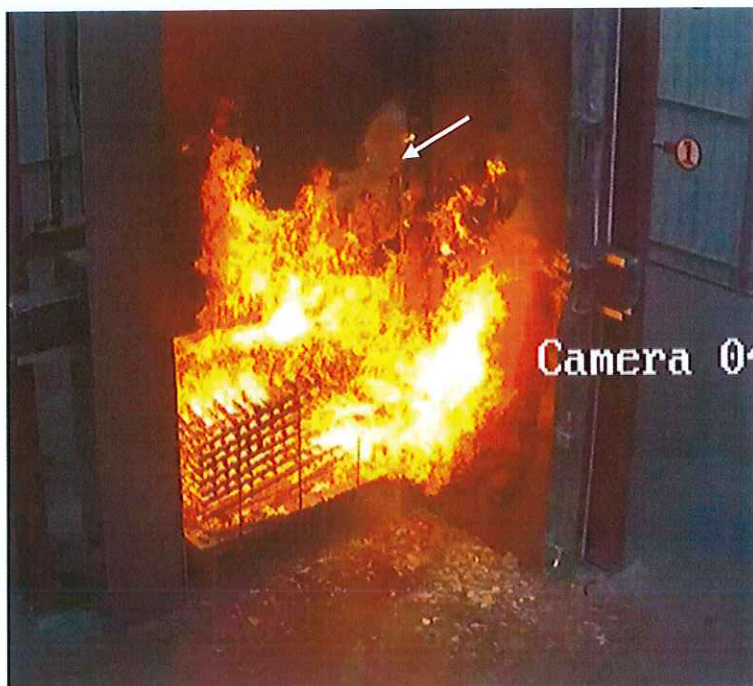
DLP C2753E/0007 Panels M5 & M6 partially melted and flames behind the panels.

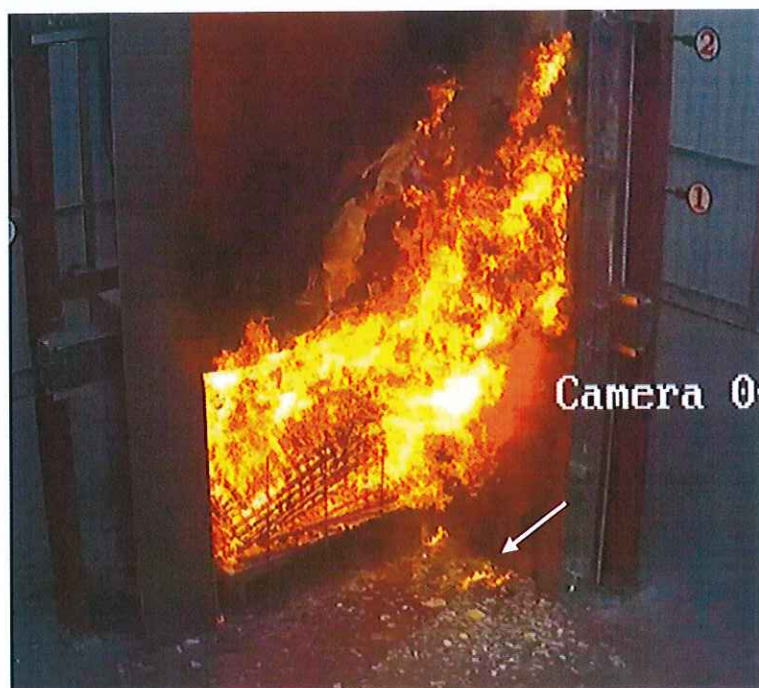
06:59:03	771	Sustained flames at panels M5 & M6 vertical joint.	-
06:59:15	783	Flaming debris observed on the floor.	DLP C2753E/0008
06:59:26	794	High intensity flames behind panels M5, M6 & W2.

DLP C2753E/0008 Flaming debris observed on the floor.

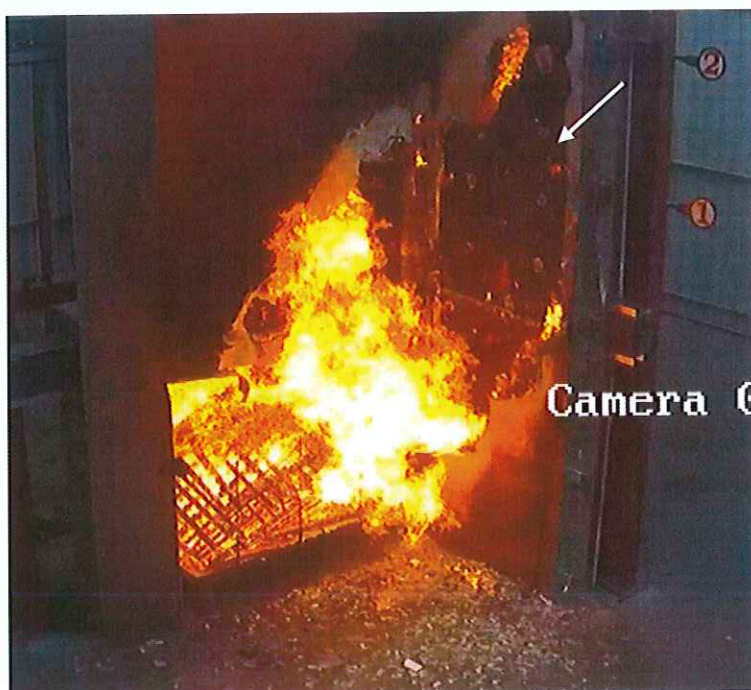
07:01:04	892	Continuous falling of flaming debris.	-
07:01:42	930	Railings behind panels M5, M6 & W2 melted.	-
07:01:55	943	Panel W3 started melting.	
07:02:28	976	Approximately 80% of panel W2 consumed.	DLP C2753E/0009

DLP C2753E/0009 Approximately 80% of panel W2 consumed.

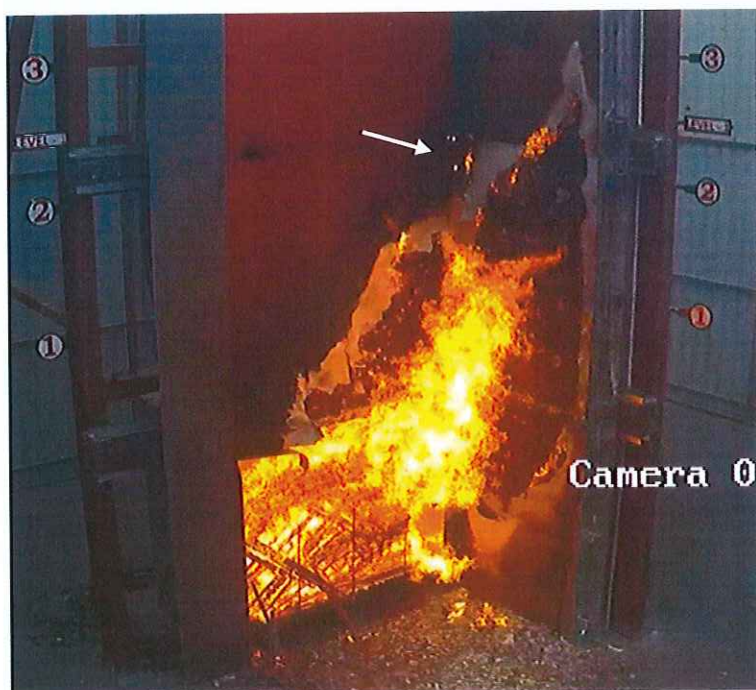
07:03:26	1034	Debris of panel M4 fell off.	-
07:03:38	1046	Flaming debris of panel M5 fell off.	-
07:03:52	1060	Self-sustained flames at panels M6 and W2 internal corner joint.	DLP C2753E/0010

DLP C2753E/0010 Self-sustained flames at panels M6 and W2 internal corner joint.

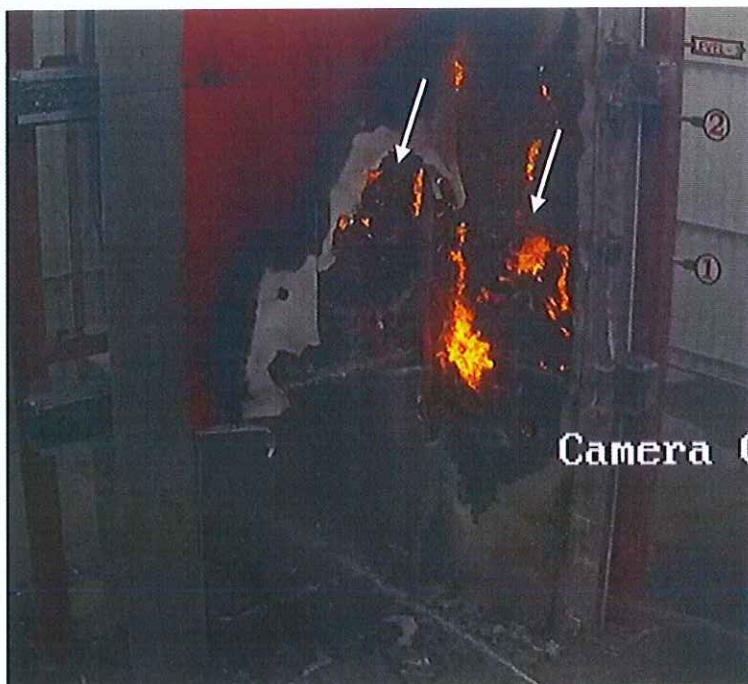
07:04:52	1120	Debris of panel W2 detached and fell off.	-
07:07:36	1284	Heat source was extinguished. Observations continued for another 30 minutes.	-
07:12:35	1583	High intensity flames behind panels M5, W1 & W2.	DLP C2753E/0011

DLP C2753E/0011 High intensity flames behind panels M5, W1 & W2.

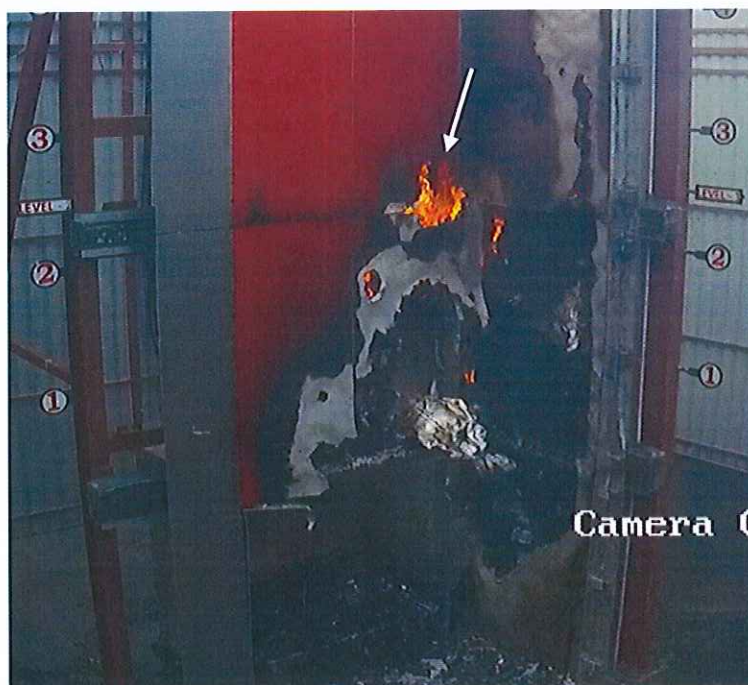
07:17:55	1903	Self-sustained flames behind panel W3.	-
07:27:38	2486	Sustained flames on the face of panel M9.	DLP C2753E/0012
07:37:36	3084	Test was terminated 60 minutes after the ignition.	-

DLP C2753E/0012 Sustained flames on the face of panel M9.

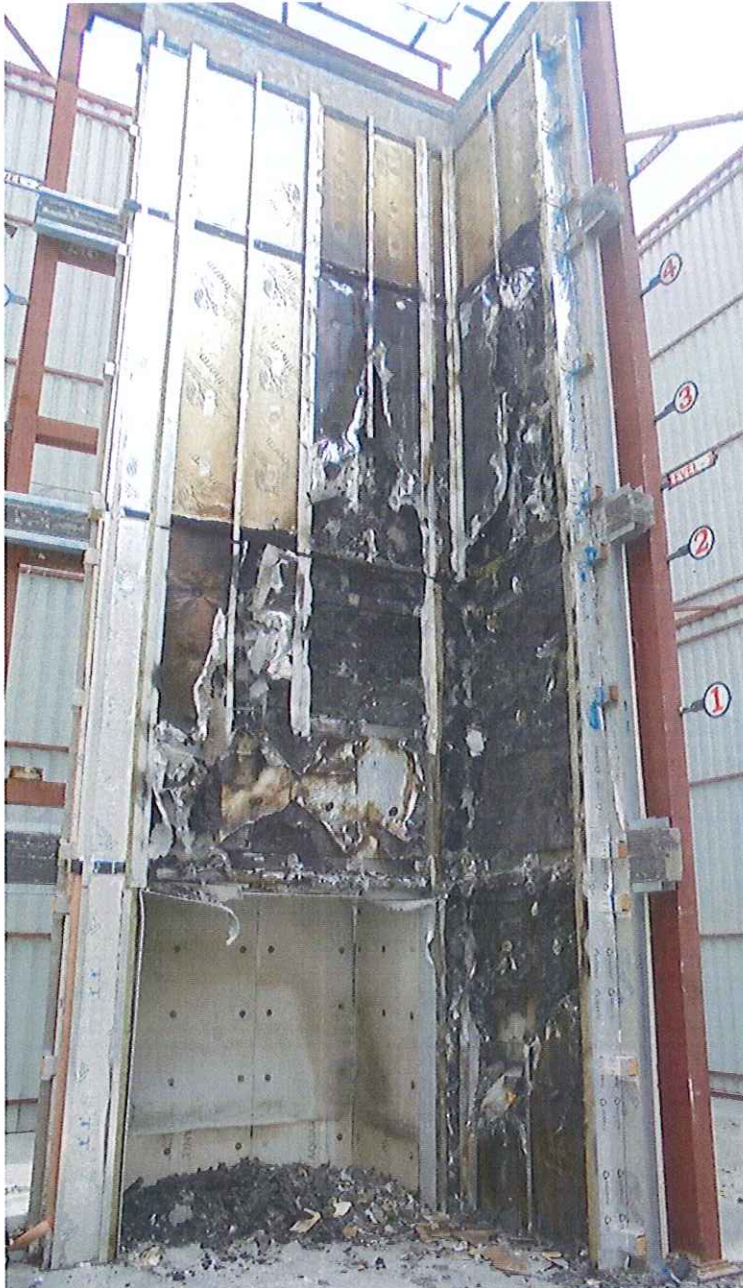
3	Kingspan Kooltherm K15 insulation	<p>Insulation behind panels M4, M5, M6, M9, M10, W1, W2 & W3 was burned and left as char.</p> <p>Minor discoloration on the insulation behind panels M8, M13, M14 & W4.</p> <p>All other insulation was in place and no significant changes observed.</p>	DLP C2753E/0014 & DLP C2753E/0018.
4	Vertical railings	<p>Main wall:</p> <p>Railings behind panels M4, M5, M6 & M9 were partially melted.</p> <p>Minor discoloration on the railings behind panels M10 & M14.</p> <p>All other railings on the main wall were in place and no damage was observed.</p> <p>Wing wall:</p> <p>Railings behind panels W1, W2 & W3 were partially melted.</p> <p>Minor discoloration was observed on the remaining railings on the wing wall.</p>	DLP C2753E/0014 & DLP C2753E/0018.

Cavity barriers, Kingspan insulation and carrier railings

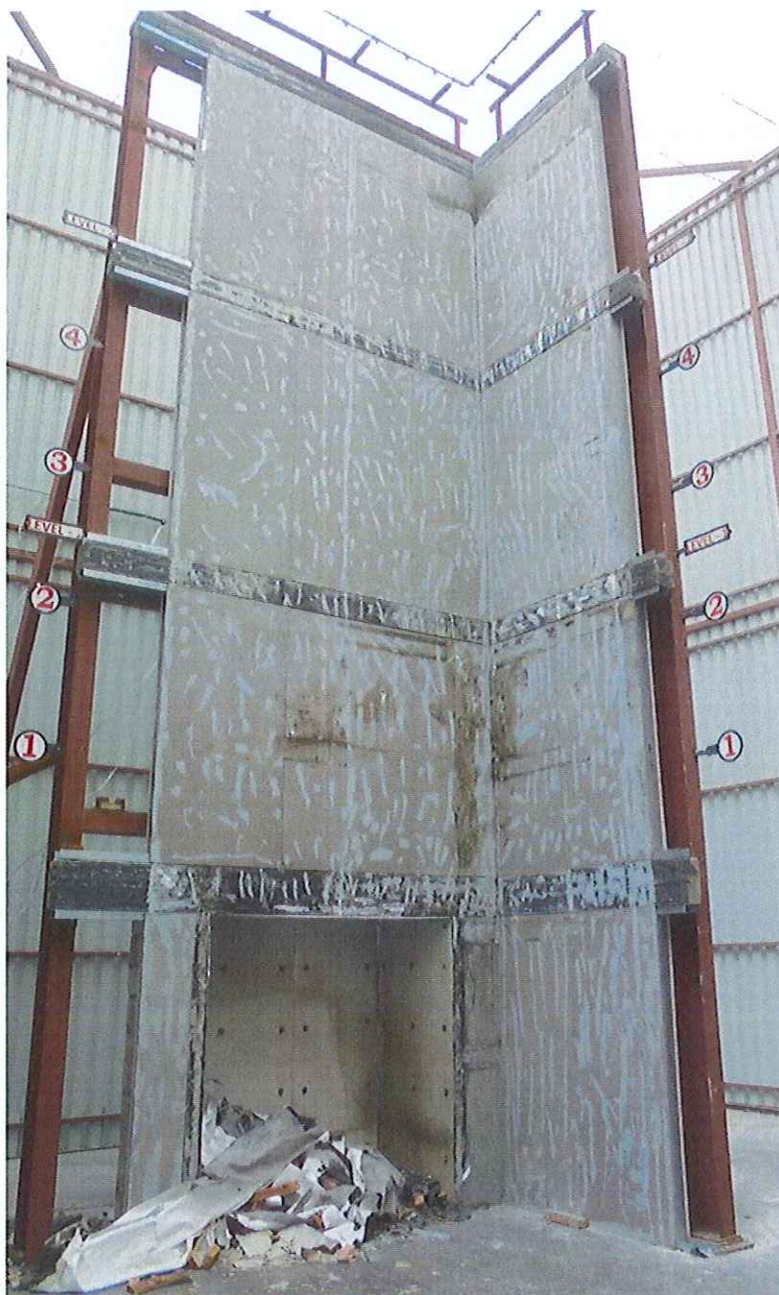
DLP C2753E/0016

Sl. No.	Components	Observation	Photo Reference
5	Brackets and Nilvent breather membrane	<p>Top Hat bracket:</p> <p>Discoloration on the brackets behind panels M4, M5, M6, W1 & W2. No significant changes on the remaining brackets.</p> <p>Helping Hand bracket:</p> <p>Approximately 5% of the Helping Hand brackets were partially melted. All other brackets were in place and no significant changes observed.</p> <p>Breather membrane:</p> <p>Minor material loss and discoloration on the Nilvent breather membrane observed.</p>	DLP C2753E/0015 & DLP C2753E/0019.
6	12mm Versapanel cement particle board	Minor discolouration on the cement particle board behind panels M5, M6, M14 & W2. No significant changes on the remaining boards.	DLP C2753E/0016.
7	SFS and plaster boards	No significant changes.

Versapanel cement particle board

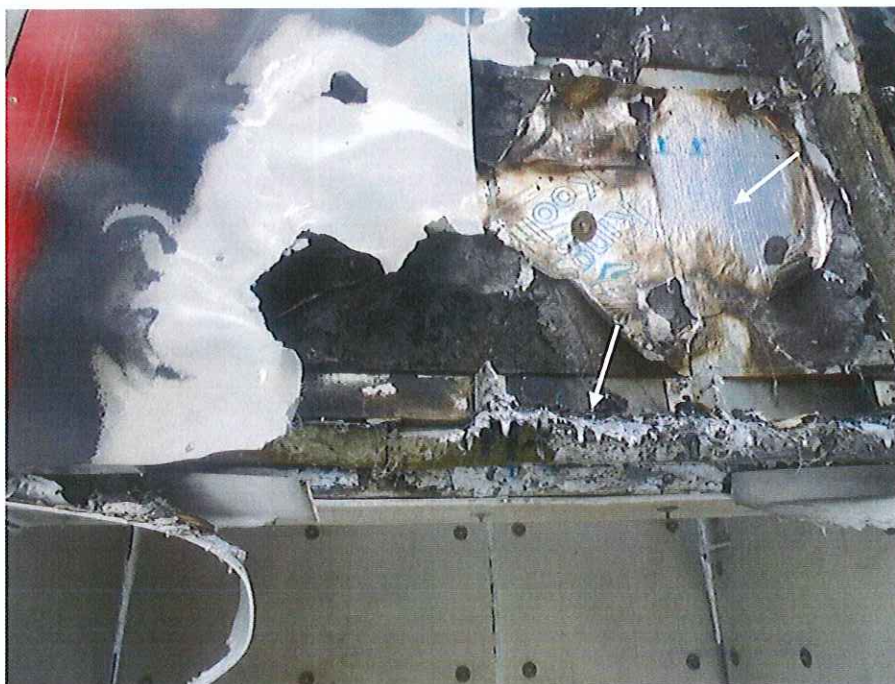
Sl. No.	Components	Observation	Photo Reference
1	ACM panels	<p>Panels M1, M3, M7, M11 & M12 - No changes on the panels.</p> <p>Panels M2, M5 & M6- Approximately 60% material loss on the panels. Remaining areas were buckled and discoloured.</p> <p>Panels M4, M9 & M10– Approximately 10% material loss on the panels. Approximately 30% of the panel discoloured. Remaining areas were buckled.</p> <p>Panels M8, M13 & M14 – Minor discoloration on the panels.</p> <p>Panel W1 - Approximately 40% material loss on the panel. Remaining area was buckled and discoloured.</p> <p>Panel W2 – 100% material loss observed.</p> <p>Panel W3 – Approximately 20% material loss on the panel. Remaining area was buckled and discoloured.</p> <p>Panel W4 - Minor discoloration on the panel.</p>	<p>DLP C2753E/0013.</p> <p>See figure 13 in this section for damaged areas.</p>
2	Cavity barrier	<p>Horizontal intumescent cavity barrier:</p> <p>Main wall:</p> <p>The 1st horizontal cavity barrier at 25mm above the combustion chamber was activated except the cavity barrier behind panel M3. Intumescent layer was not present during dismantling. Material loss observed.</p> <p>The 2nd horizontal cavity barrier at 2325mm above the combustion chamber was activated except the cavity barrier behind panel M7 intumescent layer was partially present during dismantling. Material loss observed.</p> <p>The 3rd horizontal cavity barrier at 4725mm above the combustion chamber was activated except the cavity barrier behind panels M11 and M12. Intumescent layer was present during dismantling. No material loss observed.</p>	<p>DLP C2753E/0014, DLP C2753E/0017 & DLP C2753E/0018.</p>

Cavity barrier and insulation above the combustion chamber

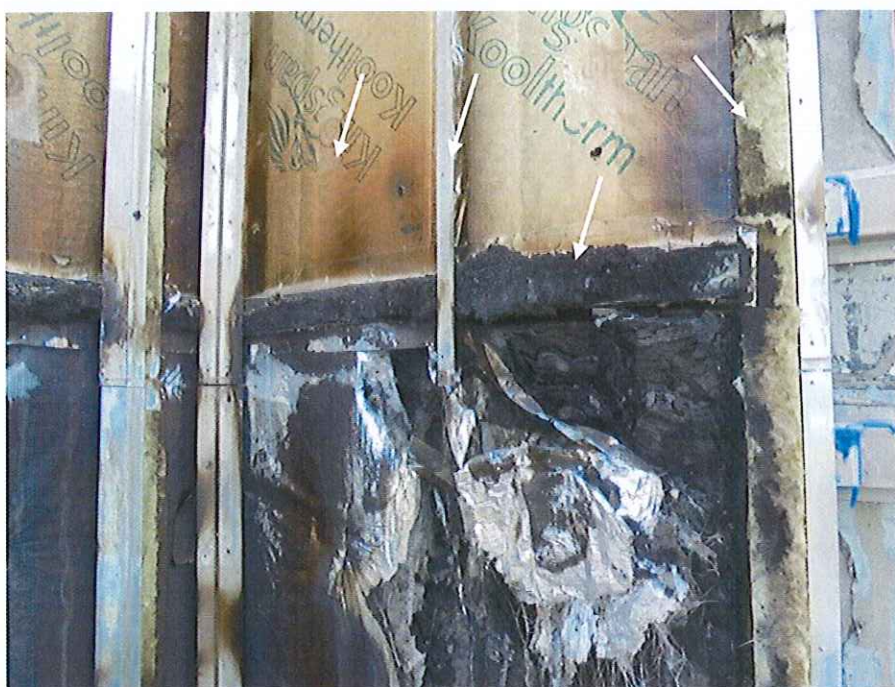
DLP C2753E/0018

Cavity barriers, Kingspan insulation and carrier rails on wing wall
