**Fire Performance Testing of an External Cladding System**  
**BS 8414-2:2015 + A1:2017**

**Test Report**

**Prepared for : Kingspan Insulation Ltd.**  
**Project : System Development**  
**Report No. : DLR1567 Rev.0**  
**Sample : 160mm Kingspan Kooltherm K15 - Alpolic A2 ACM**  
**Cassette Panel– BML100**

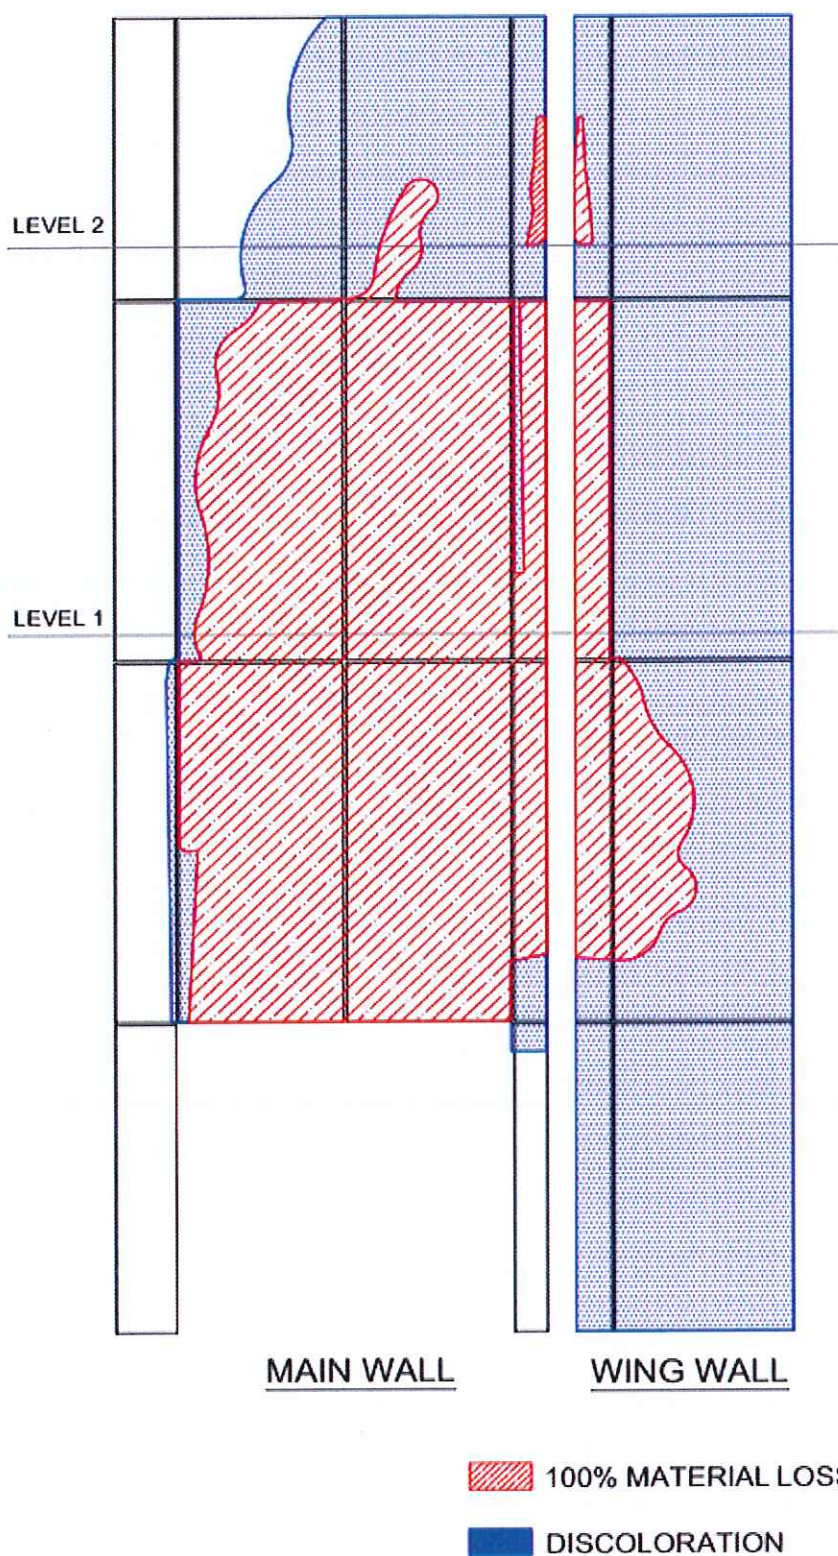
Figure 13 Area Map Showing the Condition of the ACM Panels After the Test

- Approximately 11.5m<sup>2</sup> of the total external visible area was completely consumed.
- Approximately 13m<sup>2</sup> of the total external visible area was discoloured.

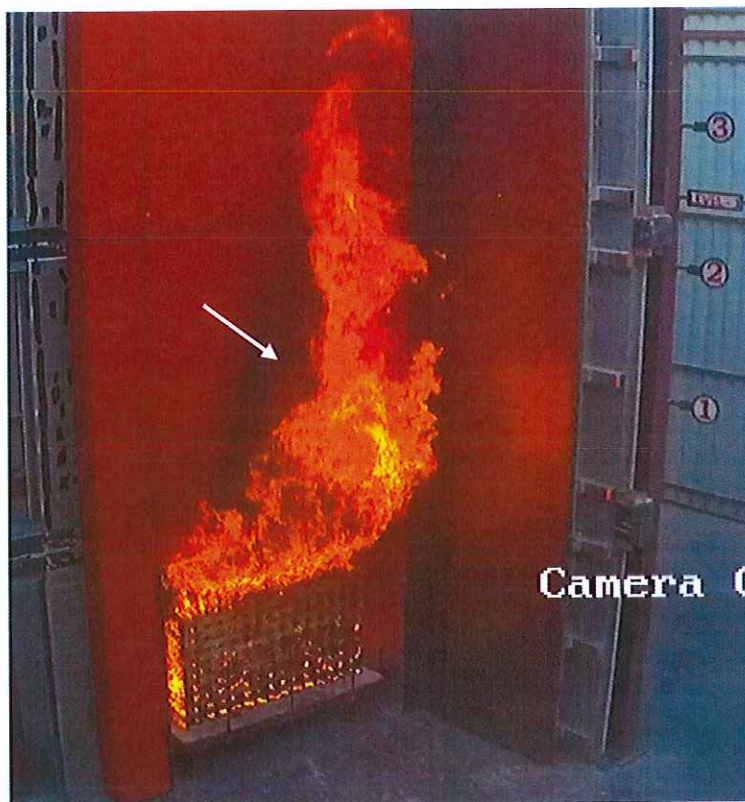
06:17:21	38	Minor buckling on panels M4 & M5.	-
06:17:51	68	Coating of panels M4 & M5 started to peel off.	-
06:18:22	99	Discoloration on panels M4 & M5.	DLP C2753I/0001

DLP C2753I/0001 Discoloration on panels M4 & M5.

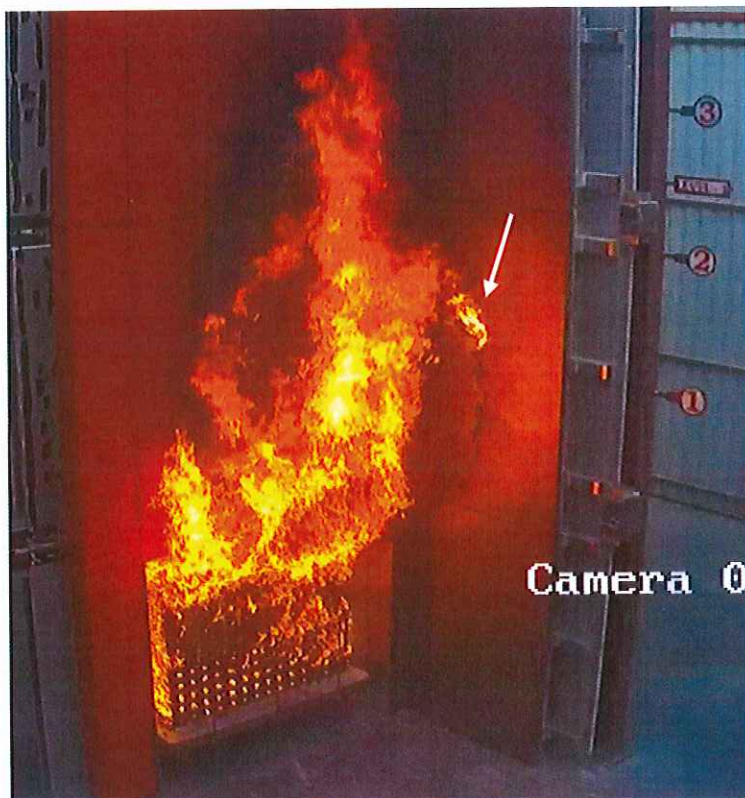
06:21:05	262	Self-sustained flames on the surface of panel W4.	DLP C2753I/0002
06:21:20	277	Coating of panel W6 started to peel off.	-
06:22:16	333	Aluminum skin of panels M4 & M5 started melting.	-

DLP C2753I/0002 Self-sustained flames on the surface of panel W4.

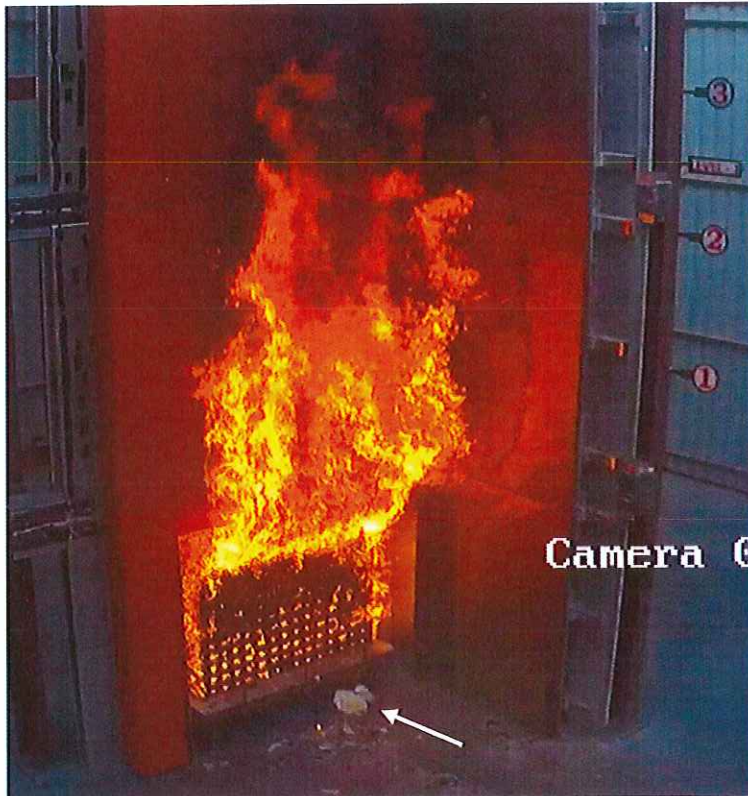
06:22:19	336	Flaming debris fell off the main wall.	-
06:22:25	342	Debris of mineral core of panel M5 fell off.	DLP C2753I/0003
06:23:08	385	Continuous falling of aluminium debris of panels M4 & M5.	-

DLP C2753I/0003 Debris of mineral core of panel M5 fell off.

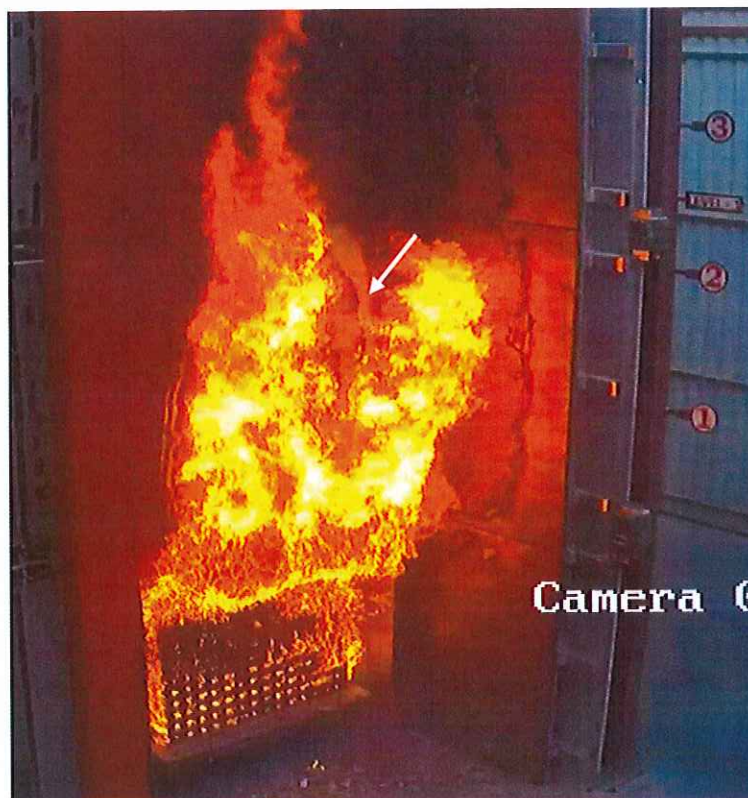
06:23:28	405	Panels M4 & M5 partially melted and insulations exposed.	DLP C2753I/0004
06:23:48	425	Coating of panel W2 started to peel off.

DLP C2753I/0004 Panels M4 & M5 partially melted and insulations exposed.

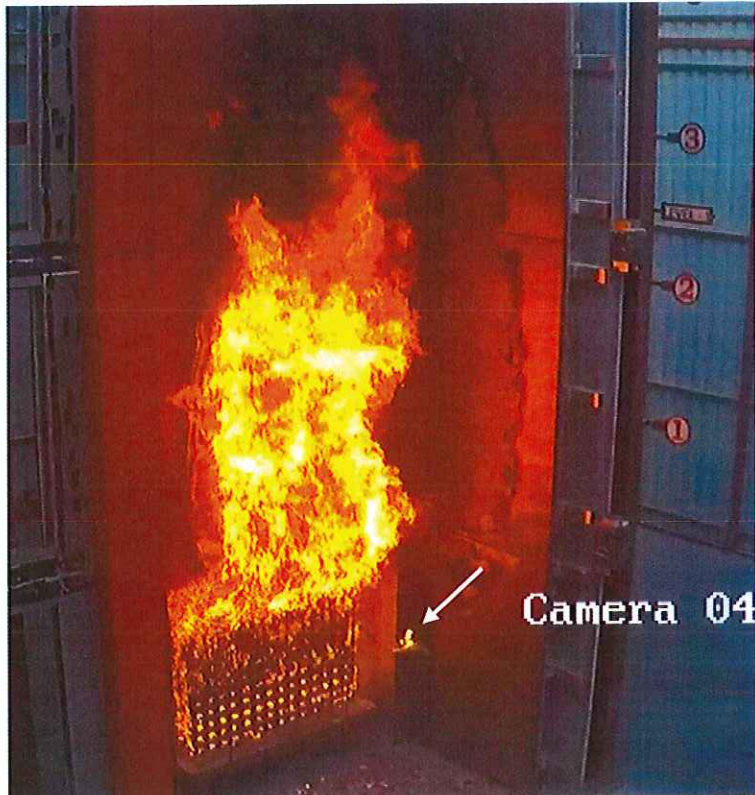
Time	Seconds	Observation	Photo Reference
06:23:56	433	Flaming debris of panel M5 fell off.	DLP C2753I/0005
06:24:04	441	High intensity flames behind the panels M4 & M5.	-

DLP C2753I/0005 Flaming debris of panel M5 fell off.

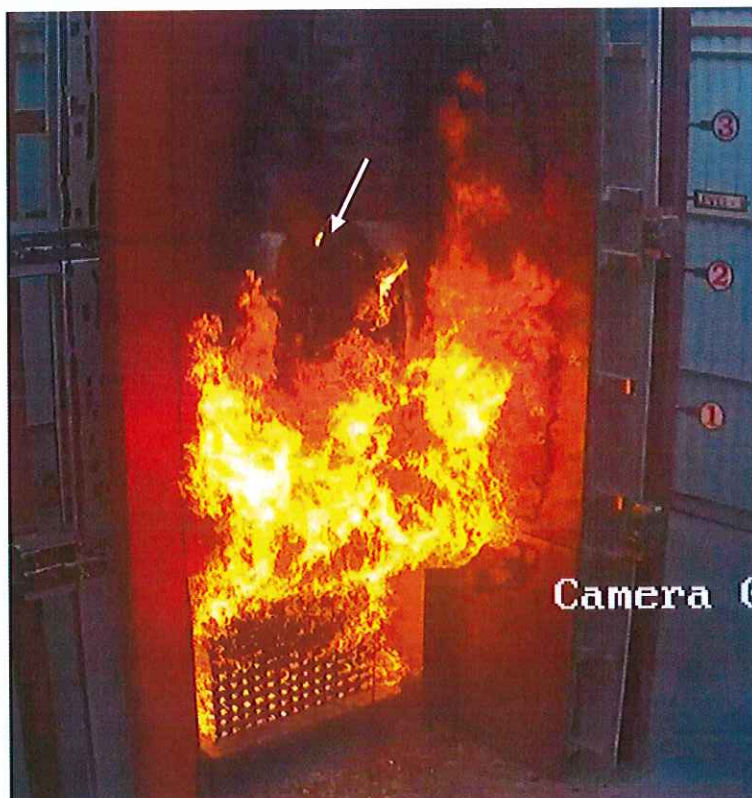
06:24:12	449	Minor buckling on panels M12 & M13.	-
06:24:32	469	Self-sustained flames on the insulations behind the panels M4 & M5.	DLP C2753I/0006
06:25:03	500	Railings behind the panels M4 & M5 melting.	-

DLP C2753I/0006 Self-sustained flames on the insulations behind the panels M4 & M5.

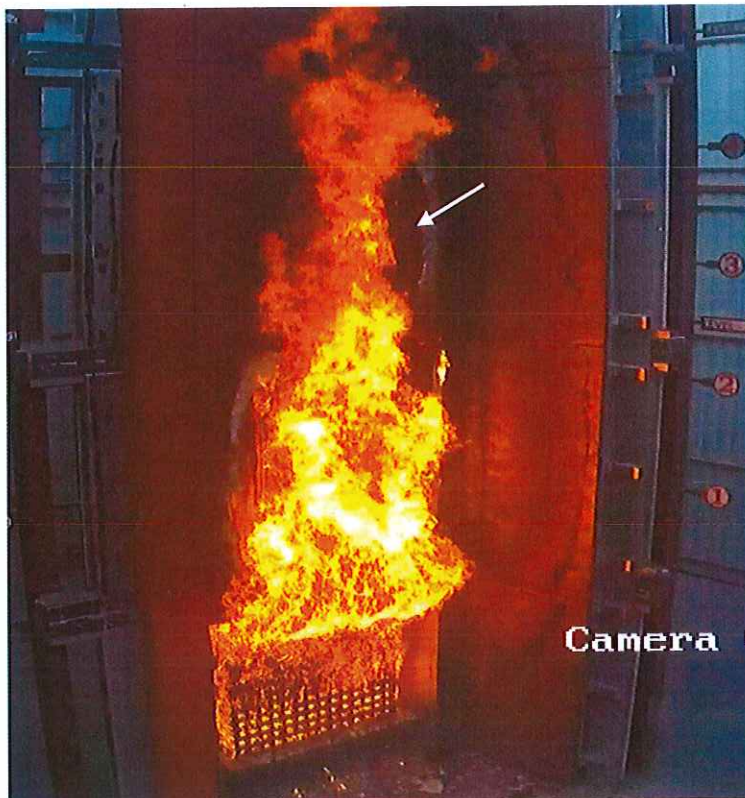
06:26:52	609	Aluminium skin of panel M9 melting.	-
06:27:20	637	Approximately 50% of panel M4 consumed.	-
06:27:40	657	Panel M9 partially melted and flames on insulations behind the panel.	DLP C2753I/0007

DLP C2753I/0007 Panel M9 partially melted and flames on insulations behind the panel.

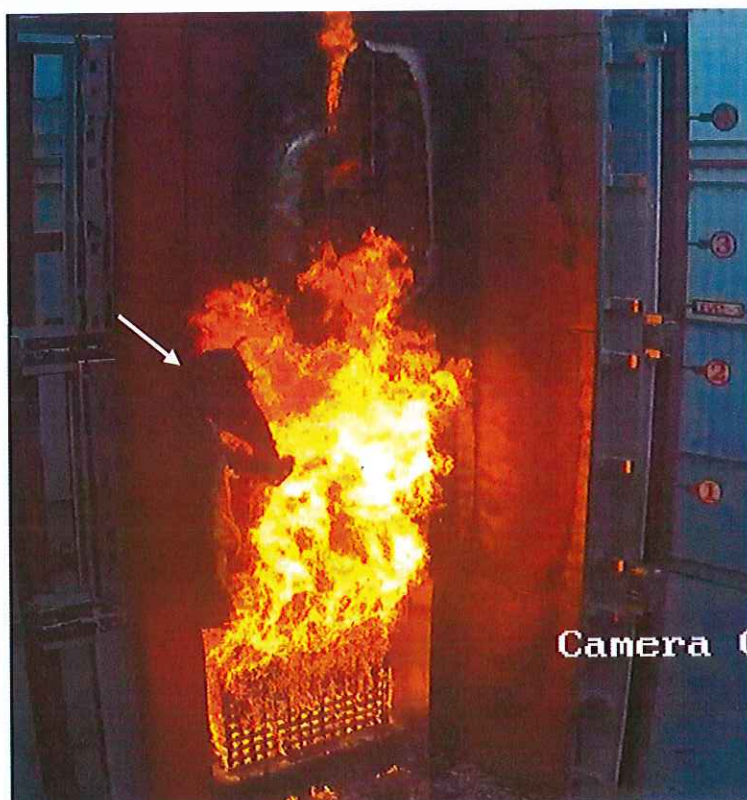
06:28:52	729	Debris of insulation behind the panel M9 fell off.	DLP C2753I/0008
06:29:03	740	Aluminium skin of panel M8 melting.	-
06:29:16	753	Continuous falling of flaming debris.	-

DLP C2753I/0008 Debris of insulation behind the panel M9 fell off.

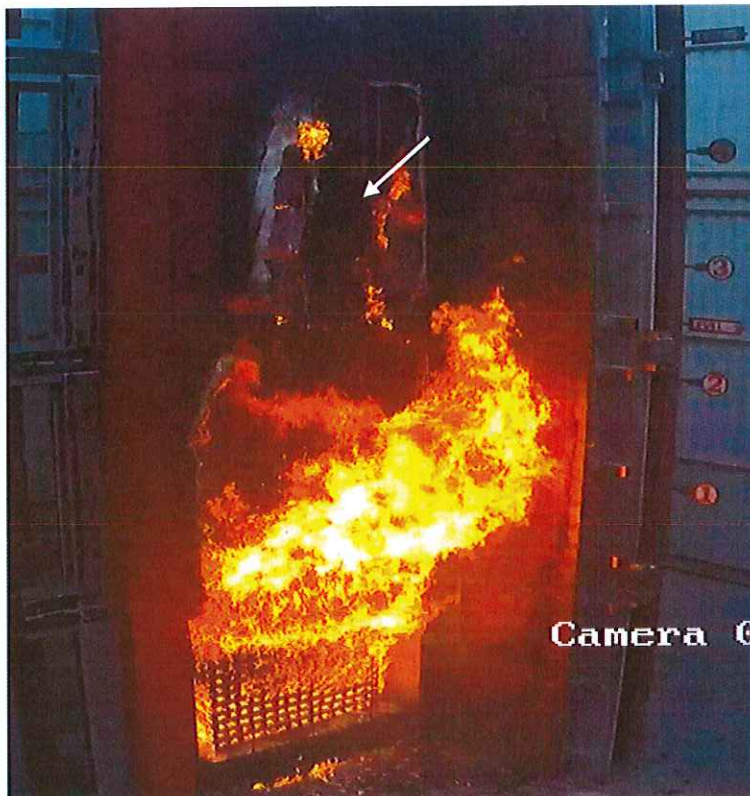
06:30:02	799	Railings behind the panels M8 & M9 partially melted.	DLP C2753I/0009
06:30:24	821	Flaming debris of insulation behind the panel M5 fell off.	-

DLP C2753I/0009 Railings behind the panels M8 & M9 partially melted.

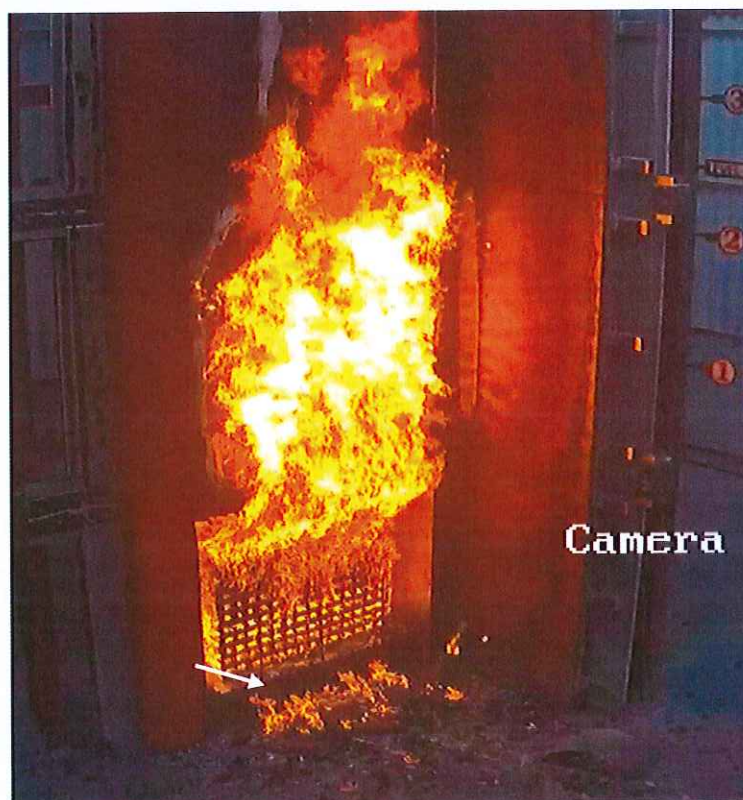
06:30:54	851	High intensity flaming debris observed on the floor.	DLP C2753I/0010
06:31:19	876	Self-sustained flames at internal corner.	-
06:32:41	958	Continuous falling of debris of aluminium and insulation.	-

DLP C2753I/0010 High intensity flaming debris observed on the floor.

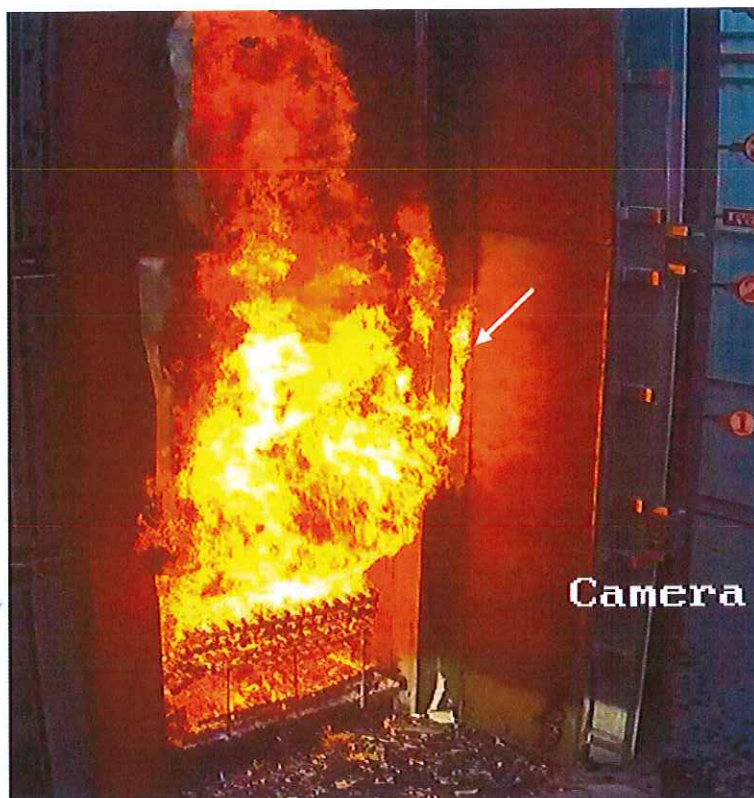
06:36:13	1170	100% of panels M5 & M9 consumed.	-
06:37:06	1223	Self-sustained flames on the surface of panel W3.	DLP C2753I/0011
06:38:04	1281	Aluminium debris of panel W3 fell off.	-

DLP C2753I/0011 Self-sustained flames on the surface of panel W3.

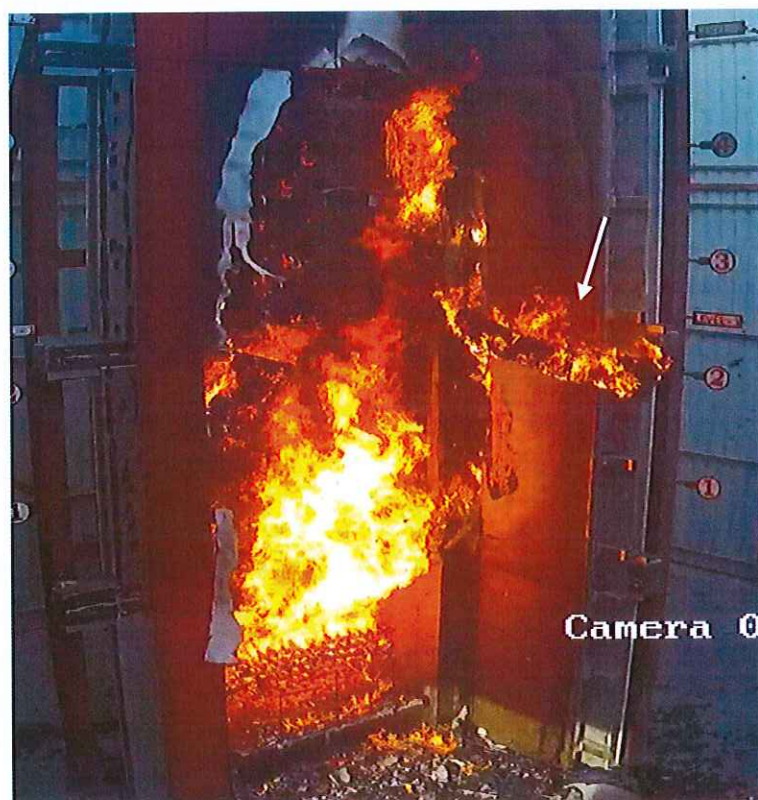
Time	Seconds	Observation	Photo Reference
06:41:06	1463	Flaming debris of insulation behind the panel M9 fell off.	DLP C2753I/0012
06:41:40	1497	Flaming debris of insulation behind the panel M8 fell off.	-

DLP C2753I/0012 Flaming debris of insulation behind the panel M9 fell off.

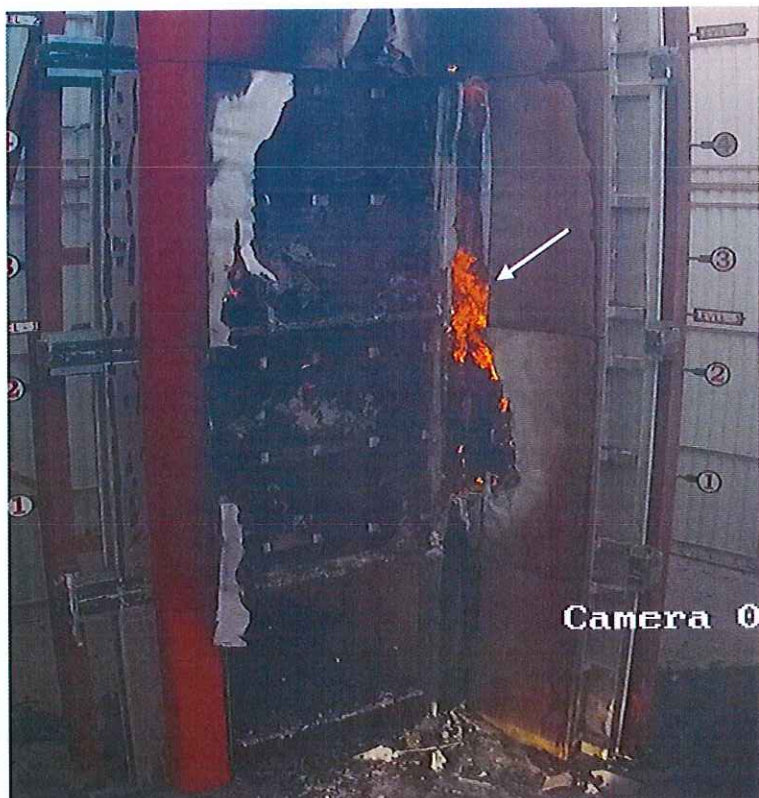
06:46:04	1761	High intensity flames behind the panel W5.	-
06:47:03	1820	Self-sustained flames at panels M12 & M13 vertical joint.	-
06:51:29	2086	Self-Sustained flames on the insulations behind the panels W3, W4 & W5.	DLP C2753I/0013

DLP C2753I/0013 Self-Sustained flames on the insulations behind the panels W3, W4 & W5.

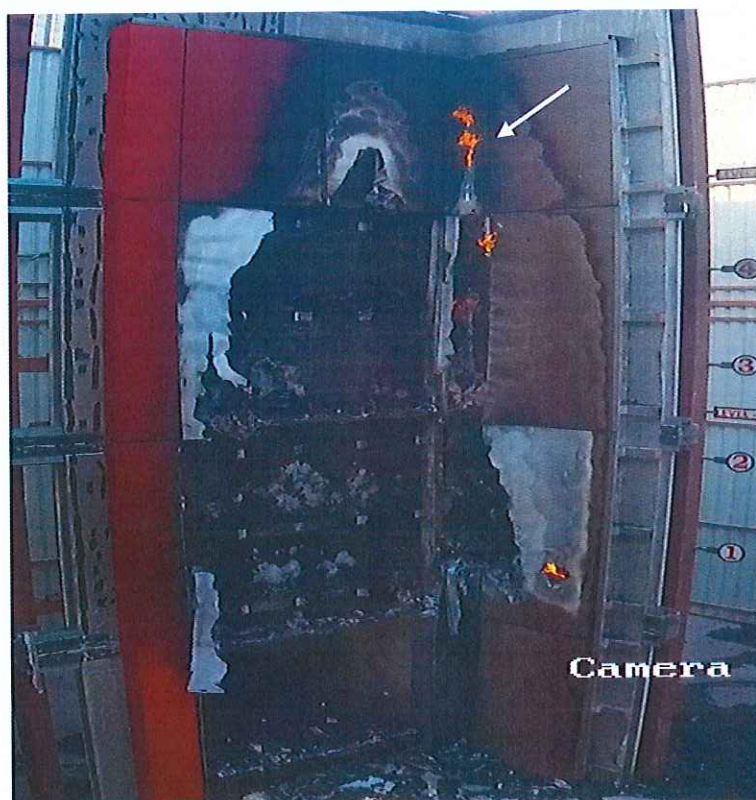
07:03:53	2830	Discoloration on panel M14.	-
07:09:16	3153	Self-sustained flames on face of panel M14 and aluminium skin of panel melting.	DLP C2753I/0014

DLP C2753I/0014 Self-sustained flames on face of panel M14

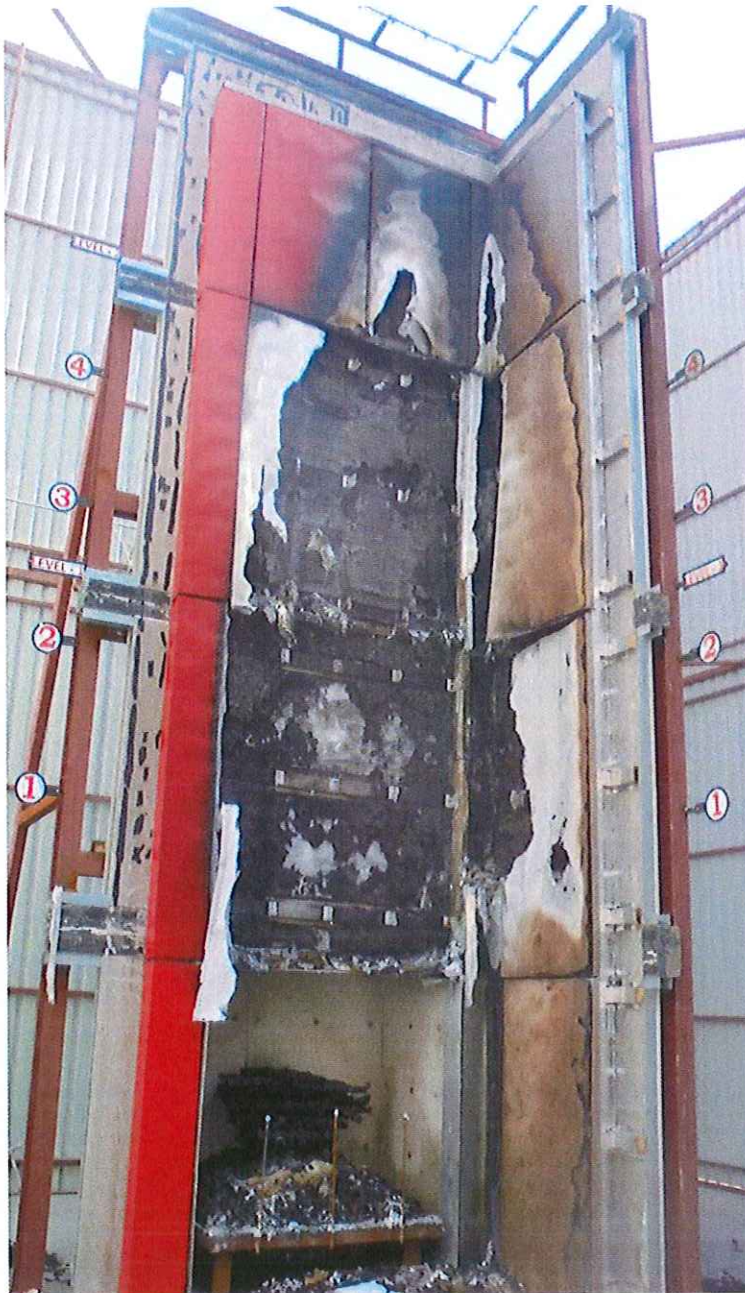
DLP C2753I/0015

Sl. No.	Components	Observation	Photo Reference
1	ACM panels	<p>Panels M1 &amp; M11 - No changes on the panels.</p> <p>Panels M2, M3, M7 – Minor discoloration and buckling on the panels.</p> <p>Panels M4, M6, M8 &amp; M10– Approximately 90% material loss on the panels. Remaining area was discoloured and buckled.</p> <p>Panels M5 &amp; M9 – 100% material loss on the panels.</p> <p>Panel M12 - Approximately 40% of the panel discoloured.</p> <p>Panels M13 &amp; M14 – Approximately 30% material loss on the panels. Remaining area was discoloured and buckled.</p> <p>Panels W1, W2, W6 &amp; W8 – 100% discoloration on the panels.</p> <p>Panels W3 – Approximately 75% material loss on the panels. Remaining area was discoloured and buckled.</p> <p>Panels W4 &amp; W7 – Approximately 25% material loss on the panels. Remaining areas were buckled and discoloured.</p> <p>Panels W5 - 100% material loss on the panels.</p>	DLP C2753I / 0015.

View of the sample after the test

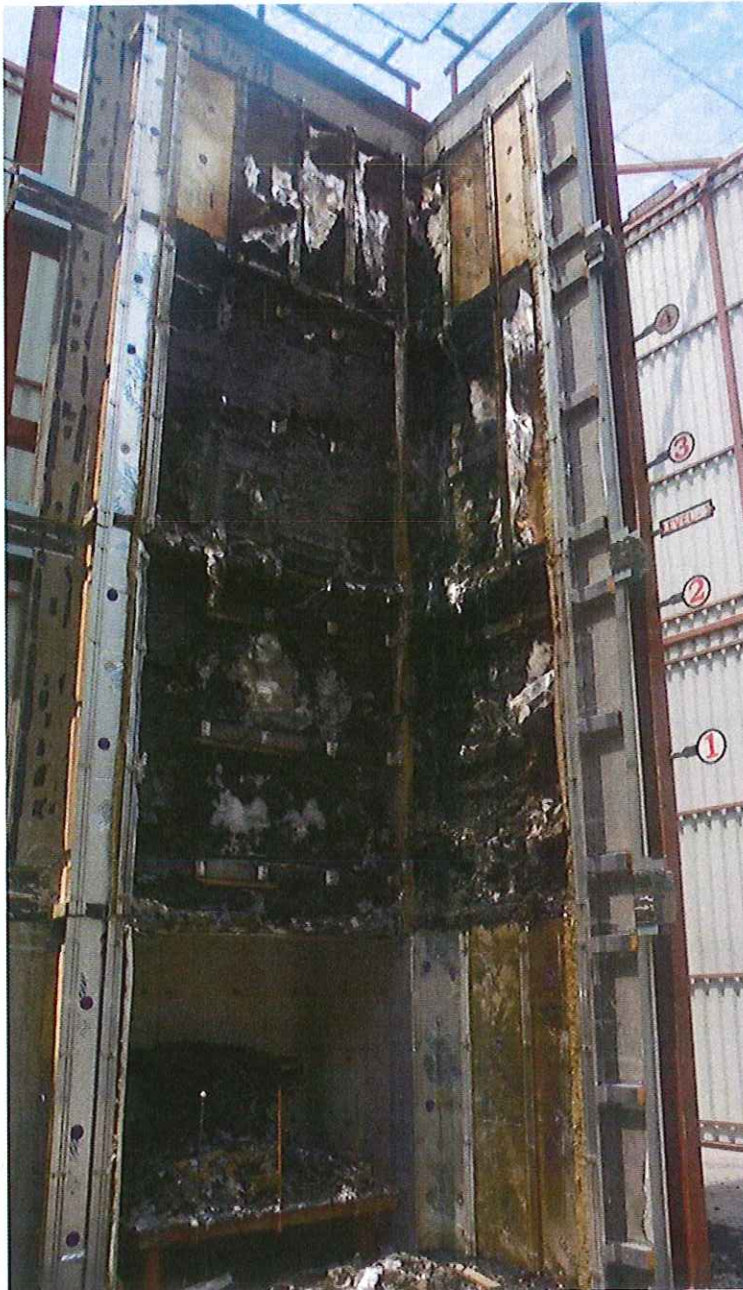
DLP C2753I/0016

2	Cavity barrier	<p><b>Horizontal intumescent cavity barrier:</b></p> <p>Main wall:</p> <p>The 1<sup>st</sup> horizontal cavity barrier at 200mm above the combustion chamber was activated except the cavity barrier behind the panel M3. Intumescent layer was not present during dismantling. Material loss observed.</p> <p>The 2<sup>nd</sup> horizontal cavity barrier at 2325mm above the combustion chamber was activated except the cavity barrier behind the panel M7. Intumescent layer was not present during dismantling. Material loss observed.</p> <p>The 3<sup>rd</sup> horizontal cavity barrier at 4725mm above the combustion chamber was activated except the cavity barrier behind the panel M11. Intumescent layer was partially present during dismantling. No material loss observed.</p>	DLP C2753I / 0016, DLP C2753I / 0020 & DLP C2753I / 0021.

3	Kingspan Kooltherm K15 insulation	<p>Insulations behind the panels M4, M5, M6, M8, M9, M10, M13, M14, W3, W4, W5, W6 &amp; W7 panels were burned. Approximately 60% of the burned insulations fell off and remaining left as char.</p> <p>Minor discoloration on the insulations behind the panels M12 &amp; W8.</p> <p>All other insulations were in place and no significant changes observed.</p>	DLP C27531 / 0016, DLP C27531 / 0020 & DLP C27531 / 0021.
4	Carrier railings	<p>Railings behind the panels M4, M5, M6, M8, M9, M10, W3, W4 &amp; W5 were melted.</p> <p>Railings behind the panels M12, M13, M14, W6, W7 &amp; W8 were discoloured.</p> <p>All other railings were in place and no damage was observed.</p>	DLP C27531 / 0016 & DLP C27531 / 0021.

Cavity barrier, Kingspan insulation and carrier railings

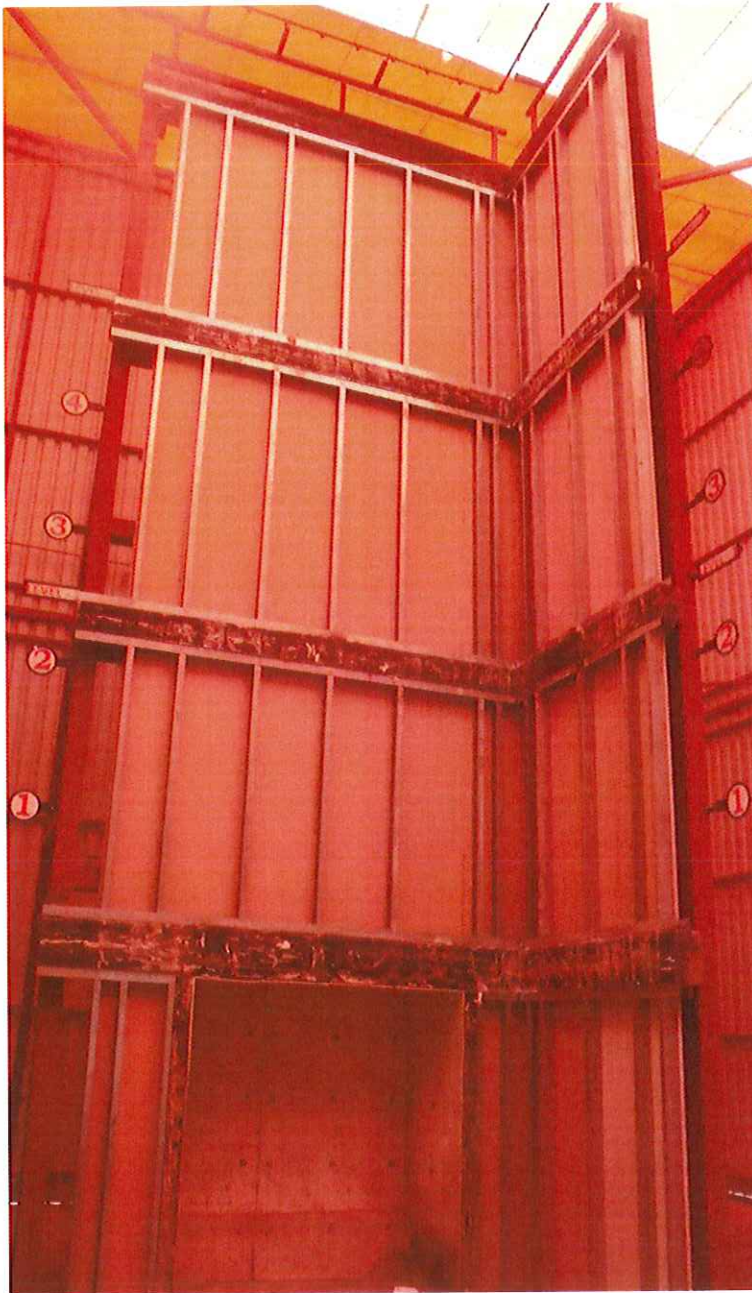
DLP C2753I/0019

Sl. No.	Components	Observation	Photo Reference
5	Brackets and Nilvent breather membrane	<p>Top Hat bracket:</p> <p>Discoloration on the brackets behind the panels M4, M5, M8, M9, W3, W4 &amp; W5. No significant changes on the remaining brackets.</p> <p>Helping hand bracket:</p> <p>Approximately 10% of the Helping hand brackets were partially melted. All other brackets were in place and no significant changes observed.</p> <p>Breather membrane:</p> <p>Minor material loss and discoloration on the Nilvent breather membrane observed.</p>	DLP C2753I / 0017 & DLP C2753I / 0022.
6	12mm Versapanel cement particle board	Minor discolouration on the cement particle boards behind the panels M4, M5, M8, M9, W3 & W5. No significant changes on the remaining boards.	DLP C2753I / 0018.
7	SFS and plaster boards	No significant changes.	DLP C2753I / 0019.

SFS and plaster board

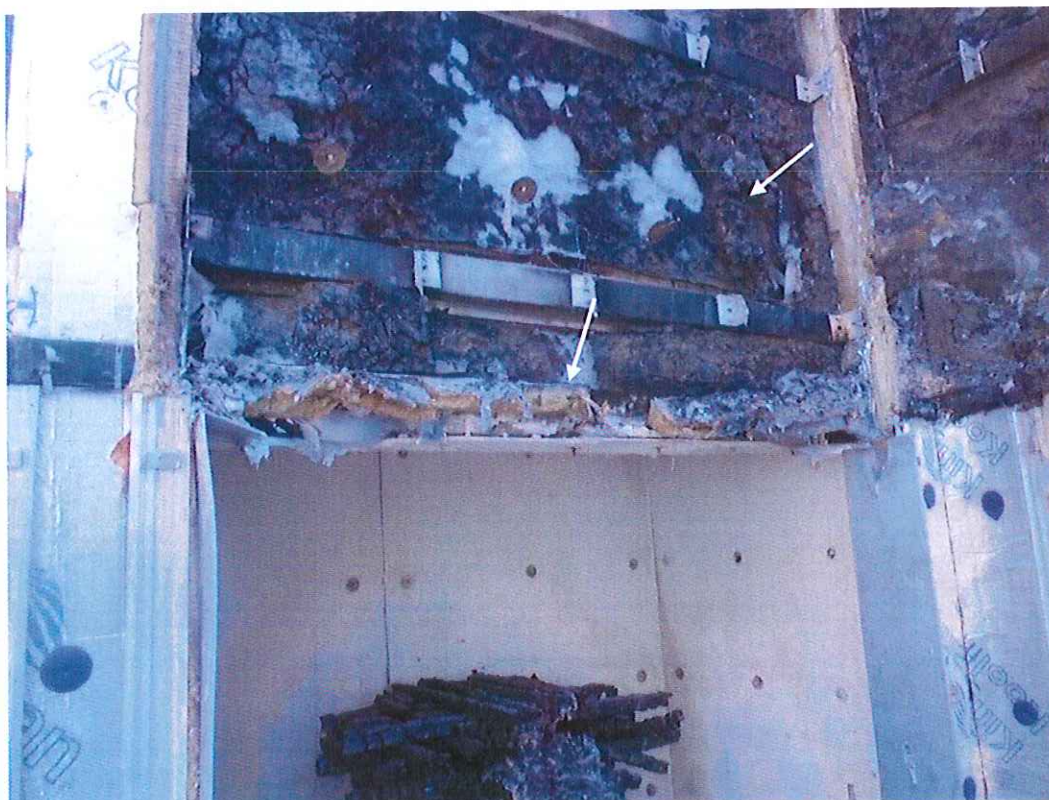
DLP C2753I/0020

Cavity barrier and insulation above the combustion chamber

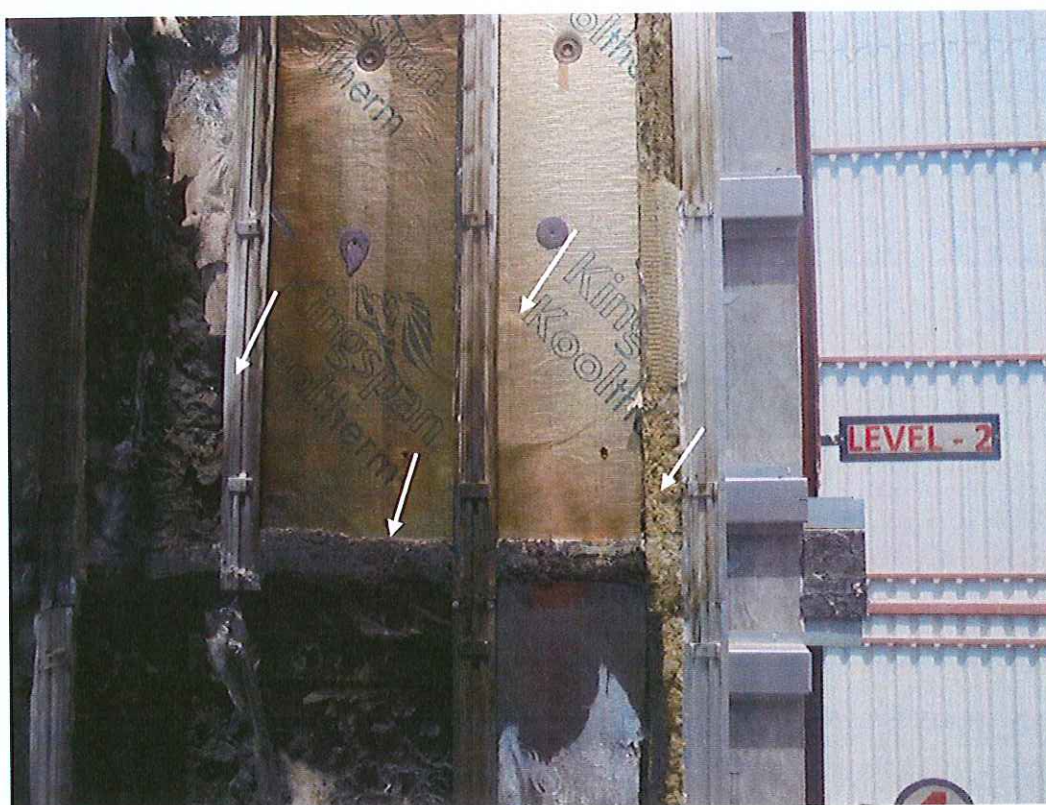
DLP C2753I/0021

Cavity barriers, Kingspan insulations and carrier rails on wing wall
