## **REACTION TO FIRE TEST REPORT No EUI - 18 - FF – 000081A**

**Test Standard:** **BS 8414-2:2015+A1:2017** – Fire performance of external cladding systems  
Part 2: Test method for non-loadbearing external cladding systems fixed to and supported by a structural steel frame

**Product:** Façade system incorporating mineral wool insulation and air cavity  
Referenced: Dri-Design with K-Roc Rainscreen Slab

**Test sponsor :** KINGSPAN Limited  
Greenfield Business Park No. 2,  
Flintshire, Holywell,  
CH8 7GJ, UK

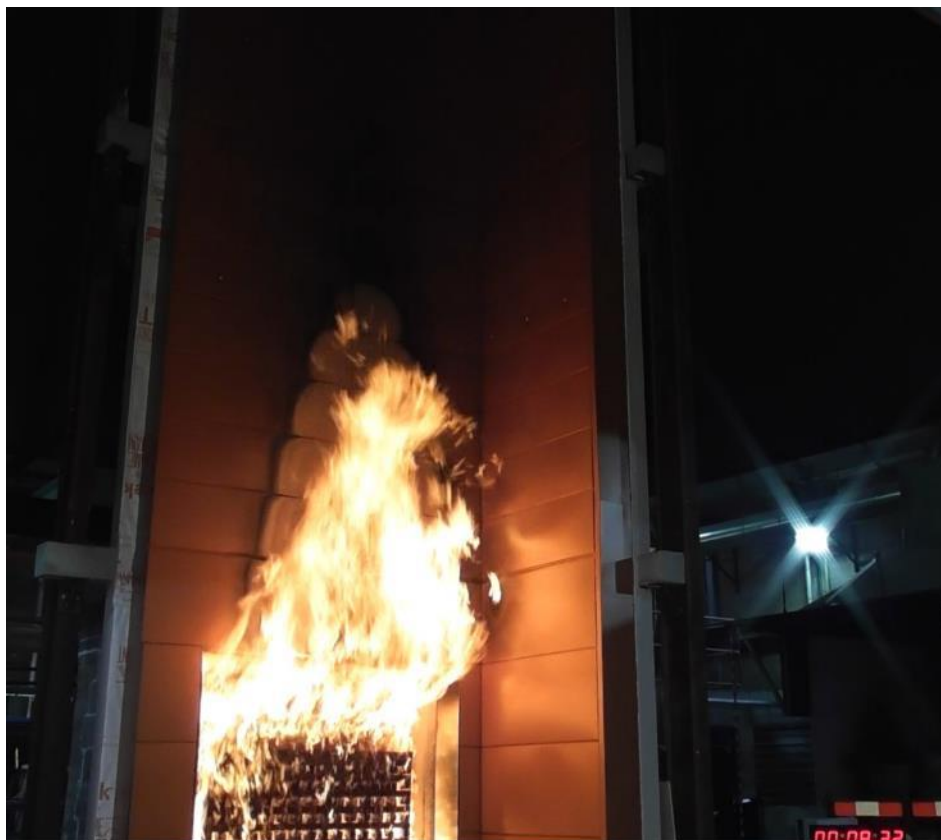
Figure 4.12. Cladding system during fire test (08 min 32 sec after ignition of the crib)-ignition of wing face.

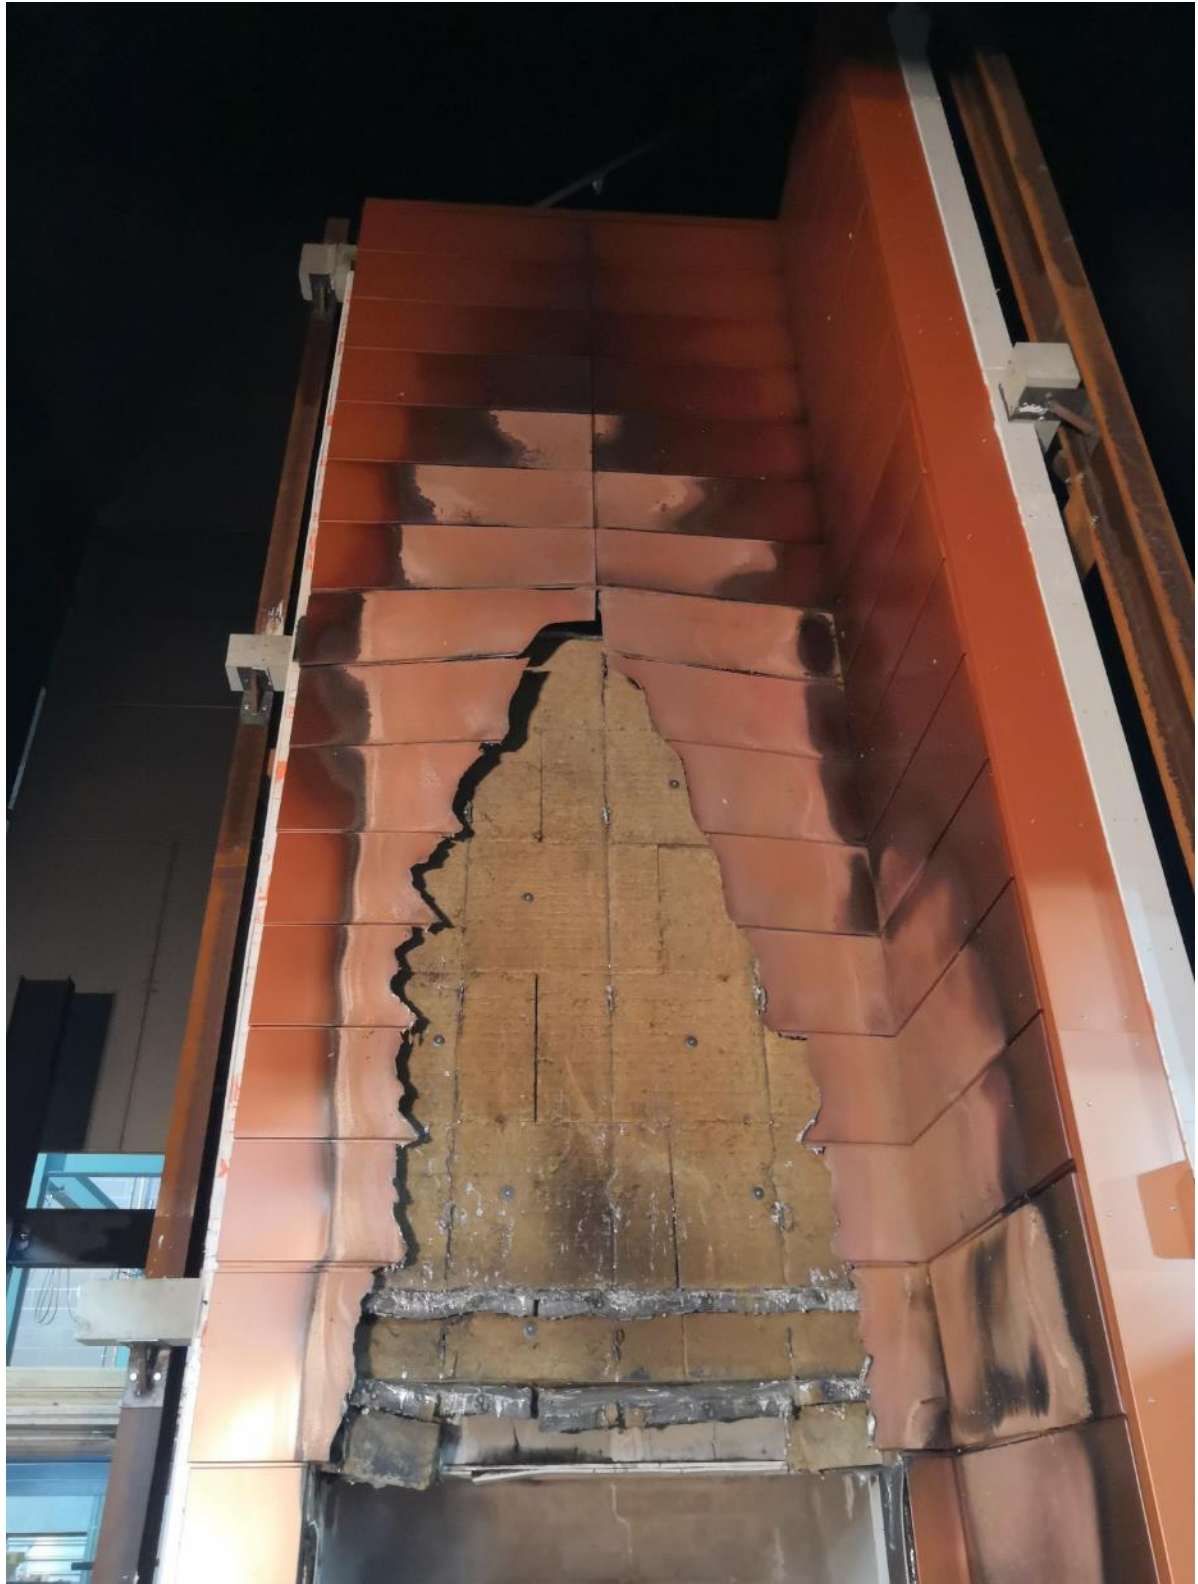
Figure 4.14. Cladding system just after fire extinguishment.

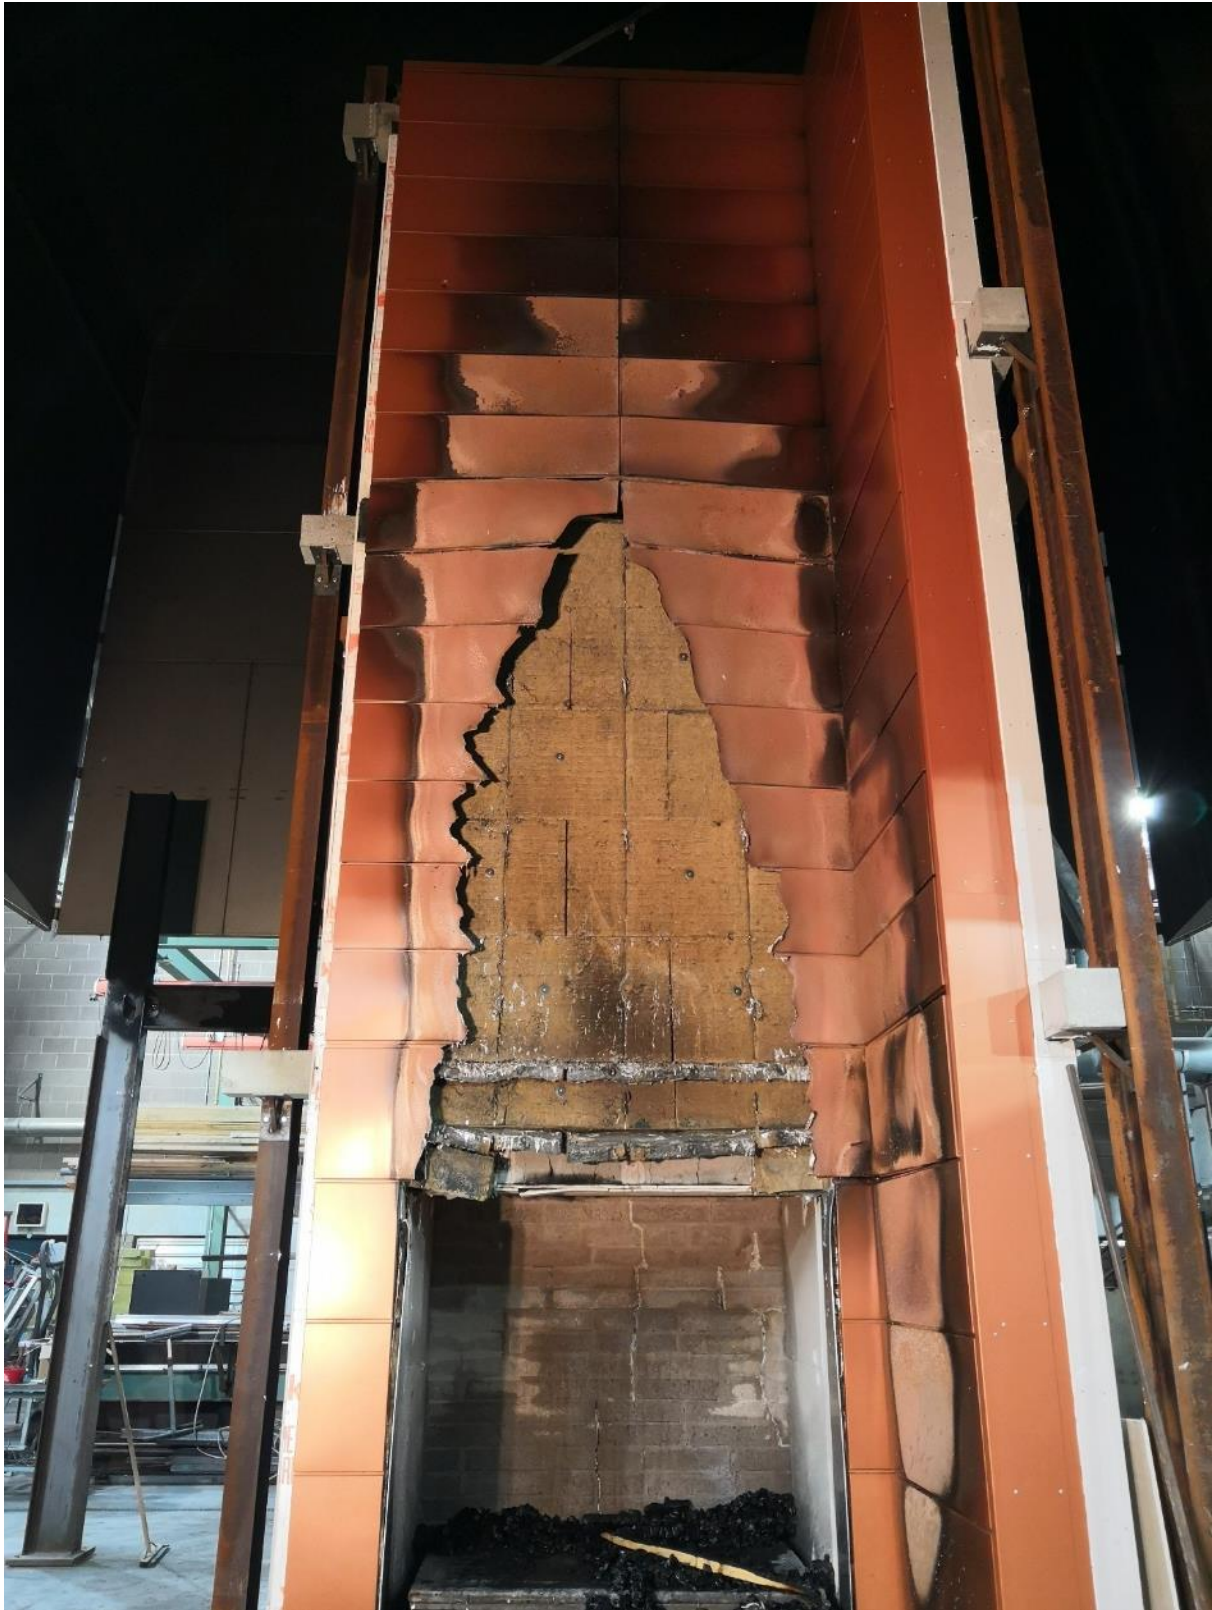
Figure 4.15. Cladding system after the fire test (60 min 00 sec after ignition of the crib).

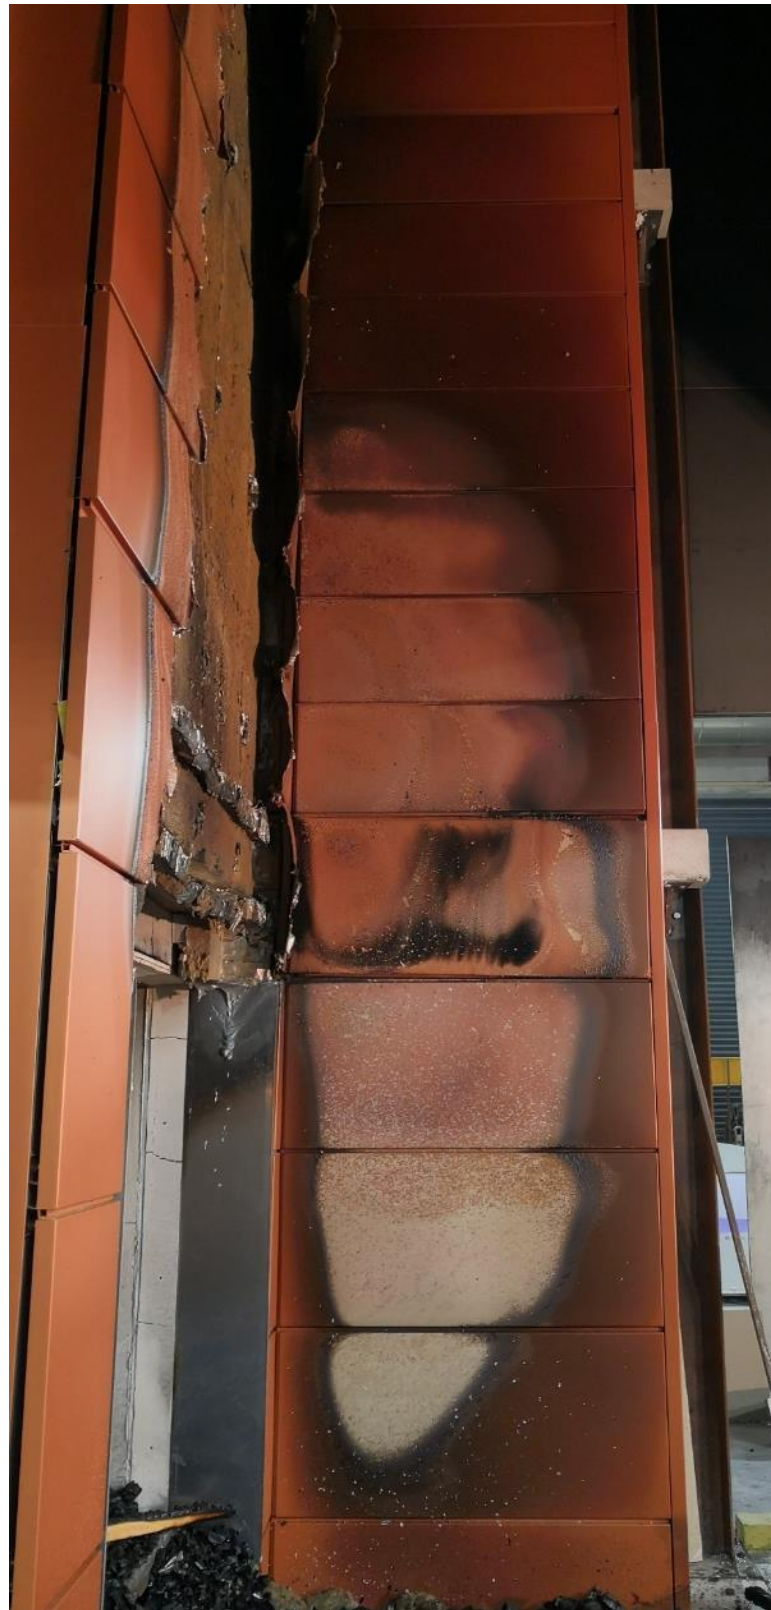
On the wing face, major discolouration was observed on C-2 to C8. Partial damage visible on cassette panels C1 and C2 with some cracks on them. Panels C9 to C15 remained in place without further damage or discolouration.

**Figure 4.16. Cladding system just after the fire test (side view). Major discoloration of C-2 to C5. Damage of C1-C2.**

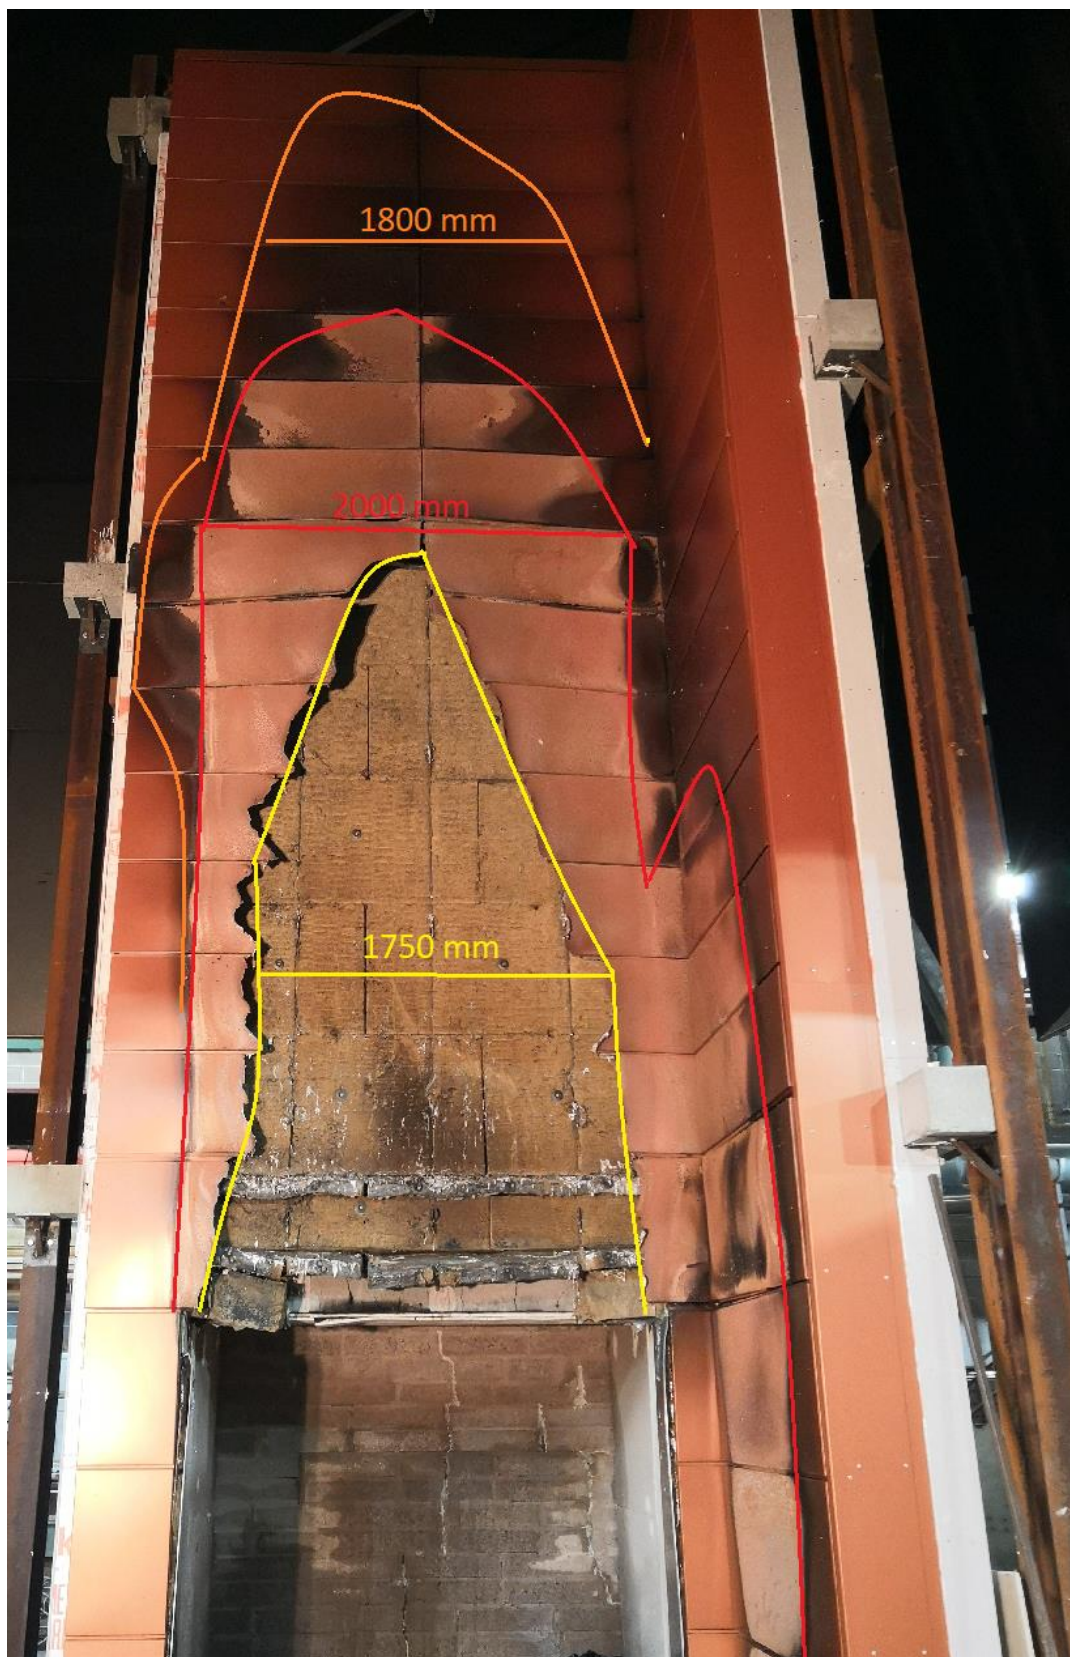
On the main face of the cladding system, cassette panels A-3 to A0 and B-3 to B0 remained in place without any major damage. Only some discolouration was observed on B0 panel.

Major damage was observed on panels A1 to A8 and B1 to B8. Most of this area was melted and all the panels were severely damaged as described more extensively below:

Figure 4.17. Photo of cladding system just after the fire test (front view). Curves show i) melting of panels ii) major discolouration of cladding panels and iii) minor discolouration.

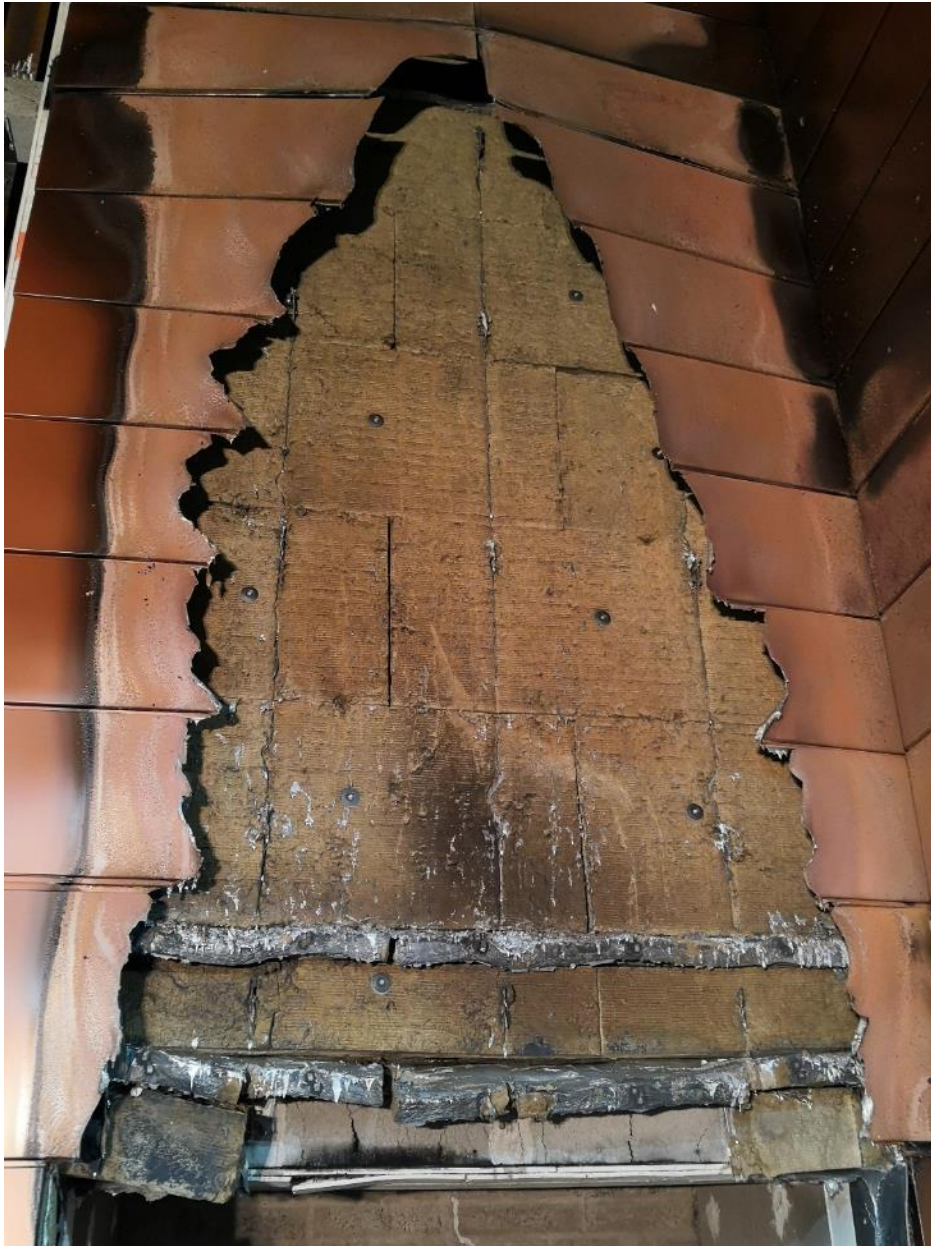
On the main face, the K-Roc Rainscreen slab insulation was mainly in place. Above the combustion chamber, contained between the vertical fire barriers and up to the 1<sup>st</sup> fire barrier height, parts of it fell down during test. Above the 1<sup>st</sup> fire barrier and up to height behind panels A3 and B3, major discolouration was observed. Up to level of A9-B9 panels, the insulation was slightly discoloured. Above this height, insulation remained without any damage or discolouration.

**Figure 4.18. Post-examination damage. Photo of K-Roc rainscreen insulation. Insulation fallen off below bottom fire barrier, major discoloration and partially damage between the two bottom fire barriers.**

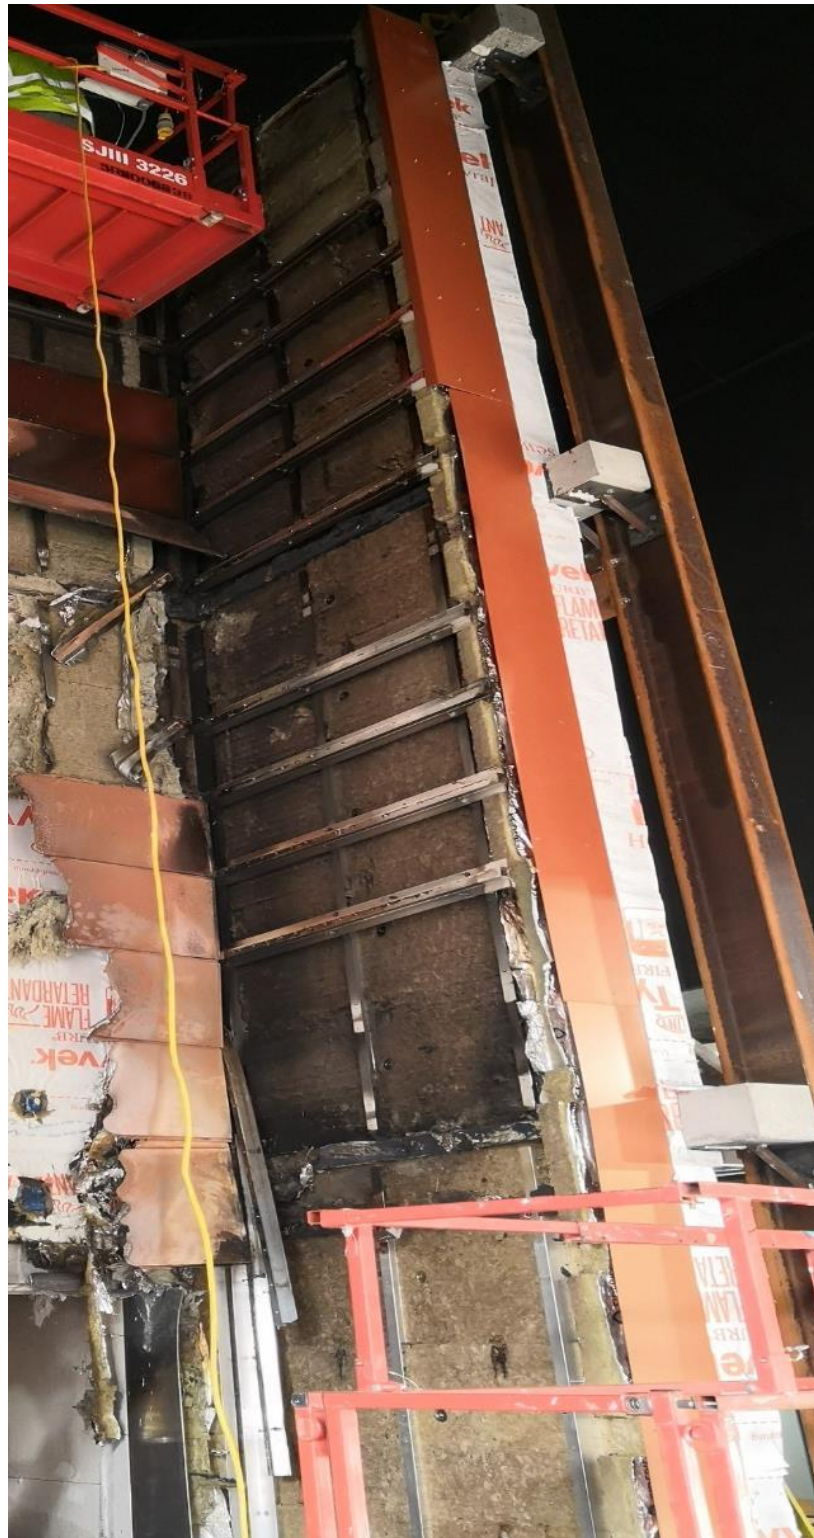
Figure 4.19. Post-examination damage. Photo of K-Roc rainscreen slab insulation on the wing face.

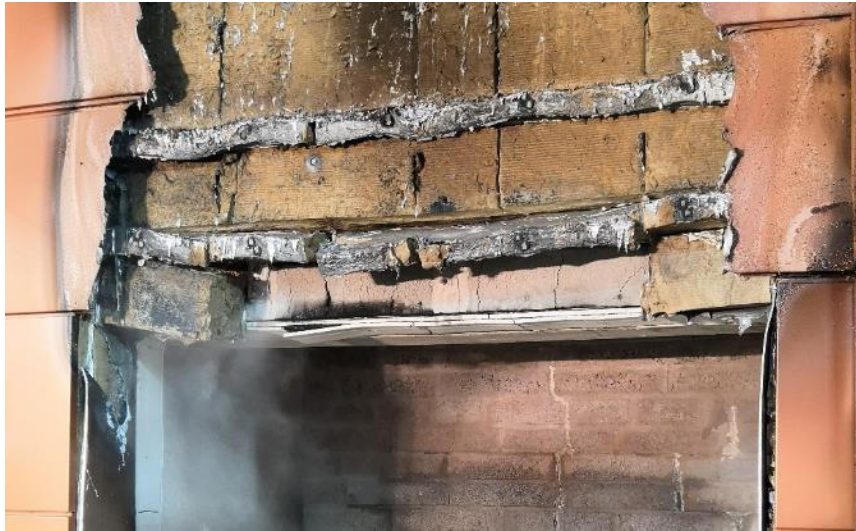
The bottom horizontal fire barrier placed just above the combustion chamber on the main face of façade system, was activated during testing. After the end of the test it was still in place but completely damaged. Same observation was made regarding the fire barrier of the same height on the wing face.

The 2<sup>nd</sup> horizontal fire barrier, which was placed in line with the bottom concrete slab, was activated during testing. After the end of the test it was still in place but completely damaged. Same observation was made regarding the fire barrier of the same height on the wing face.

**Figure 4.20. Post-examination damage. Zoomed photo of the bottom two fire barriers above combustion chamber.**

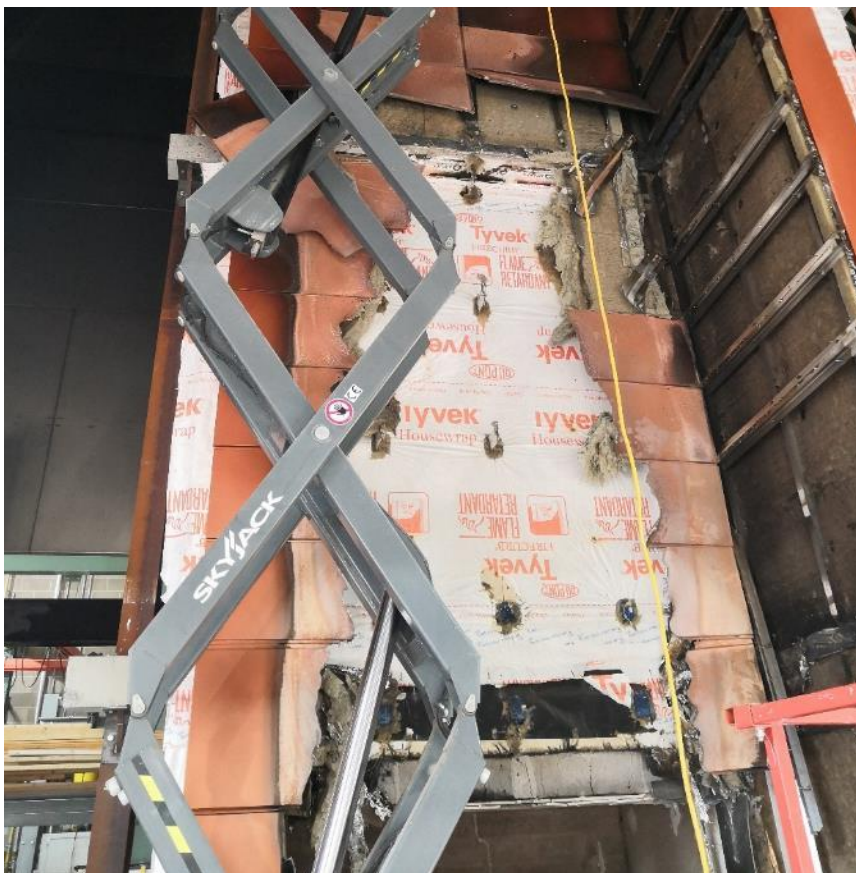
**Figure 4.21. Post-examination damage. Third fire barrier from floor level not damaged-discolouration observed.**

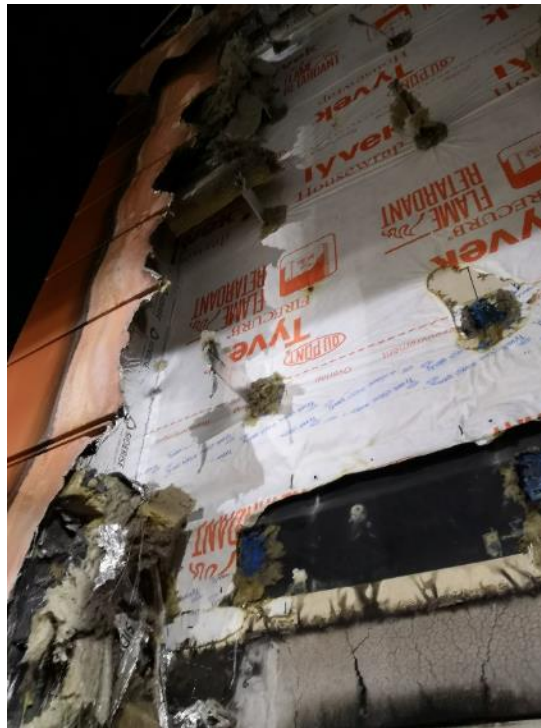
On the main face, the rail system supporting the cassette panels was completely damaged and melted on the area confined in between the vertical fire barriers and vertically from combustion chamber up to the 3<sup>rd</sup> horizontal fire barrier. The rest of the rails were in place after removing the cassette panel and only minor discolouration was observed on them just above the 3<sup>rd</sup> fire barrier and those close to the corner. On the wing face, all rails were in place with minor discolouration on those behind panels C-1 to C3.

Figure 4.22. Some bottom brackets (up to second fire barrier level) of the centreline melted during test.

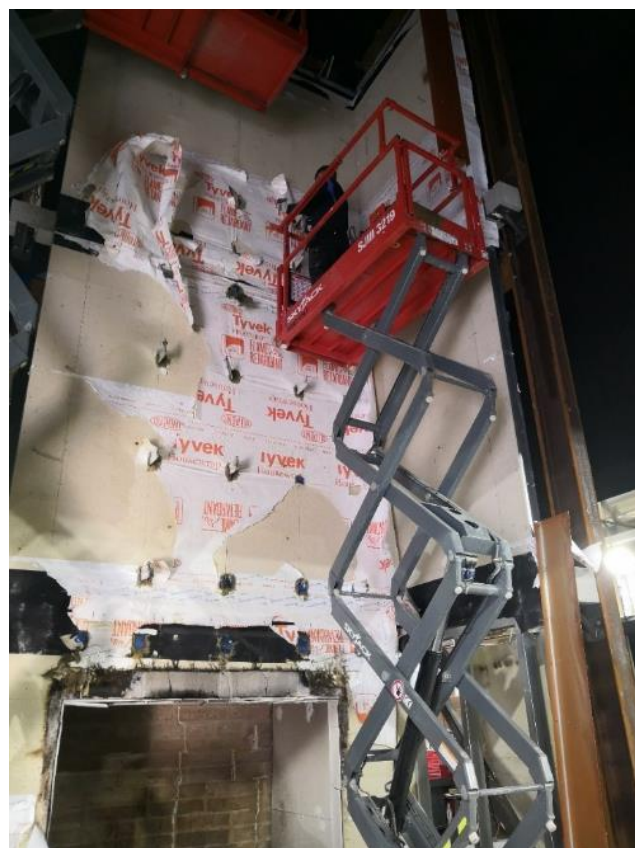
All boards were intact and no damage was observed.

Figure 4.23. Post-examination damage. Removing the Tyvek FireCurb membrane. No damage on the sheathing board layer behind.
