## Fire Performance Testing of an External Cladding System

### BS 8414-1:2015 + A1:2017

Sample : 10mm Trespa Meteon FR Panel with 100mm Kingspan  
Kooltherm K15 Insulation

Report No. : DLR1709 Rev.0

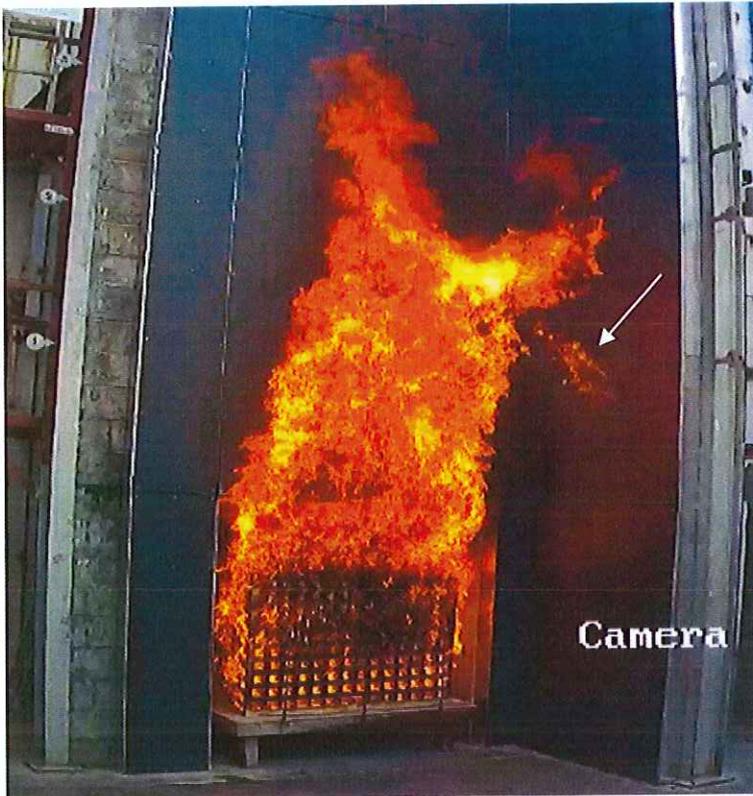
08:56:06	327	Flame impinged on wing wall panel W2.	Photo 7
08:56:41	362	Debris started to fall from the main wall.	-
08:59:20	521	Self-sustained flames on surface of panel W2.	Photo 8

Photo 7 Flame impinged on wing wall panel W2.

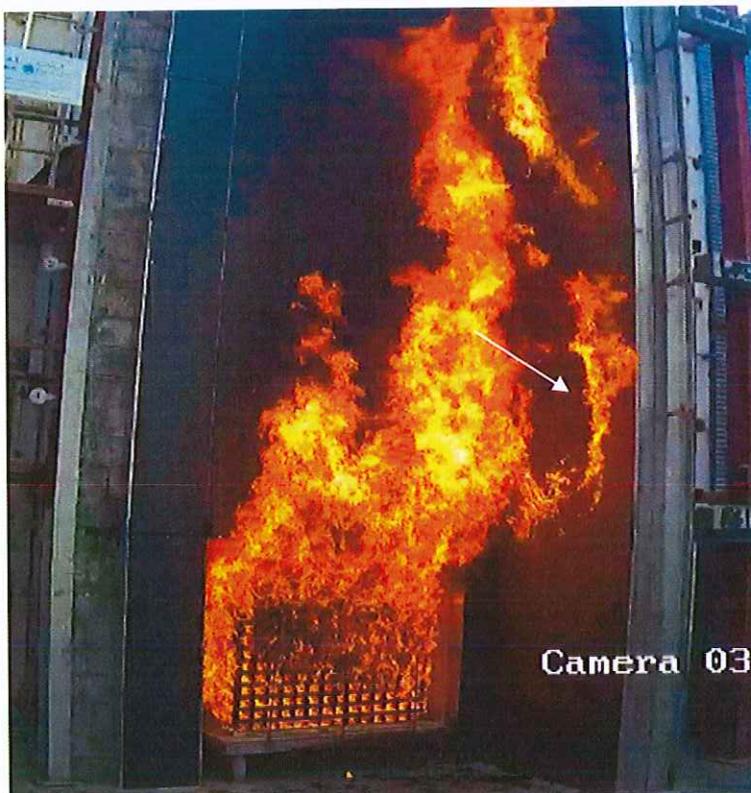
Photo 8 Self-sustained flames on surface of panel W2.

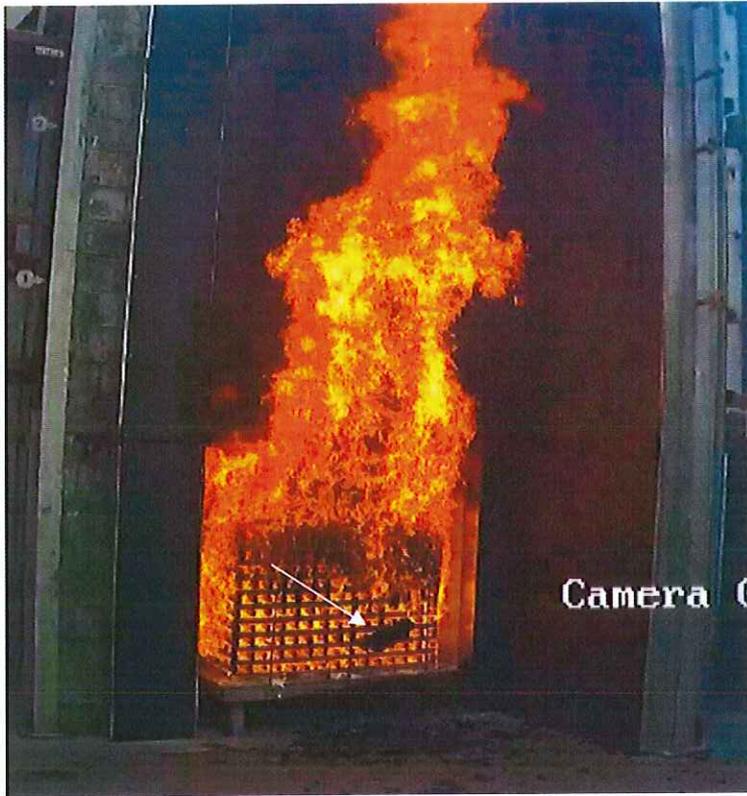
09:00:02	563	Panels M4 & M5 partially burned.	-
09:01:13	624	Self-sustained flames at panels M3 & M4 vertical joint.	-
09:01:41	662	Debris of panel M4 fell off.	Photo 9

Photo 9 Debris of panel M4 fell off.

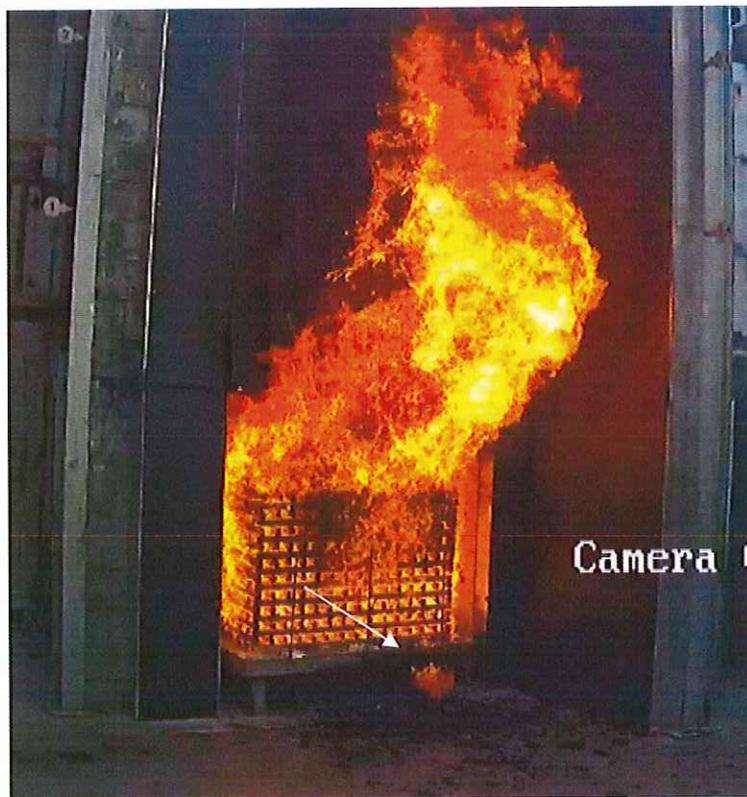
09:02:00	681	Flaming debris of panel M5 fell off.	Photo 10
09:02:11	692	Panels M4 & M5 partially consumed and insulations exposed.	Photo 11
09:02:36	717	Flaming debris observed on the floor.	Photo 12

Photo 10 Flaming debris of panel M5 fell off.

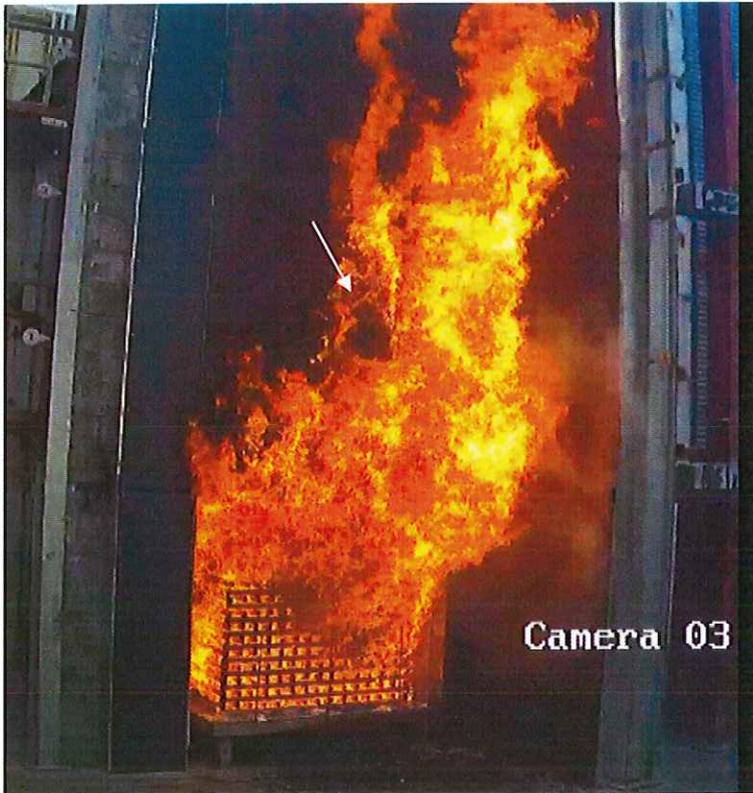
Photo 11 Panels M4 & M5 partially consumed and insulations exposed.

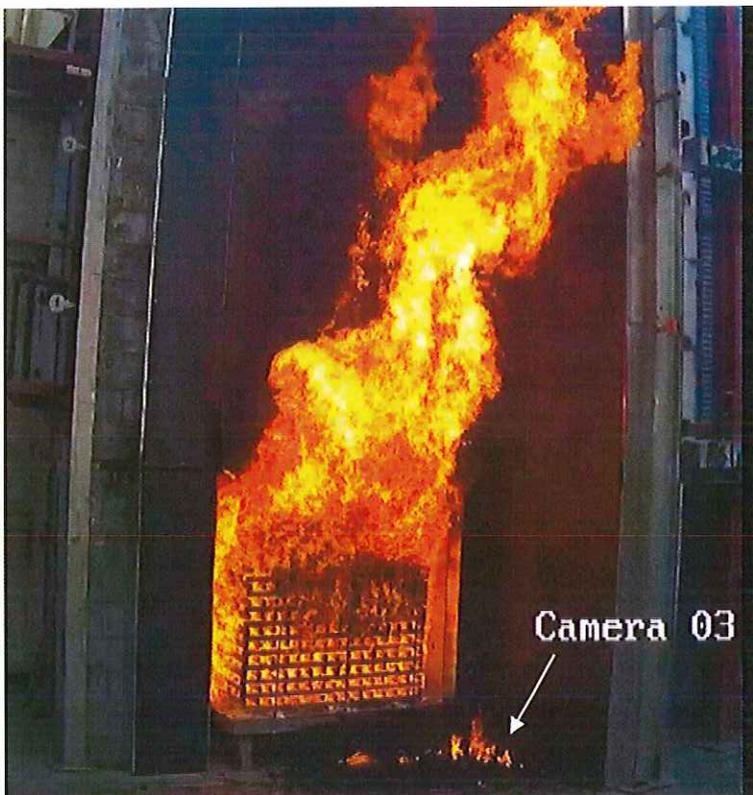
Photo 12 Flaming debris observed on the floor.

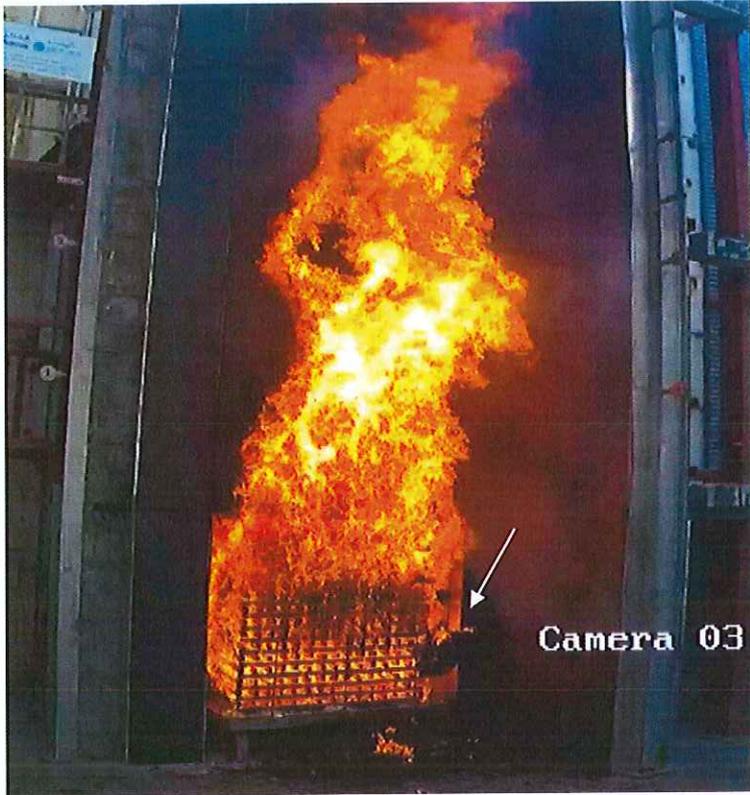
09:03:39	780	Continuous falling of debris.	-
09:03:57	798	Flaming debris fell off the main wall.	Photo 13
09:04:06	807	Self-sustained flames on the surface of panel W1.	Photo 14

Photo 13 Flaming debris fell off the main wall.

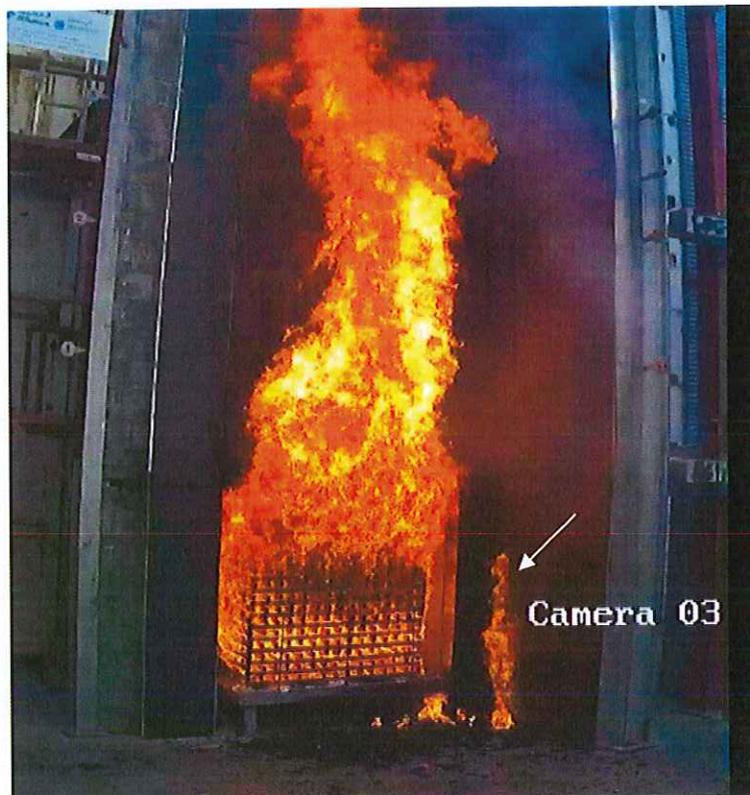
Photo 14 Self-sustained flames on the surface of panel W1.

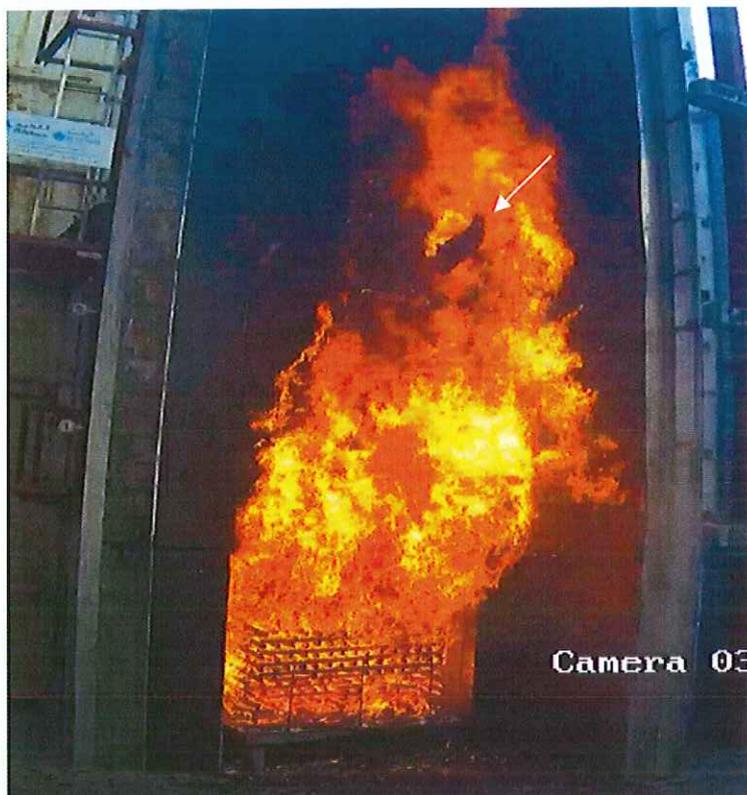
09:07:50	1031	Flaming debris of panels M9 fell off.	Photo 15

Photo 15 Flaming debris of panels M9 fell off.

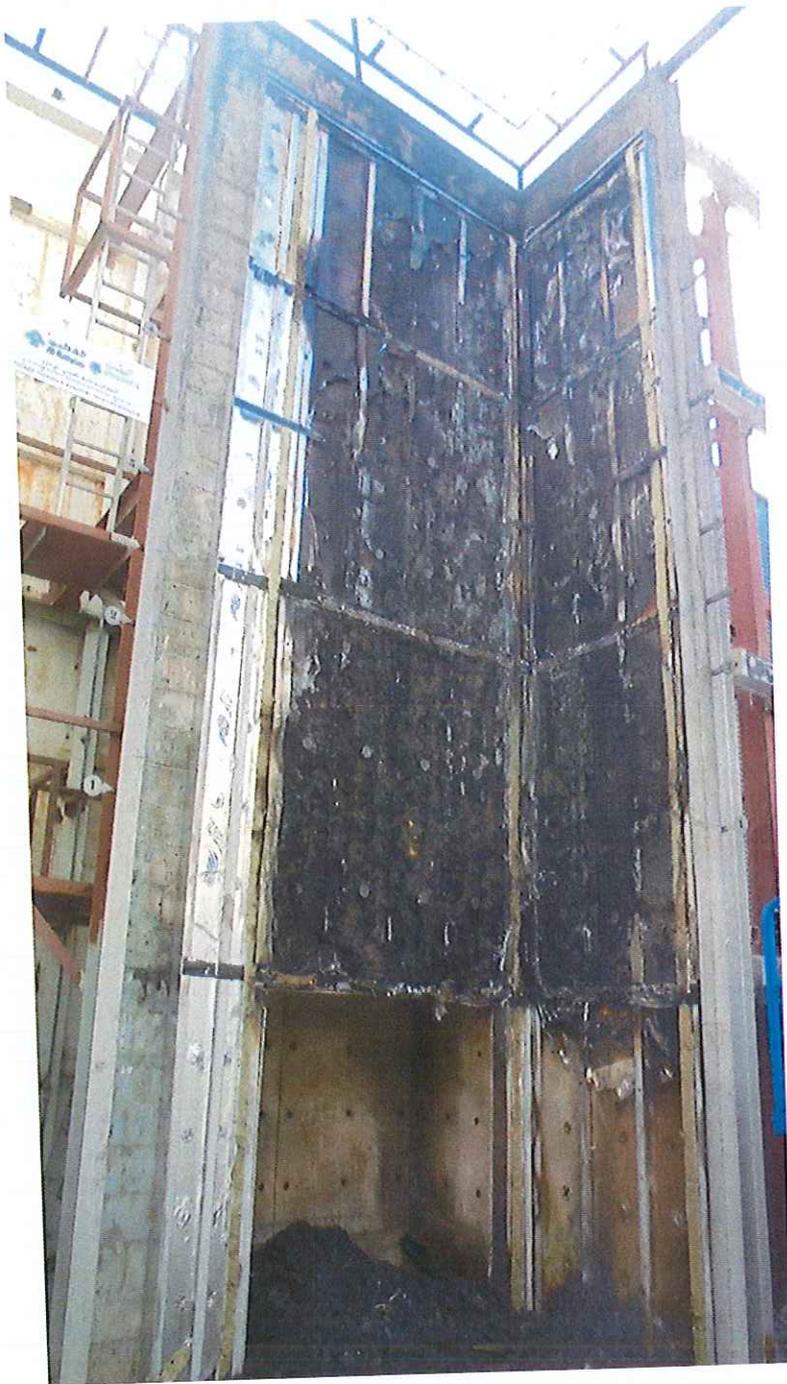
Photo 17 Cavity barrier, Kingspan Kooltherm K15 insulation and railings

Component	Observation	Photo Ref. (Section 6.4)
Trespa Meteor FR Panel	<p>Panels M1, M3 &amp; M7 – Minor discoloration and buckling on the panels.</p> <p>Panels M2 &amp; M10 – Panel was burned and left as char.</p> <p>Panels M5 &amp; M6 - 100% of the panel was consumed.</p> <p>Panels M4 &amp; M9 – Approximately 75% of the panel was consumed and remaining area was burned.</p> <p>Panels M8– Approximately 25% of the panel was consumed and remaining area was burned.</p> <p>Panel W1– Approximately 25% of the panel was consumed and remaining area was burned.</p> <p>Panel W2 – Approximately 90% of the panel was consumed and remaining area was burned.</p> <p>Panel W3 – Approximately 50% of the panel was consumed and remaining area was burned.</p>	Photo 16
Cavity barrier	<p><b>Horizontal intumescent cavity barrier:</b></p> <p>Main wall:</p> <p>The 1<sup>st</sup> horizontal cavity barrier at 65mm above the combustion chamber was activated except the cavity behind Panel M3. Material loss and damage were observed.</p> <p>The 2<sup>nd</sup> horizontal cavity barrier at 2455mm above the combustion chamber was activated except the cavity behind Panel M3. Material loss and damage were observed.</p> <p>The 3<sup>rd</sup> horizontal cavity barrier at 4785mm above the combustion chamber was activated except the cavity behind Panel M7. Material loss and damage were observed.</p> <p>The 4<sup>th</sup> horizontal cavity barrier at 6420mm above the combustion chamber was activated except the cavity behind Panel M7. Cavity barrier was intact and no material loss observed.</p> <p>Wing wall:</p> <p>The 1<sup>st</sup> horizontal cavity barrier at 2065mm above the ground level was activated. Material loss and damage were observed.</p> <p>The 2<sup>nd</sup> horizontal cavity barrier at 4455mm above the ground level was activated. Material loss and damage were observed.</p>	Photos 17, 19, 20 & 21

Component	Observation	Photo Ref. (Section 6.4)
	<p>The 3<sup>rd</sup> horizontal cavity barrier at 6785mm above the ground level was activated. Material loss and damage were observed.</p> <p>The 4<sup>th</sup> horizontal cavity barrier at 8420mm above the ground level was activated. Material loss and damage were observed.</p> <p><b>Vertical cavity barrier:</b></p> <p>Discolouration and buckling to the vertical cavity barriers on the main wall and wing wall was observed.</p>	
Kingspan Kooltherm K15 insulation	<p>Main wall:</p> <p>Insulations behind the panels M4, M5, M6, M8, M9 &amp; M10 were burned.</p> <p>No significant changes on the remaining insulations on the main wall.</p> <p>Wing wall:</p> <p>Insulations behind the panels W2 &amp; W3 were burned.</p> <p>Insulations behind the panel W1 was partially burned and remaining area was discoloured.</p>	Photos 17, 20 & 21
Railing	<p>Main wall:</p> <p>All railings behind panels M4, M5 &amp; M6 were completely melted.</p> <p>Railings behind panels M8, M9 &amp; M10 were partially melted. Remaining area was discoloured and buckled.</p> <p>All other railings were in place and no damage was observed.</p> <p>Wing wall:</p> <p>Railings behind panels W2 were partially melted. Remaining area was discoloured and buckled.</p> <p>Railings behind panels W1 &amp; W3 were discoloured.</p>	Photos 17,20 & 21

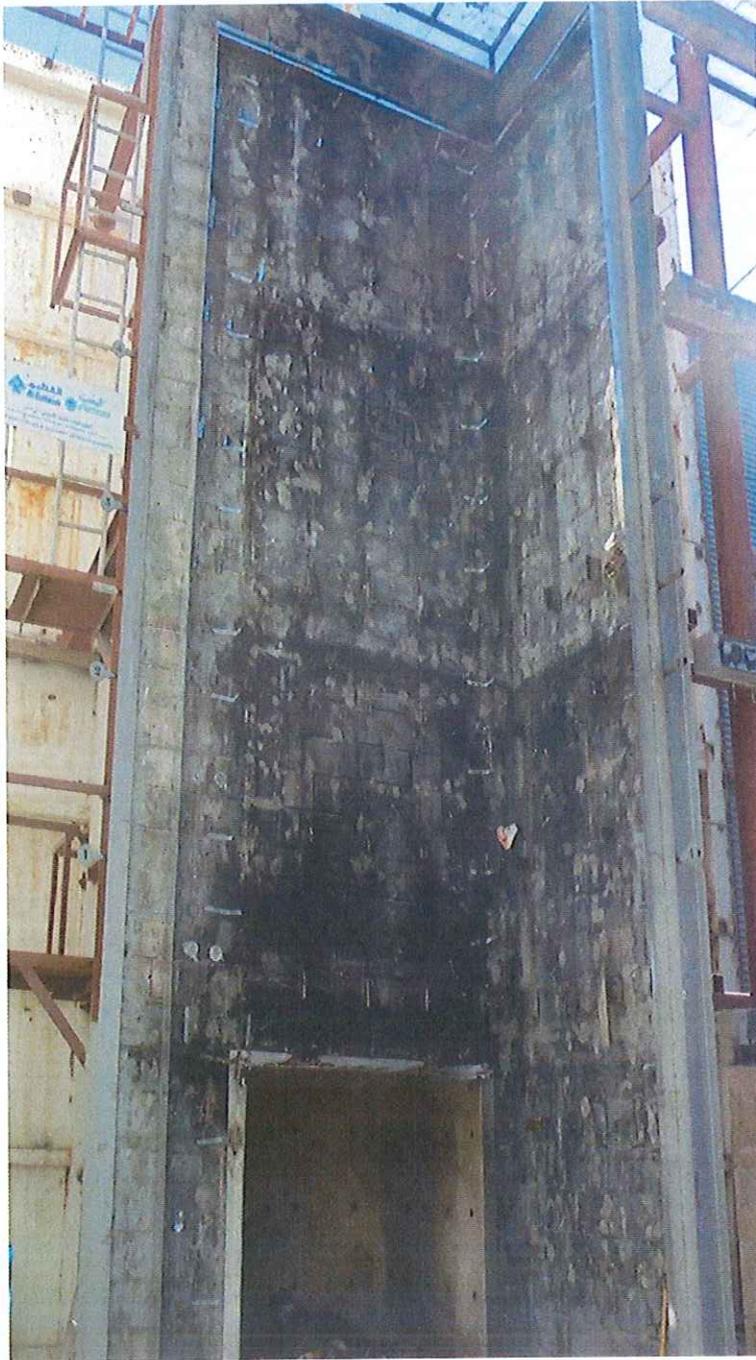
Photo 18 Helping Hand brackets

Bracket	All brackets were intact. Material loss and discolouration were observed.	Photo 18 & 22

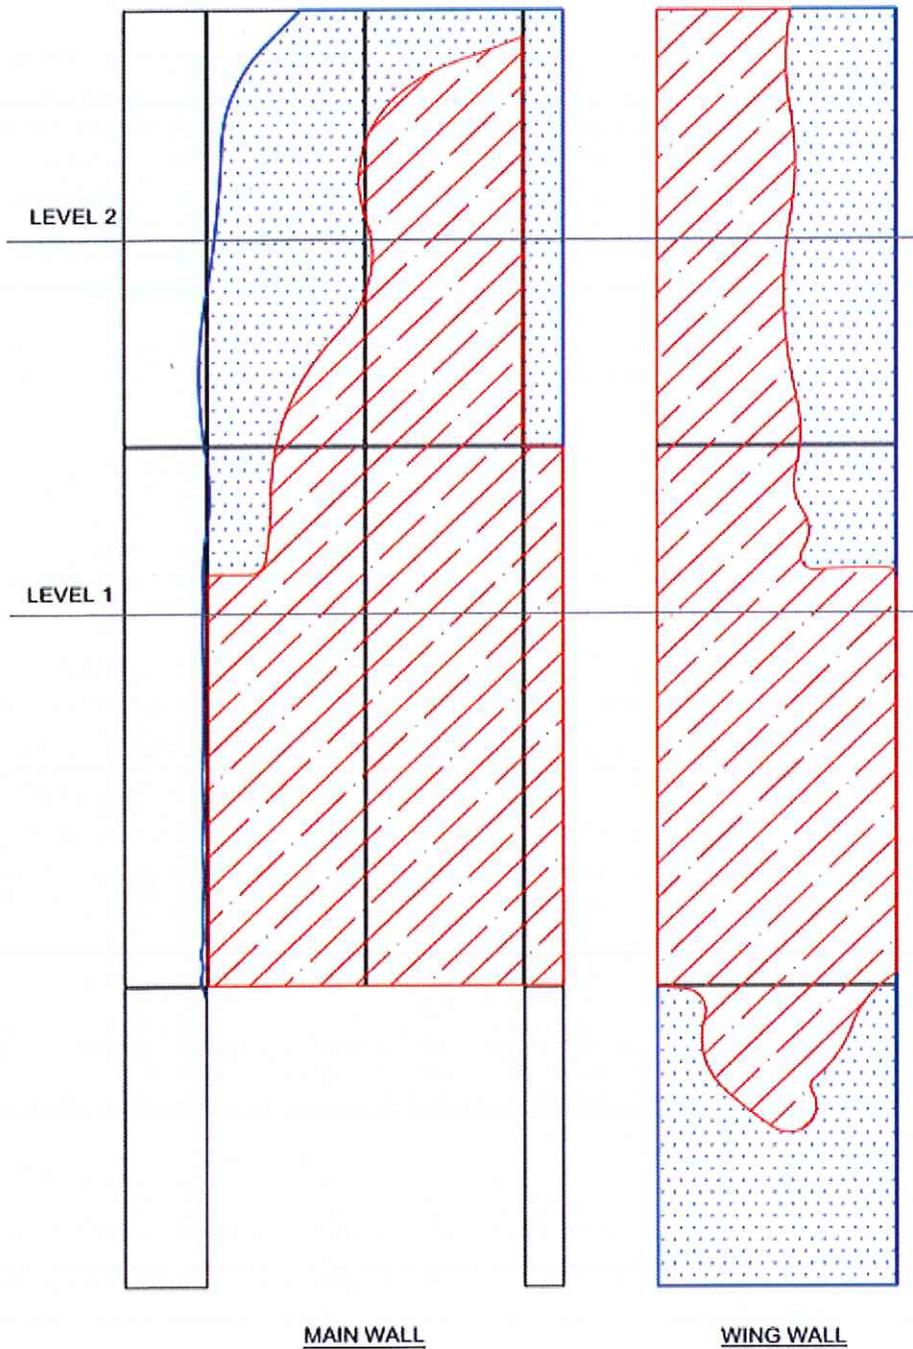
**Figure 4 Area Map Showing the Condition of the Trespa Meteor FR Panels After the Test**

- Approximately 19m<sup>2</sup> of the total external visible area was completely consumed.
- Approximately 6.5m<sup>2</sup> of the total external visible area was discoloured.
