BRE Global Summary Test Report

BS8414-2:2005 Test on Aluminium panels and Kingspan K15 insulation

Prepared for: Kingspan Insulation Limited

Report Number: P100184-1002 Issue: 1

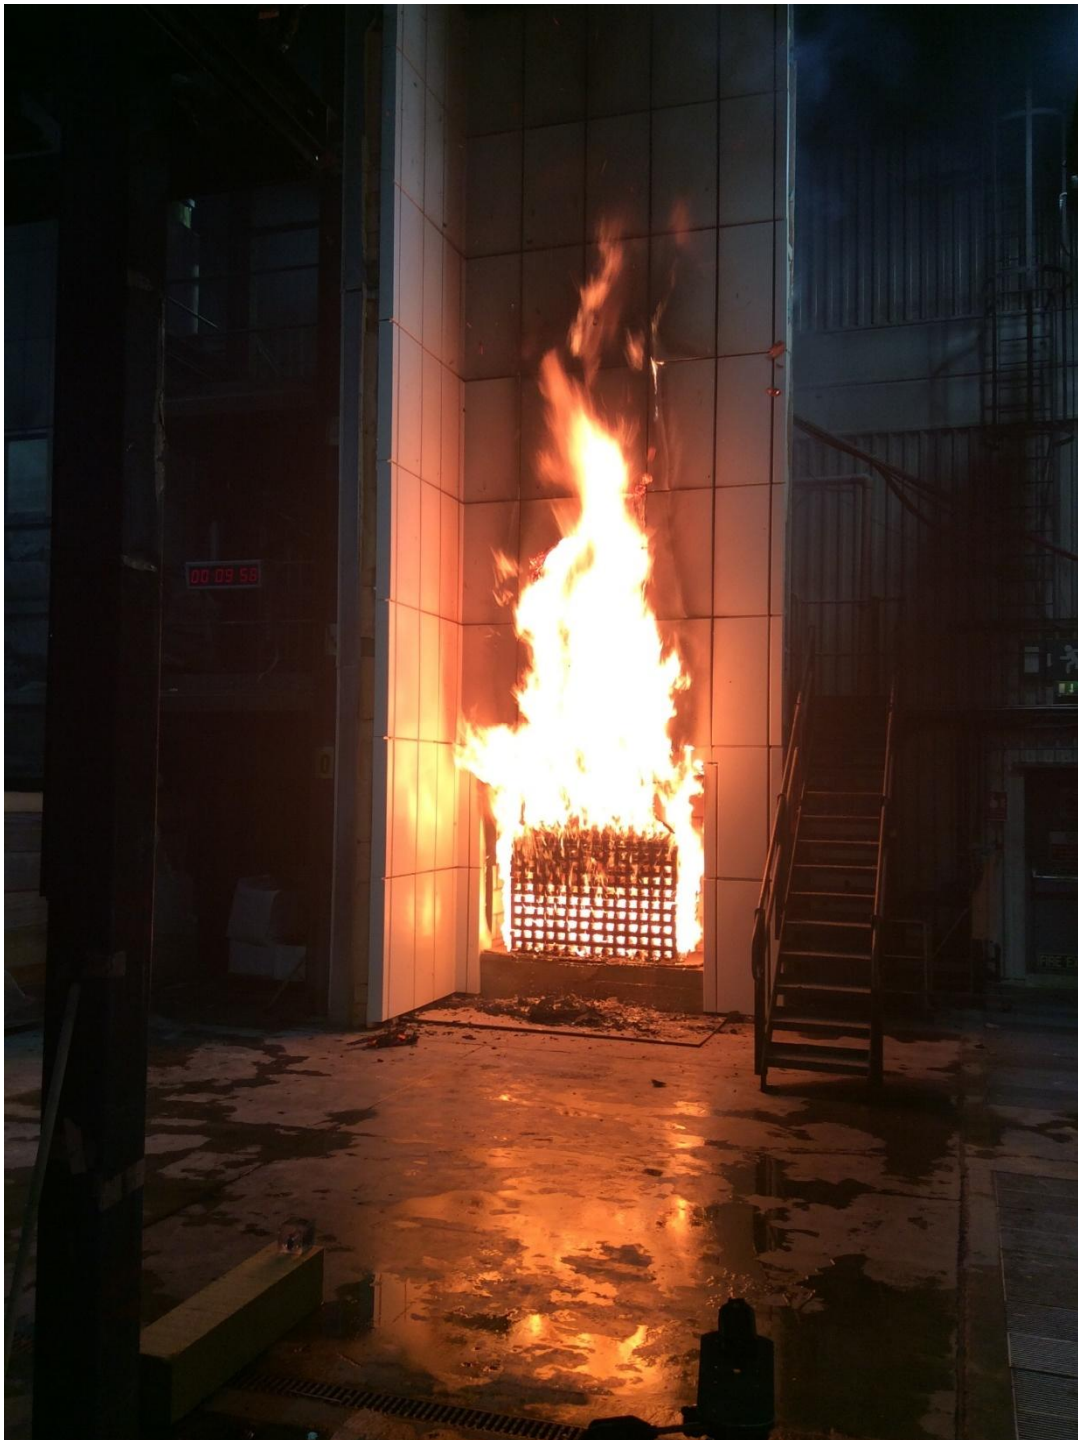
Figure 16. Main wall panels melted to approx. 2m above chamber, falling debris (00:09:56 from ignition)

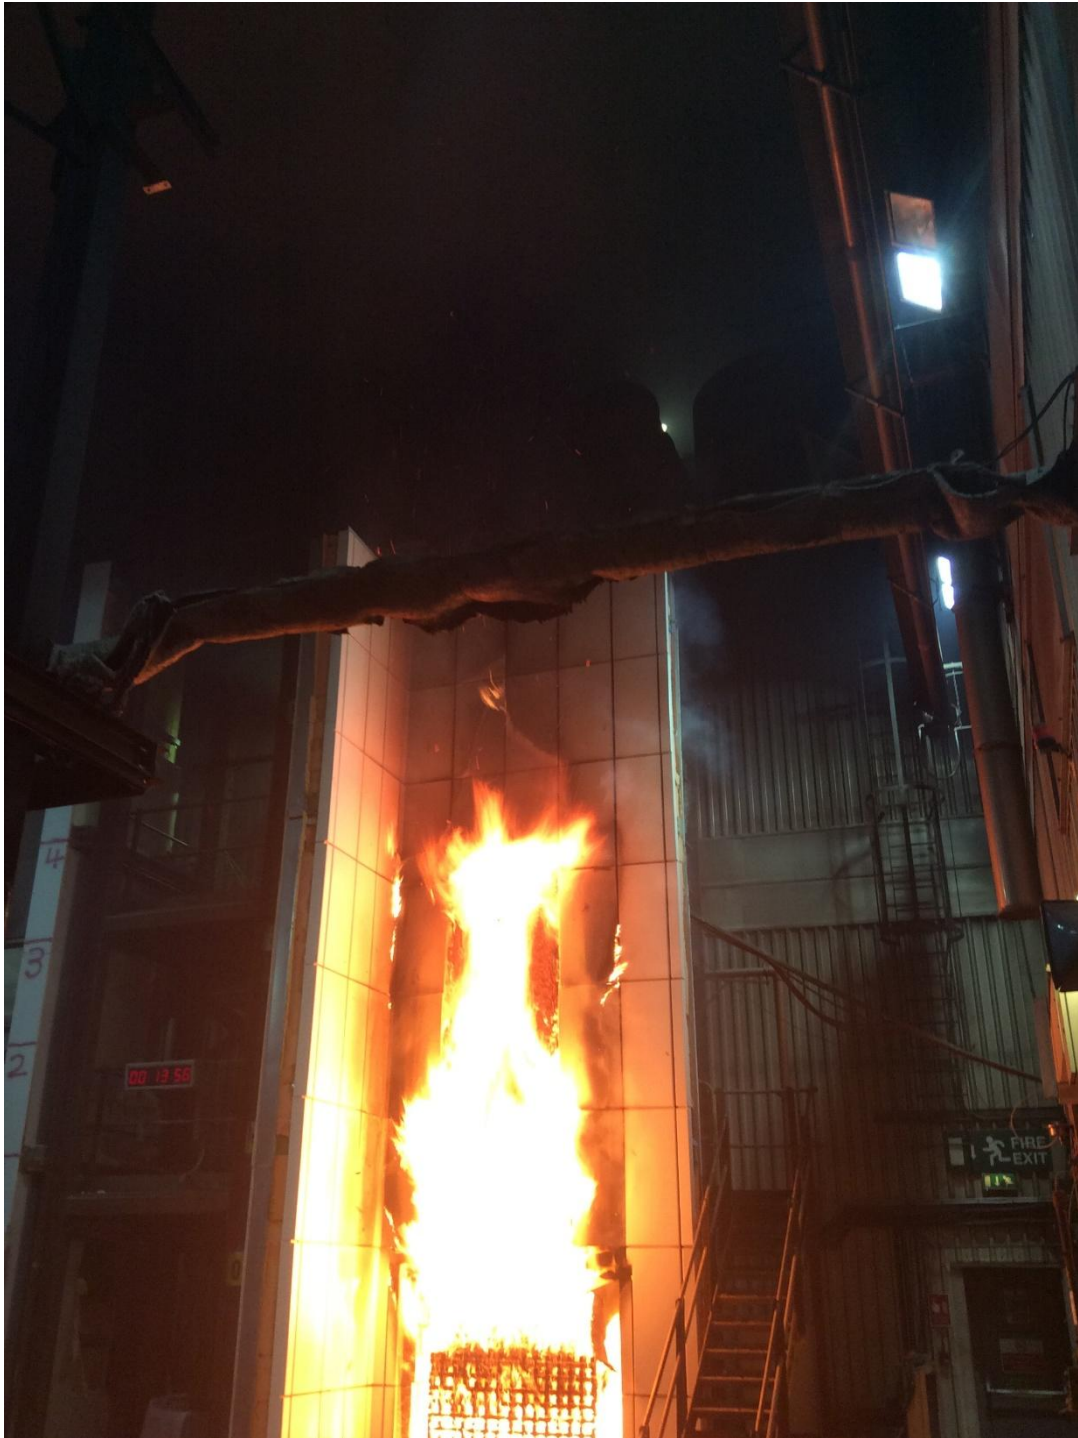
Figure 17. Main wall panels melted/detached to approx. 3.5m above combustion chamber, flaming at main-wing wall junction (00:13:56 from ignition)

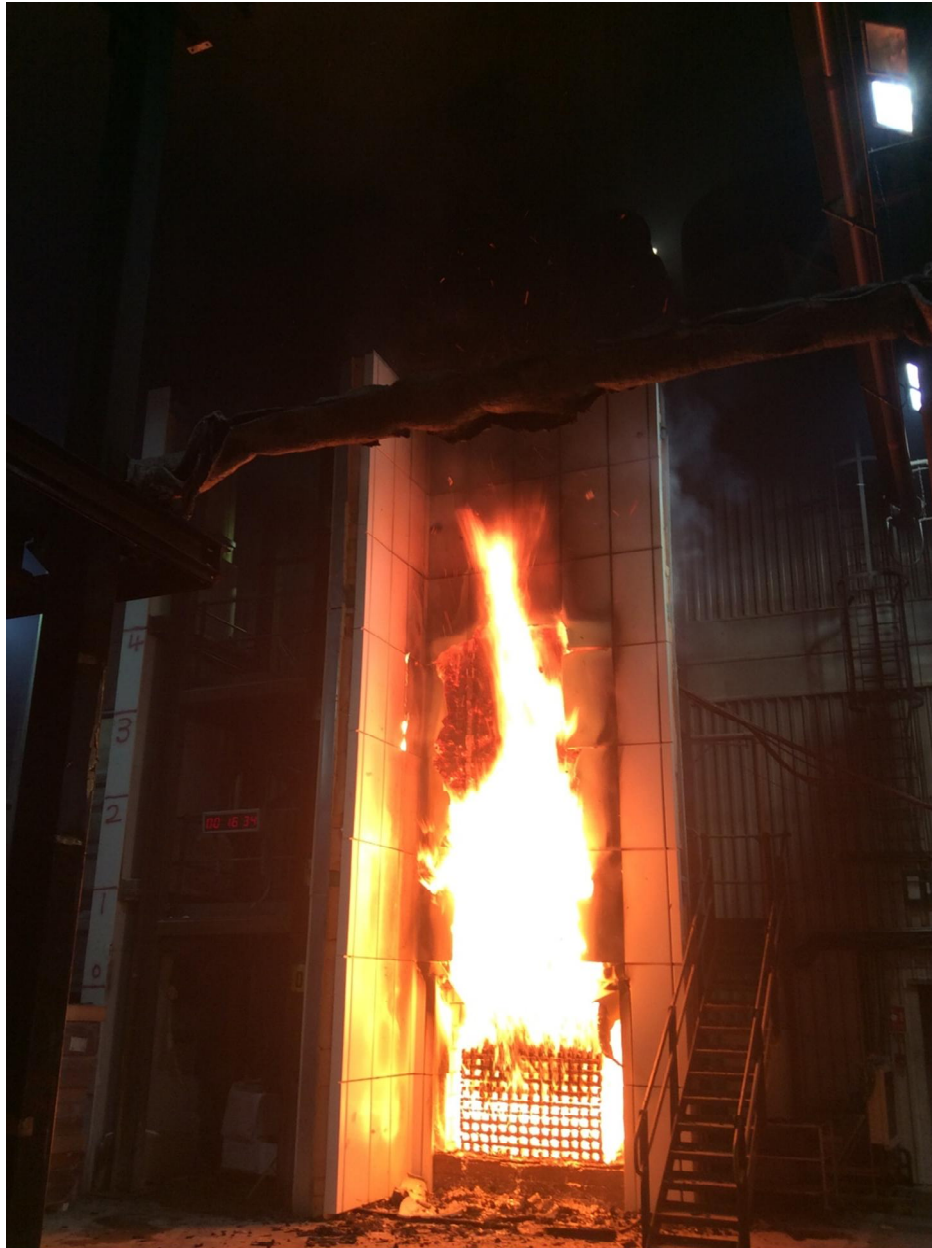
Figure 18. Increased melting/detachment of main wall panels, flaming from wing wall at approx. 3.5m above combustion chamber (00:16:34 from ignition)

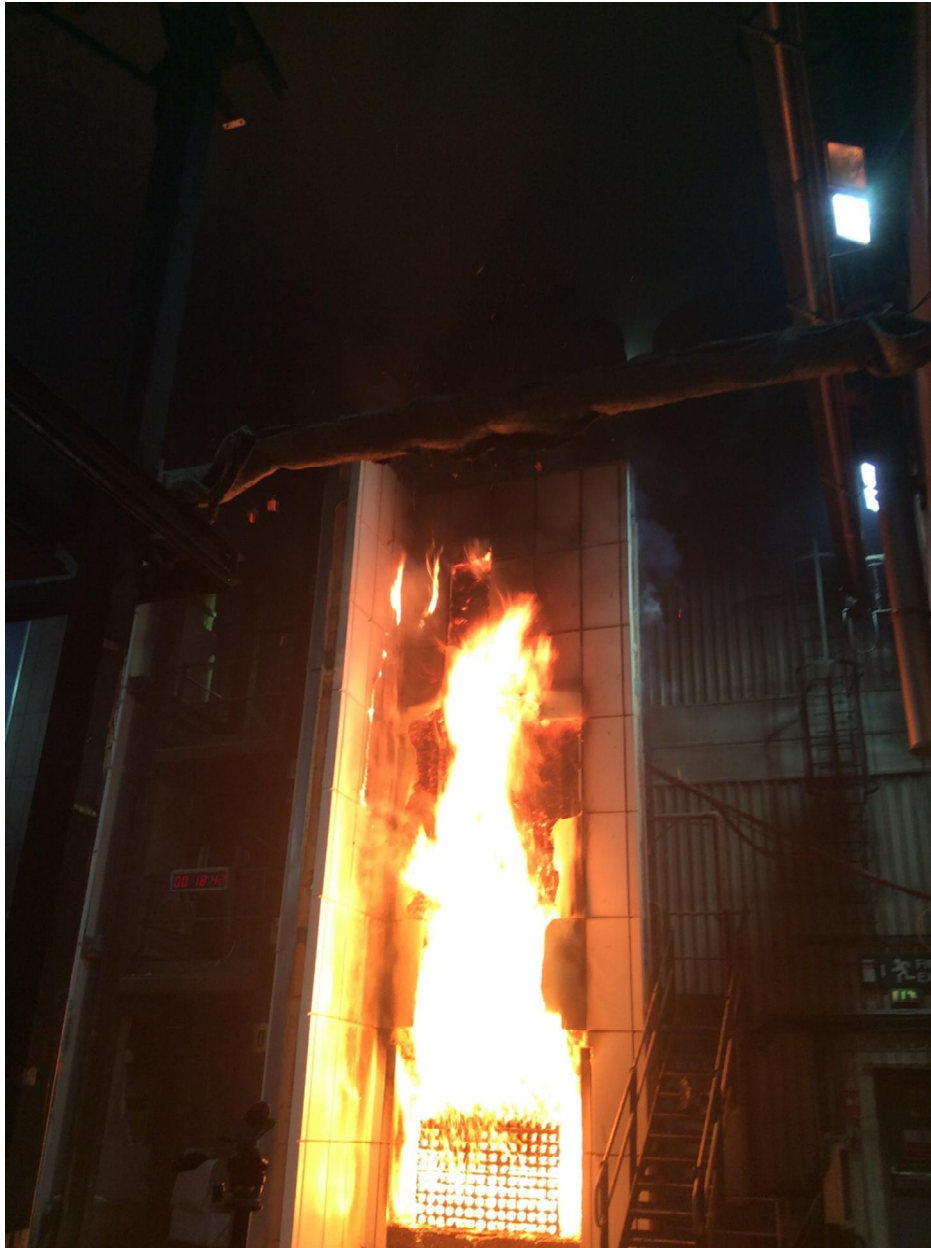
Figure 19. Increased melting/detachment of main wall panels up to approx. 6m above combustion chamber, flaming from main and wing wall at this height (00:18:42 from ignition)

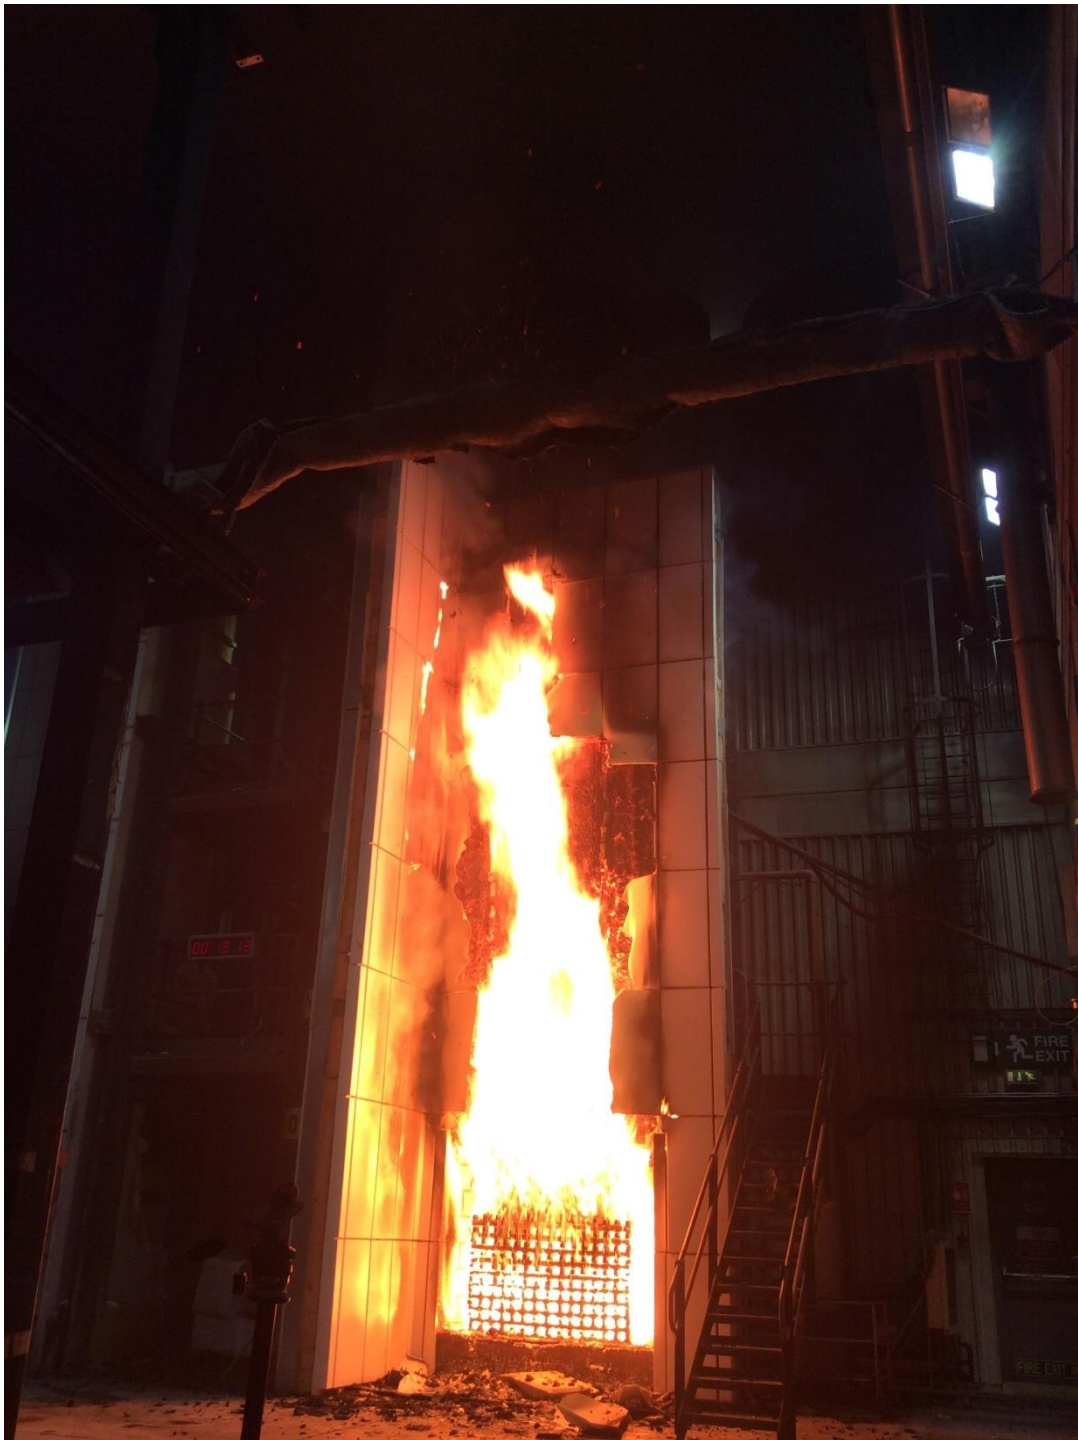
Figure 20. Increased flaming from main wall at approx. 6m above combustion chamber, increased debris (00:19:13 from ignition)

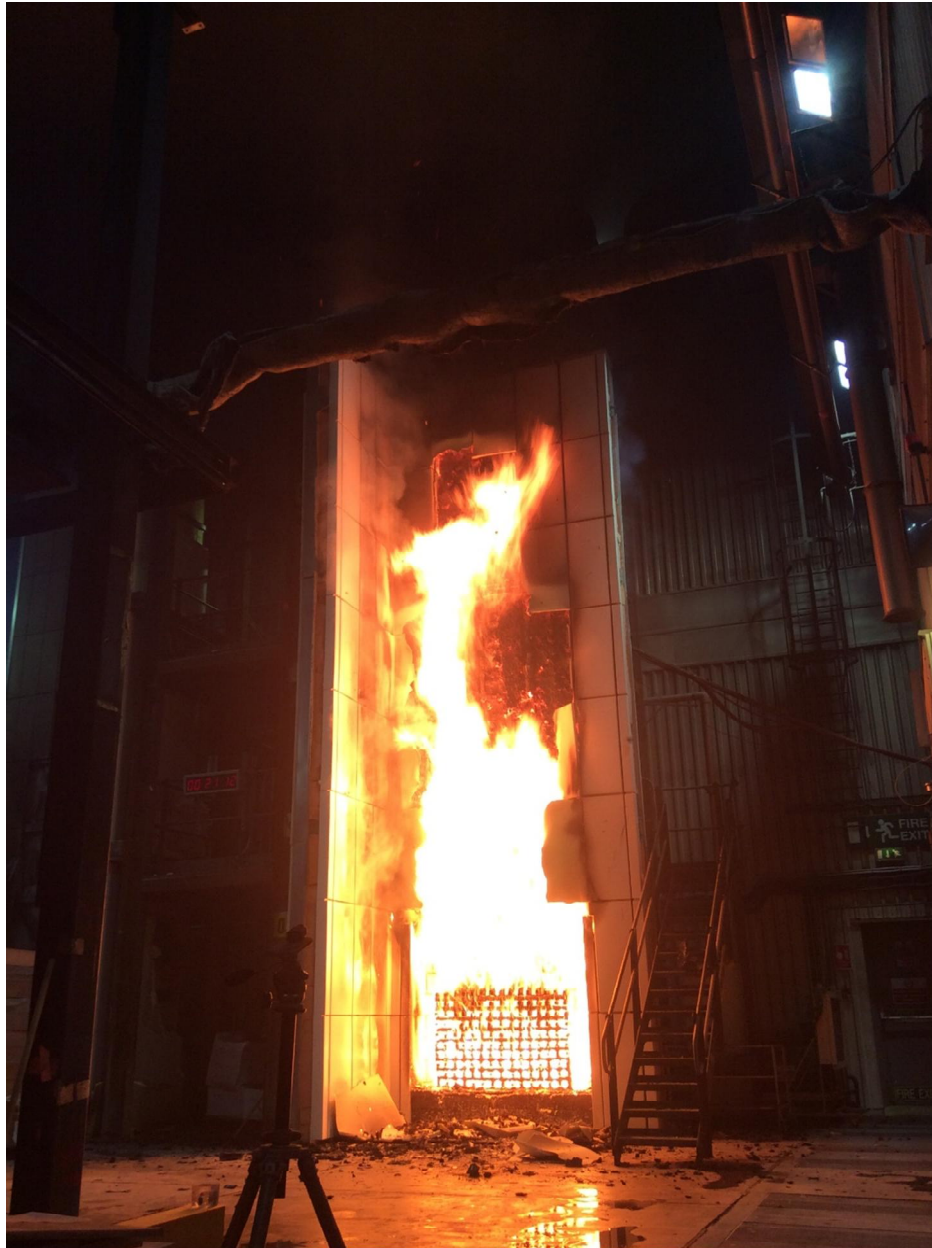
Figure 21. Increased melting/detachment of panels on main wall at approx. 6m above combustion chamber, increased debris (00:21:12 from ignition)

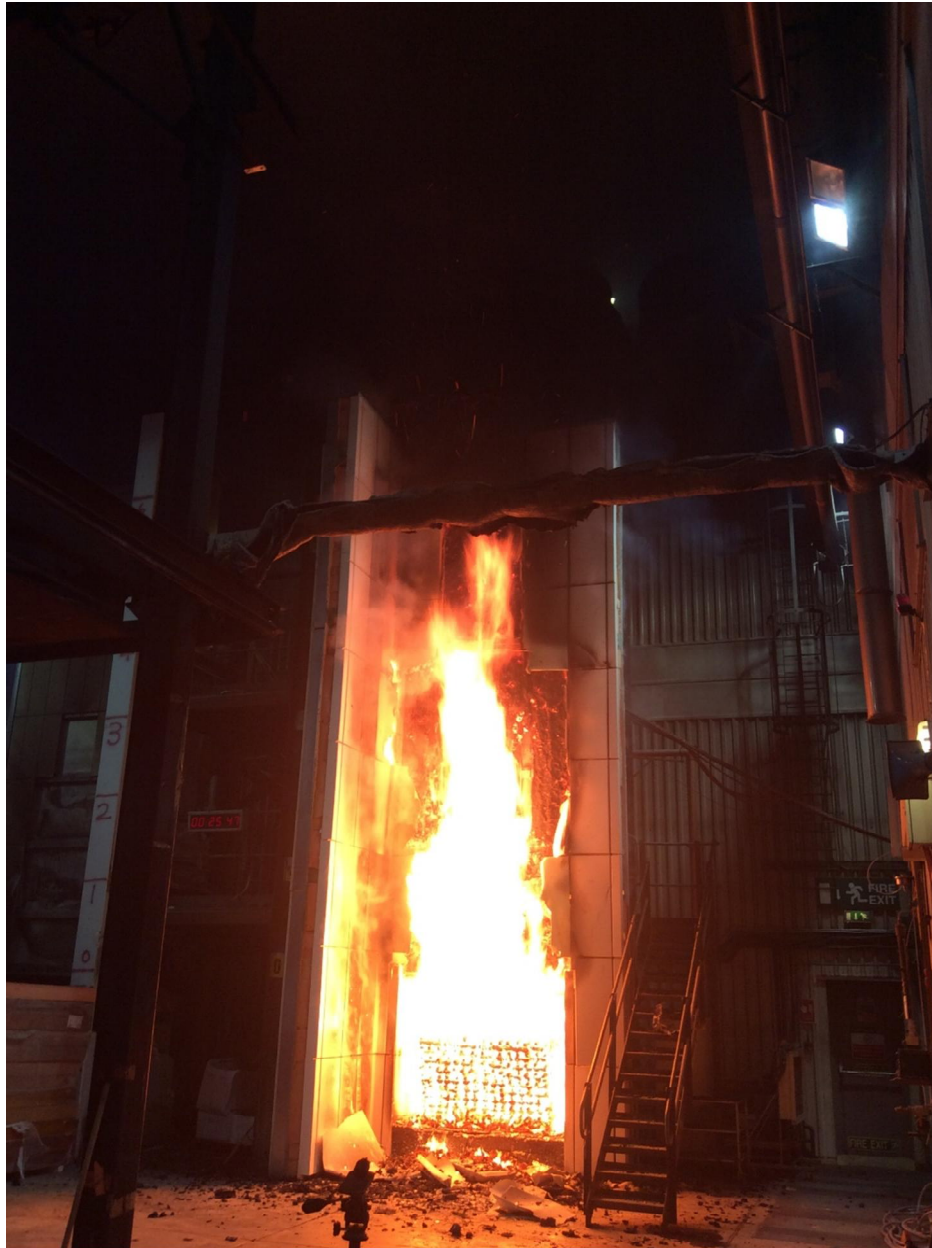
Figure 22. Melting of wing wall panel at approx. 3m above combustion chamber (00:25:47 from ignition)

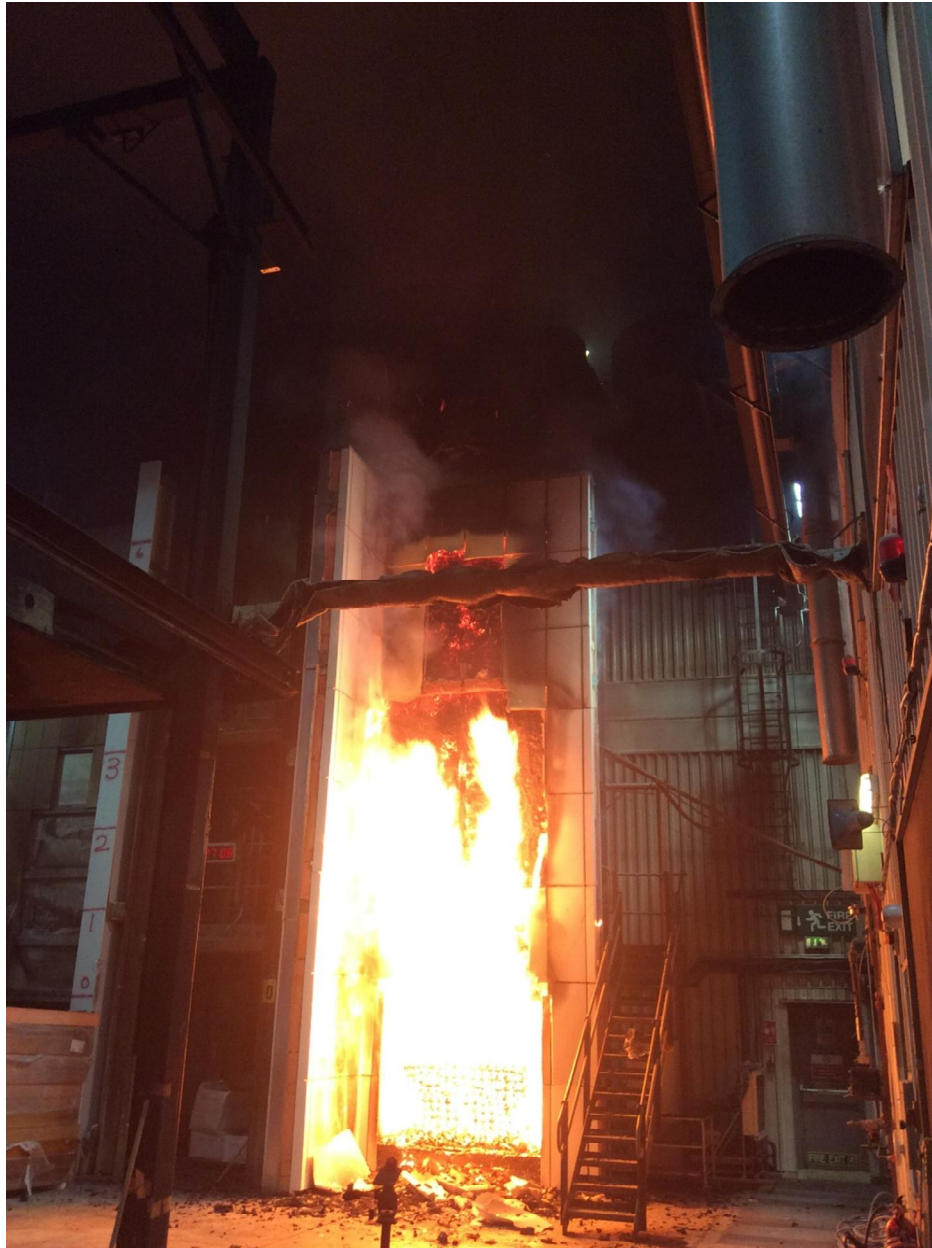
Figure 23. Melting of panels and insulation smouldering to top row of main wall panels, increased flaming from wing wall (00:27:08 from ignition)

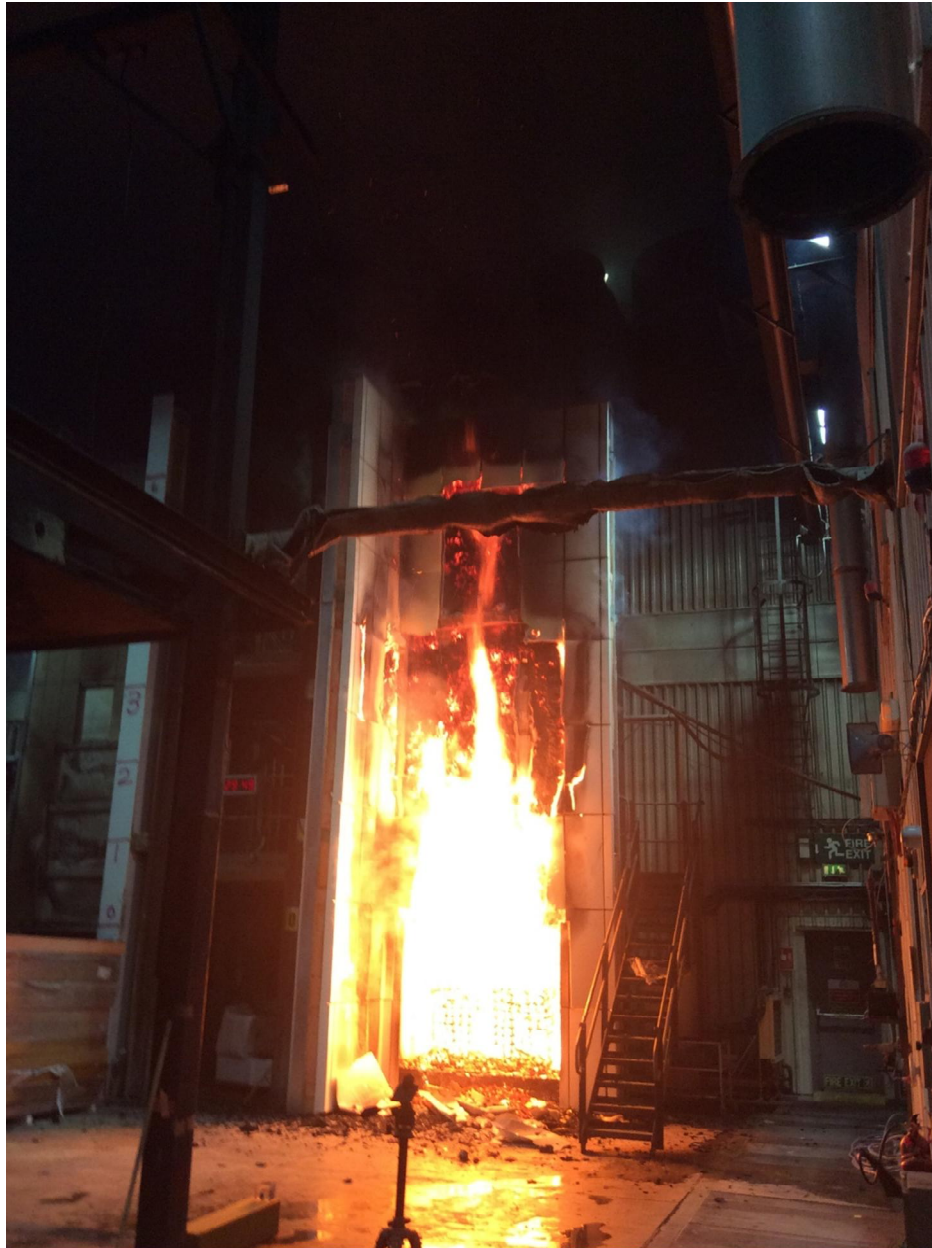
Figure 24. Flaming from top row main wall panel to top of test specimen (00:29:49 from ignition)

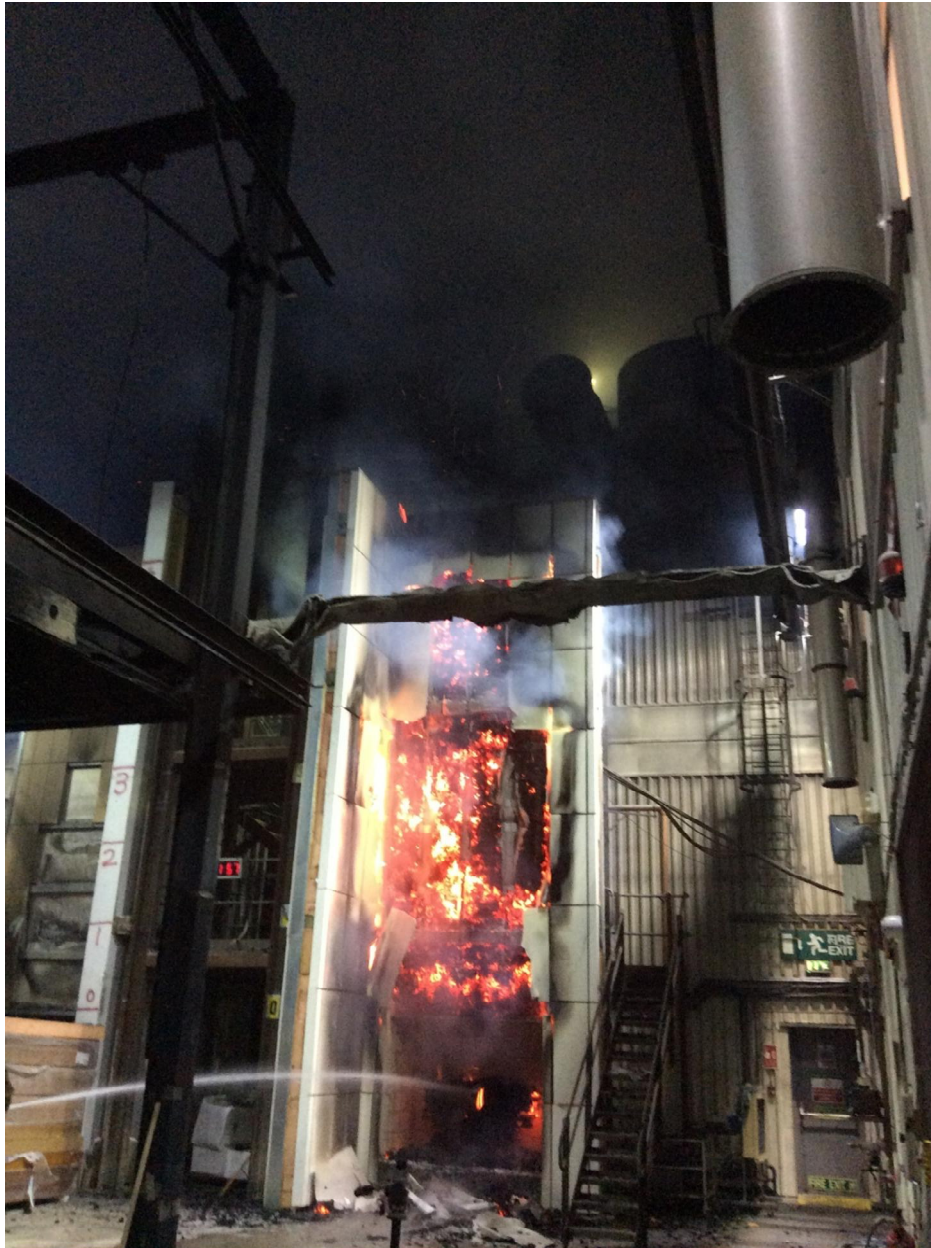
Figure 25. Crib extinguished at 30 minutes from ignition, flaming from top of test specimen (approx. 32mins)

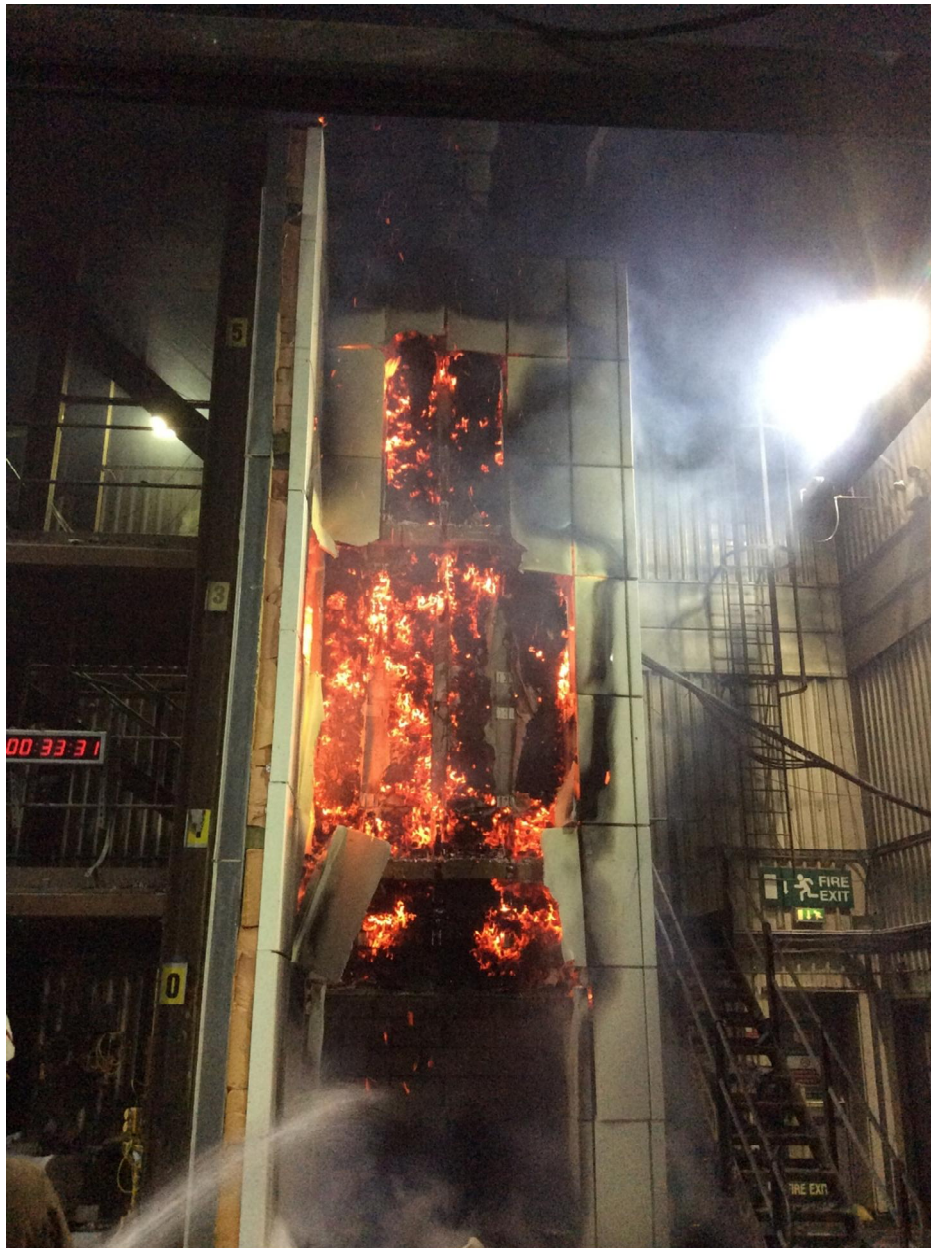
Figure 26. Crib extinguished at 30mins, flaming from insulation continues. Possible flaming at top of wing wall (00:33:31)

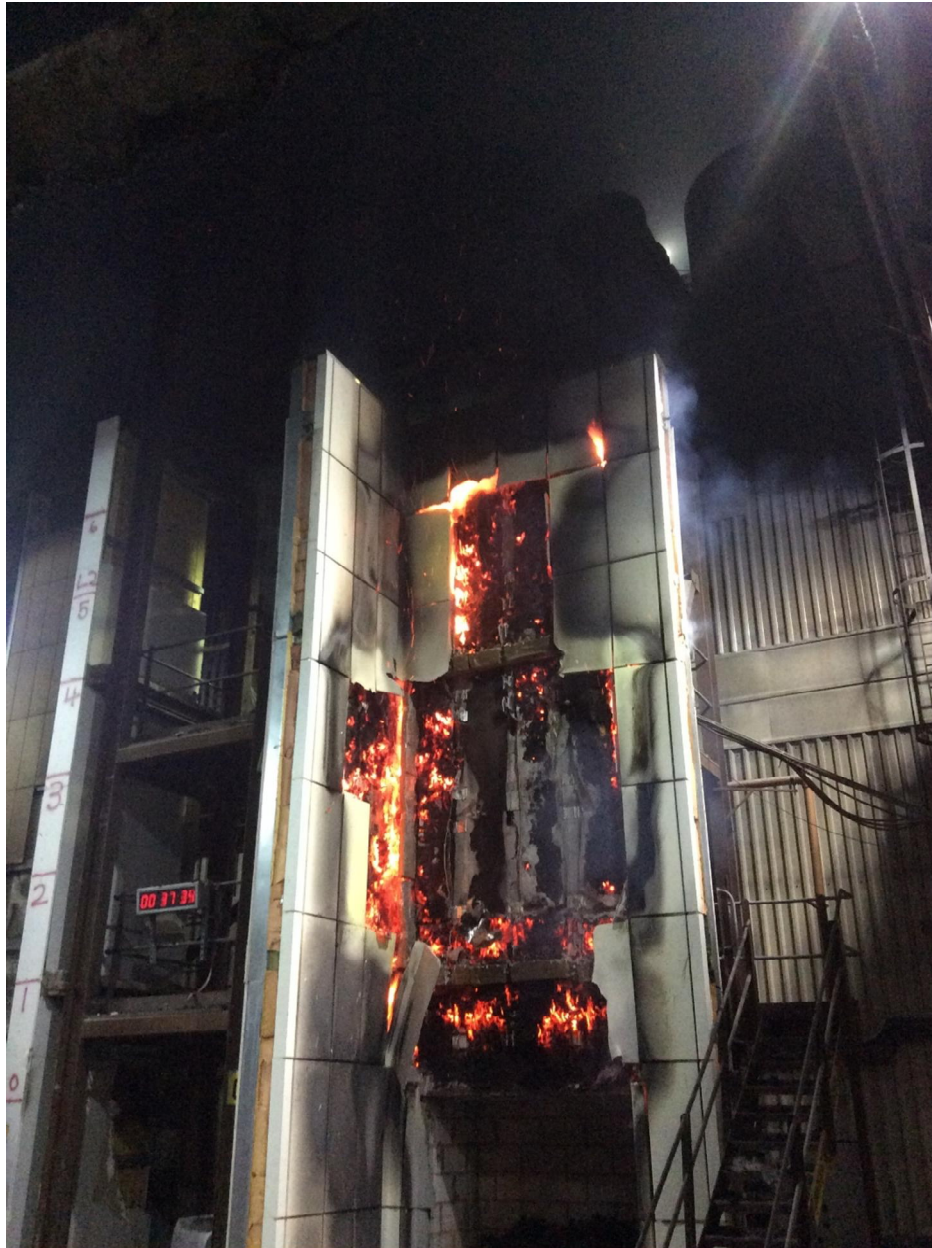
Figure 27. Increased flaming from behind main wall panels at approx. 6m above combustion chamber (00:37:39)

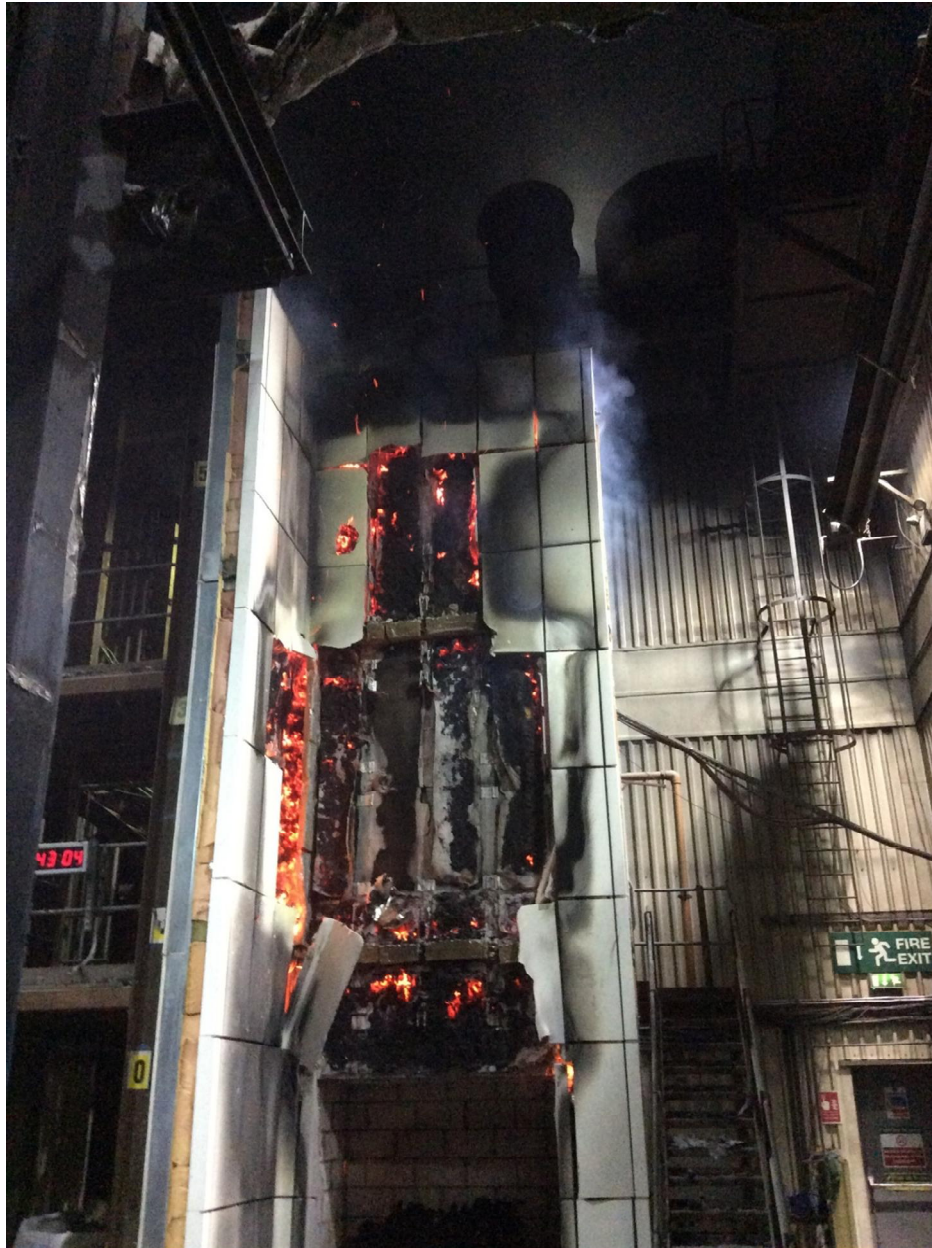
Figure 28. Flaming continues but has reduced in intensity (00:43:04)

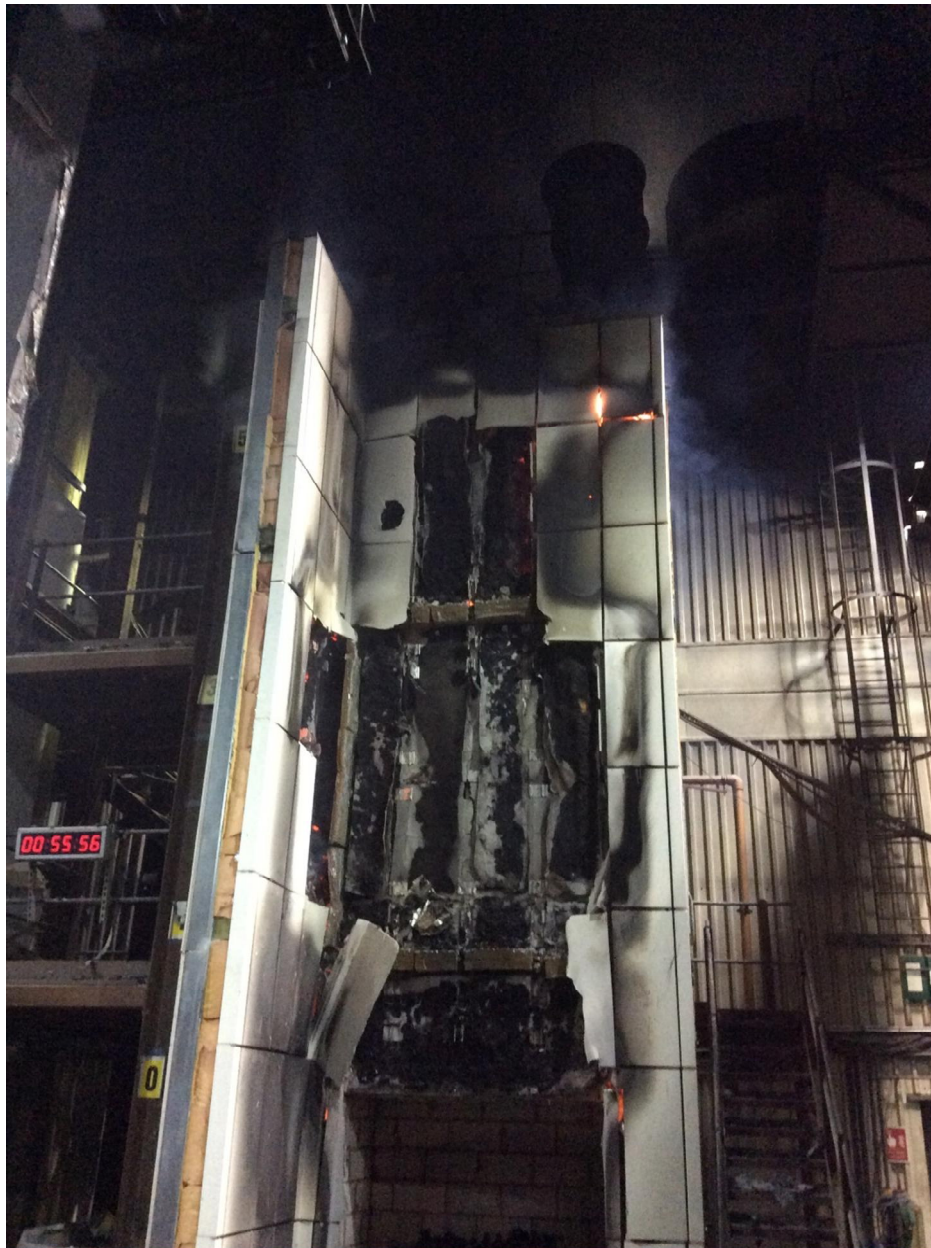
Figure 29. Significant reduction in flaming except at outside edge of main wall, 6m above combustion chamber (00:55:56)

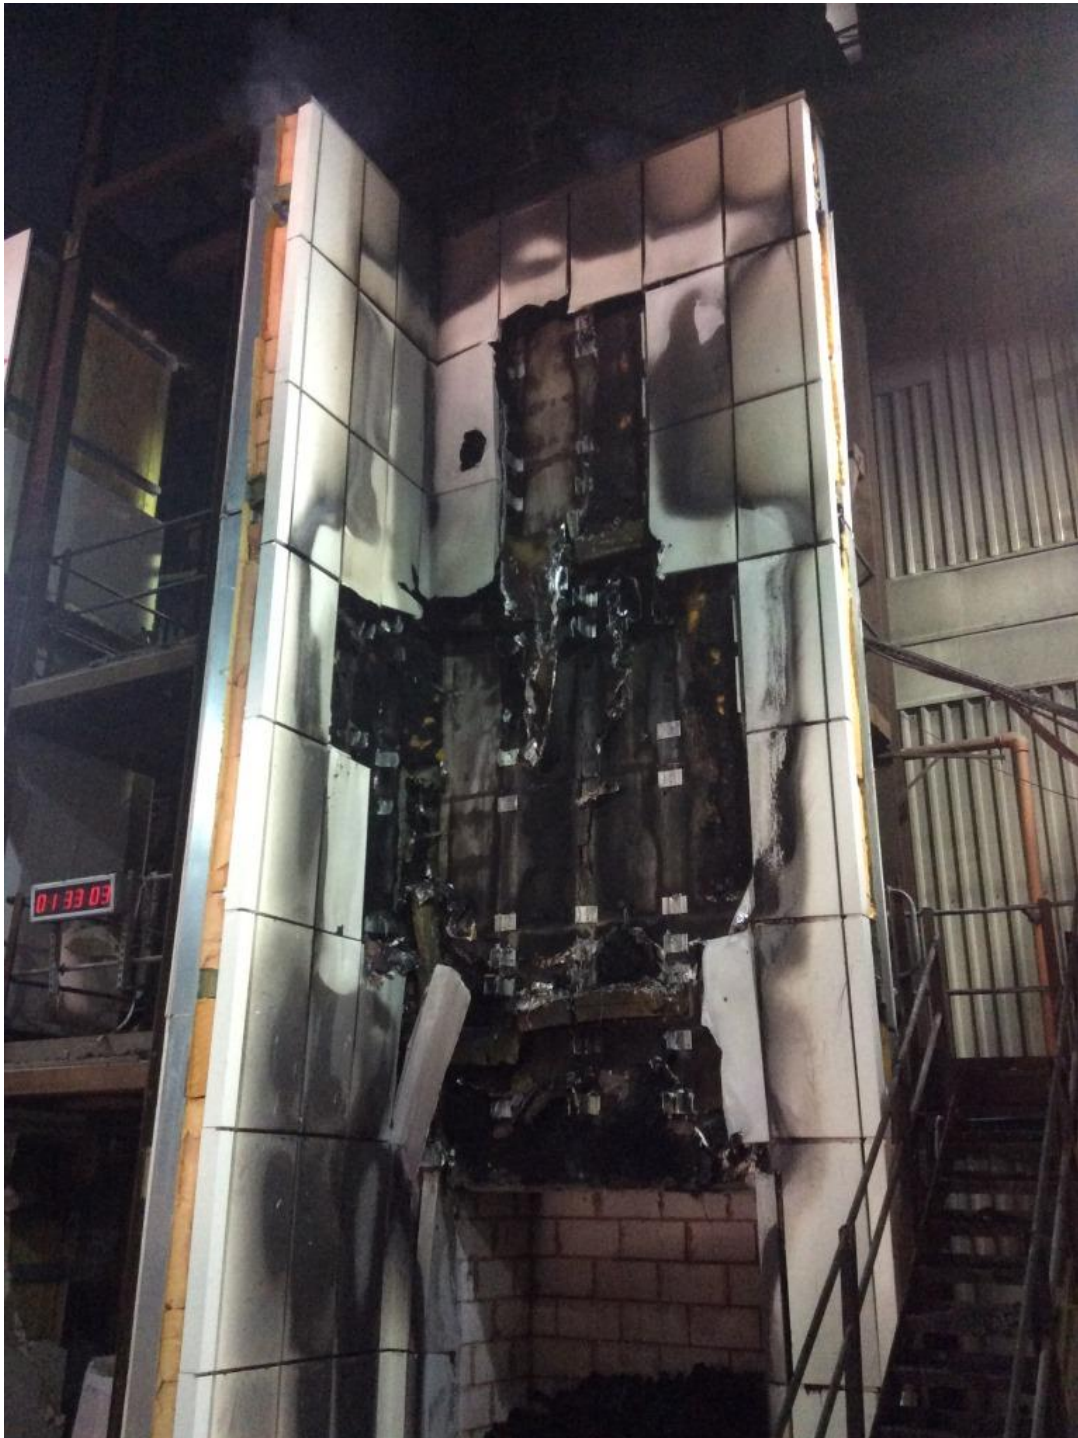
Figure 38. Full-height photograph of cladding system following post-test dousing.

With reference to *Figure 13*, the damage observed to the aluminium panels was as follows.

Fully melted/detached panels:

0E, 0F, 0G,

1E, 1F,

2C, 2C, 2D, 2E, 2F, 2G,

3B, 3C, 3D, 3E, 3F, 3G,

4E, 4F,

5E, 5F

Partially melted/detached panels:

1C (15%), 1D (60%), 1G (40%), 4D (15%), 6E (15%)

The panels were discoloured and distorted adjacent to the main area of damage.

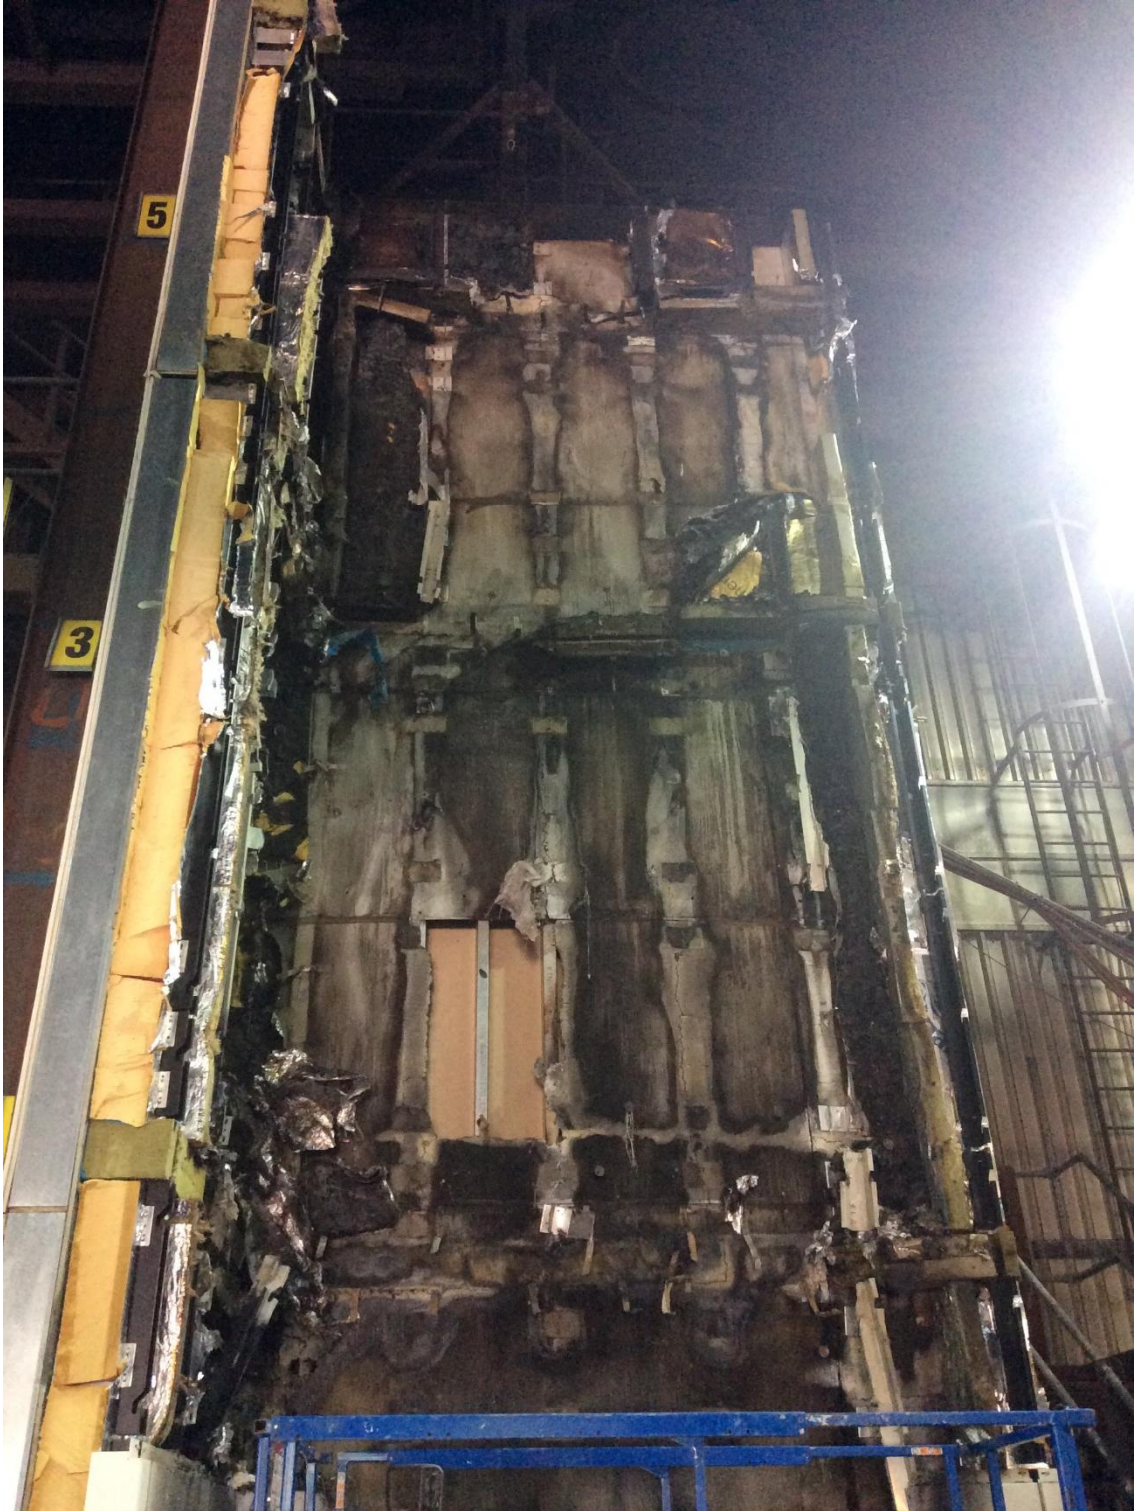
Figure 39. Post-test photograph of main wall following panels removal.

The majority of the four mullions located in line with the combustion chamber opening had melted up to the height of the 3rd horizontal cavity barrier. The centre left mullion had melted to the top of the test specimen. The mullion at the outside edge of the main wall appeared to have no significant damage.

On the main wall, the majority of the aluminium brackets supporting the four central mullions had also melted. On the wing wall, the brackets had partially melted in the locations where the mullions had melted.

On the main wall, the majority of the insulation had been consumed during test, some detached during post-test dousing of the system. Some insulation remained towards the top of the test specimen, adjacent to the wing wall, but was significantly charred. The insulation at the outside edge of the main wall remained intact and in place. See *Figure 39*.

The horizontal cavity barriers remained intact and in place during the test. Where the aluminium panels had melted, the intumescent strip was no longer visible. There was some detachment of the cavity barriers during post-test dousing of the test specimen. See *Figure 39-40*.

The vertical cavity barriers remained intact and in place during the test. There was some detachment of the cavity barriers during post-test dousing of the test specimen. Some sections of the vertical cavity barriers had fire damage on the inside edge (facing the combustion chamber). See *Figure 39-40*.
