BRE Global Summary Test Report

BS8414-2:2005 Test on Aluminium panels and Kingspan K15 insulation

Prepared for: Kingspan Insulation Limited

Report Number: P100184-1002 Issue: 1

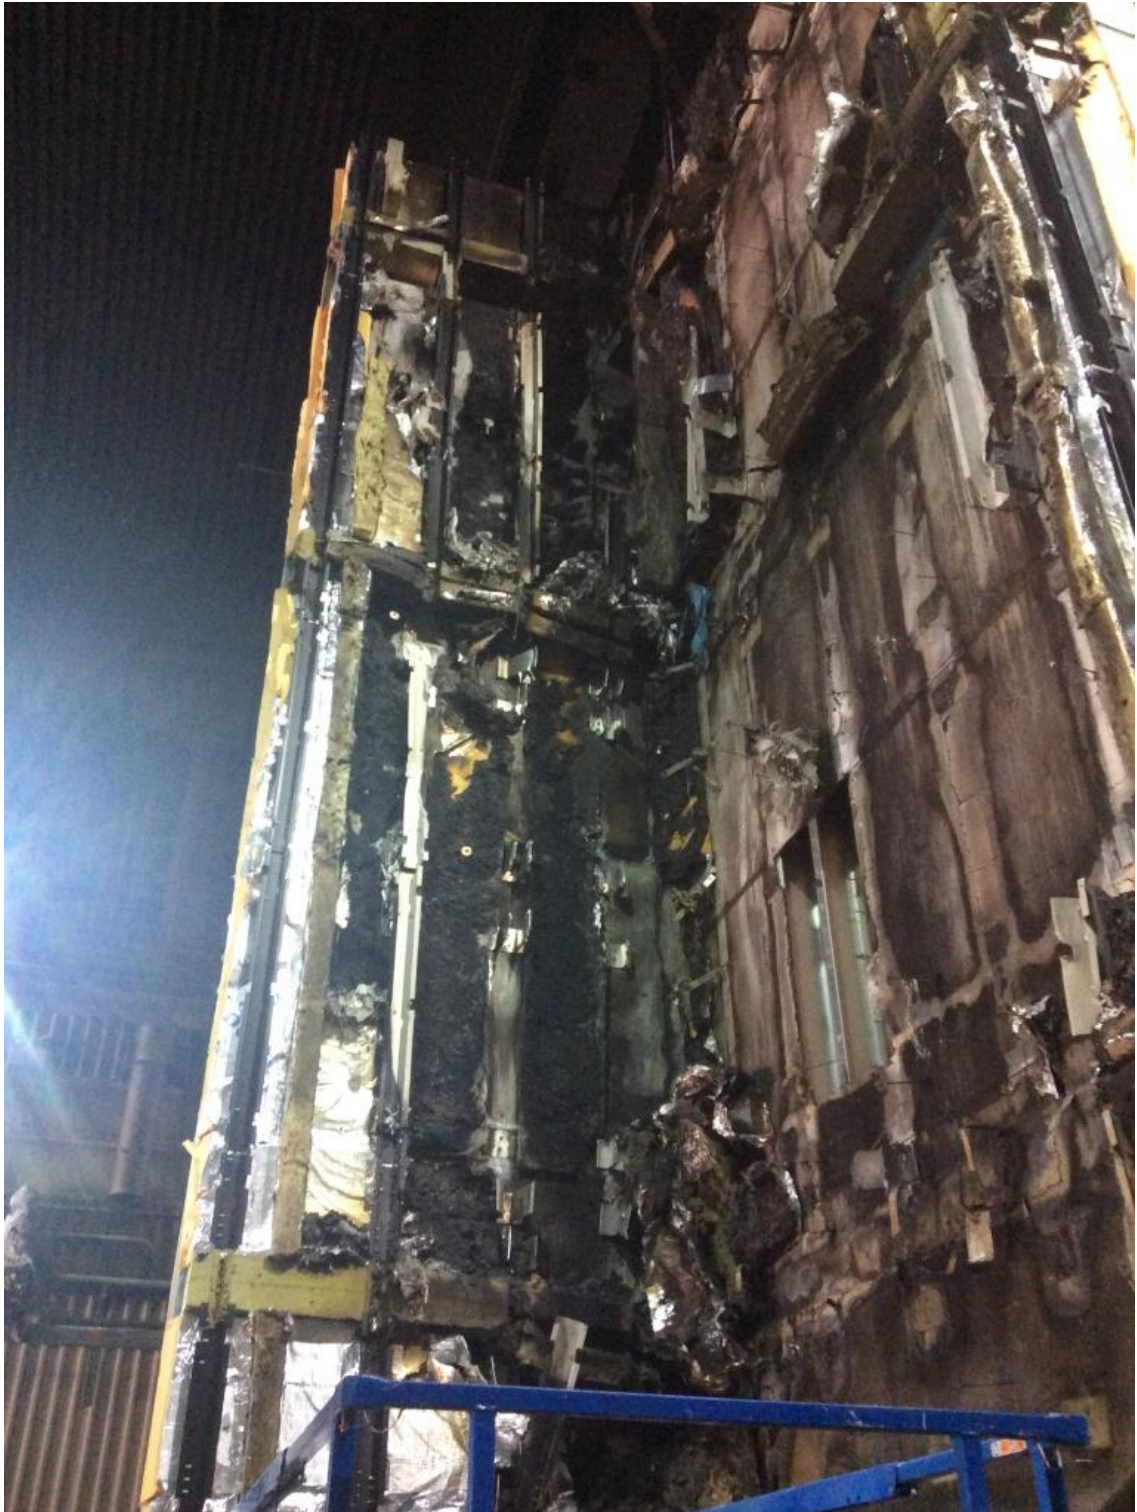
Figure 40. Post-test photograph of wing wall following panel removal.

From the main-wing wall junction to the outside edge of wing wall:

- The first mullion had melted from the height of the combustion chamber opening to the third horizontal cavity barrier.
- The second mullion had melted between the first and second horizontal cavity barrier. Immediately below the first cavity barrier a section of mullion had partially detached. Between the second and third cavity barrier the mullion was distorted.
- The third mullion had partially melted between the first and second horizontal cavity barrier. Elsewhere the mullion remained intact and in place.
- The fourth mullion appeared to have no significant damage.

On the wing wall, between the first and second horizontal cavity barrier, the insulation had been consumed between the first mullion and the main wall. The insulation was significantly charred adjacent to the first mullion with depth of char decreasing towards the vertical cavity barrier towards the outside edge. The foil face of the insulation remained intact at the junction between the vertical cavity barrier and first horizontal cavity barrier. A similar, though less severe, pattern of damage was observed between the second and third horizontal cavity barrier. Some charred insulation remained adjacent to the main wall. The foil face remained intact at the top of the test specimen with some fire damage. See *Figure 40*.

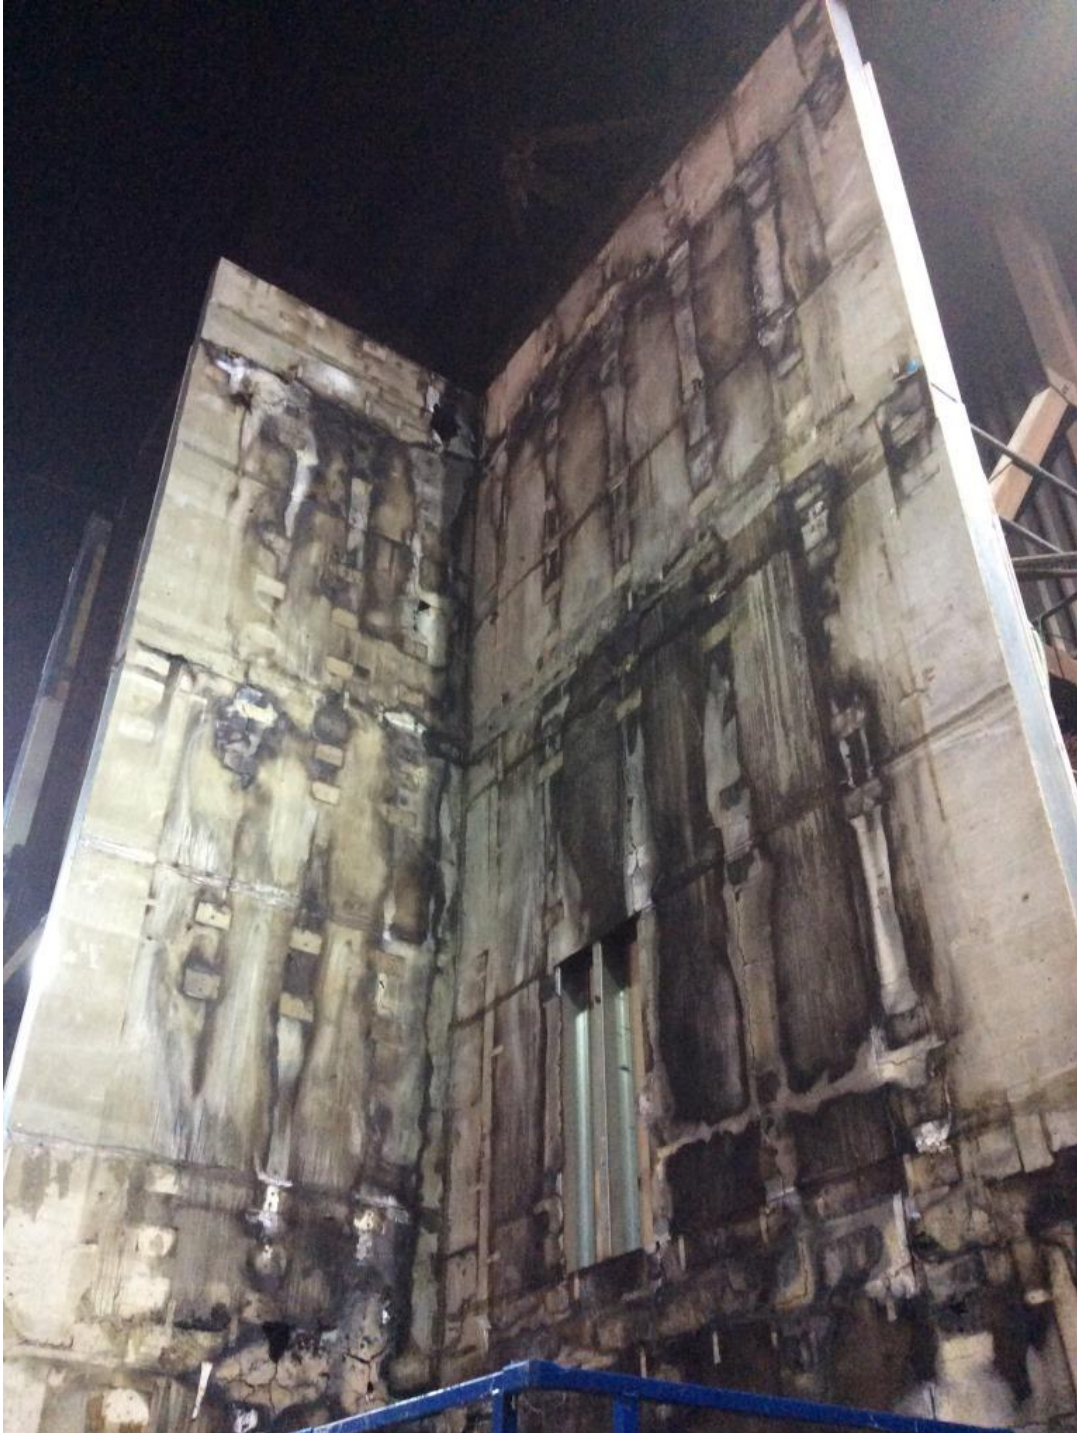
Figure 41. Post-test photograph of sheathing board layer.

The sheathing board appeared to remain intact and in place during the test, however; there was some detachment during post-test dousing. The sheathing board was cracked on the main wall and was charred to full-width and full-height across both main and wing wall.
