# BRE Global Test Report

**BS 8414-1:2015 + A1:2017 test on a ventilated façade system with Kingspan Kooltherm K15 insulation and Alpolic/fr panels.**

**Report Number:** P107017-1000 **Issue:** 1

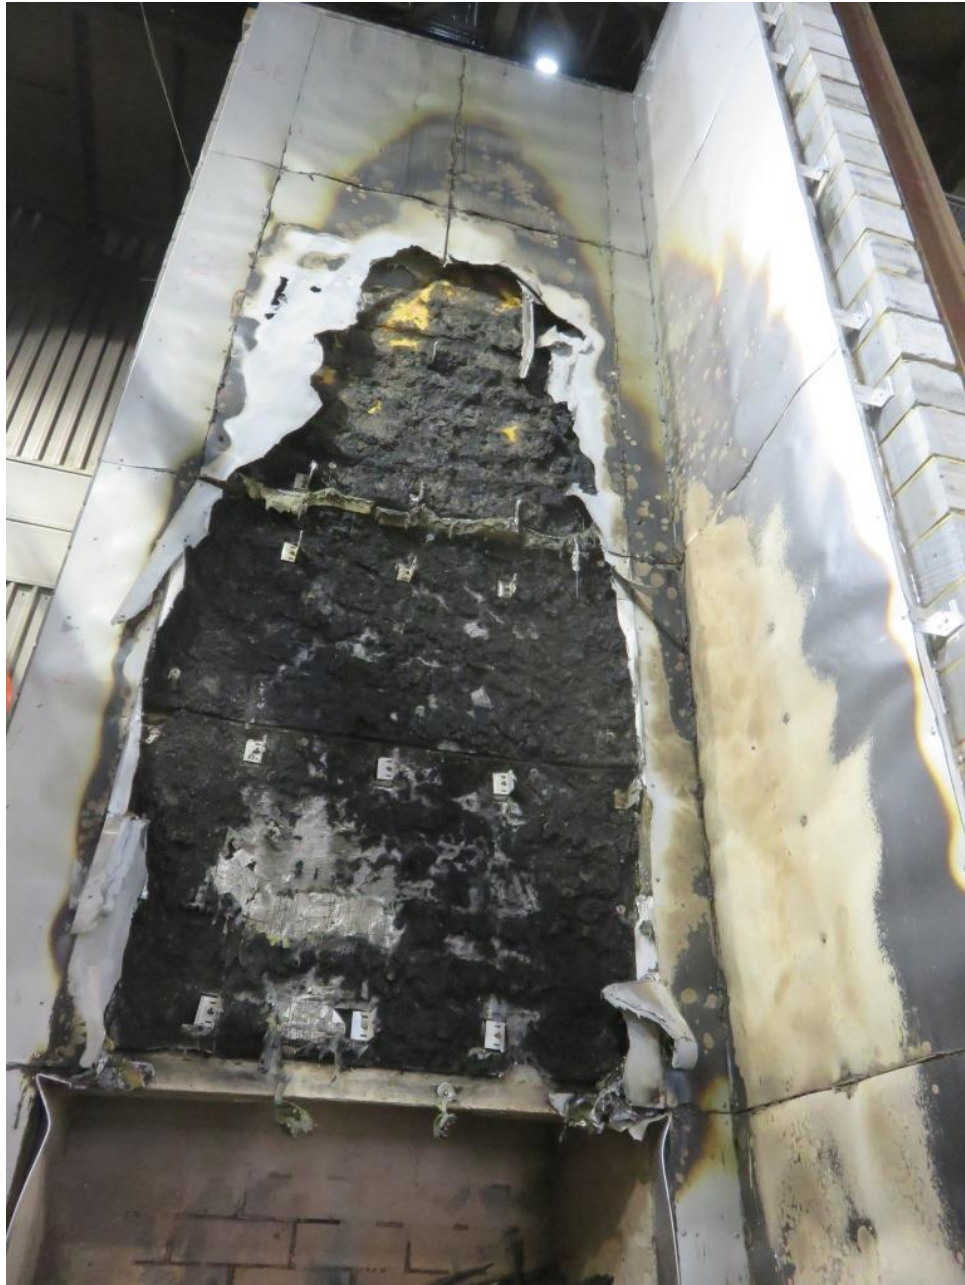
Row 0 – Panel 0A was significantly distorted and discoloured (approximately 70% panel coating removed, 25% dark discolouration). On panel 0B there was a small area (approximately 300mmx150mm) of dark discolouration in the top left hand corner of the panel (adjacent to the combustion chamber). Panel 0E was not visibly damaged.

Row 1 – Panel 1A was significantly distorted and discoloured (approximately 50% panel coating removed, 25% dark discolouration). Panel 1B was significantly distorted and discoloured (approximately 50% panel coating removed, 50% dark discolouration). Panels 1C and 1D were both almost fully consumed. Panel 1E was distorted and darkly discoloured in a 50mm-wide full-height vertical strip in line with the combustion chamber opening.

Row 2 – Panel 2A was distorted and discoloured (<10% panel coating removed, 50% dark discolouration). Panel 2B was distorted and discoloured at the base of the panel (small areas of panel coating removed, 40% dark discolouration). Panels 2C and 2D were damaged across the full panel surface: panel consumed (55% and 40% respectively), distorted and discoloured across the remaining panel. An area approximately 1500mm x 400mm of panel 2D remained loosely attached with consumption of the panel core. Small holes approximately 50mm x 300mm and 50mm x 50mm were observed in panel 2D approximately 3750mm above combustion chamber. Panel 2E was distorted and slightly discoloured.

Row 3 – Panels 3A&3B had minor distortion. Panel 3C was distorted and discoloured (small areas of panel coating removed, approximately 30% dark discolouration). Panel 3D was distorted and discoloured (small areas of panel coating removed, approximately 25% dark discolouration). Panel 3E had minimal visible damage.

Figure 14. Full-height photograph immediately after test.

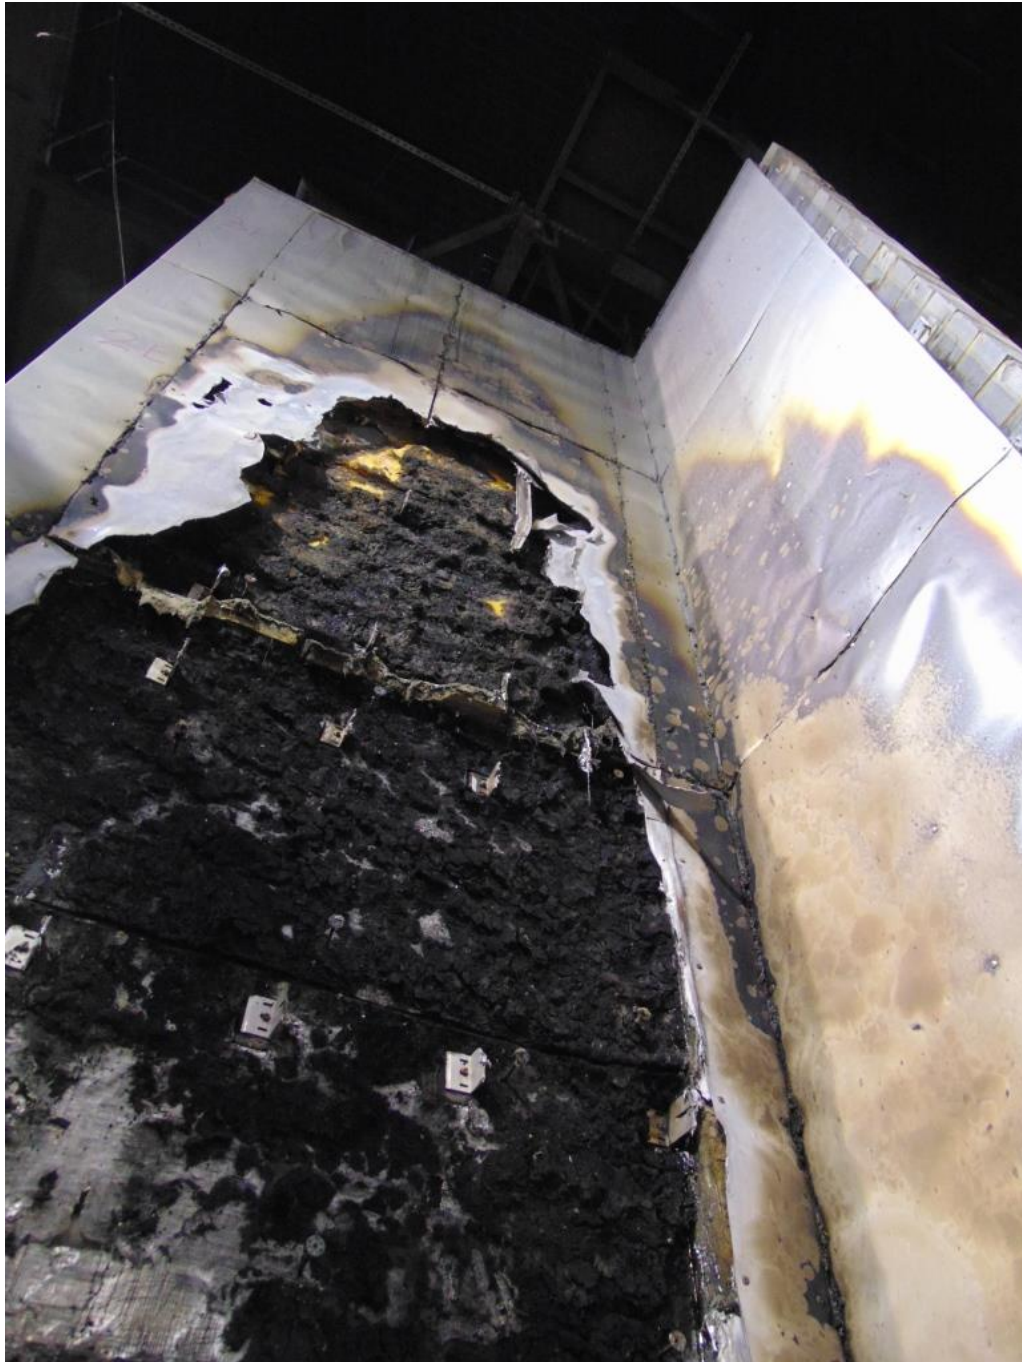
- 0E. The foil facing on the insulation remained intact
- 1B. Dark discolouration towards the second horizontal cavity barrier and small areas of detachment/consumption of foil facing.
- 1C&1D. Small amount of charred insulation remains. Rear foil facing visible across approximately 10%, mostly intact.
- 1E. Foil facing of insulation intact Slight discolouration in places.
- 2B. Minor discolouration of the foil facing.
- 2C. Charring of the insulation occurred in decreasing severity between the second and third cavity barrier. External foil facing and some uncharred insulation remained adjacent to the third horizontal cavity barrier. The internal foil facing was not visible.

- 2D. Damage to the insulation was similar to that observed beneath panel 2C, however; a band of significant insulation consumption and detachment extended from approximately mid-height to approximately 300mm below the third cavity barrier. The blockwork was exposed in an approximately 300mm-width which would have been directly below the damaged edge of the remains of panel 2D.
- 2E. Insulation appeared to be undamaged.
- 3B. Insulation appeared to be undamaged.
- 3C&3D. Discolouration of the foil facing most pronounced along centre line of combustion chamber opening.
- 3E. Insulation appeared to be undamaged.

Figure 15. Post-test photo of exposed insulation on the main wall.

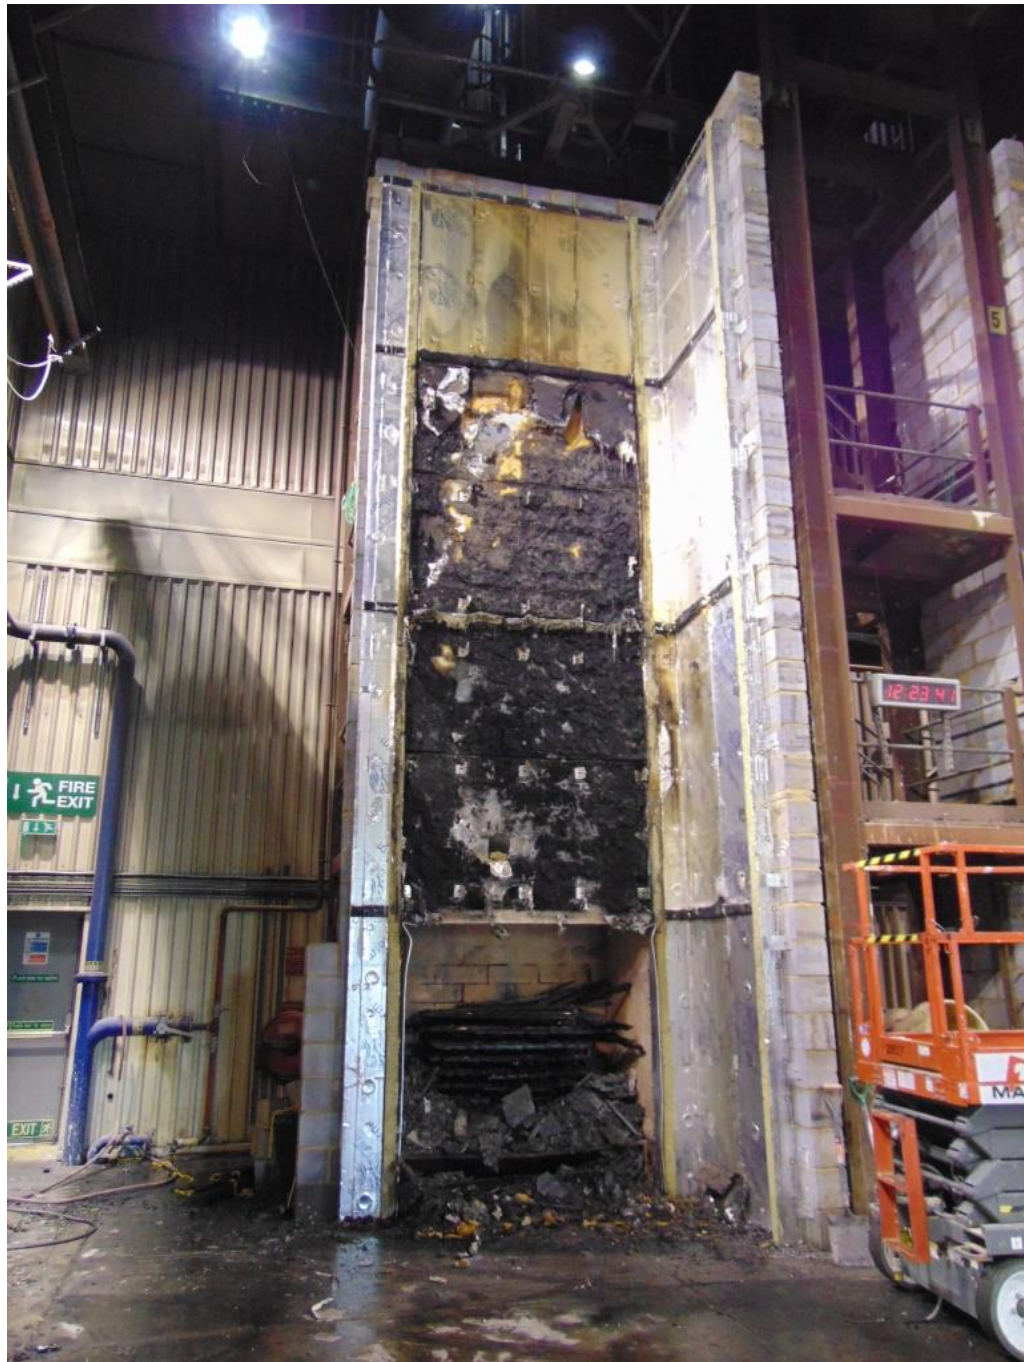
The central aluminium 'T'-shaped rail on the main wall was fully consumed up to a height of approximately 4m. Partial consumption and distortion continued to the top of 2C-2D panel junction.

The 'L'-shaped rails to the left and right of centre on the main wall were fully consumed up to a height of approximately 3.5m. Partial consumption and distortion continued for approximately 500mm.

Figure 16. Full-height photograph of system following removal of ACM panels and aluminium rail substructure.

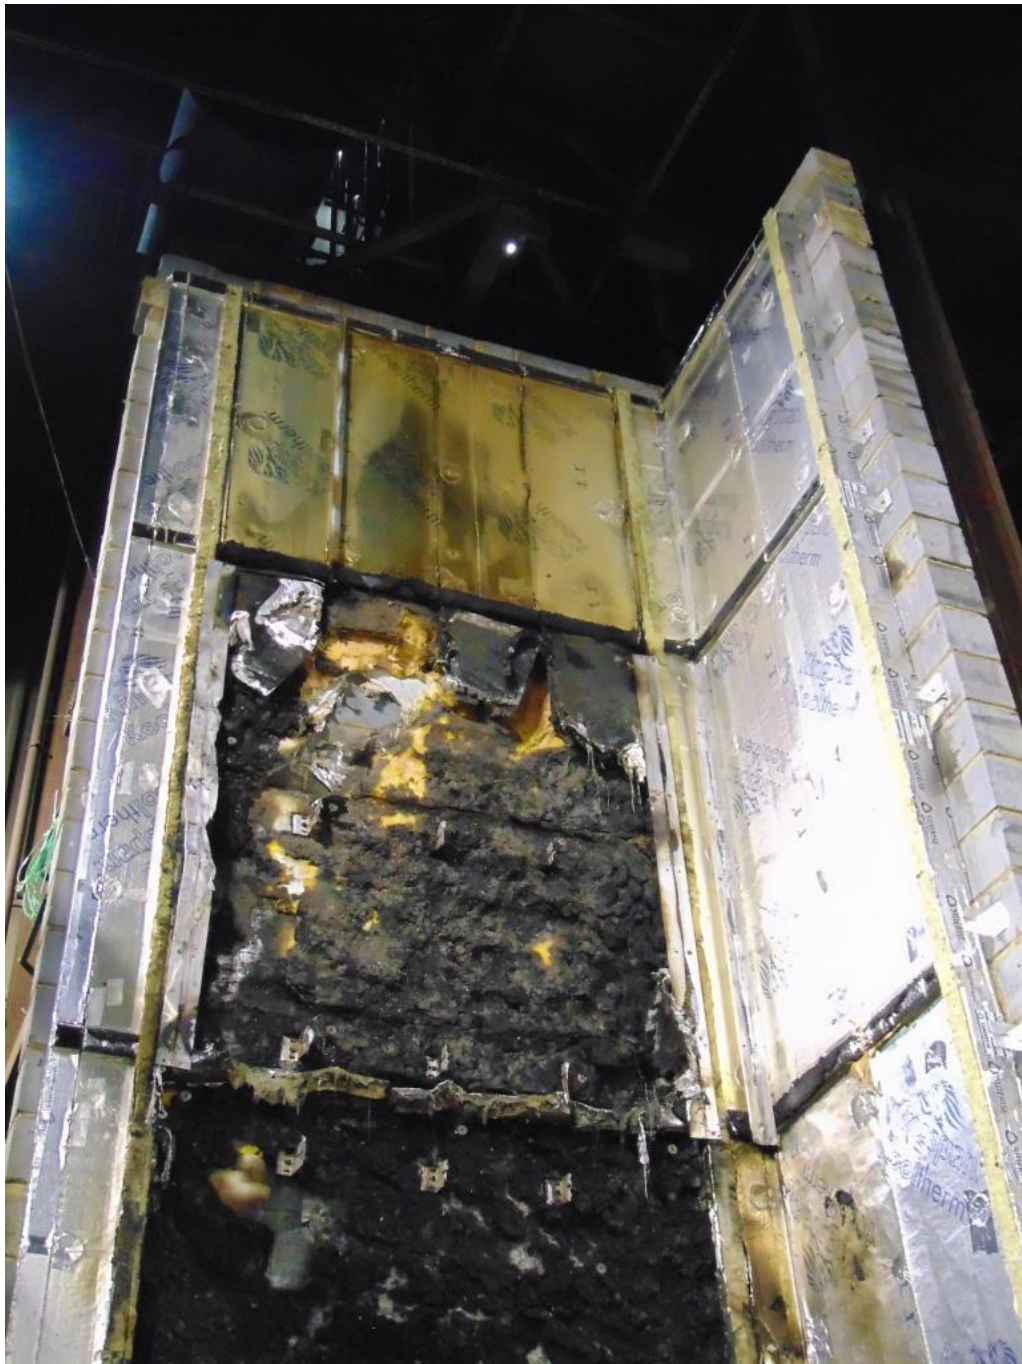
Figure 17. Post-test photo of system following removal of cladding panels.

Note: majority of aluminium rail substructure has been removed.

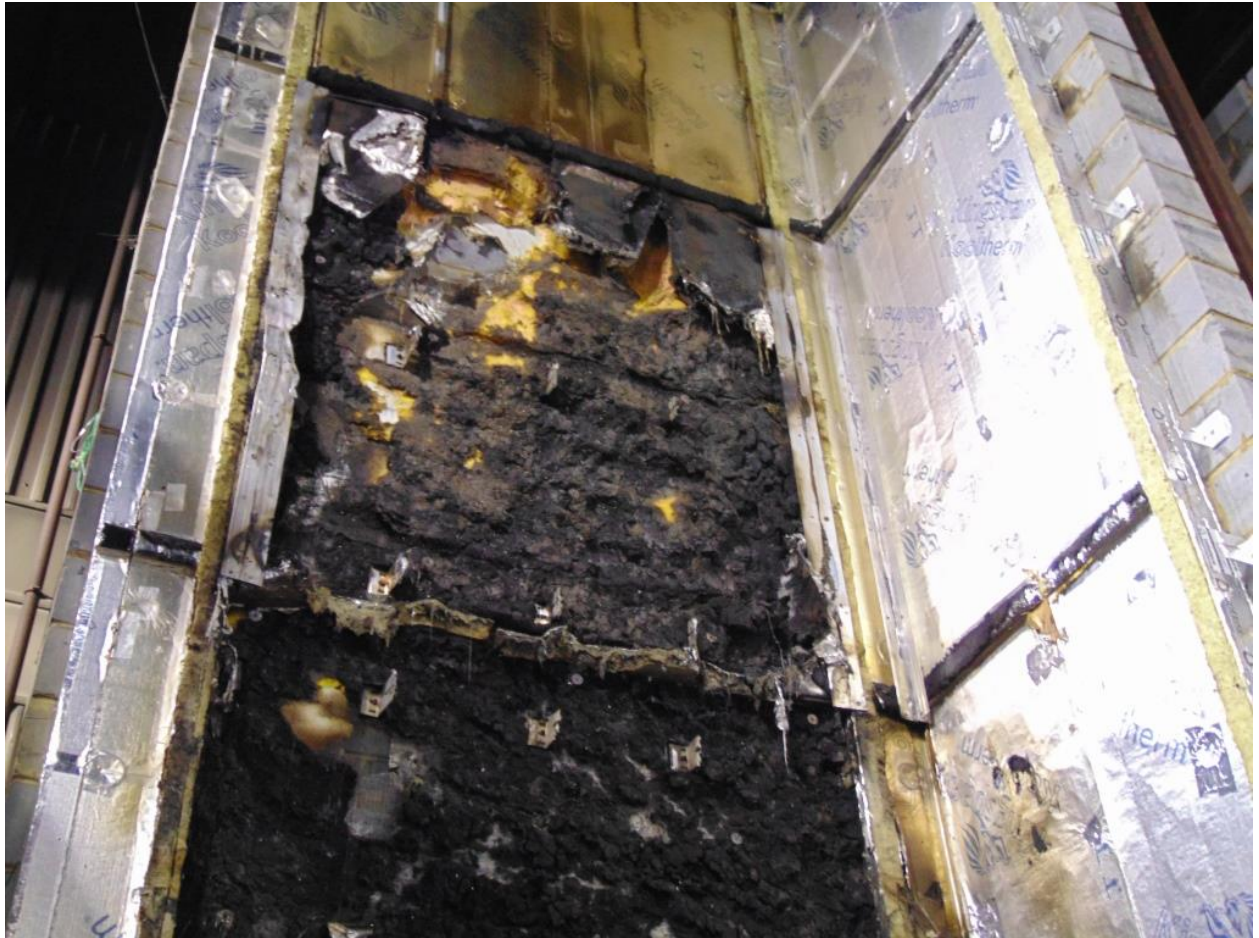
The second row horizontal cavity barrier had activated but was significantly damaged (directly in line with the combustion chamber opening) up the vertical cavity barriers, beyond these there was evidence of activation across the full width of main and wing walls.

Figure 18. Post-test photo between second and third row Siderise RH25G 90/30 horizontal open state cavity barriers.

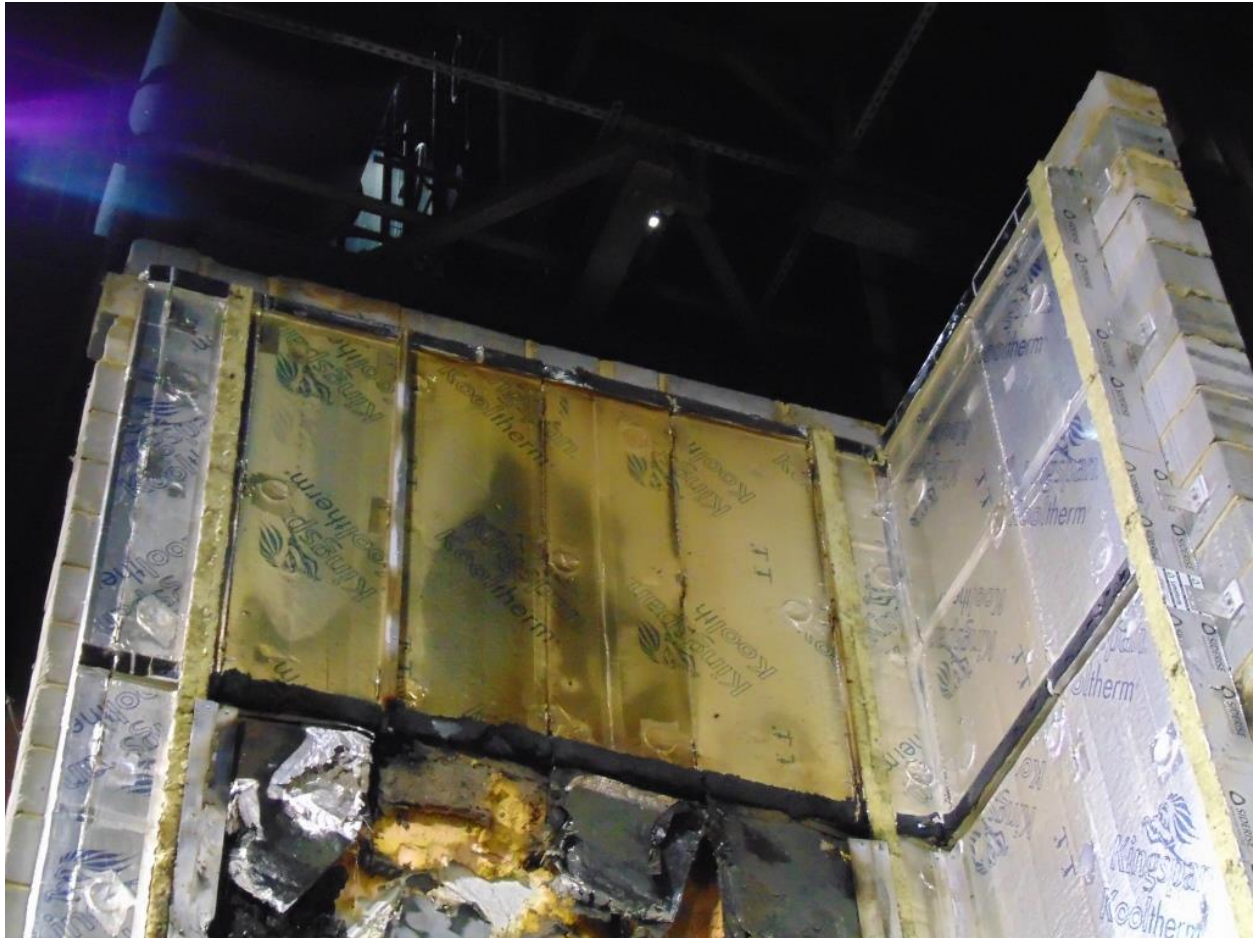
The third row horizontal cavity barrier had fully activated across the central 2000mm-width (directly in line with the combustion chamber opening). Partial activation of the intumescent strip occurred across the wing wall. Evidence of slight heat damage was visible at the outside edge of the main wall.

Figure 19. Post-test photo between third and fourth row Siderise RH25G 90/30 horizontal open state cavity barriers.
