BRE Global Test Report

BS8414-2 : 2005 Test on a Carea Insulated facade system

Date: 14 May 2015

Report Number: 302995 Issue 1

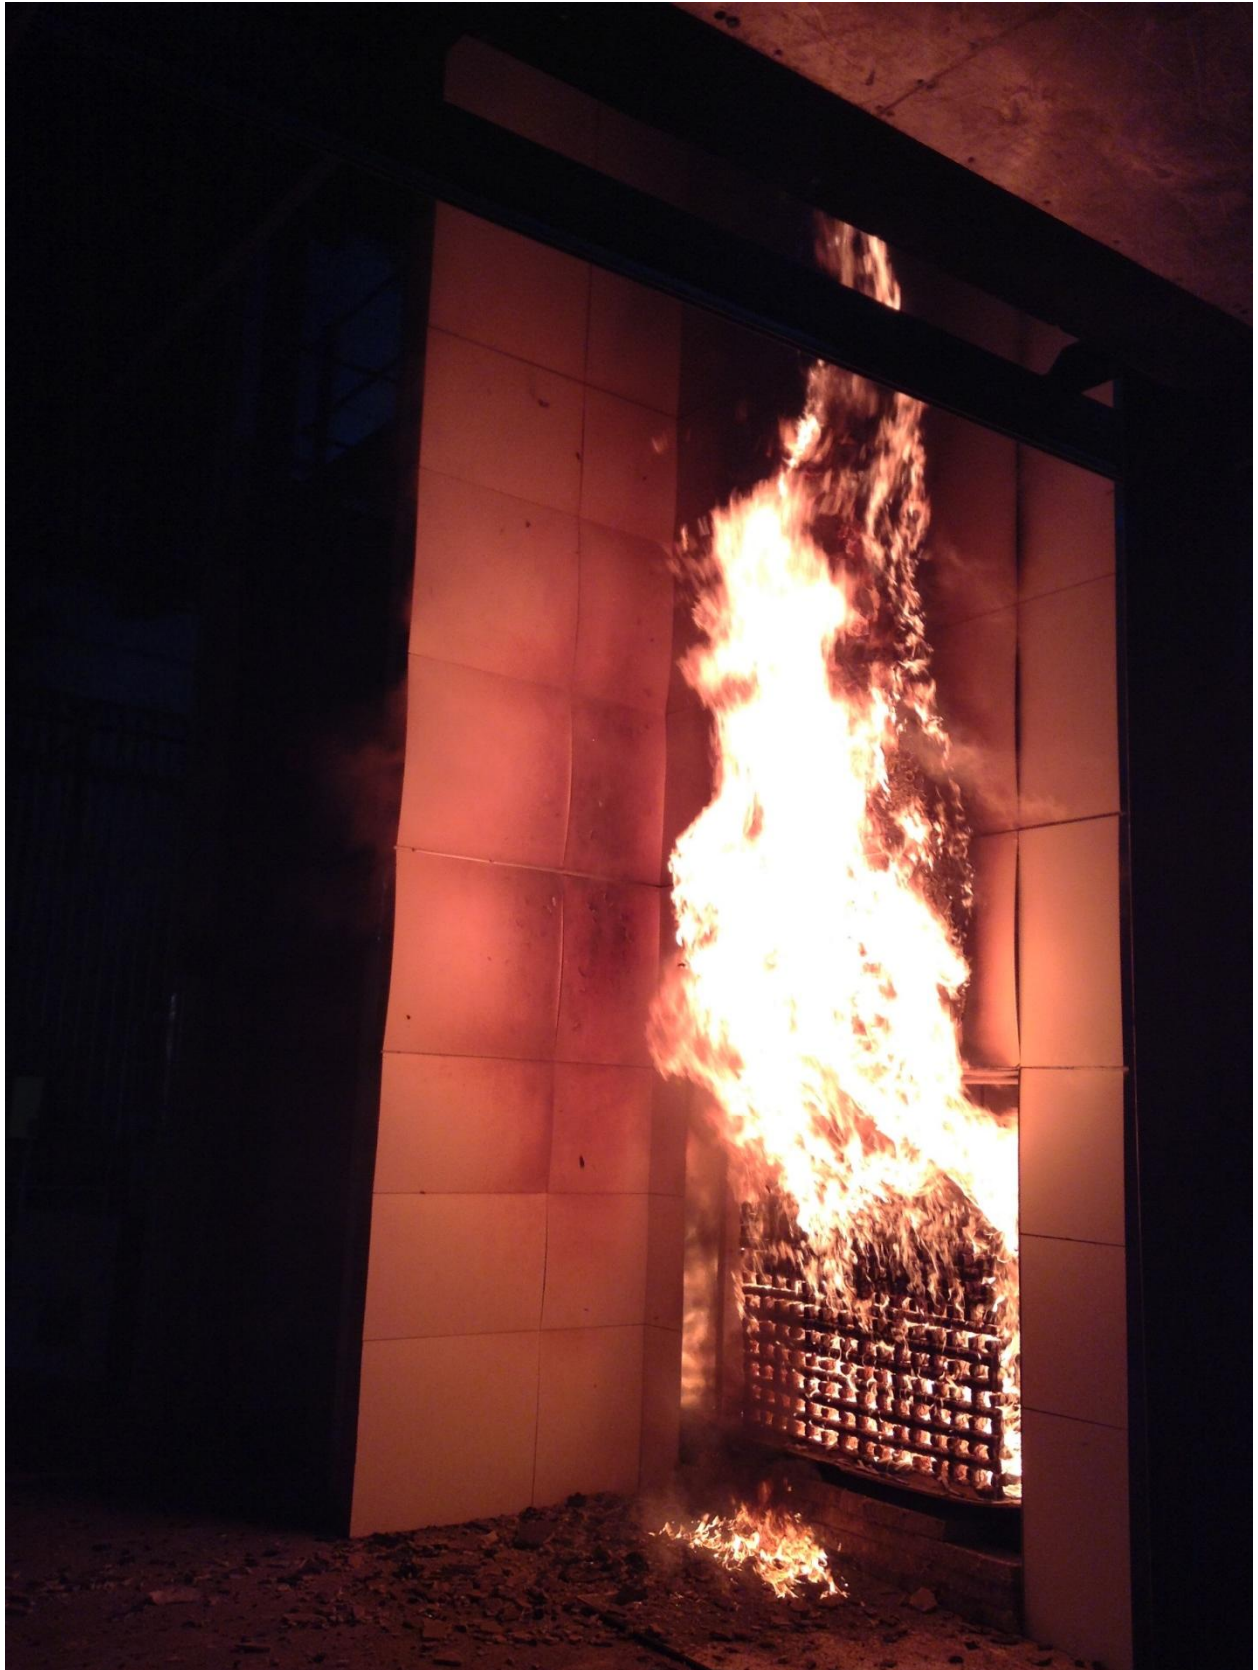
Figure 17. Cladding system during the test.

5:01	Flames to 2.5m cladding wall main face
6:31	Char on cladding wall wing face at 0m corner
7:41	Bowing of panels on left hand side of cl cladding wall main face

9:33	Flames to 3m cladding wall main face additional burning of system in plume area
10:05	10:05 small area of tile away 0 m cladding main face on centreline, flames to 3.5m.

12:20	Panel away. 0m cladding wall main face
13:05	Panel away to 2.5m cladding wall main face. Flames to 4.5m
15:00	Small pool fire (burning debris) lasting 10 seconds plus, smoke from cladding wall wing face.

17:15	Deformed panels at 4m cladding wall main face left hand side cl
19:50	Panels away at 5 m cladding wall main face, with large fire LHS of cladding wall main face (burning debris within 1.2 x 2.4m area)

23:00	Surface flaming on wing face with tile falling way
23:35	Tile away 2m on cladding wall wing face.
33:50	Flames out above barrier at 3m
37:00	Continue to burn left hand side cladding wall main face

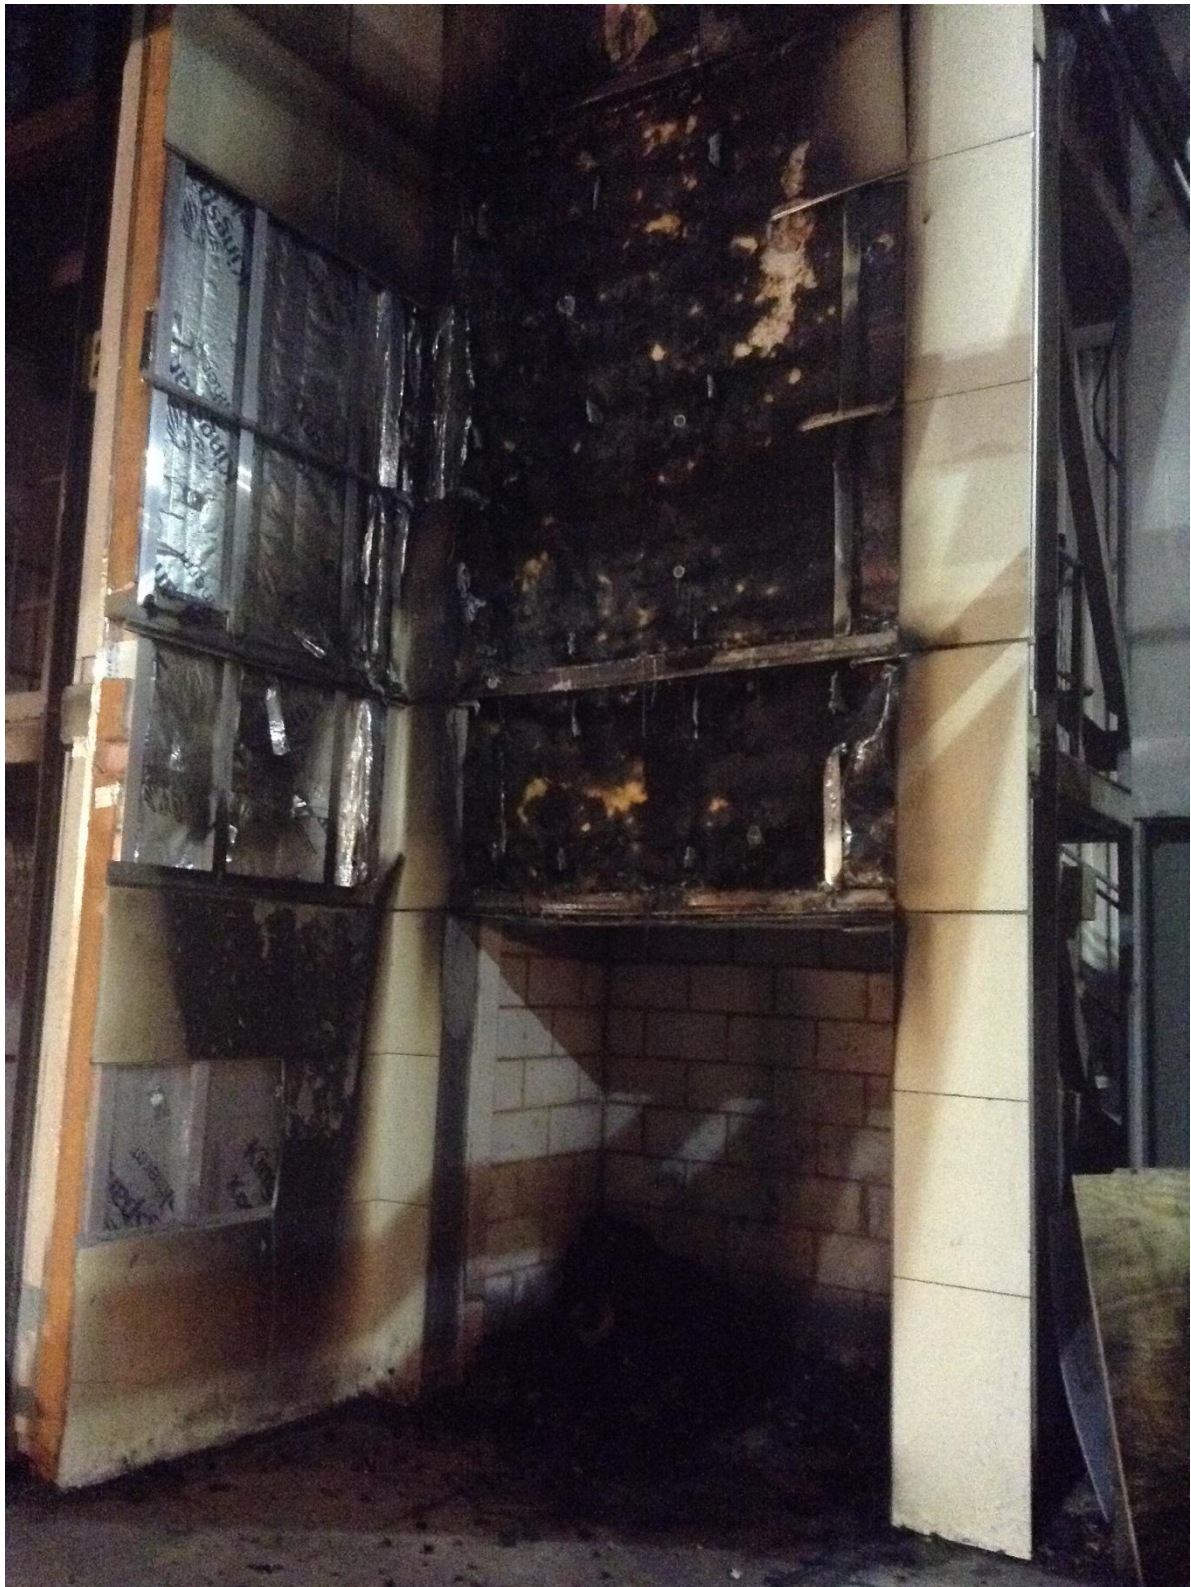
Figure 18. Tested system on completion of the test (1)

Tiles had detached from the system and fallen to the floor at the following locations.

Row 1. Two full tiles and one ½ tile detached. The half tile remained in place in column 4.

Row 2. Two full tiles and one ½ tile detached. The half tile remained in place in column 4.

Row 3. Two full tiles and one ½ tile detached. The half tile remained in place in column 4.

Row 4. Tiles in columns 1, 2 and 3 detached. Tile in column 3 partially detached (but remained on frame).

Row 5. Tiles in columns 1 & 2 detached. Other tiles remained on the frame.

Insulation charred across full width of system up to the level two fire break. All of the foil facing had been burnt away from the insulation. There were areas of unburnt insulation where the char had been removed/ fallen away.

Above the level 2 fire break, the foil facing of the insulation was intact except for an area approximately 900mm x 900mm below the row 5 column 2 tile. Unburnt insulation was visible at this location.

Vertical and horizontal framing on the main wall had melted away up to the level two fire break in the fire plume area.

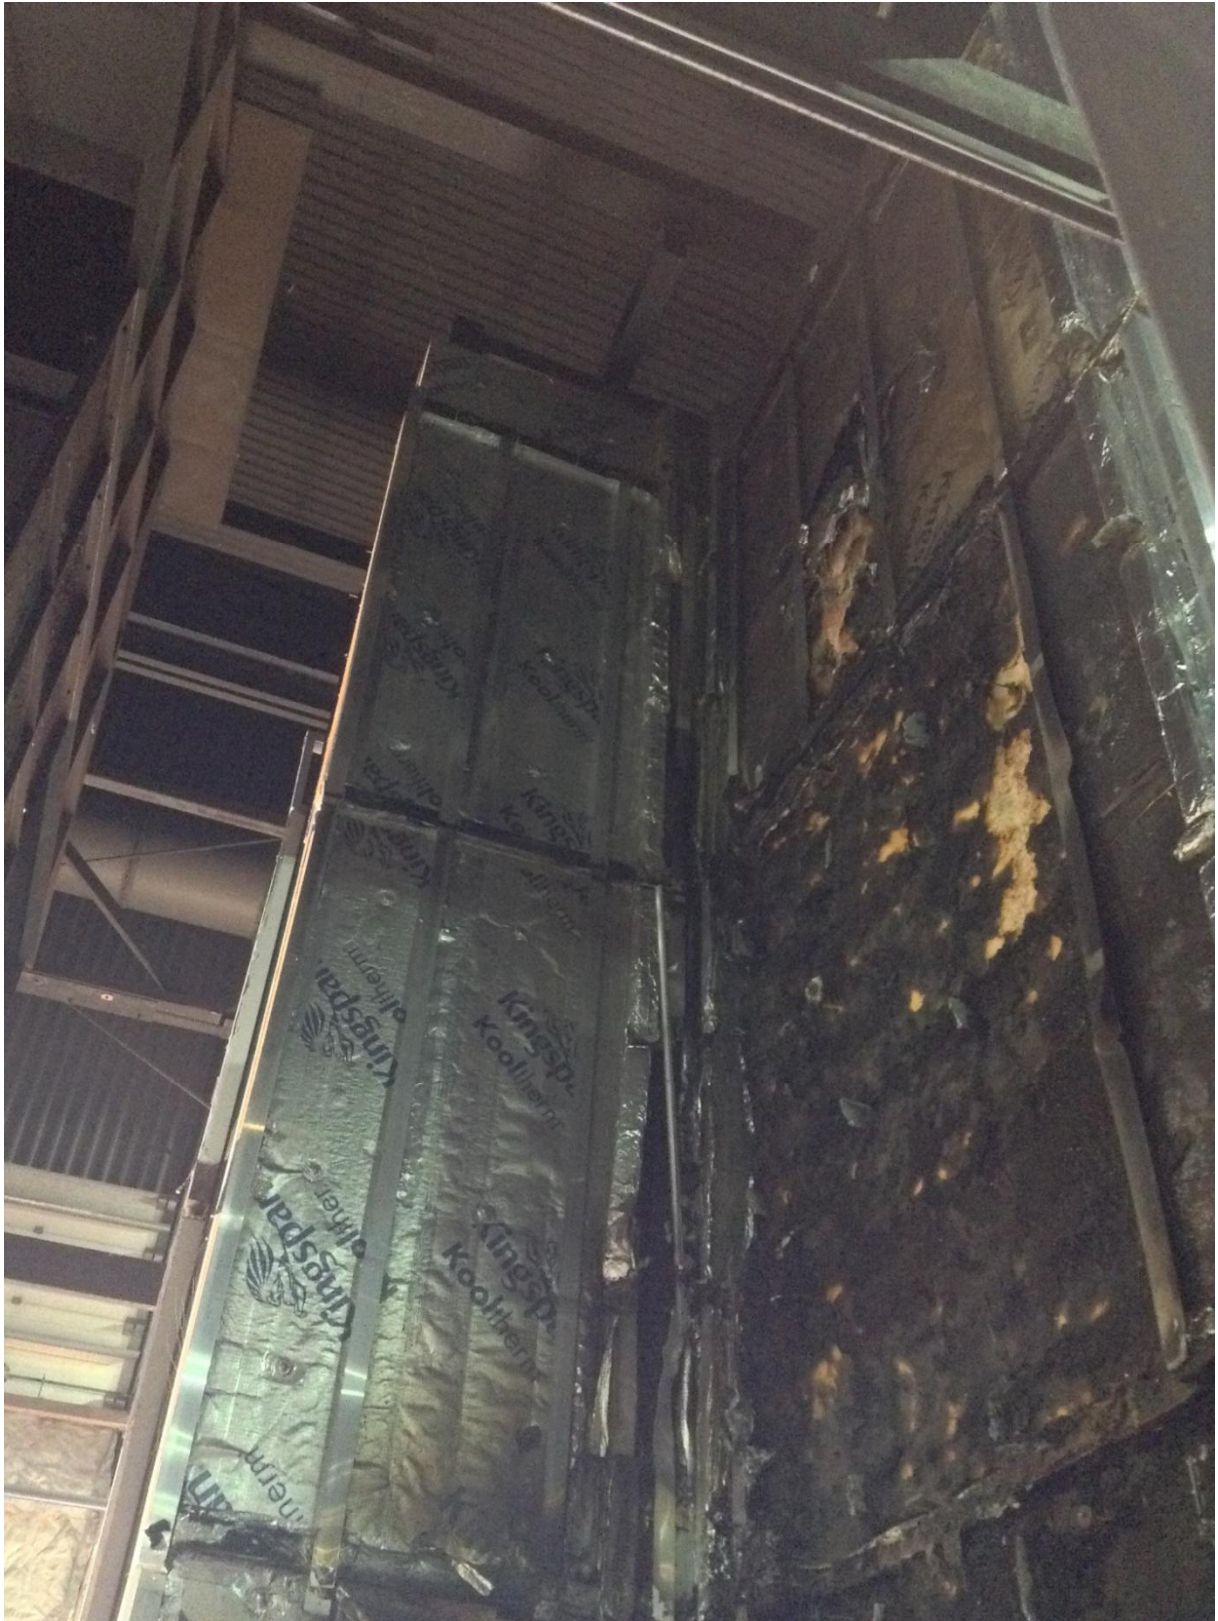
Figure 19. Tested system on completion of the test (2)

Rows 1, 2 and 3. Tiles detached across the full width of system.

Row -1, column 1 tile detached

Foil facing on the insulation was intact to the full height of the system. Some surface heat damage was visible on the foil of the insulation above the hearth.

The framing was intact on the wing wall.
