Fire Performance Testing of an External Cladding System BS 8414-1:2015 + A1:2017

Test Report

Prepared for : Kingspan Insulation Ltd.
Project : System Development
Report No. : DLR1516 Rev.0
Sample : Vitracore G2 Composite Panel With 180mm Rockwool Duo Slab Insulation

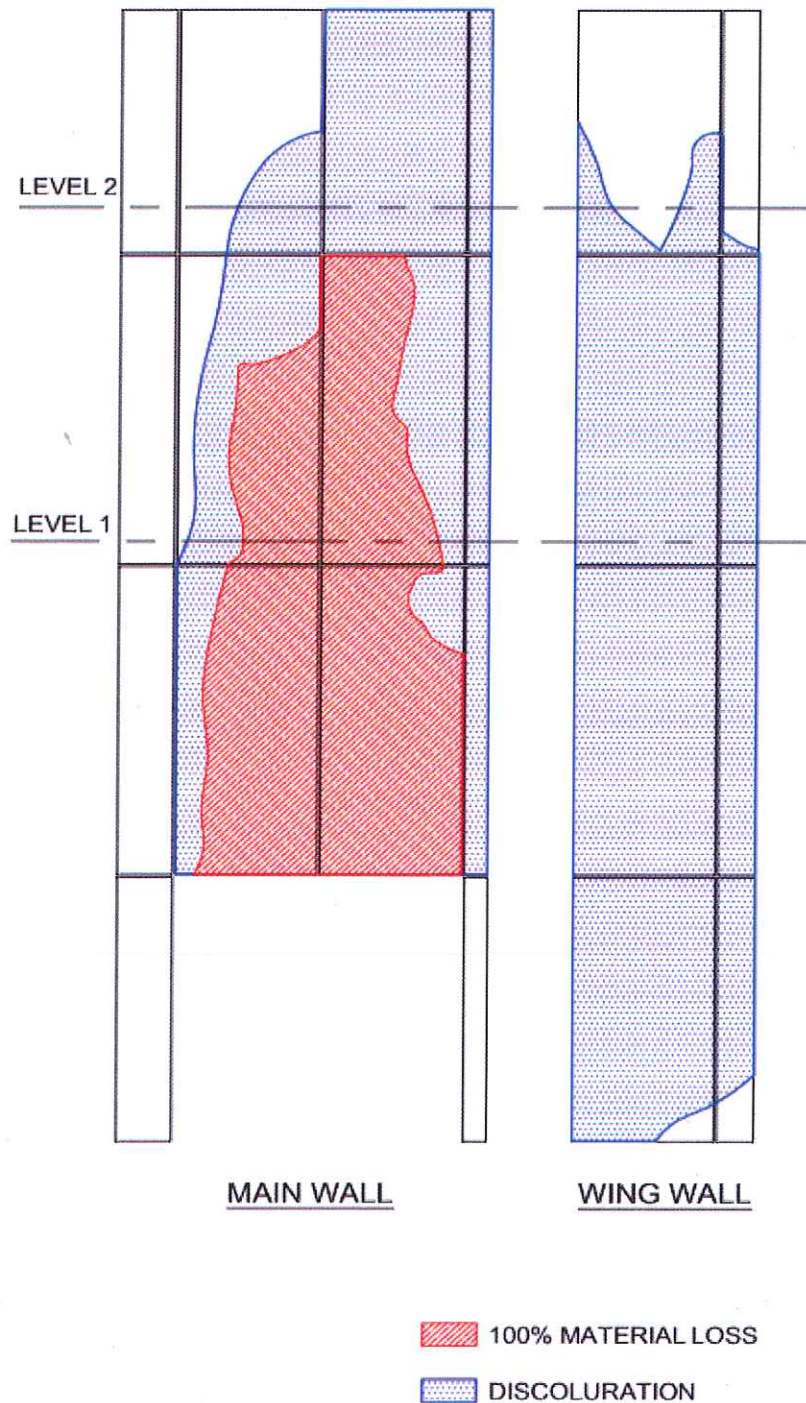
Figure 9 Area Map Showing the Condition of the ACM Panels After the Test

- Approximately 6m² of the total external visible area was completely consumed.
- Approximately 14m² of the total external visible area was discoloured.

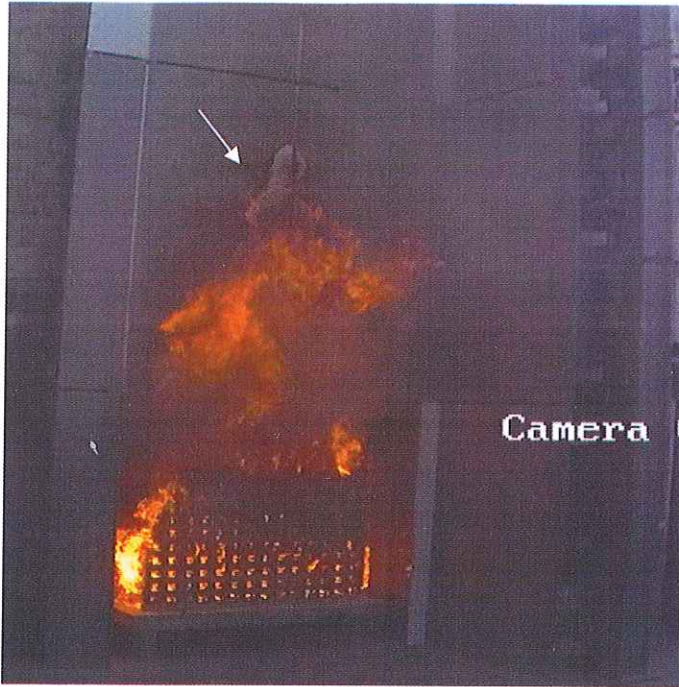
06:09:46	42	Coating of panels M4 and M5 started peeling off.	DLP C2753H/0001
06:10:40	96	Coating of panels M8 and M9 started peeling off.	-
06:11:56	172	Approximately 50% of coating of panels M4 & M5 burned.	-

Coating of panels M4 & M5 started peeling off.

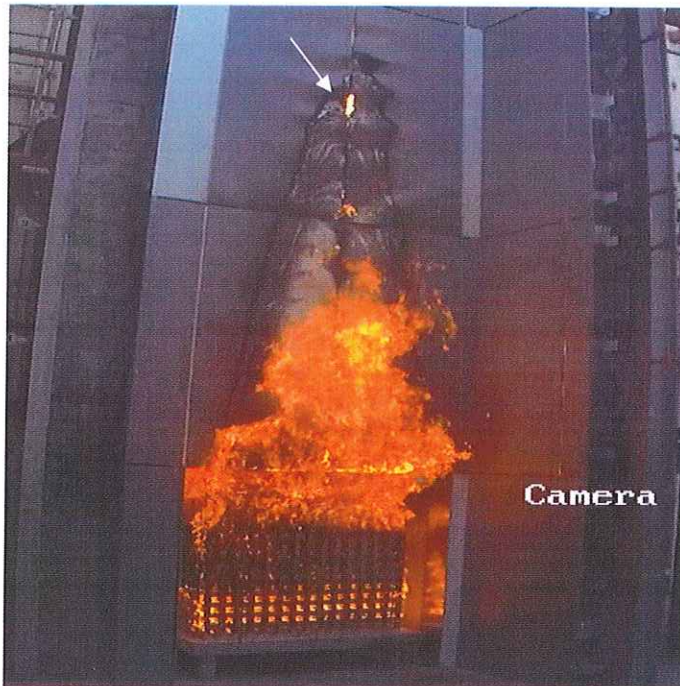
06:12:46	222	Sustained flame on panels M8 and M9 vertical joint.	DLP C2753H/0002
06:13:48	284	Top aluminium skin of panels M4 and M5 melting.	-
06:14:21	317	Coating of panels W3 started peeling off	-

Sustained flame on panels M8 & M9 vertical joint.

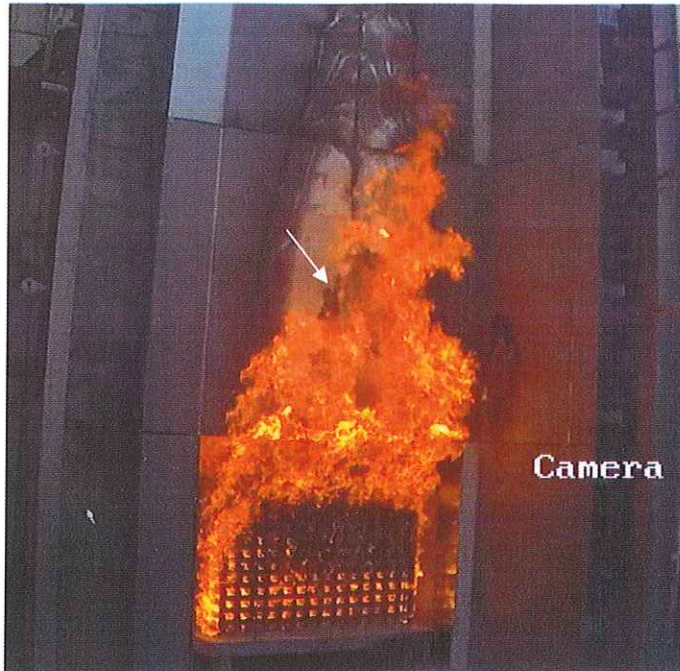
06:14:47	343	Panels M4 and M5 partially melted and insulation burning.	DLP C2753H/0003
06:15:48	404	Debris of panel M4 fell off.	-
06:16:08	424	Insulation behind the panel M9 burning.	DLP C2753H/0004

Panels M4 & M5 partially melted and insulation burning.

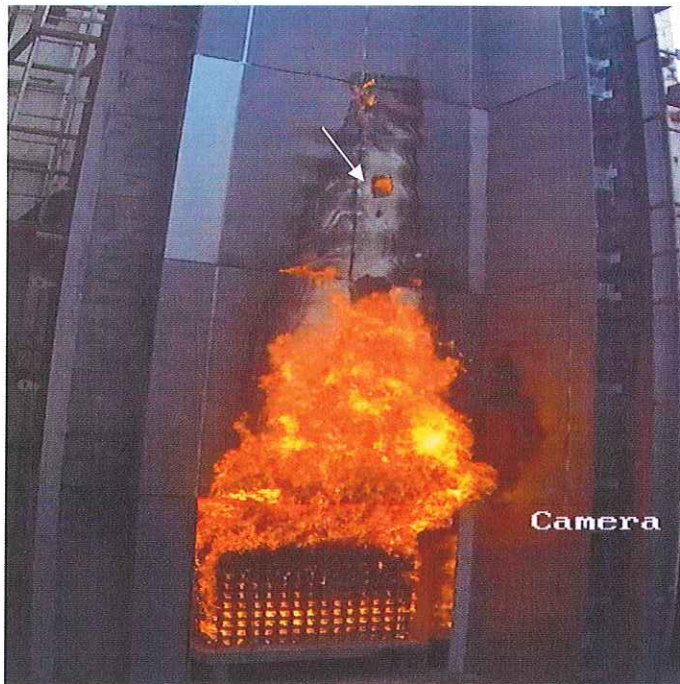
DLP C2753H/0004

Insulation behind the panel M9 burning.

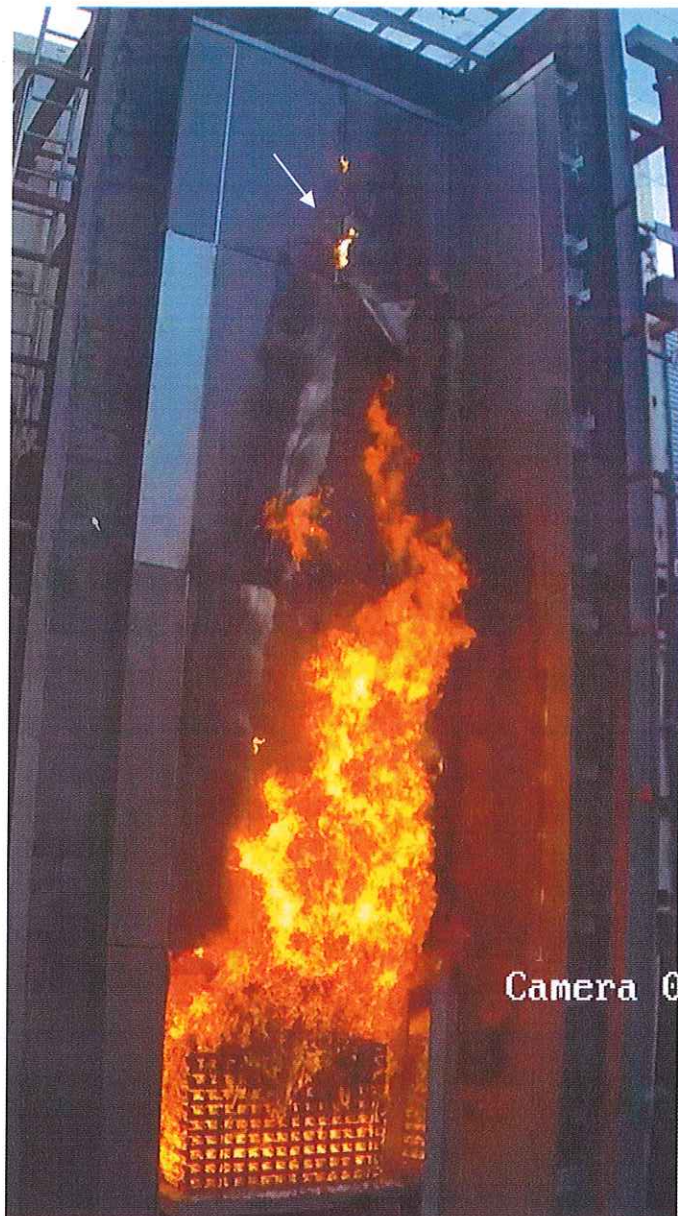
06:18:56	592	Discolouration on panel W5.	-
06:19:46	642	Panel M9 partially melted and insulation burning.	-
06:21:12	728	Self-sustained flame on panels M12 and M13 vertical joint.	DLP C2753H/0005

Self-sustained flame on panels M12 & M13 vertical joint.

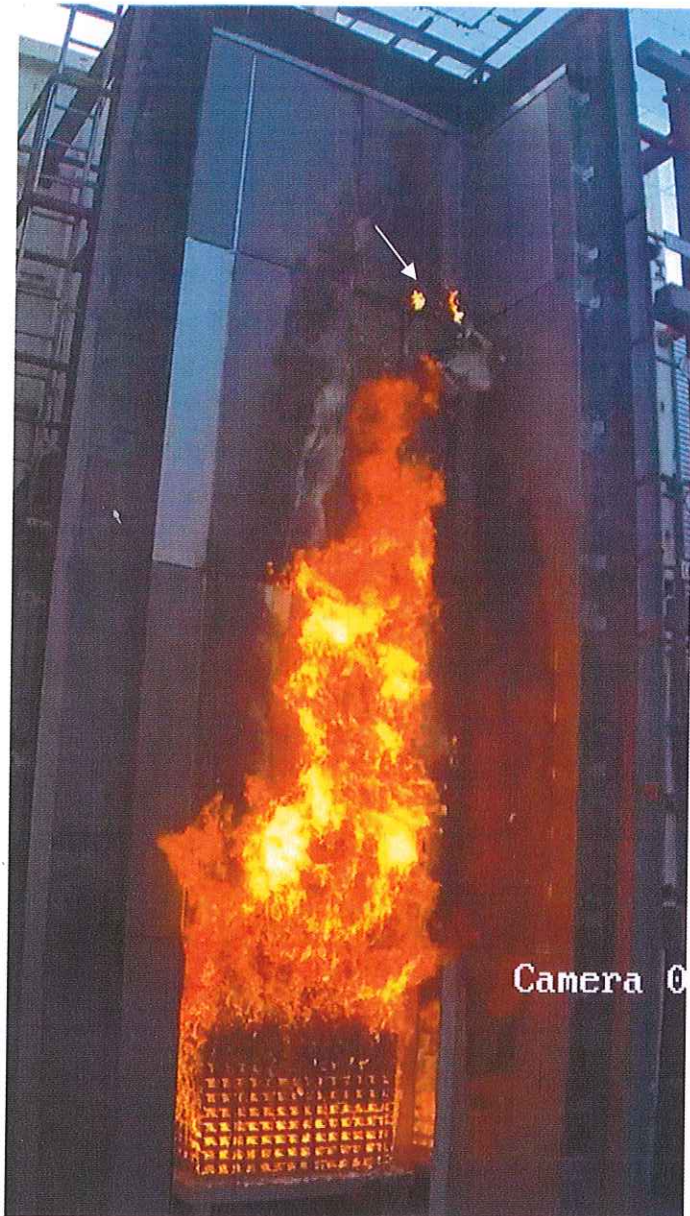
06:21:25	741	Horizontal cavity barrier behind the panels M9 & M10 burning.	DLP C2753H/0006
06:22:12	788	Self-sustained flame on panels W3 and W4 vertical joint.	-

DLP C2753H/0006 Horizontal cavity barrier behind the panels M9 & M10 burning.

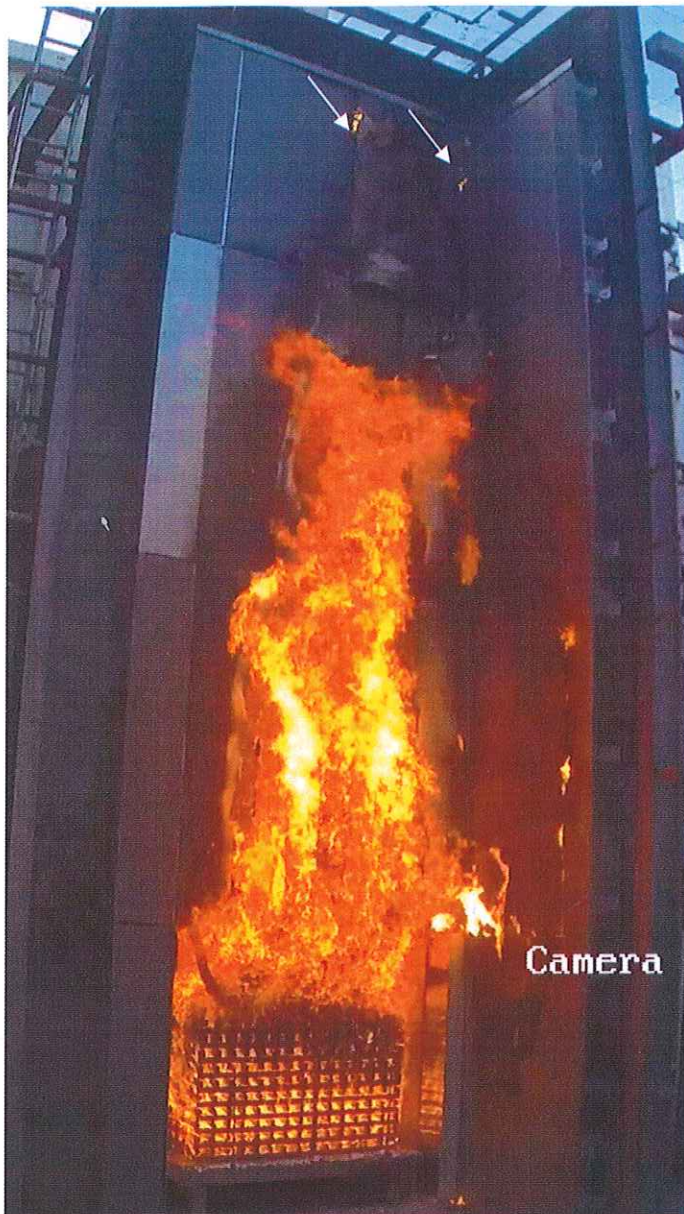
Time	Seconds	Observation	Photo Reference
06:23:03	839	Sporadic flame on panels M12, M13 and M14 vertical joints.	DLP C2753H/0007
06:23:14	850	High intensity sustained flames on panels W1, W2, W3 & W4 joints.	DLP C2753H/0008
06:24:36	932	Approximately 85% of panels M4 and M5 melted.	-
06:25:48	1004	Self-sustained flame on panels W5 and W6 vertical joint.	-
06:28:50	1186	Flame behind the panel W5.	-
06:36:19	1635	The heat source was extinguished, observation continued for another 30 minutes.	-
06:40:09	1865	All visible flames ceased. Temperature dropped.	-
07:06:19	3435	Test was terminated 60min after the ignition.	-

DLP C2753H/0007 Sporadic flame on panels M12, M13 & M14 vertical joints.

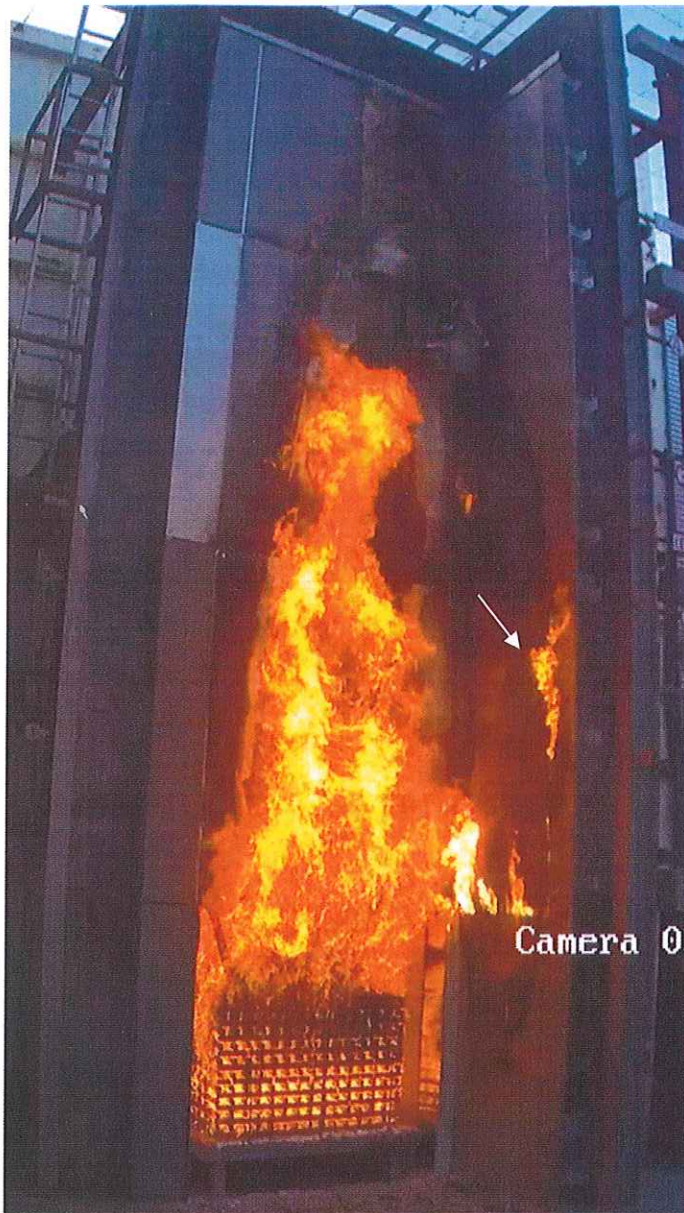
DLP C2753H/0008

High intensity sustained flames on panels W1, W2, W3 & W4 joints.

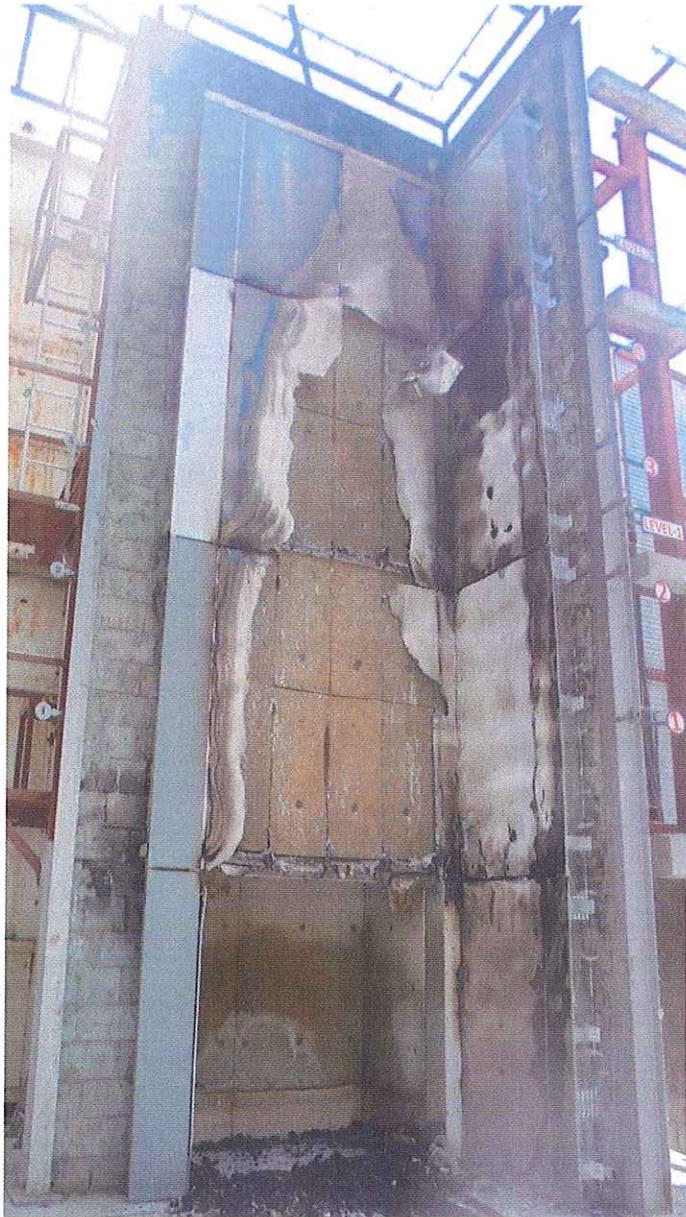
DLP C2753H/0009

Sl. No.	Components	Observation	Photo Reference
1	Aluminium composite panels	<p>Panels M1 & M11–No significant changes to the panels.</p> <p>Panels M2, M6, M10 & M14– 100% discolouration of the panels.</p> <p>Panels M3 & M7 - Minor discolouration was observed at the edge. No other damage was observed</p> <p>Panels M4 & M5 – Approximately 90% of the panel was consumed and remaining area was discoloured and buckled.</p> <p>Panels M6, M10, M12 & M13 – No material loss on the panels. Discoloration was observed.</p> <p>Panels M8 & M9 - Approximately 50% of the panel was consumed and remaining area was discoloured and buckled.</p> <p>Panel M12 - Approximately 20% of the top coating of panel was burned. Discolouration observed on the remaining areas.</p> <p>Panel M13 - Approximately 80% of the top coating of panel was burned. Discolouration observed on the remaining areas.</p> <p>Panels W1, W2, W3, W4, W5 & W6 – 100% discolouration on the panels. Minor material loss observed.</p> <p>Panels W7 and W8- No material loss on the panels. Discoloration observed.</p>	<p>DLP C2753H/0009</p> <p>See Figure 9 in this section for the damaged areas.</p>

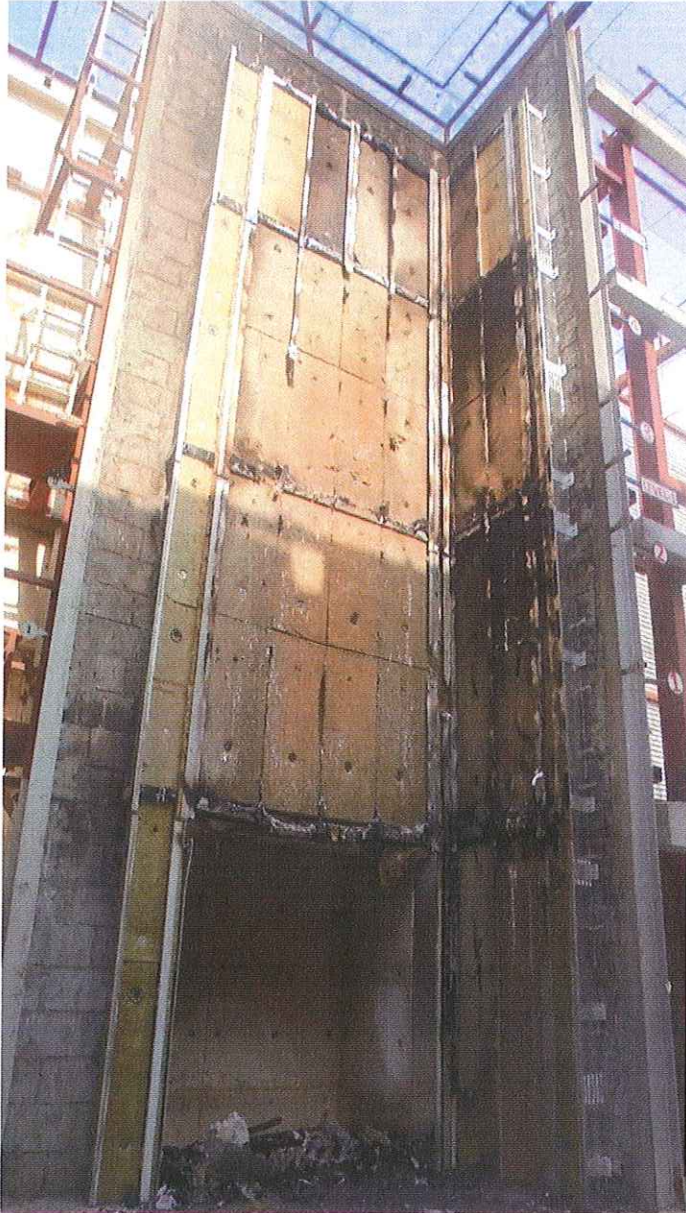
DLP C2753H/0010

2	Cavity barrier	<p>Horizontal intumescent cavity barrier:</p> <p>Main wall:</p> <p>The 1st horizontal cavity barrier at 75mm above the combustion chamber was activated except the cavity behind M3. Material loss and damage was observed.</p> <p>The 2nd horizontal cavity barrier at 2425mm above the combustion chamber was activated except the cavity behind M7. Material loss and damage was observed.</p>	<p>DLP C2753H/0010, DLP C2753H/0012, DLP C2753H/0013, DLP C2753H/0014, & DLP C2753H/0015.</p>

3	180mm Rockwool Duo Slab insulation	<p>All the insulation was in place.</p> <p>Discolouration and minor damage to the rock wool insulations on the main wall and wing wall was observed.</p>	DLP C2753H/0010, DLP C2753H/0011, & DLP C2753H/0015
4	Railing	<p>All railings behind panels M4, M5, M8 & M9 were melted off. Railings behind panels M2, M6, M10, M12, M13 & M14 were discoloured and buckled.</p> <p>All other railings were in place and no damage was observed.</p>	DLP C2753H/0014 & DLP C2753H/0015
5	Brackets	<p>All other brackets were intact. Minor damage and discolouration was observed.</p>	DLP C2753H/0011
