BRE Global Classification Report

Kingspan Insulation Limited Classification of fire performance in accordance with BR 135: 2013 Annex B

Report Number: P109938-1001 Issue: 1

Product name: Alpolic A2 ACM panels with 100mm-thick Kingspan Kooltherm insulation

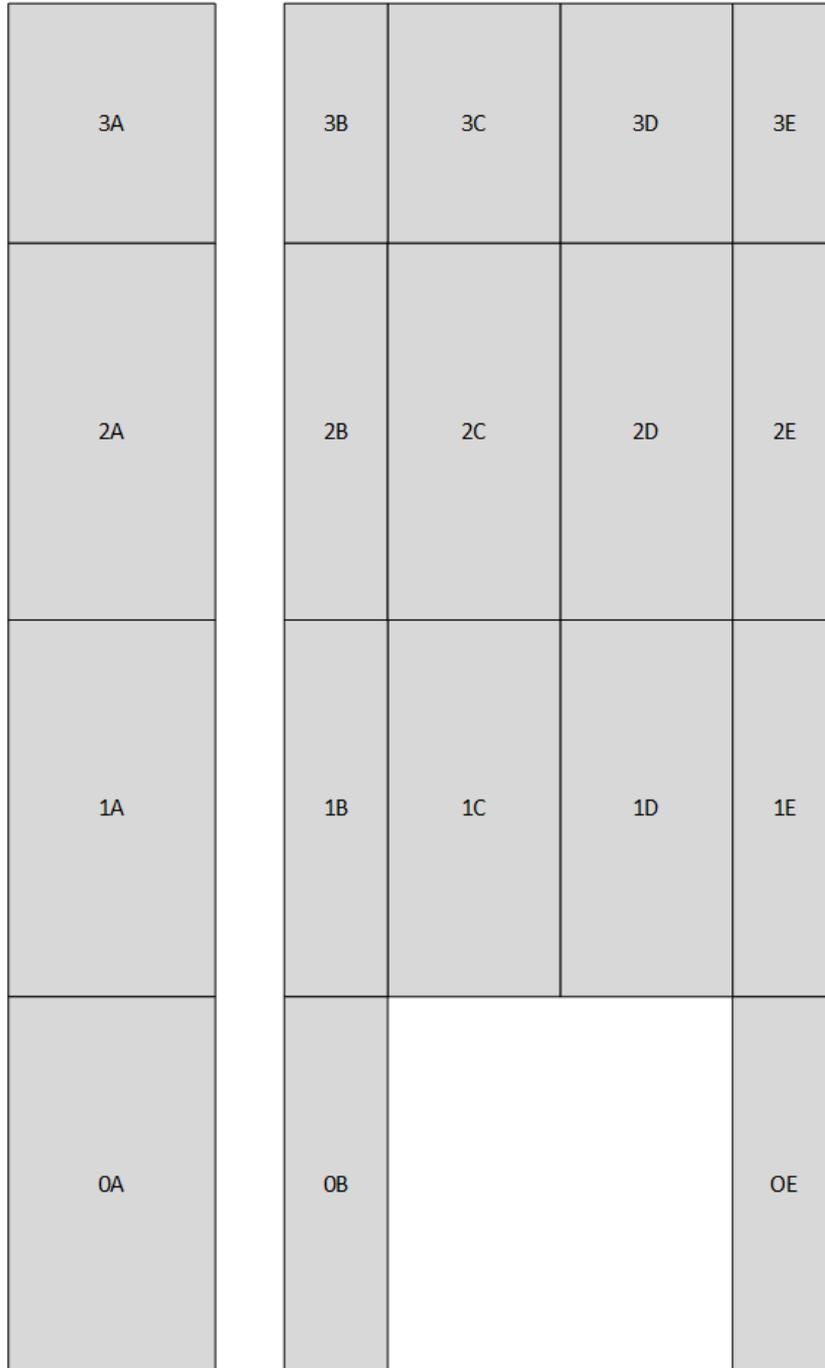
Figure 1. Layout of panels and numbering system used for reporting. Not to scale.

With reference to *Figure 1* the damage to the ACM panels was as follows:

Panel 0A – 70% of coating removed and 20% dark discolouration and panel distorted.

Panel 0B – Intact and in place with distortion across panel.

Panel 0E – dark discoloration at top left-hand corner, no visible damage across the rest of the panel.

Panel 1A – 70% coating removed and 20% dark discolouration, panel distorted.

Panel 1B – 90% dark discolouration with distortion.

Panel 1C – 80% consumed. 80% of coating removed and 20% dark discolouration on the remainder of the panel.

Panel 1D – 80% consumed. 60% of coating removed and 30% dark discolouration on the remainder of the panel.

Panel 1E – localised areas of dark discolouration with minor distortion across the panel.

Panel 2A – 30% dark discolouration with distortion across the panel.

Panel 2B – dark discolouration at bottom left-hand corner. Distortion across panel.

Panel 2C – 40% consumed. 60% of coating removed and 20% dark discolouration on the remainder of the panel.

Panel 2D – 40% consumed. 40% coating removed and 20% dark discolouration on the remainder of the panel.

Panel 2E – dark discolouration at bottom left-hand corner. Minor distortion across panel.

Panel 3A – intact and in place. Slight distortion.

Panel 3B – intact and in place. Slight distortion.

Panel 3C – slight consumption at base of panel (<0.01m²). 30% dark discolouration and 10% of coating removed.

Panel 3D – 20% dark discolouration with 10% of coating removed. Heavy distortion at base with slight distortion throughout panel.

Panel 3E – no visible damage.
