## **FIRE PERFORMANCE OF EXTERNAL THERMAL INSULATION - CLASSIFICATION REPORT No EUI-18-000081A**

**System name:** Dri-Design with K-Roc Rainscreen Slab

**Classification report No.:** EUI-18-000081A

**Date of issue:** 18 April 2019

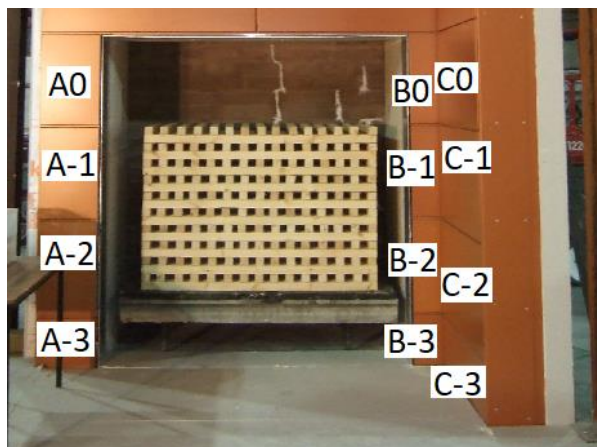
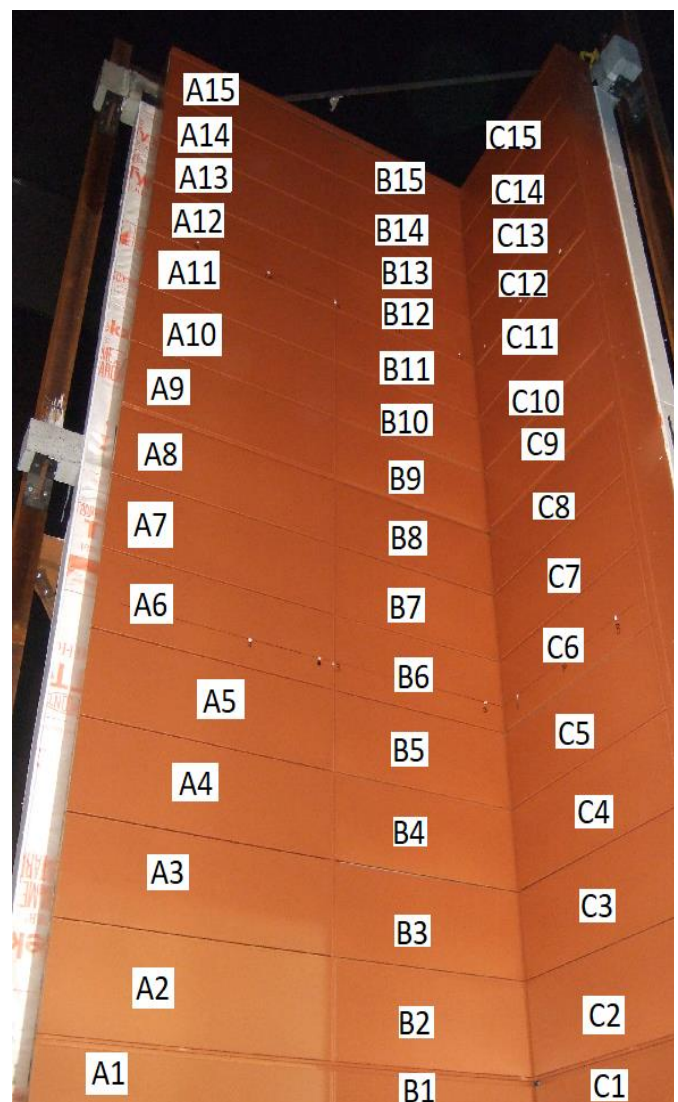
Figure 1. System photos before testing for reference of identified area parts.
