# BRE Global Test Report

**BS 8414-1:2015 + A1:2017 Test on Eternit Equitone Natura panel ventilated rainscreen system with Kingspan K15 insulation.**

**Prepared for:** Kingspan Insulation  
**Date:** 7<sup>th</sup> February 2020  
**Report Number:** P114679-1000 **Issue:** 1

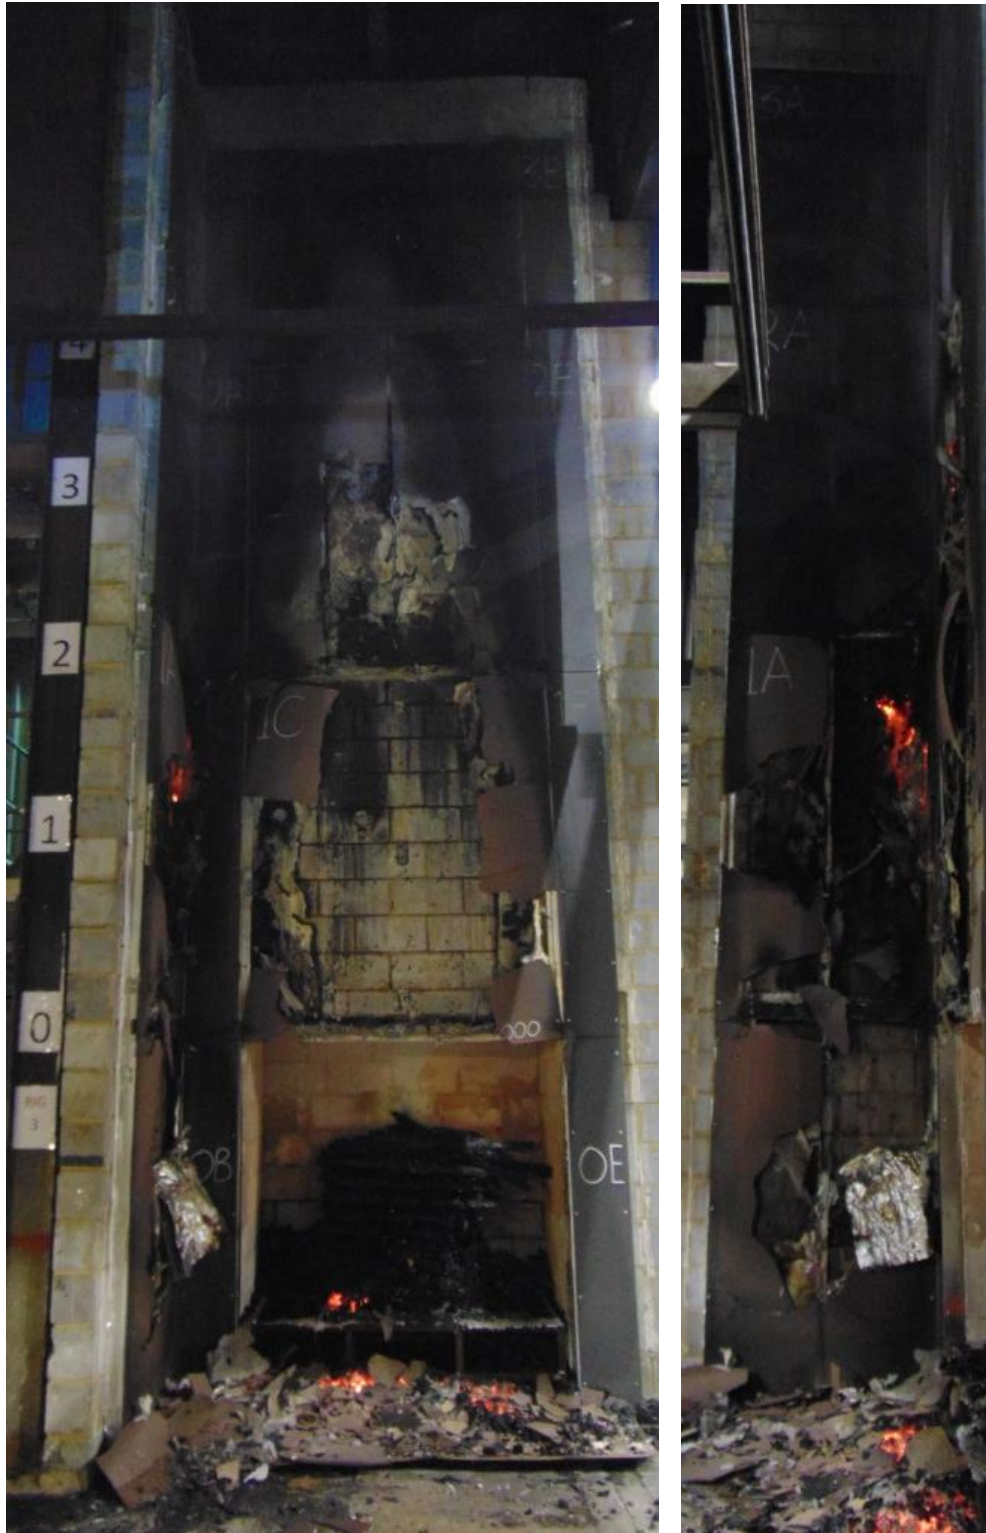
Figure 18. Full-height photograph of cladding system immediately after test.

On the main wall, the panels had fallen/burnt away exposing an area of approx. 1.2m-wide×3.9m-high (approx. 4.7m<sup>2</sup>) above the combustion chamber opening. The surfaces of the panels were cracked up to 4.6m and discoloured up to 5.5m above the combustion chamber opening.

On the wing wall, the panels had fallen/burnt away exposing an area of approx. 0.9m-wide×4.4m-high (approx. 4.0m<sup>2</sup>) from ground. The panels were discoloured up to approx. 3.5m-high covering the full width of the panels from ground with panels discoloured further along the main-wing wall up to approx. 6.6m.

See *Figure 18*.

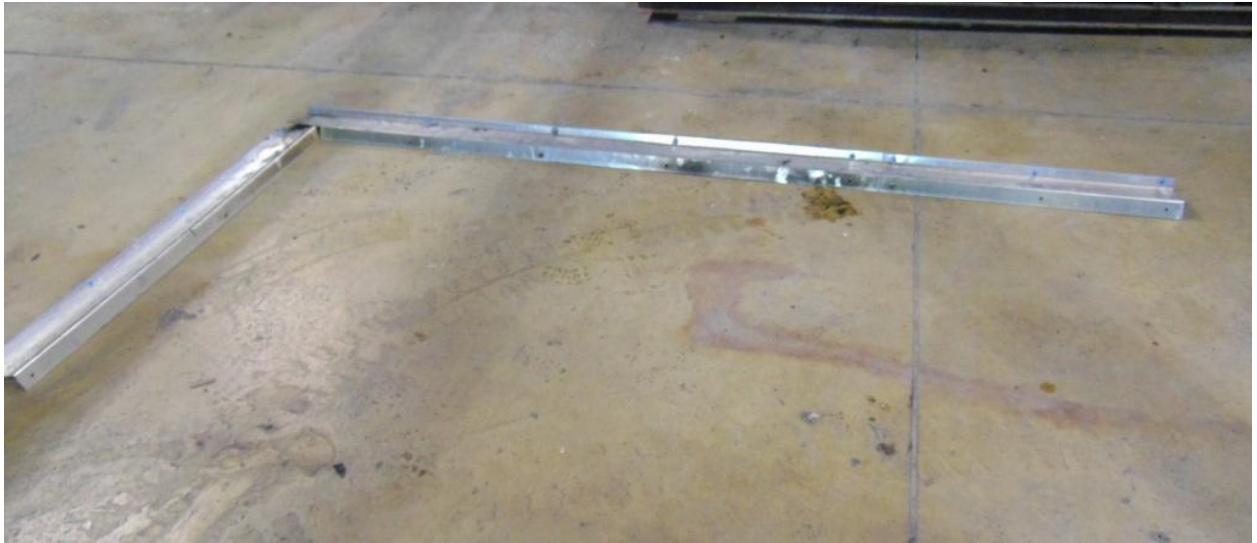
Figure 19. Capping at the top of the system.

On the main wall, the capping was discoloured to full width. On the wing wall, the capping was discoloured on main-wing junction. See *Figure 19*.

The combustion chamber surround pod top edge was consumed approx. 1.5m-wide. The vertical edges were distorted and discoloured.

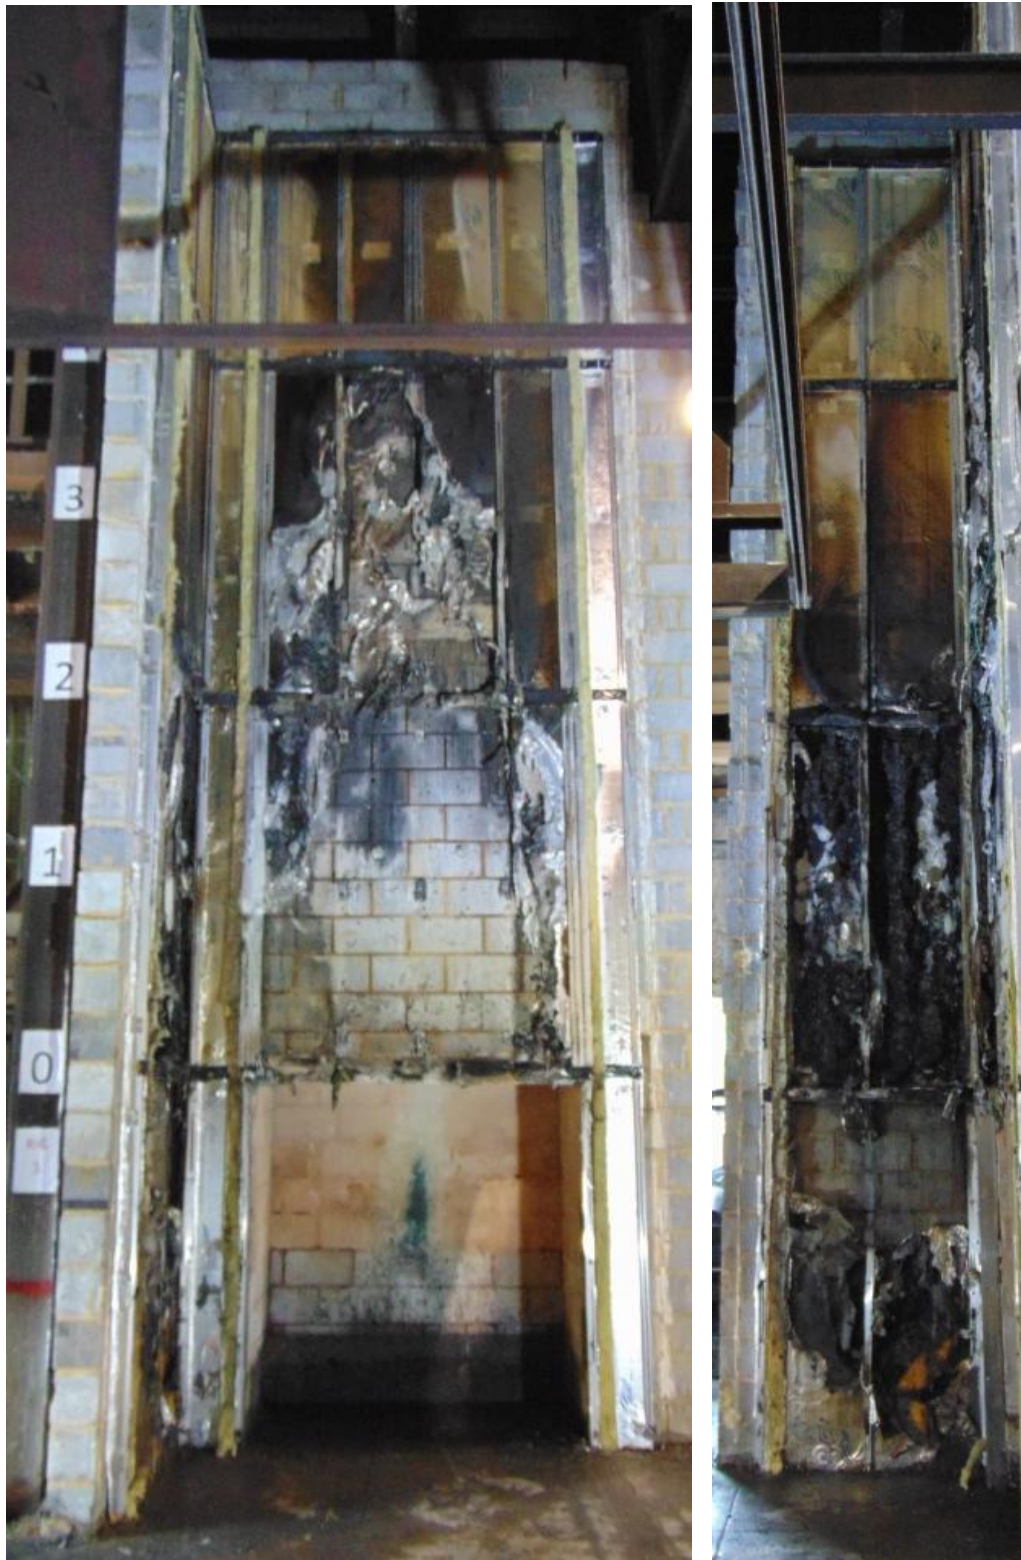
Figure 20. Post-test photograph following removal of panels.

On the main wall, the rail in line with the combustion chamber centre line was consumed to 6.7 from ground. The rails either side of the centre rail were consumed up to 5m and 4.m respectively. All rails up to 7m from ground were distorted between both vertical cavity barriers. The rails were discoloured between both vertical cavity barriers up to the top of the system.

On the wing wall, the central rail had consumed sections up to 2.8m. The rails were distorted to 4.4m and discoloured to 7m from ground.

See *Figure 20*.

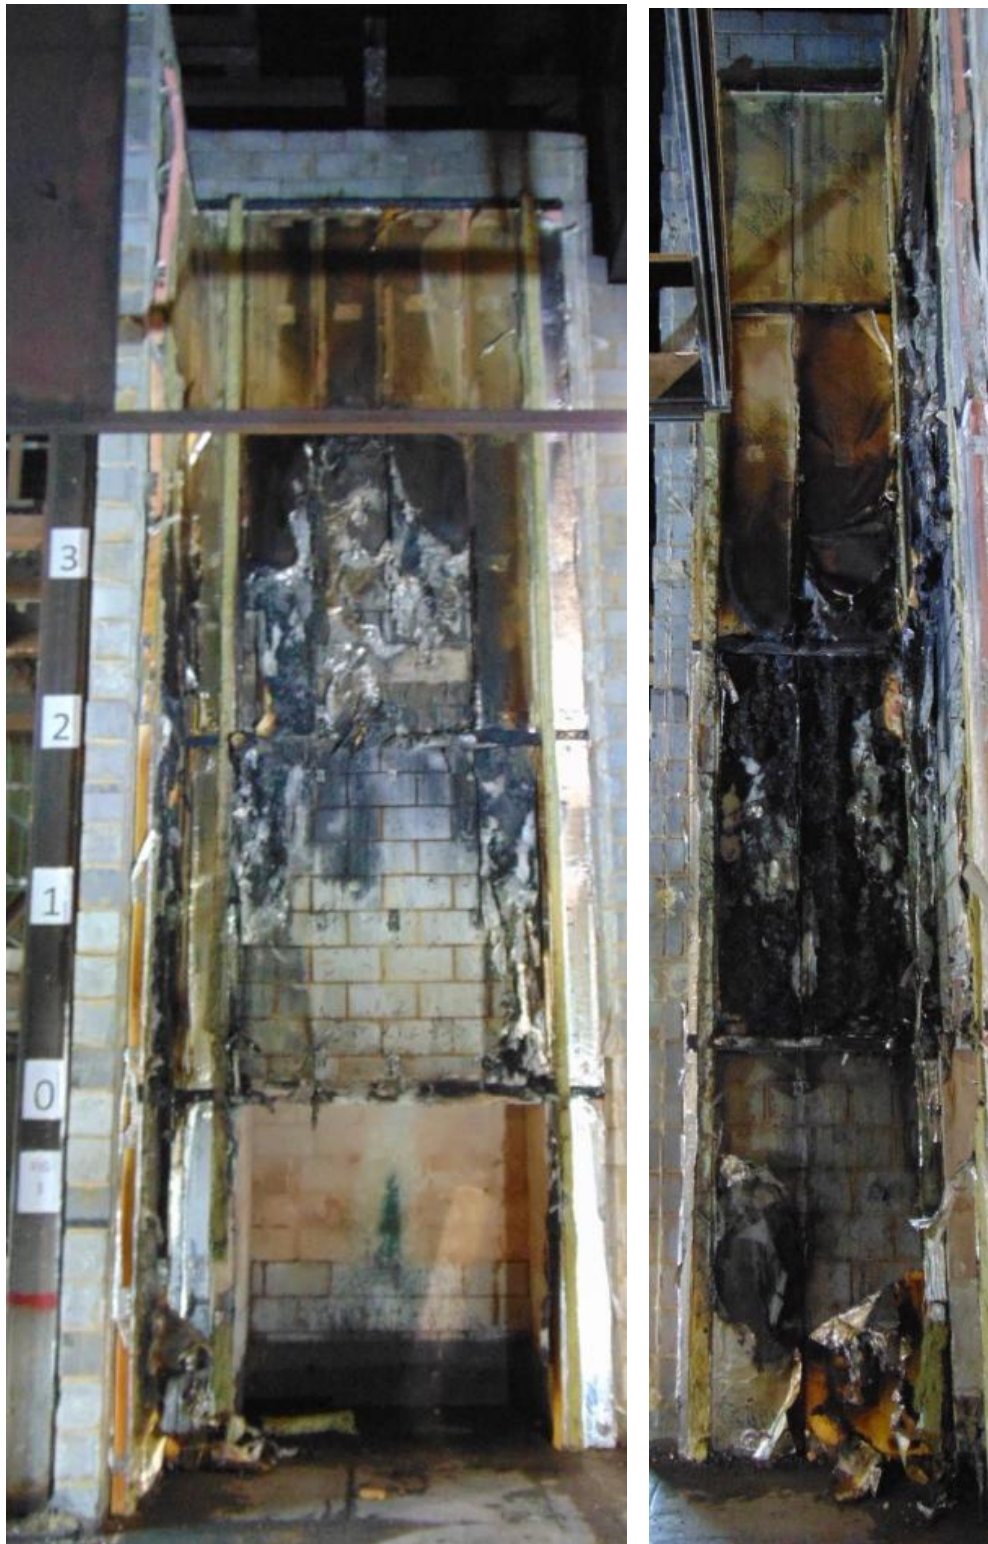
Figure 21. Post-test photograph following removal of rails.

On the main wall, the insulation had burnt/fallen away to approx. 2m-wide×6.7m-high from ground, in a tapering fashion reducing to 0.5m-wide. The insulation was discoloured between the combustion chamber opening to top of system, to a width of 2.5m measured from the main-wing wall junction.

On the wing wall, the insulation had burnt/fallen away to approx. 1.2m-wide×4.8m-high. The insulation was discoloured to the top of the system.

*See Figure 21.*

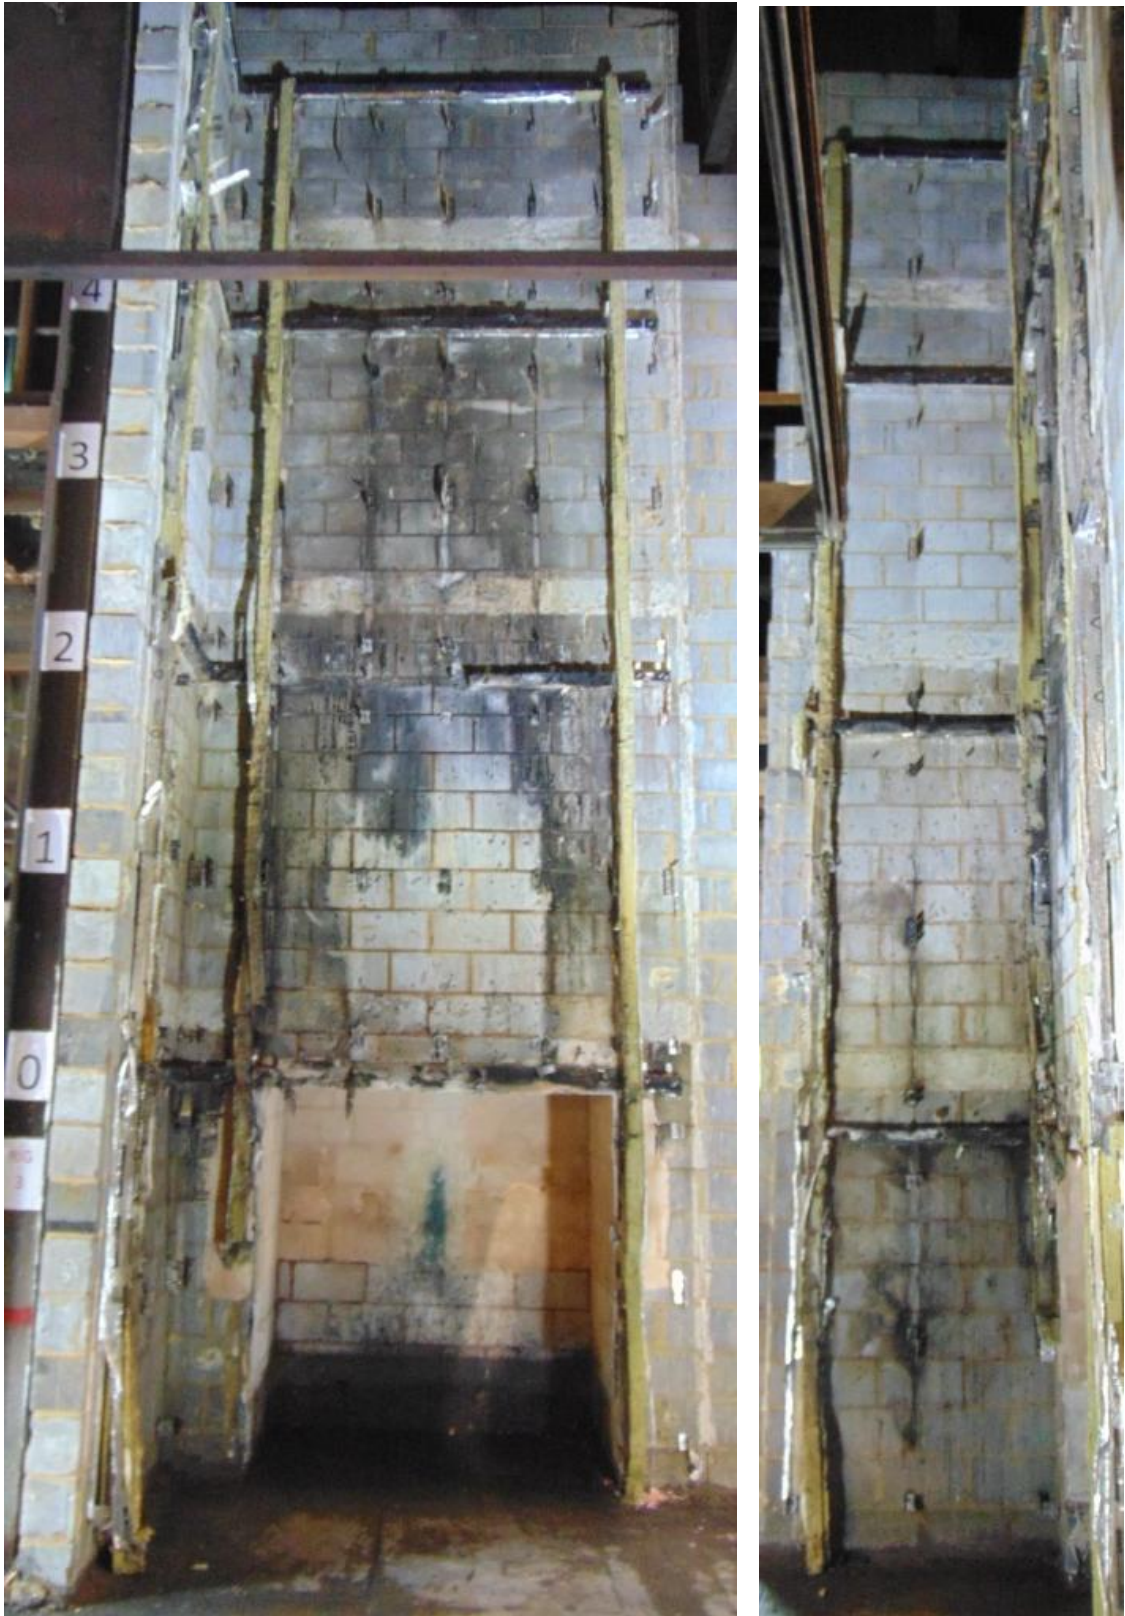
Figure 22. Post-test photograph of the horizontal and vertical cavity barriers

On the main wall, a 1m-wide section of horizontal cavity barrier had detached from the horizontal cavity barriers located at 2065mm and 4390mm from ground. The intumescent strip on the remaining sections and horizontal cavity barriers located at 6695mm and 8430mm from ground had activated.

On the wing wall, the horizontal cavity barriers located at 2065mm and 4390mm from ground were intact and activated. The horizontal cavity barriers located at 6695mm and 8430mm from ground had not fully activated.

*See Figure 22*

On the main wall, both vertical cavity barriers were intact and discoloured up to approx. 7.m from ground. On the wing wall, the vertical cavity barrier surface had detached sections up to approx. 4m and discoloured up to 5.5m from ground. *See Figure 22.*

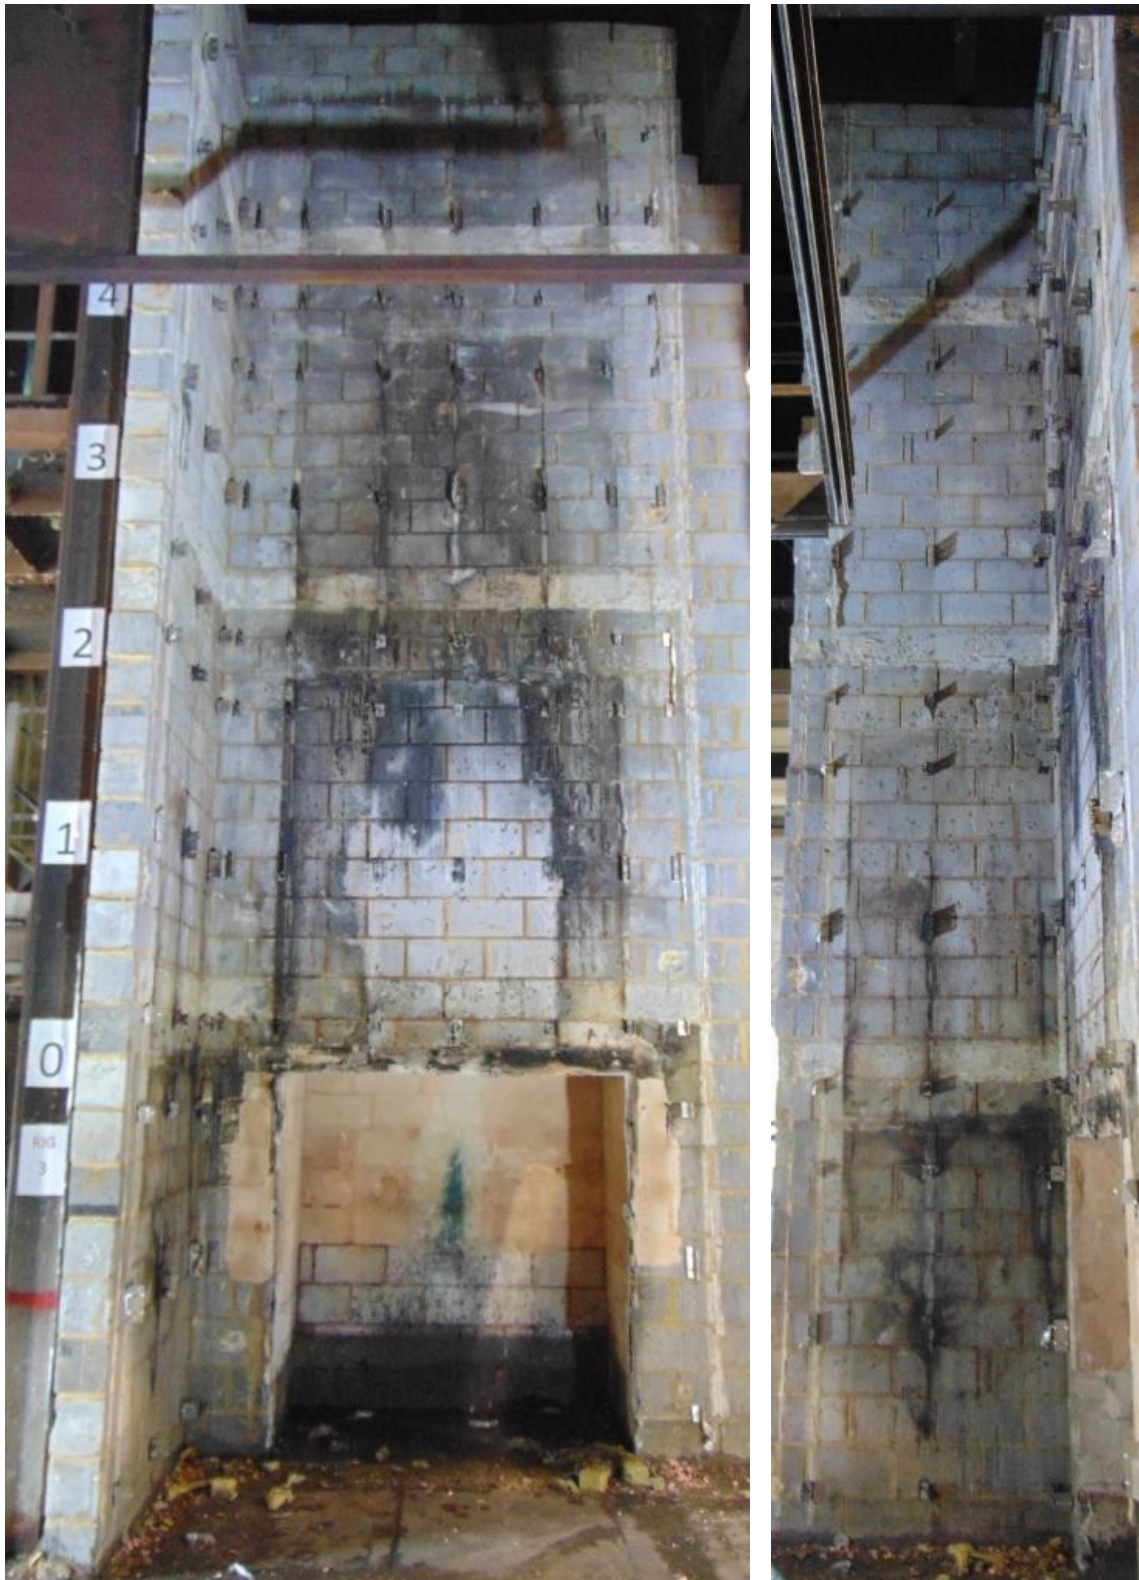
Figure 23. Post-test photograph of the 'L'-shaped brackets.

On the main wall, the three central columns of brackets were consumed in line with the combustion chamber opening to approx. 4m. The brackets were discoloured to of system, measured from the main-wing wall junction to 2.5m-wide.

On the wing wall, the column of brackets located at centre and the main-wing wall junction were consumed between 1m-2m from ground. The brackets were distorted up 4m

*See Figure 23.*
