# BRE Global Test Report

**BS 8414-2:2015 + A1:2017 Test on Trespa FR panel ventilated rainscreen system with Kingspan K15 Insulation.**

**Prepared for: Kingspan Insulation**

**Report Number: P114901-1000 Issue 1**

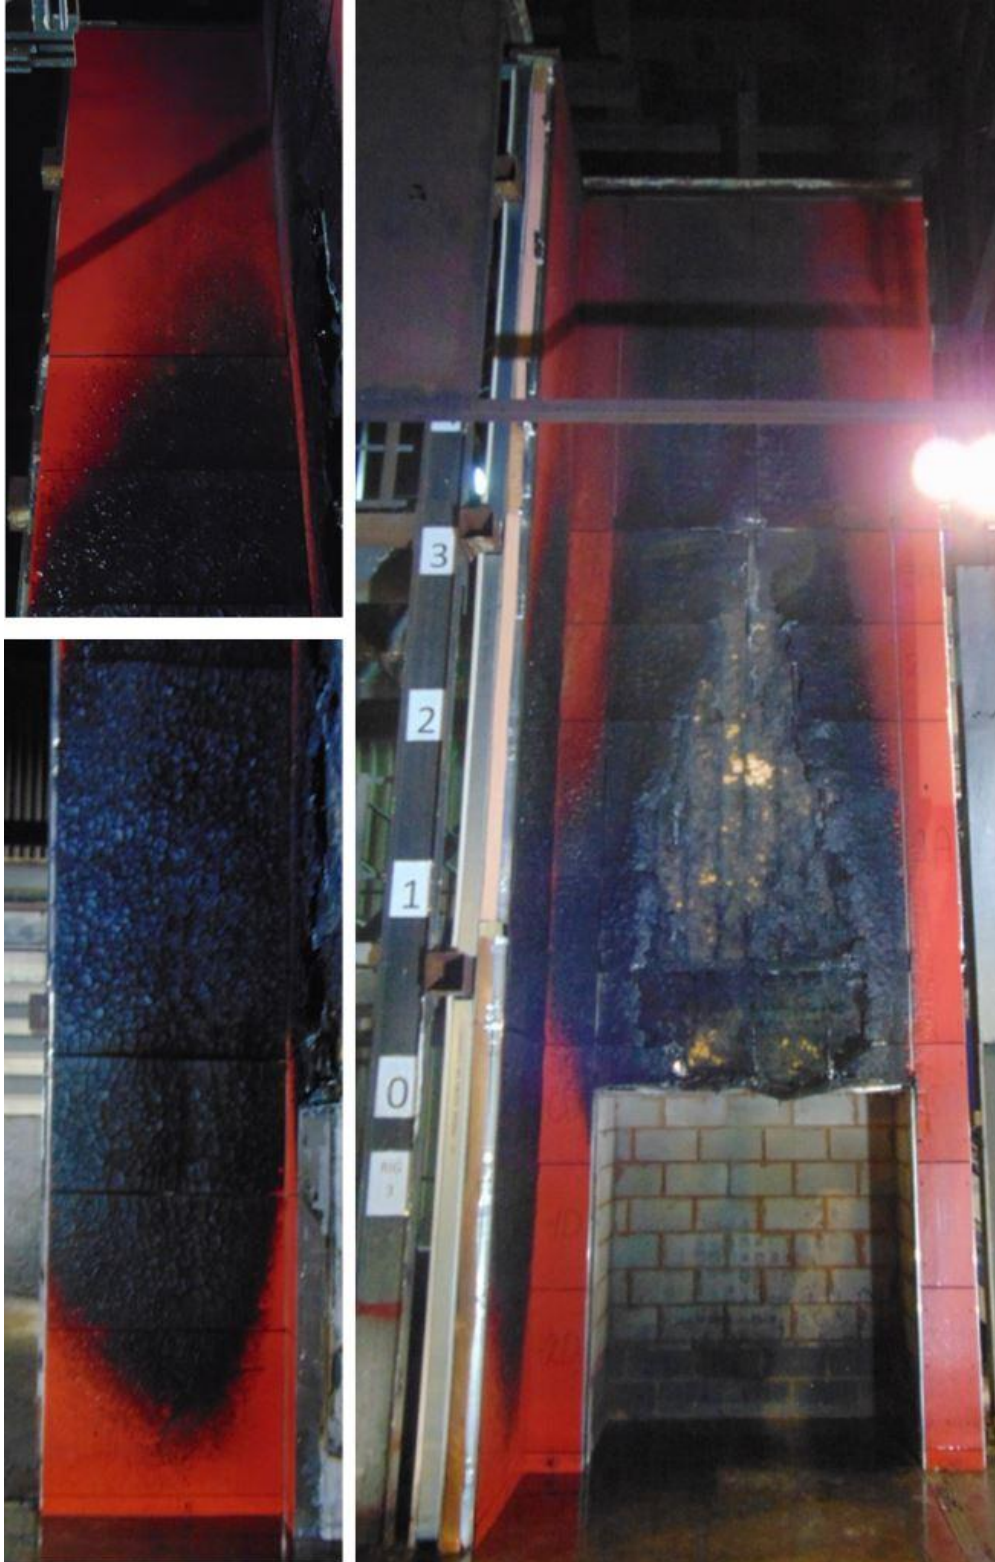
Figure 30. Full-height photograph of cladding system immediately after test.

On the main wall, the panels had fallen/burnt away exposing the insulation beneath. This was an approximately triangular area ( $2.7\text{m}^2$ ) of max dimensions  $1.4\text{m}$ -wide $\times$  $3.8\text{m}$ -high that tapered from the top of the combustion chamber opening. The panels had surface charring to  $5.3\text{m}$  above the combustion chamber in line with the fire plume. Panels were discoloured to top of system in line with combustion chamber opening.

On the wing wall, the panels had surface charring between  $0.5\text{m}$ - $6\text{m}$  from ground with discolouration up to top of system along the main-wing wall junction.

See Figure 30.

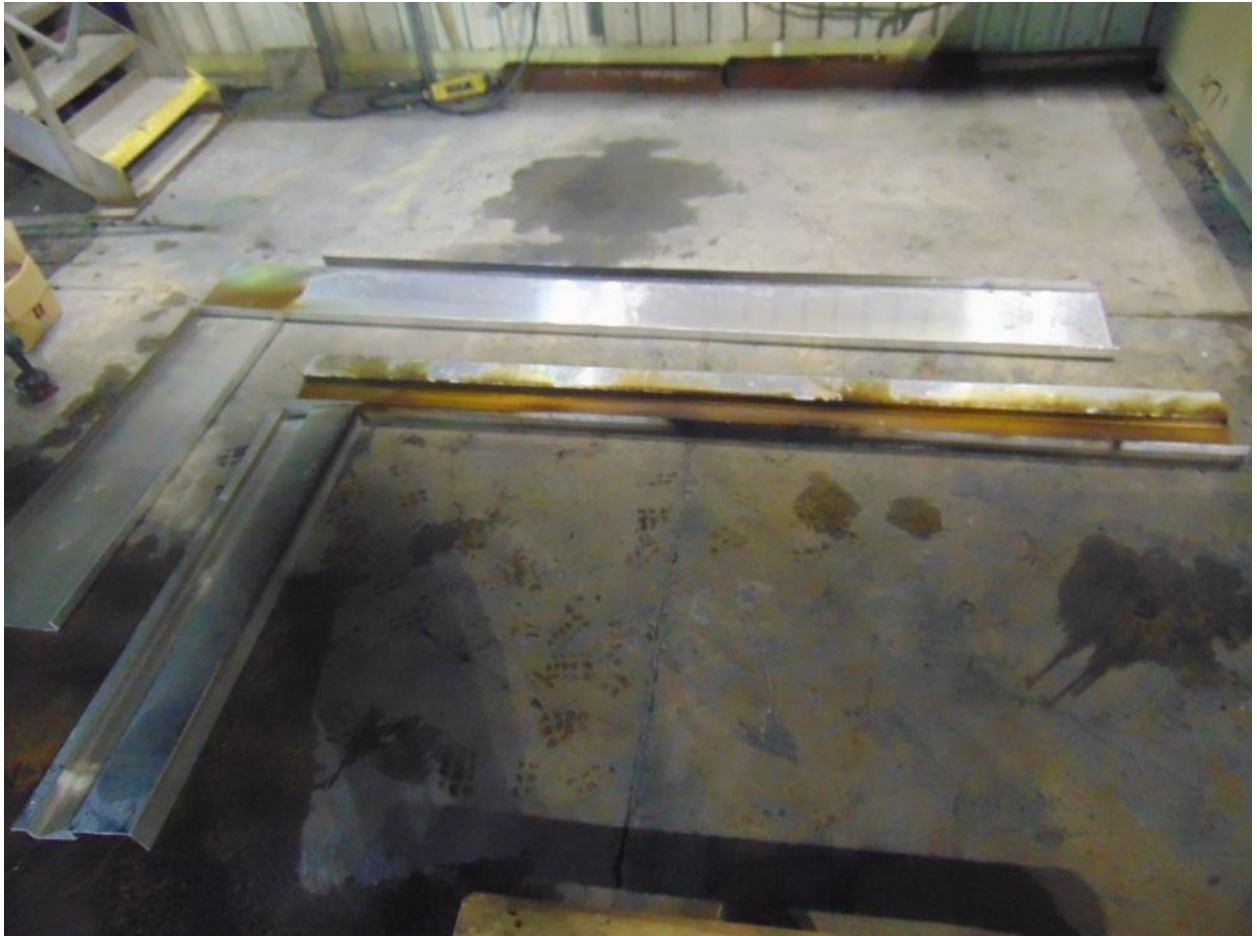
Figure 31. Underside of capping from the top of system.

The profiled aluminium capping was discoloured to full width on the main wall and discoloured along the front face on the wing wall.

The 'U'-shaped aluminium over clad capping was discoloured at main-wing junction.

See Figure 31.

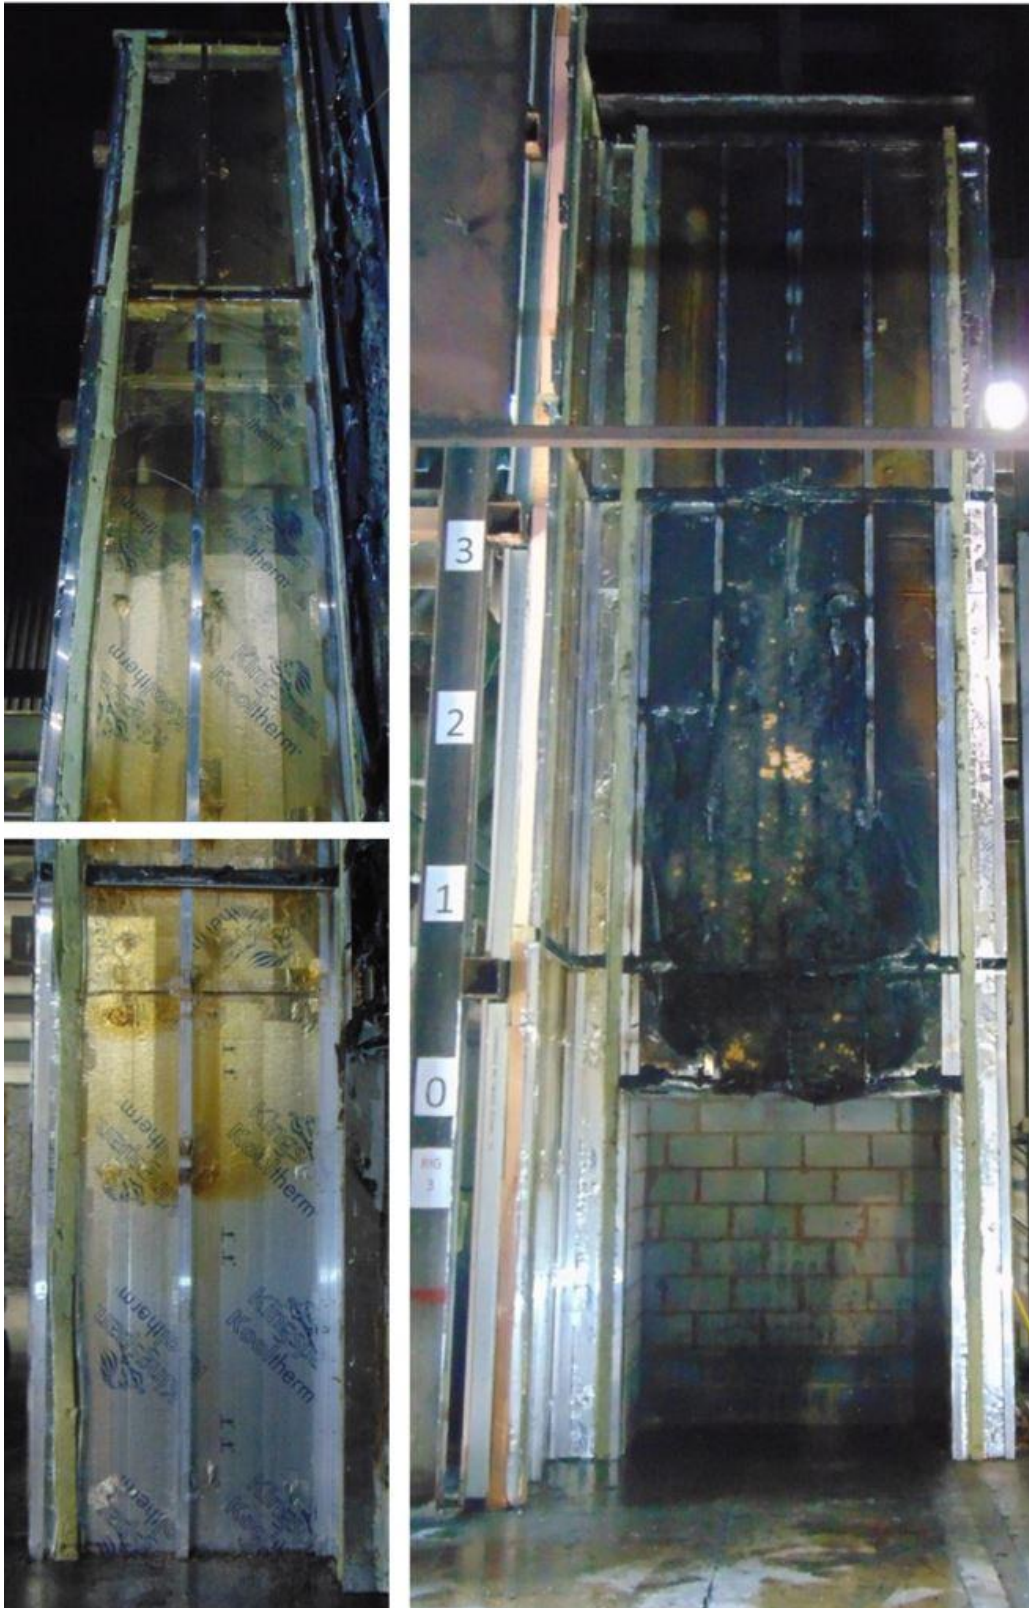
Figure 32. Post-test photograph following removal of panels.

On the main wall, the rail in line with the combustion chamber centre line was melted to  $5.3\text{m}$  from ground. The rails either side of the centre rail were melted to  $4.5\text{m}$  and  $3.7\text{m}$  respectively. The rails between both vertical cavity barriers were discoloured to the top of system.

On the wing wall, both rails located at the main-wing wall junction and centre of wall were discoloured from  $1.7\text{m}$  from ground to top of system.

See Figure 32.

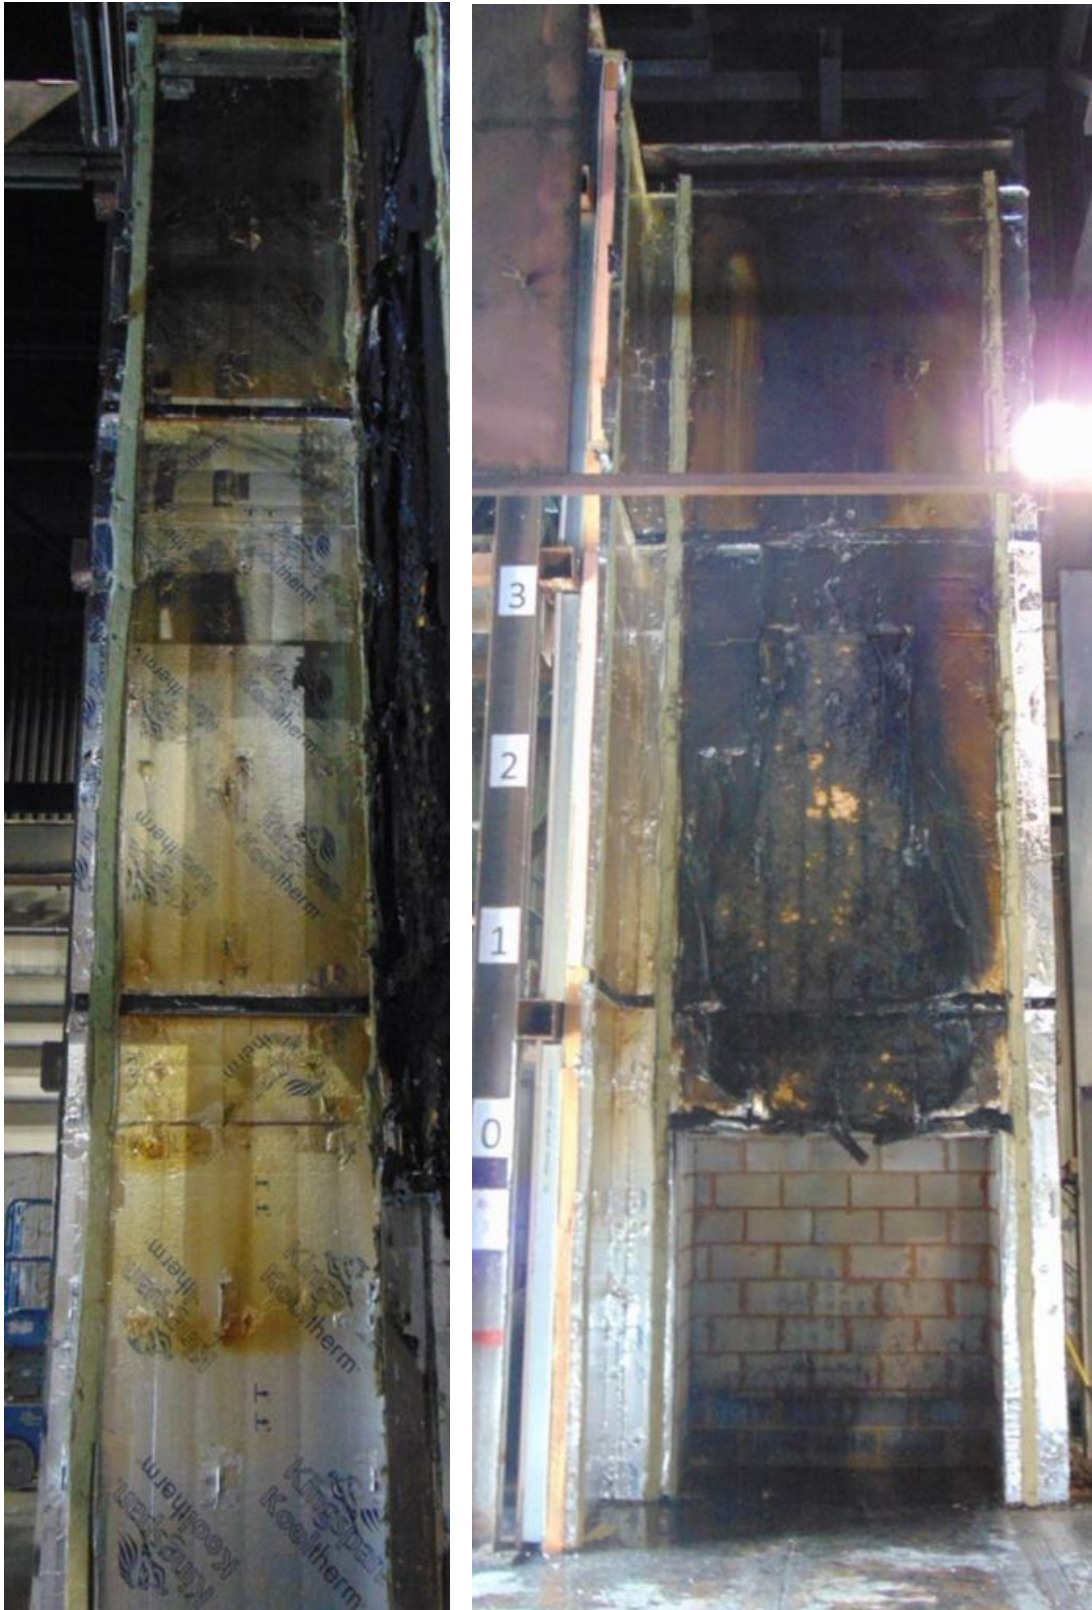
Figure 33. Post-test photograph following removal of rails.

On the main wall, the insulation had burnt/fallen away to approx.  $2\text{m}$ -wide $\times$  $5.5\text{m}$ -high from ground, in a tapering fashion reducing to  $1\text{m}$ -wide. The surrounding insulation was charred to  $7\text{m}$  from ground and remaining insulation was discoloured the top of system, between the vertical cavity barriers.

On the wing wall, the insulation remained in place and was discoloured from  $1.6\text{m}$  from ground to top of system.

See Figure 33.

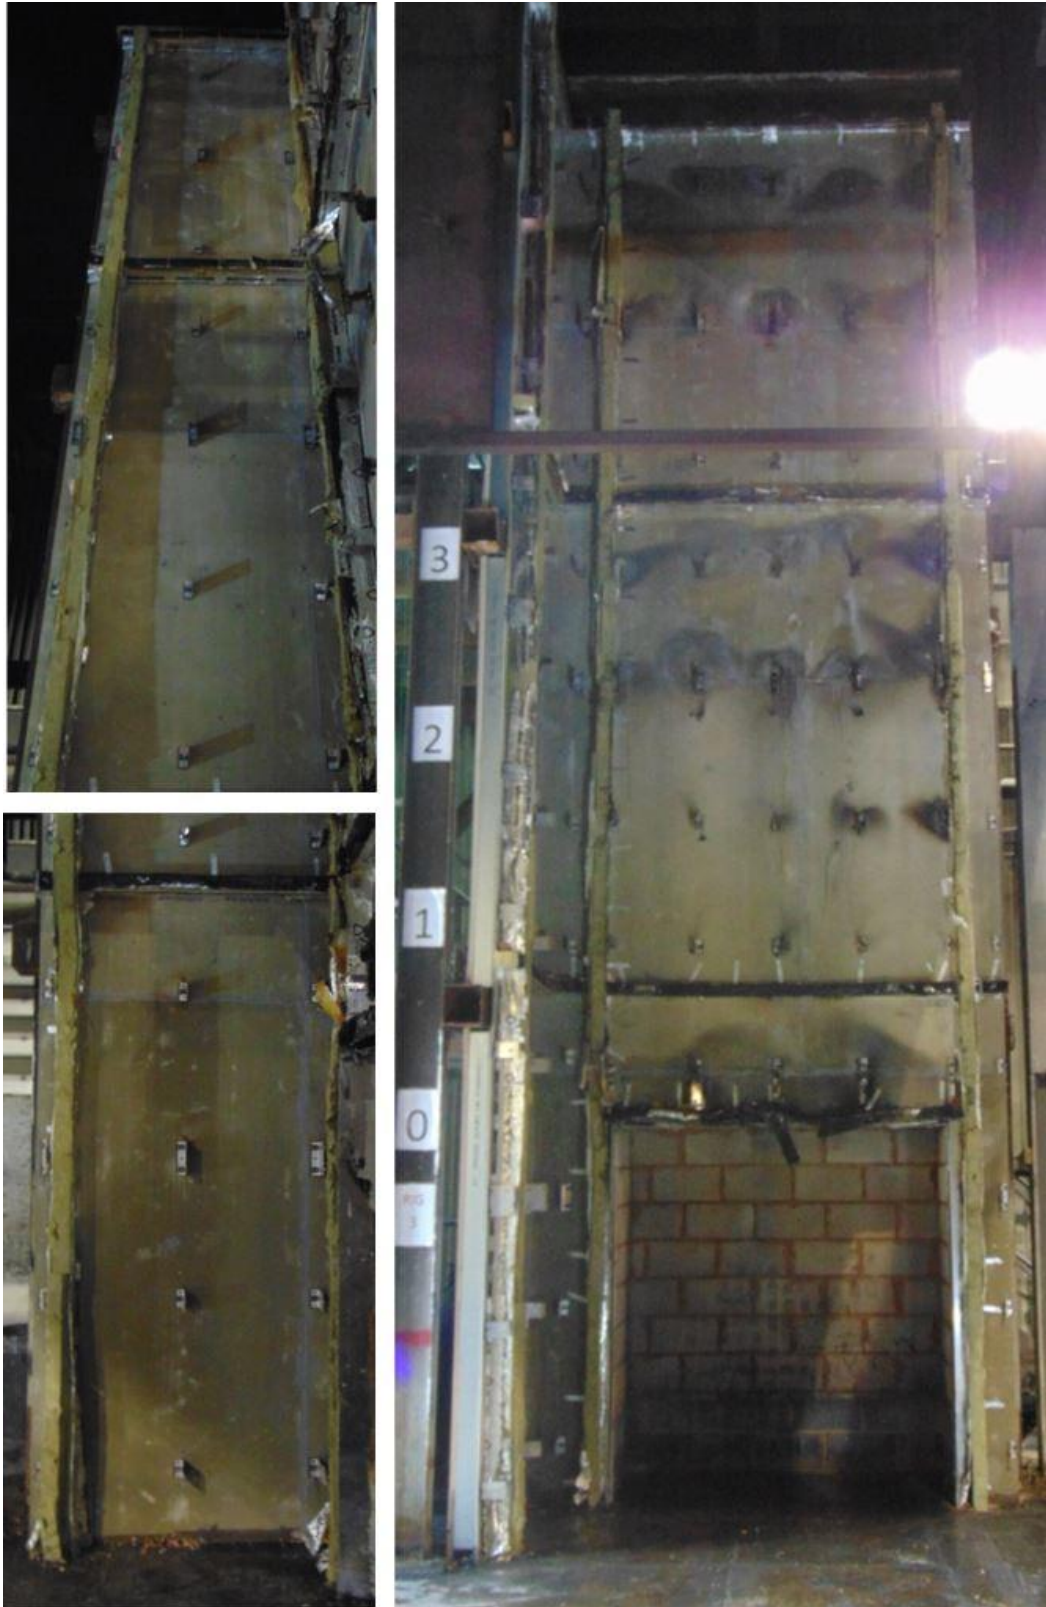
Figure 34. Post-test photograph of the horizontal and vertical cavity barriers.

On the main wall, the horizontal cavity barrier located at 2170mm from ground had activated with detached patches of intumescent strip. The horizontal cavity barriers located at 2885mm, 5985mm and 8675mm from ground were activated between the vertical cavity barriers.

On the wing wall, the horizontal cavity located at 2885mm from ground had activated. The horizontal cavity barriers located at 5985mm and 8675mm from ground remained intact but were discoloured.

See Figure 34.

On the main wall, both vertical cavity barriers remained intact and in place but were discoloured from 1.8m from ground to top of system. On the wing wall, the vertical cavity barrier remained intact and in place with no visible damage.

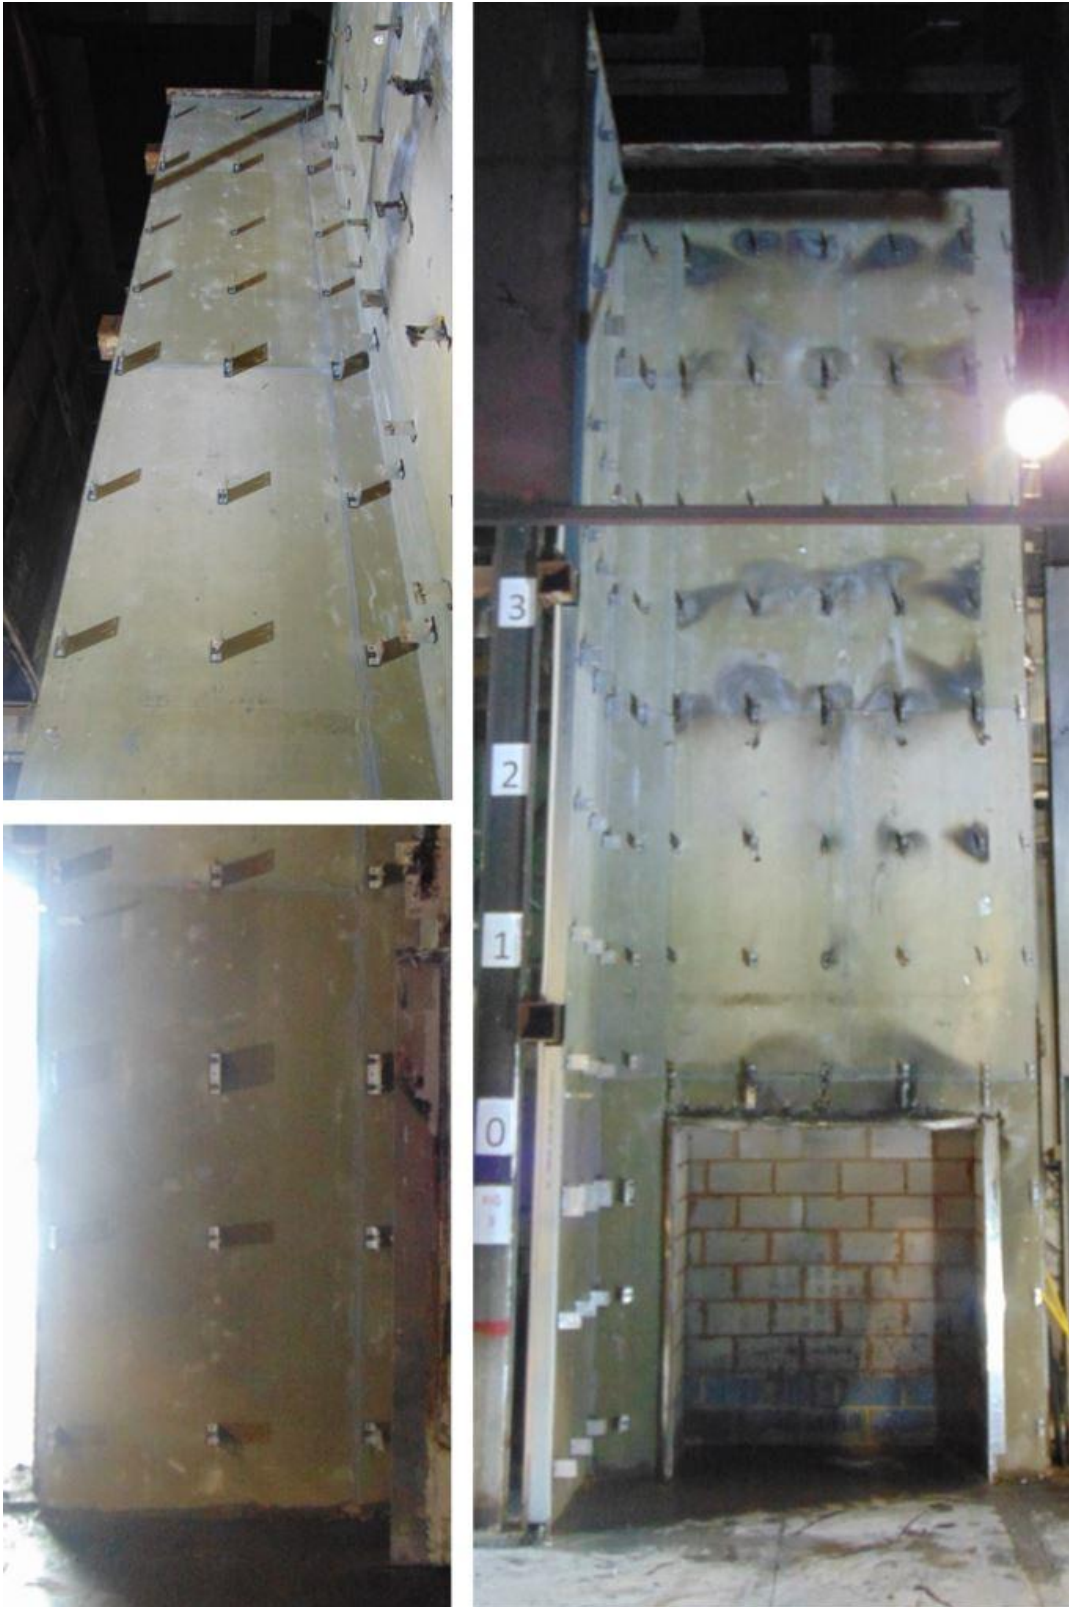
Figure 35. Post-test photograph of 'L'-brackets.

On the main wall, the three central columns of brackets were melted in line with the combustion chamber opening to approx. 2m. The brackets were discoloured to top of system in line with the combustion chamber width.

On the wing wall, the column of brackets located at centre and the main-wing wall junction were discoloured from 2.2m from ground to top of system.

See Figure 35.

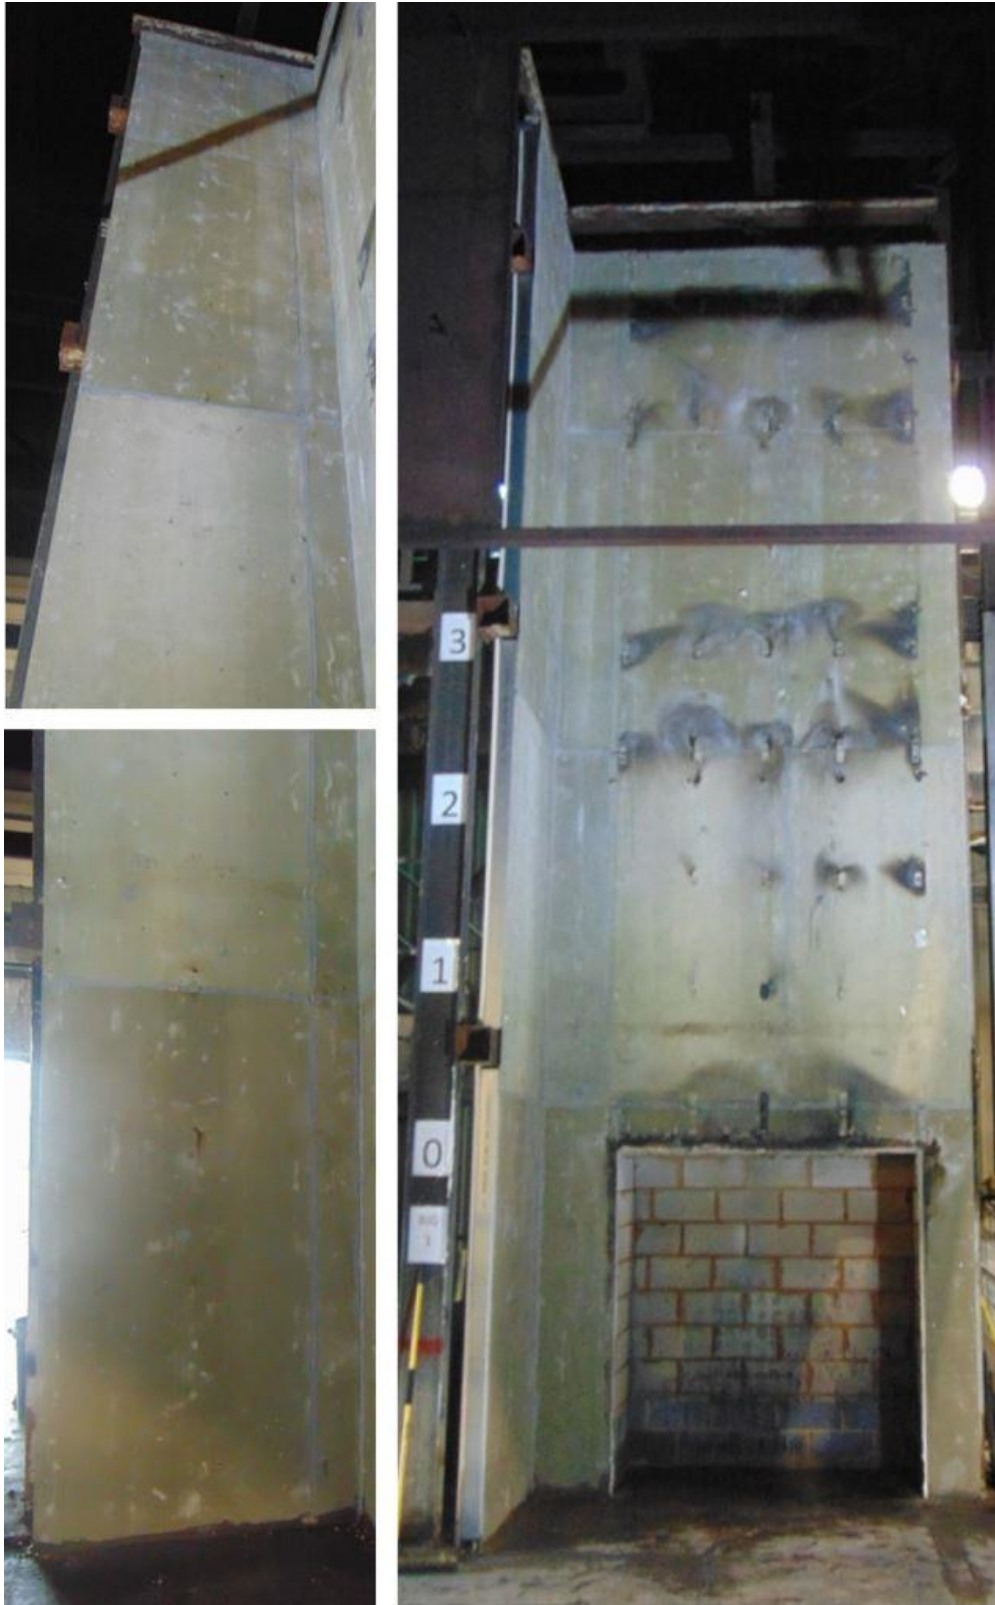
Figure 36. Post-test photograph of the cement board.

On the main wall, the cement board had charred in localised areas from above the combustion chamber, to top of system in line with the aluminium bracket locations. The cement board was also discoloured in that area.

On the wing wall, the cement board remained intact and in place but had discoloured in localised areas from 2.2m from ground to top of system.

See Figure 36.

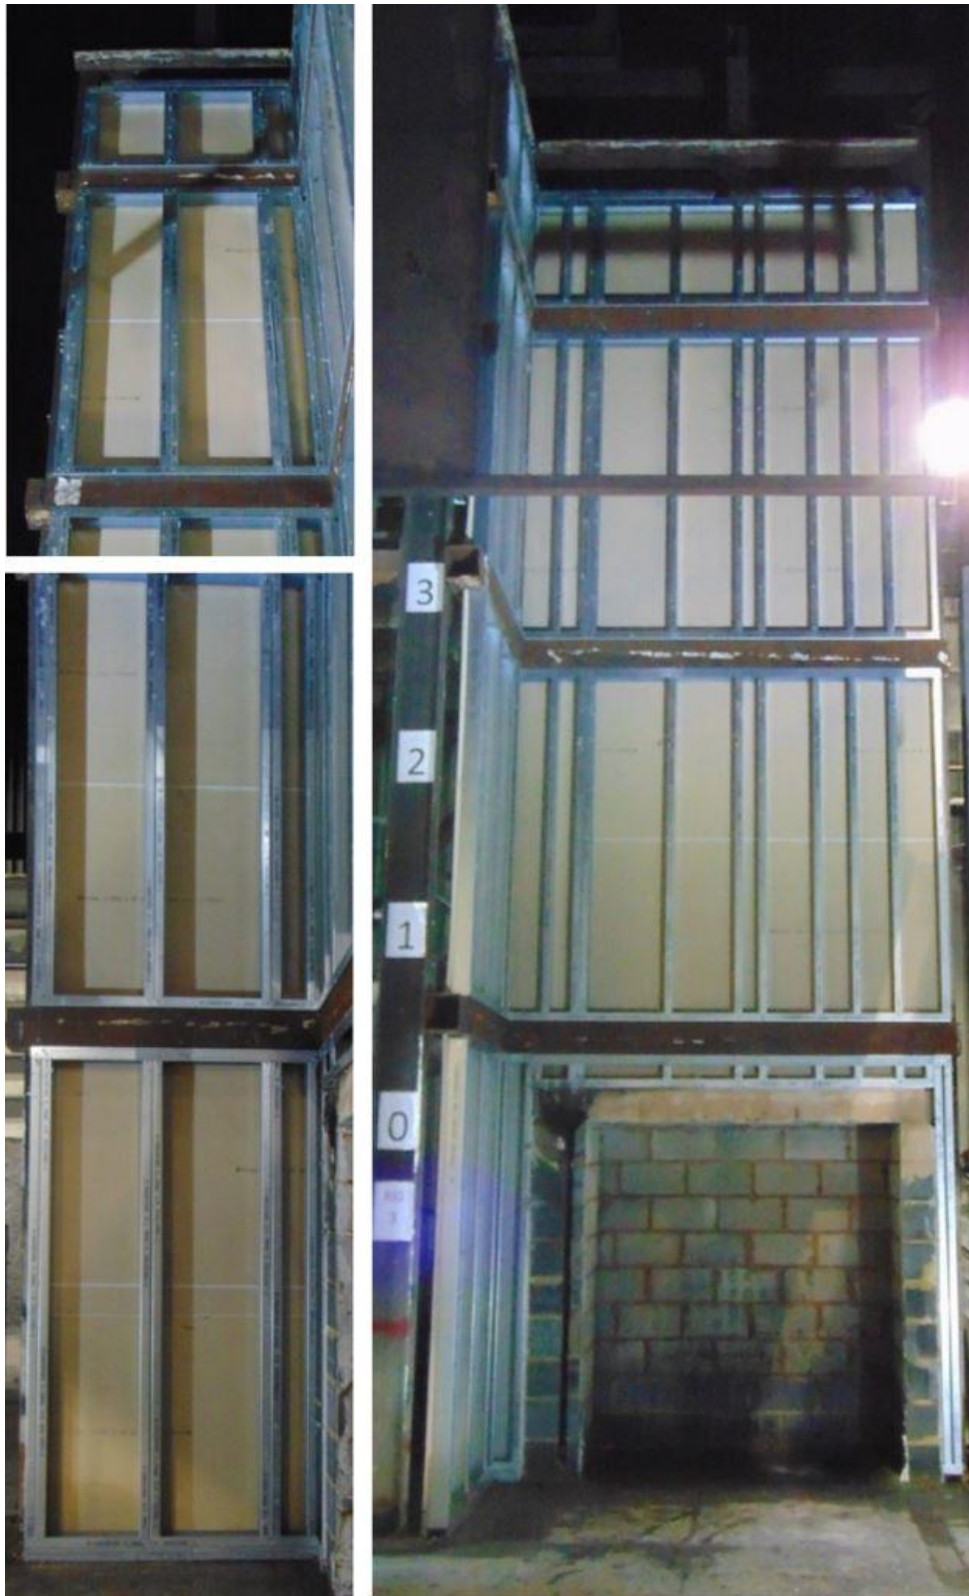
Figure 37. Post-test photograph following removal of cement board.

The plasterboard remained in place with no visible damage. See Figure 37.

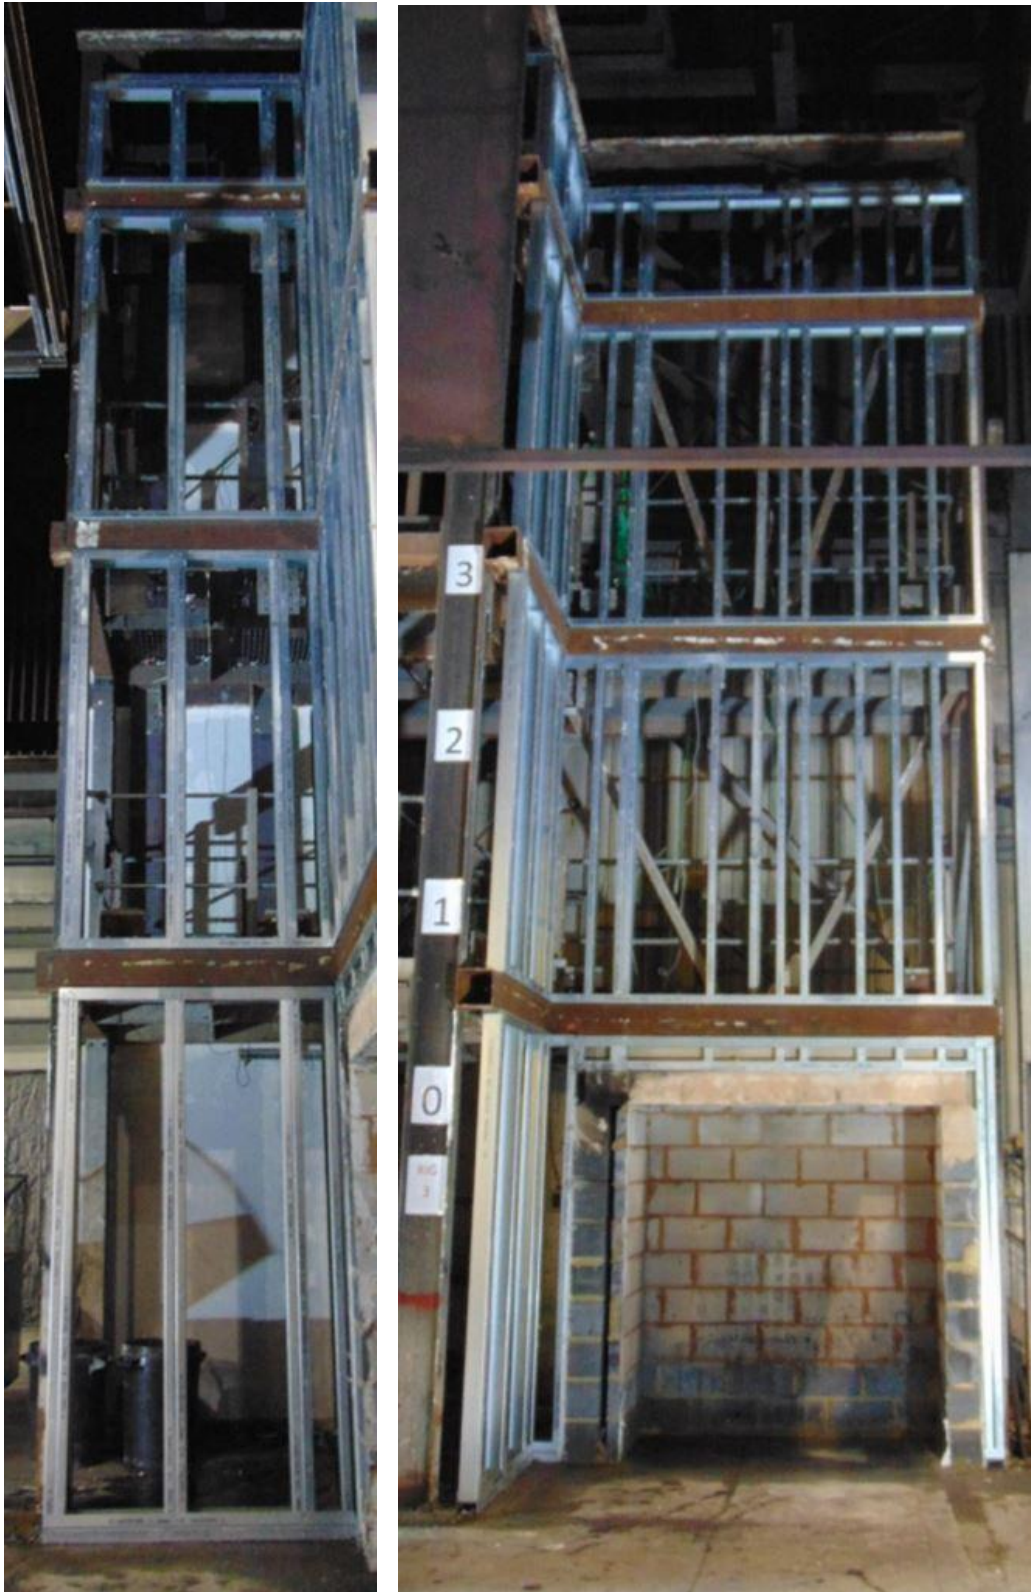
Figure 38. Post-test photograph of the SFS.

On the main wall, the base track directly above the combustion chamber opening had discoloured in localised areas. The head track and vertical studs at the top of the system had discoloured in localised areas. On the wing wall, the SFS had no visible damage. See Figure 38.
