BRE Global Classification Report

Classification of fire performance in accordance with BR135:2013 Annex B on a Kingspan BENCHMARK 80mm QuadCore™ Karrier & Dri Design Cassette system.

Prepared for: Kingspan Limited
Date: 14th June 2018
Report Number: P107922-1001 Issue 1

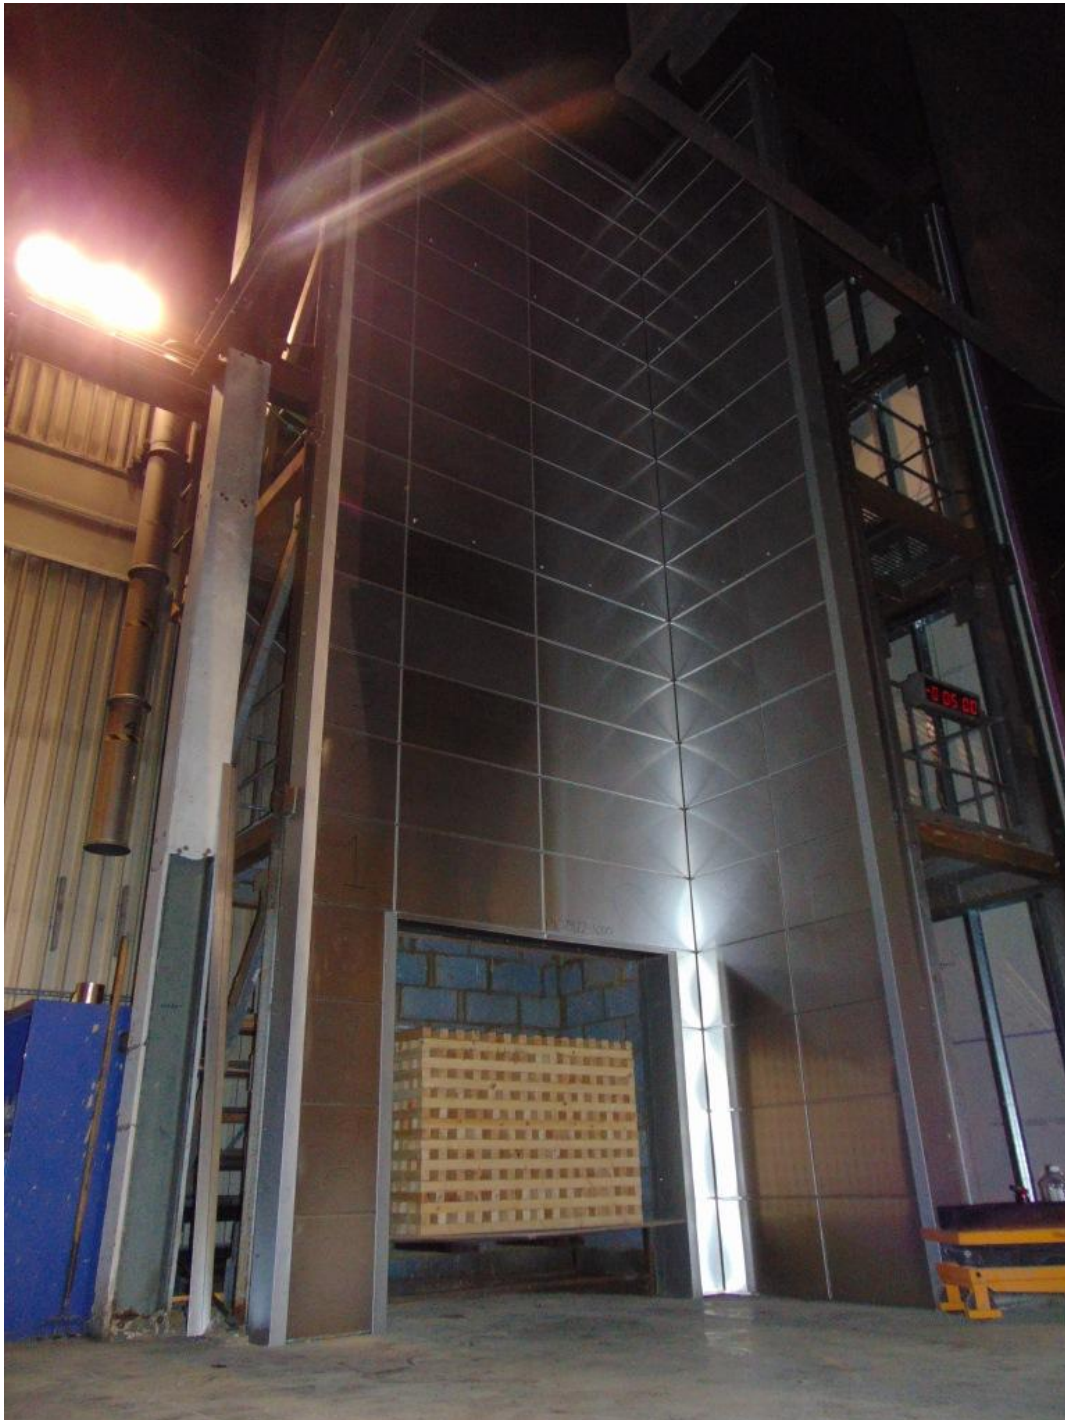
Figure 1. System prior to test.

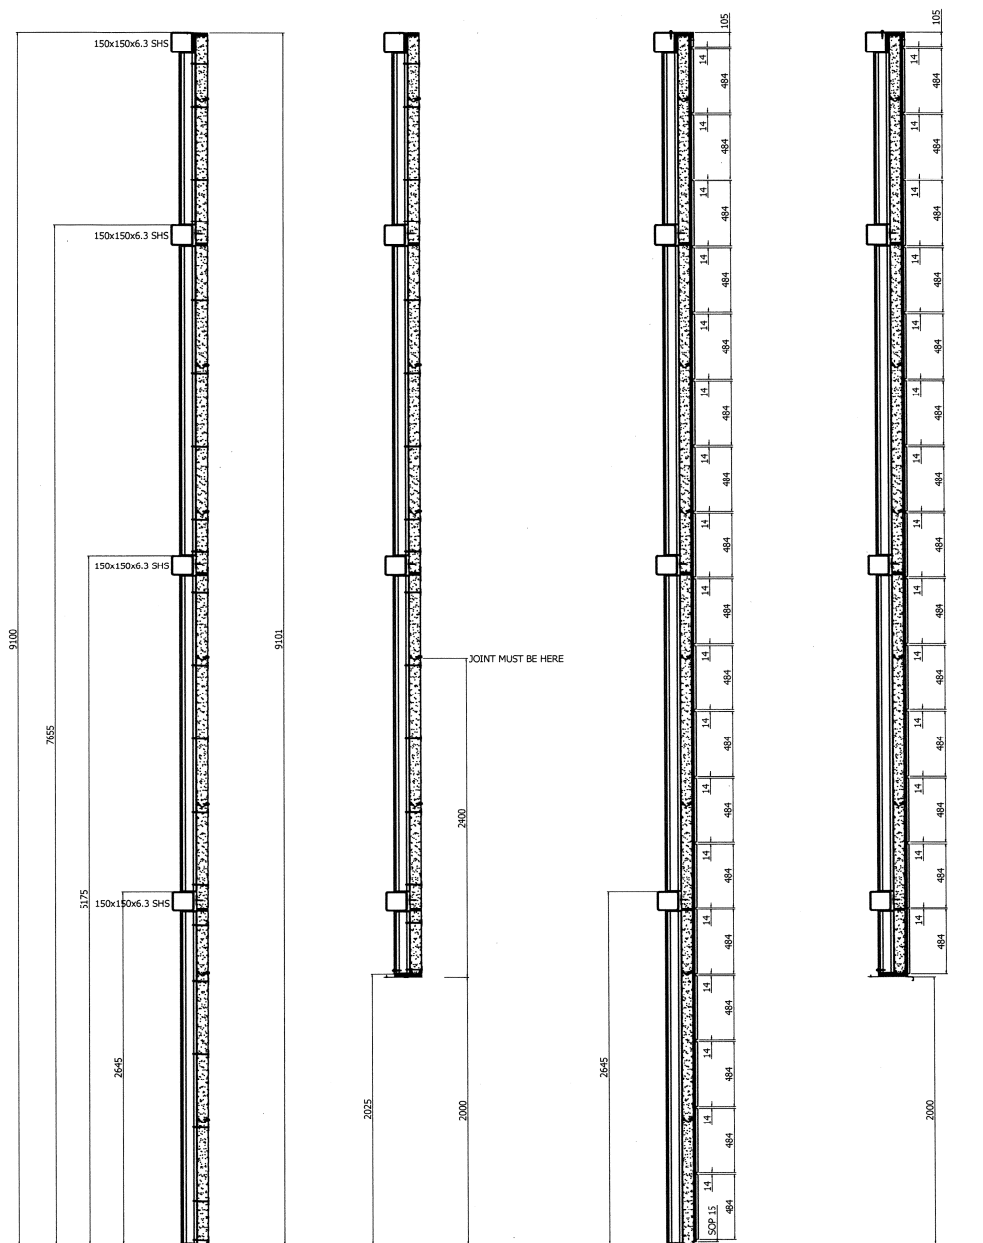
Figure 3. Client supplied drawing - Cross section of the system.

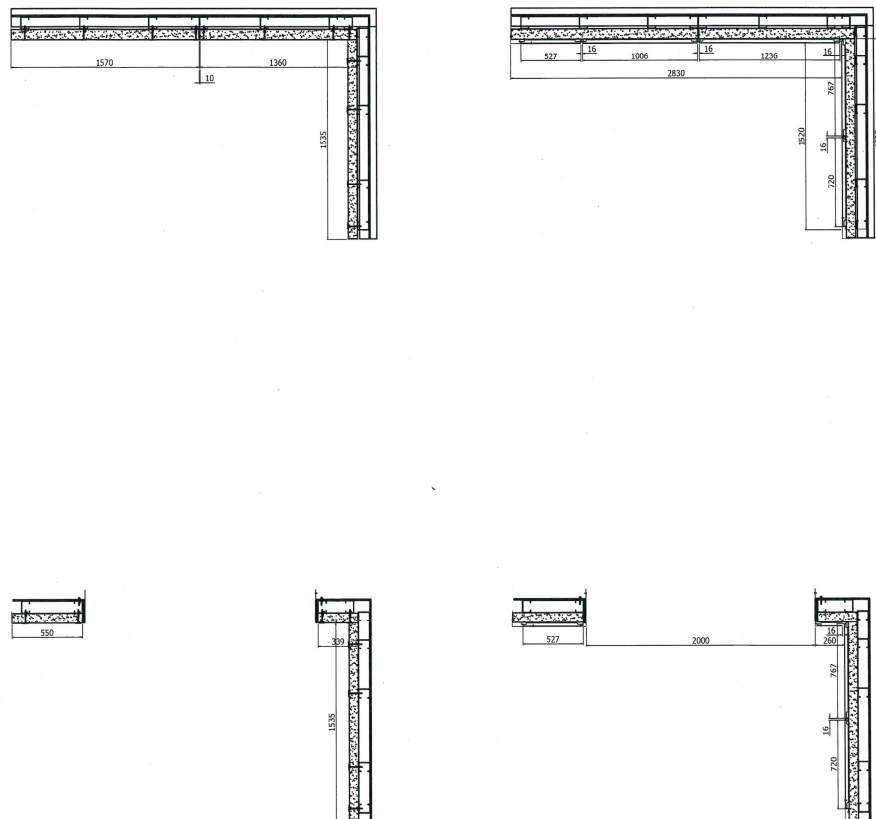
Figure 4. Client supplied drawing – Plan view of the system.

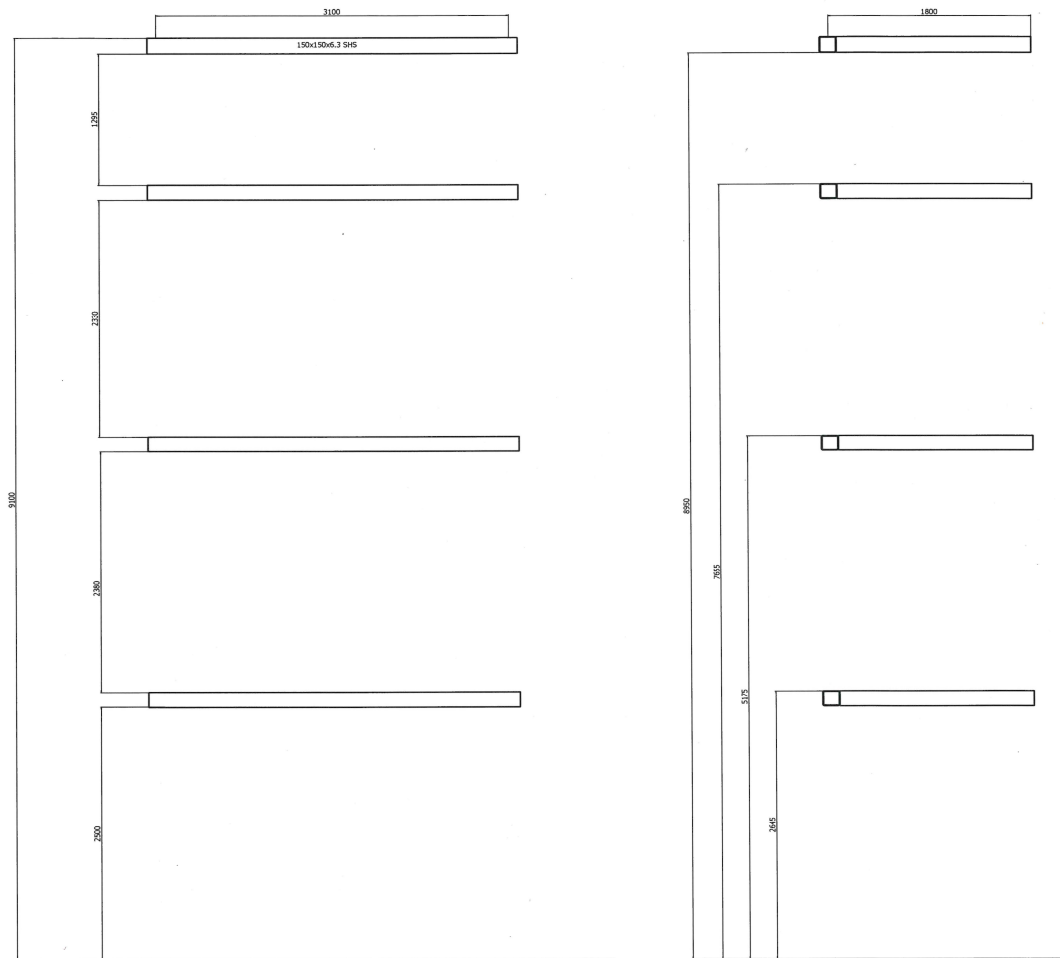
Figure 5. Client supplied drawing – Frame layout showing box sections at floor level.

The floor slab edge onto which the façade system was installed was 150mm x 150mm steel box section.

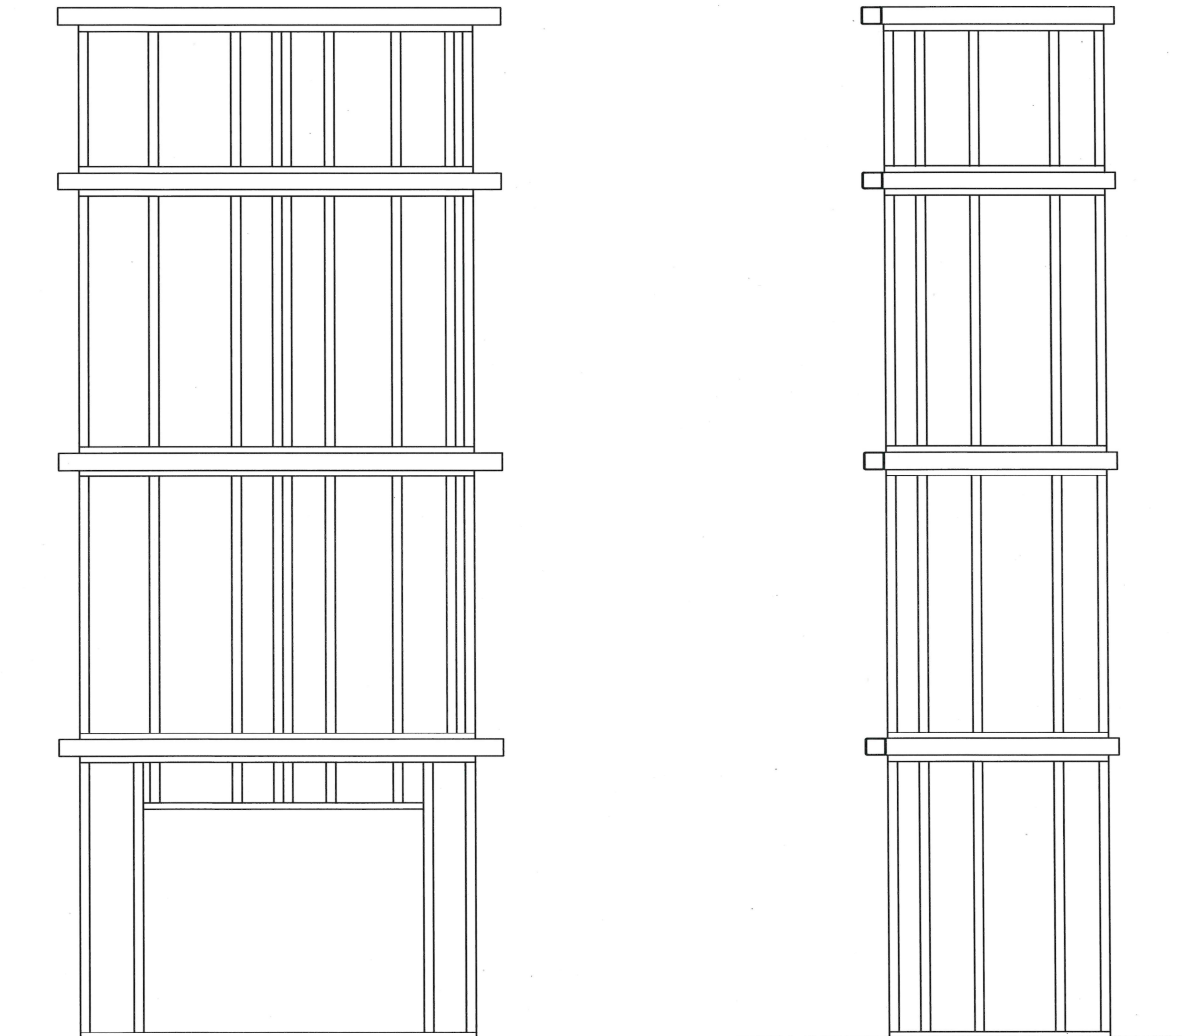
Figure 6. Client supplied drawing – Framing system.

The framing system and insulated panels were supplied in modular form at the correct size to fit the BS8414 test frame. The module comprised of BENCHMARK QuadCore™ Karrier panels pre-installed on to Kingspan Kingframe steel frame system.

The modules were installed so that the Kingspan Kingframe was installed between and secured to the floor slab edges and the insulated panels formed a continuous façade on the front of the test frame.

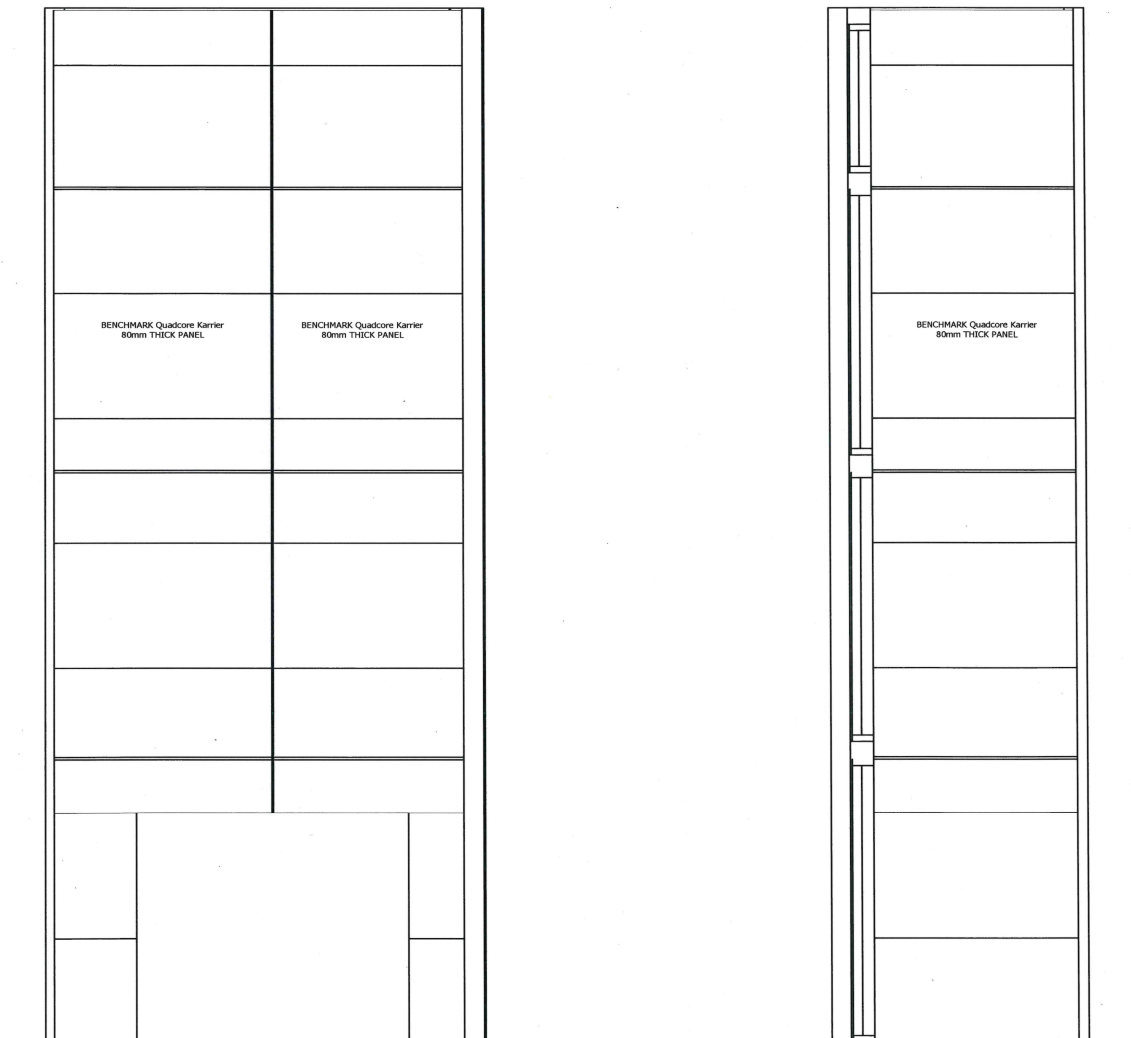
Figure 7. Client supplied drawing – BENCHMARK QuadCore™ Karrier panel layout.

The panels were cut and installed so that there was a vertical joint central to the combustion chamber running the full height of the system. This joint was packed with stone wool insulation and covered with 100mm wide mild steel flashing secured to the panel fronts using 4.8mm x 22mm stitching screws at nominal 275mm centres.

At each of the floor levels the panels were cut to form a horizontal 'butt' joint. This joint was packed with stone wool insulation and covered with 100mm wide flashing secured at 275mm centres. The remaining horizontal joints were 'panel' to 'panel' joints. The panel to panel joints were stitched with SXW-L12-5.5 x 42mm screws at 600mm centres.

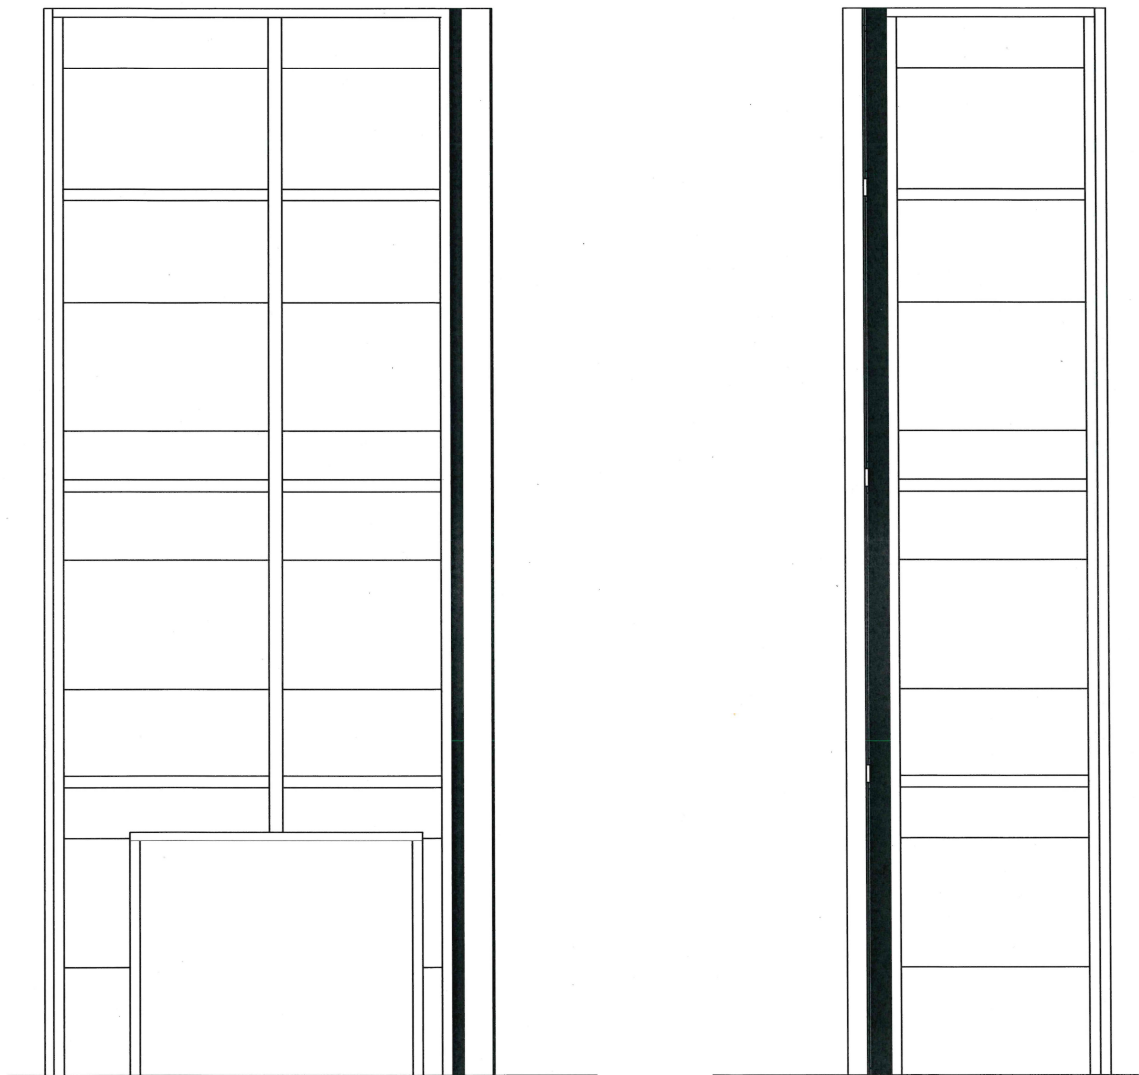
Figure 8. Client supplied drawing – Location of flashings.

The junction of the main and wing walls was covered with mild steel coated flashing 75mm x 75mm and secured to the front of the panels using 4.8mm x 22mm stitching screws at nominal 275mm spacing on both sides.

The exposed edges of the panels at the edge of both the main and wing walls were finished with 75mm x 180mm coated mild steel flashing secured to the front face of the panels using 4.8mm x 22mm stitching screws at 275mm centres. The 75mm section of flashing was on the front face of the cladding system.

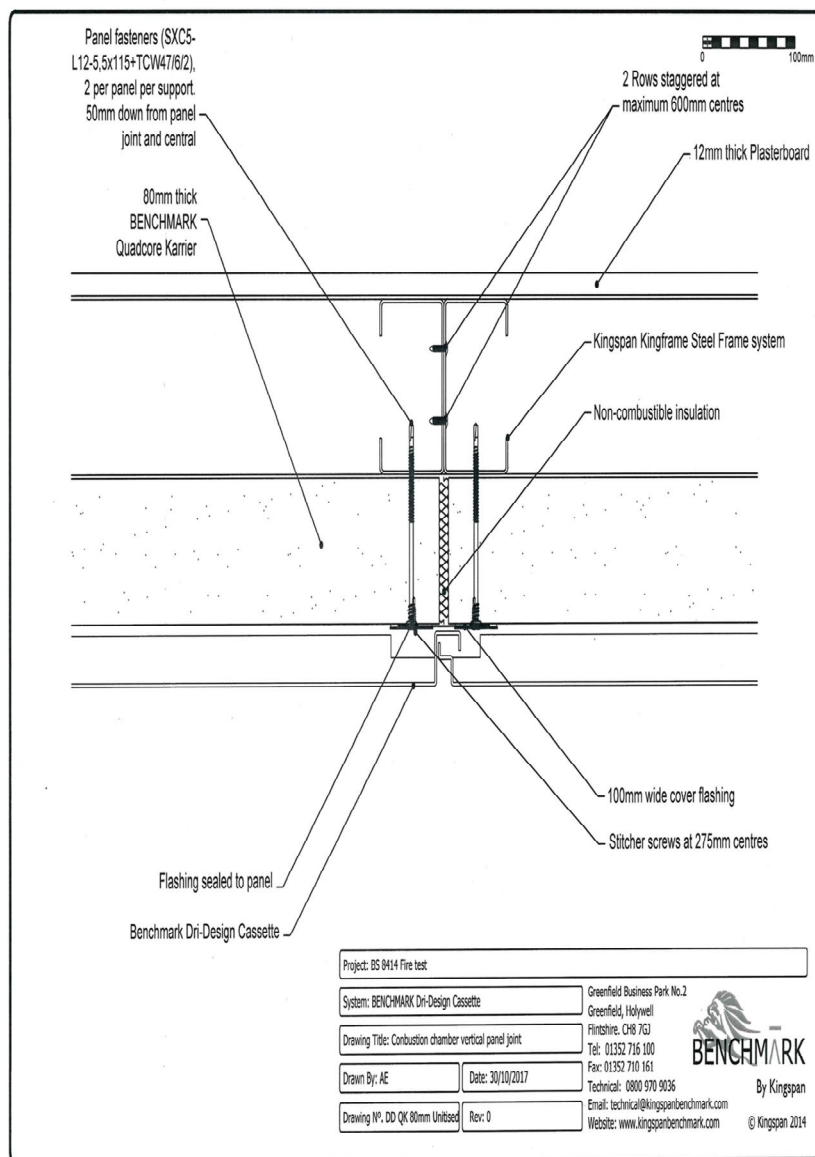
Figure 10. Client supplied drawing – Combustion chamber vertical panel joint.

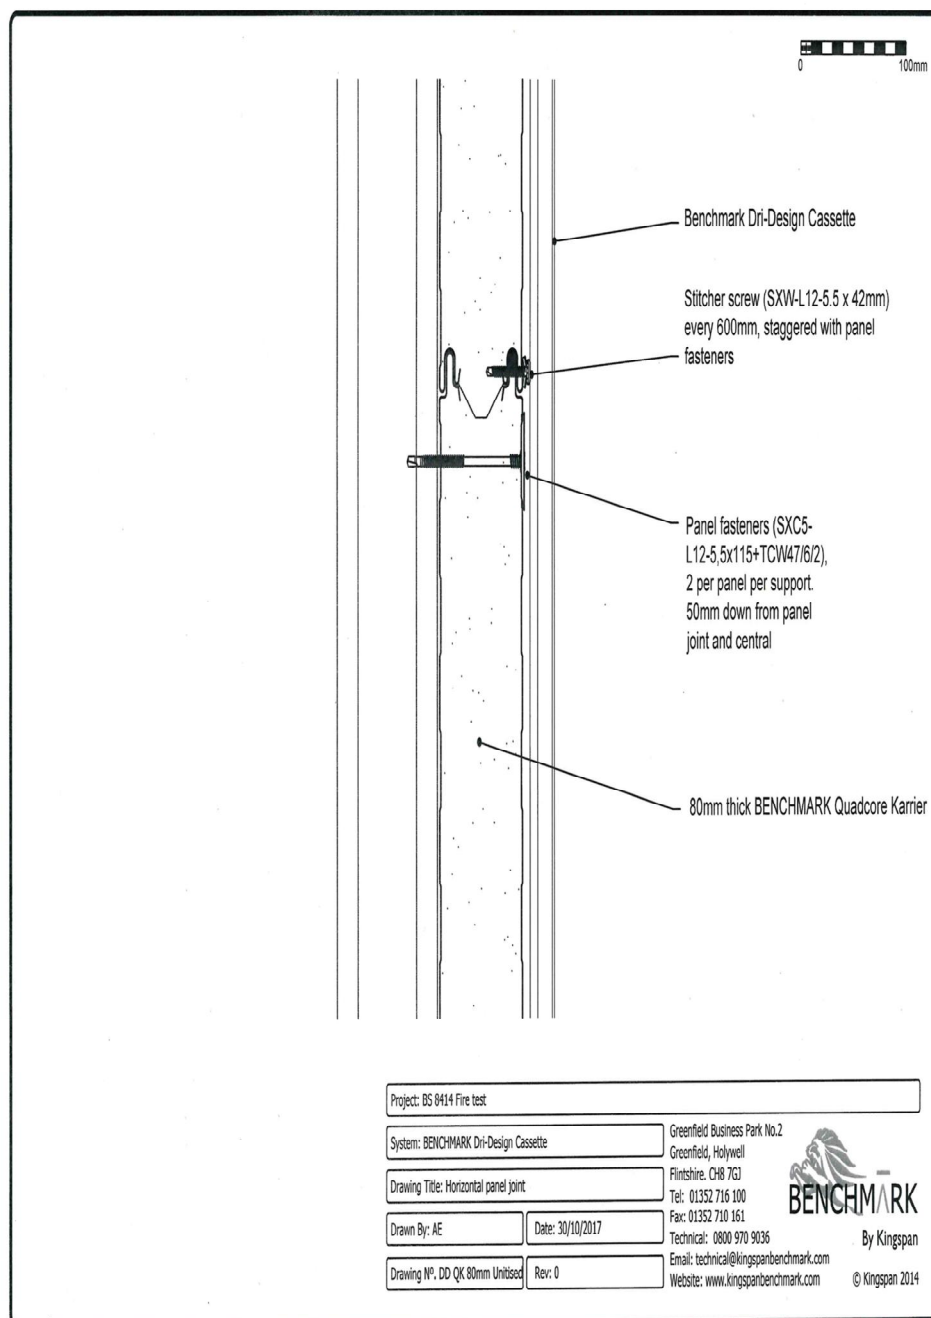
Figure 11. Cross section through system (supplied by Test Sponsor).

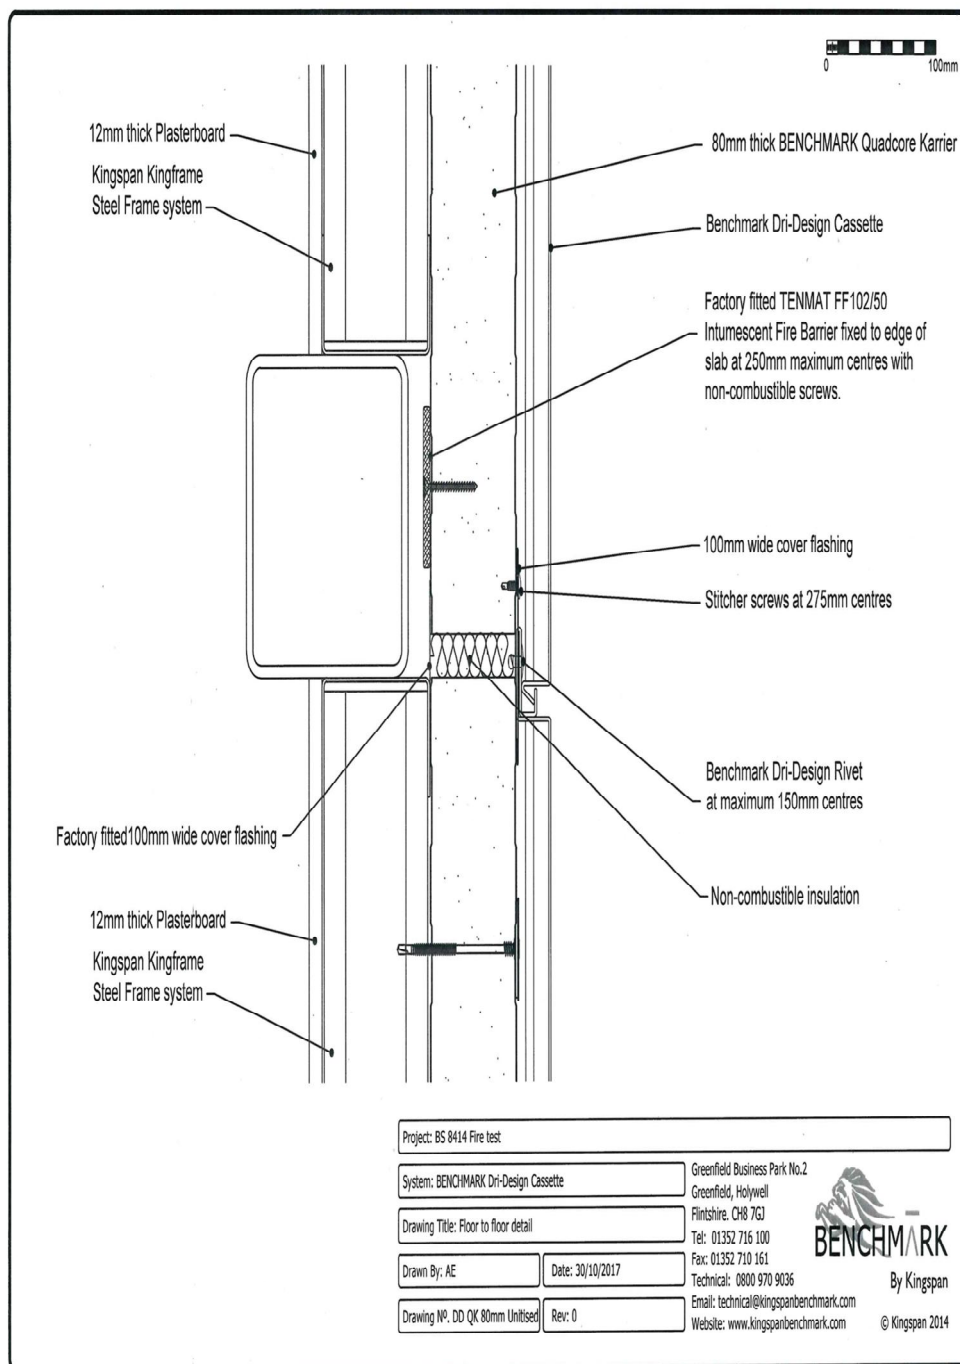
Figure 12. Client supplied drawing - Floor to floor edge detail.

Tenmat FF102/50 intumescent horizontal fire barrier fitted to rear of BENCHMARK Karrier panel to align with floor slab edge.

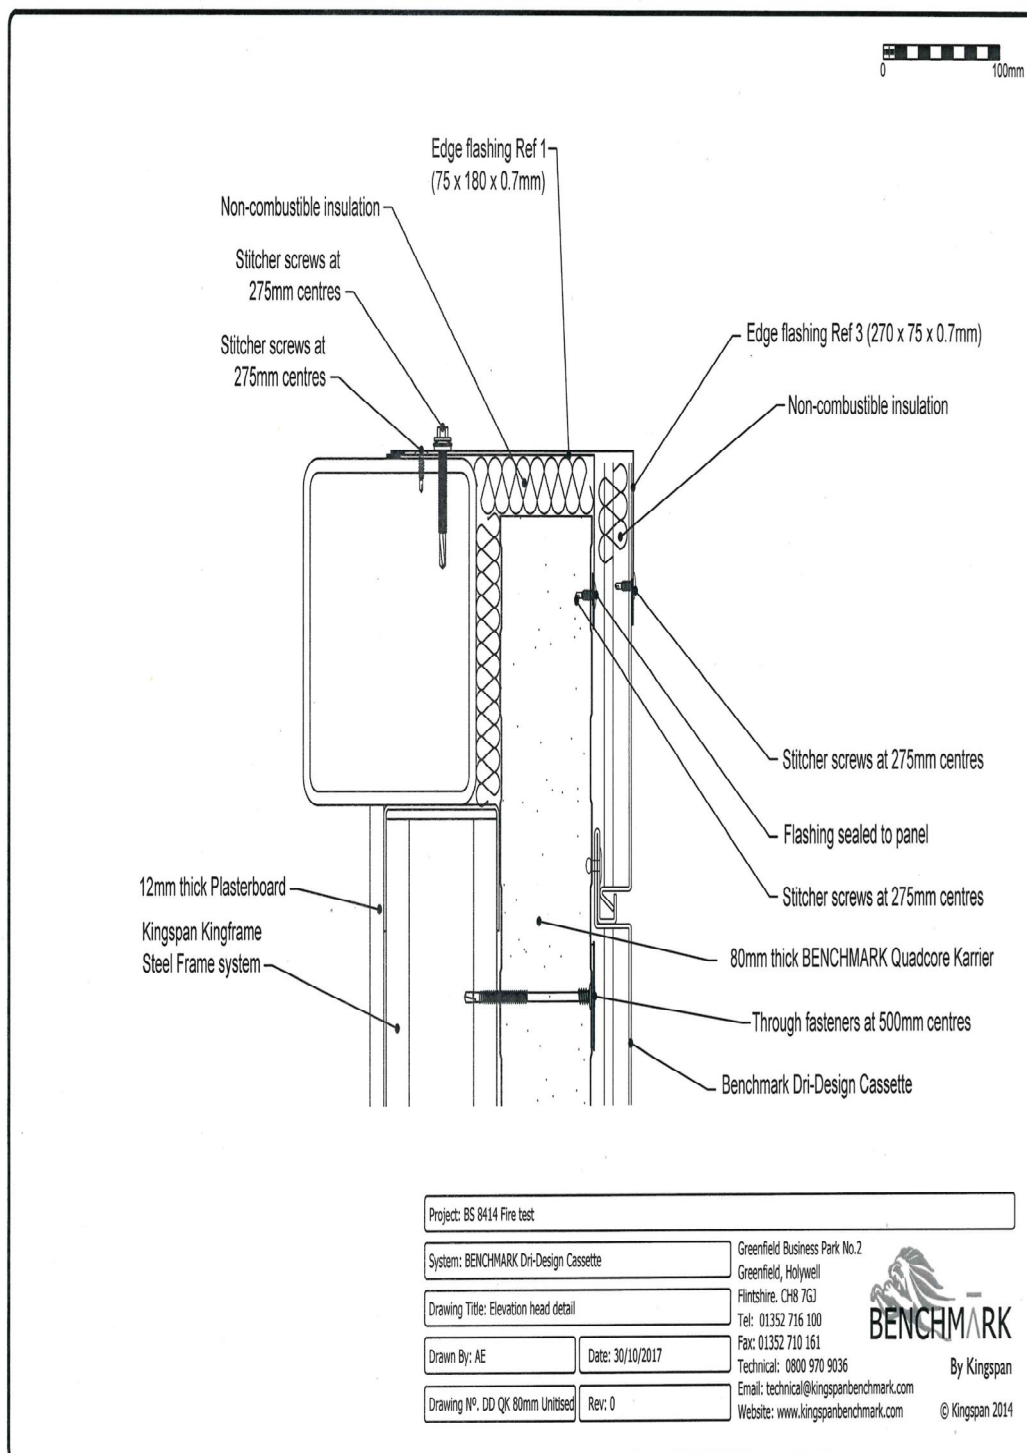
Figure 13. Client supplied drawing – Elevation head detail.

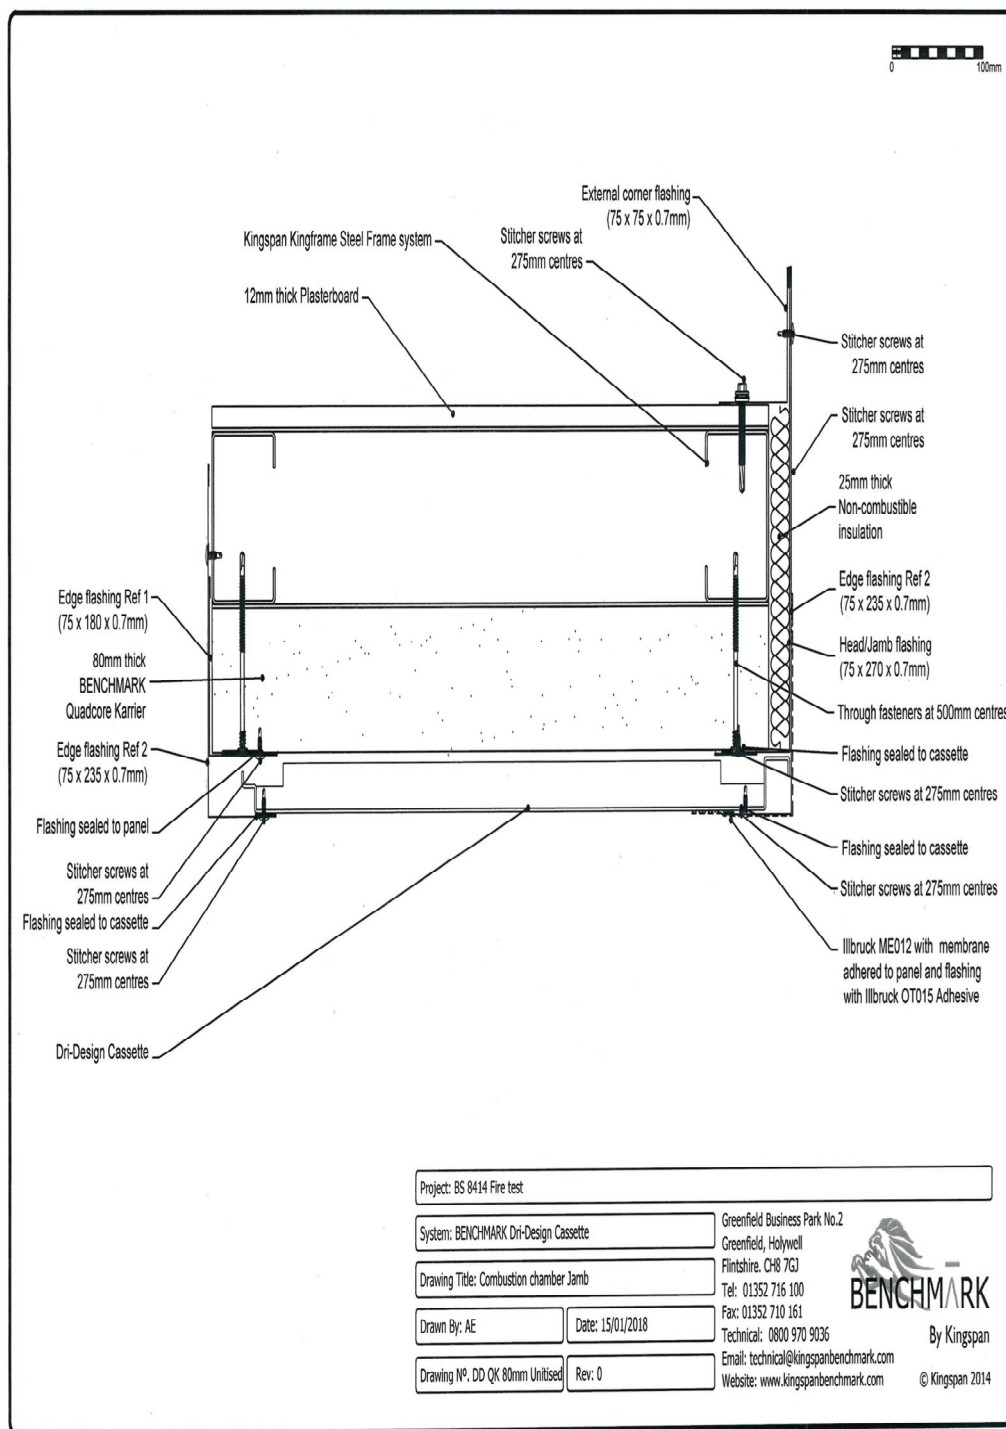
Figure 14 Client supplied drawing -Combustion chamber jamb detail

75mm x 75mm x 0.7mm flashing was installed on the rear of the system and attached to the plasterboard using 4.8mm x 22mm stitching screws at 275mm centres. Stone wool insulation was installed across the width of the wall and this was secured in place with 75mm x 270mm x 0.7mm 'Head/Jamb flashing'.

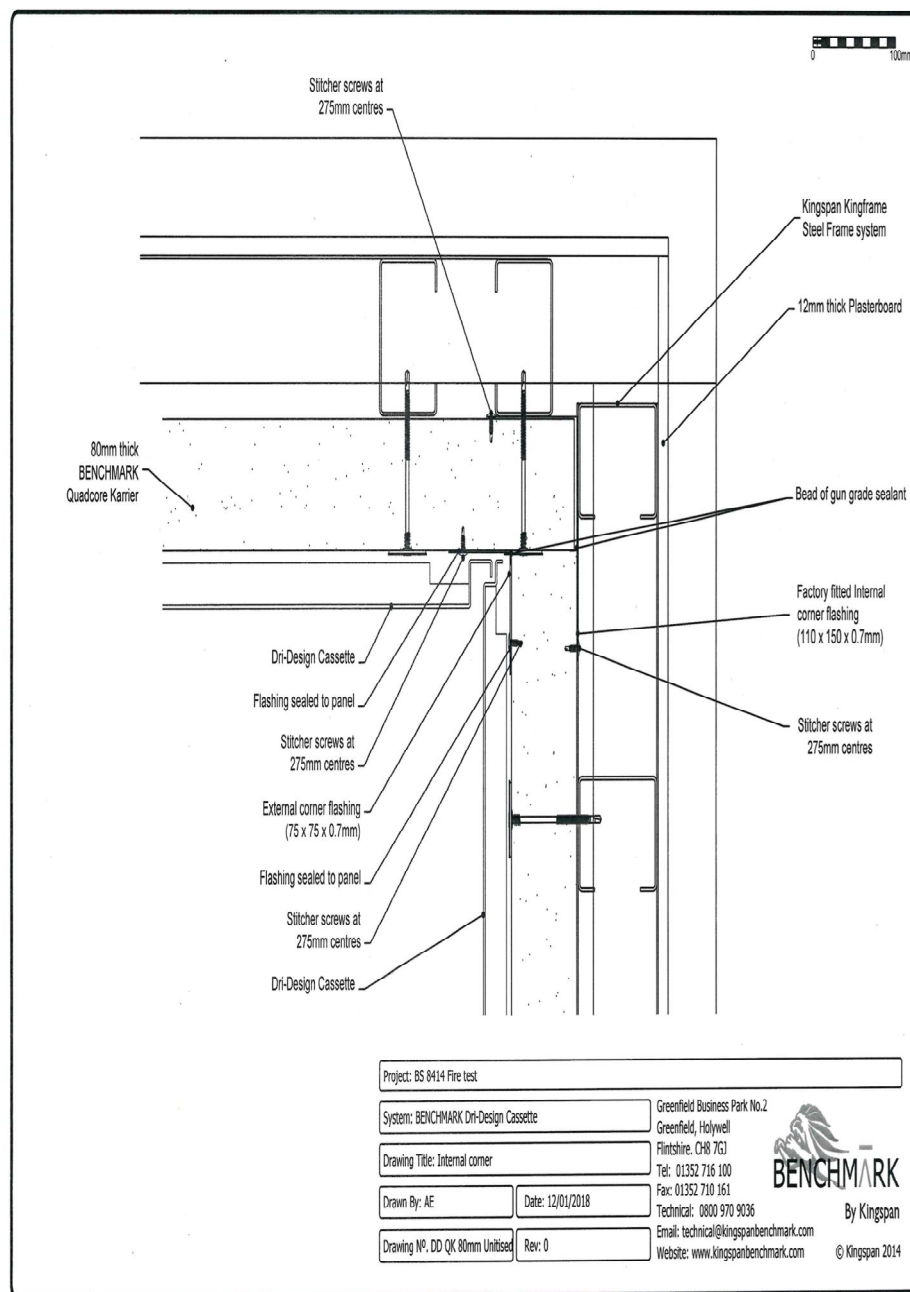
Figure 15. Client supplied drawing - Corner detail.

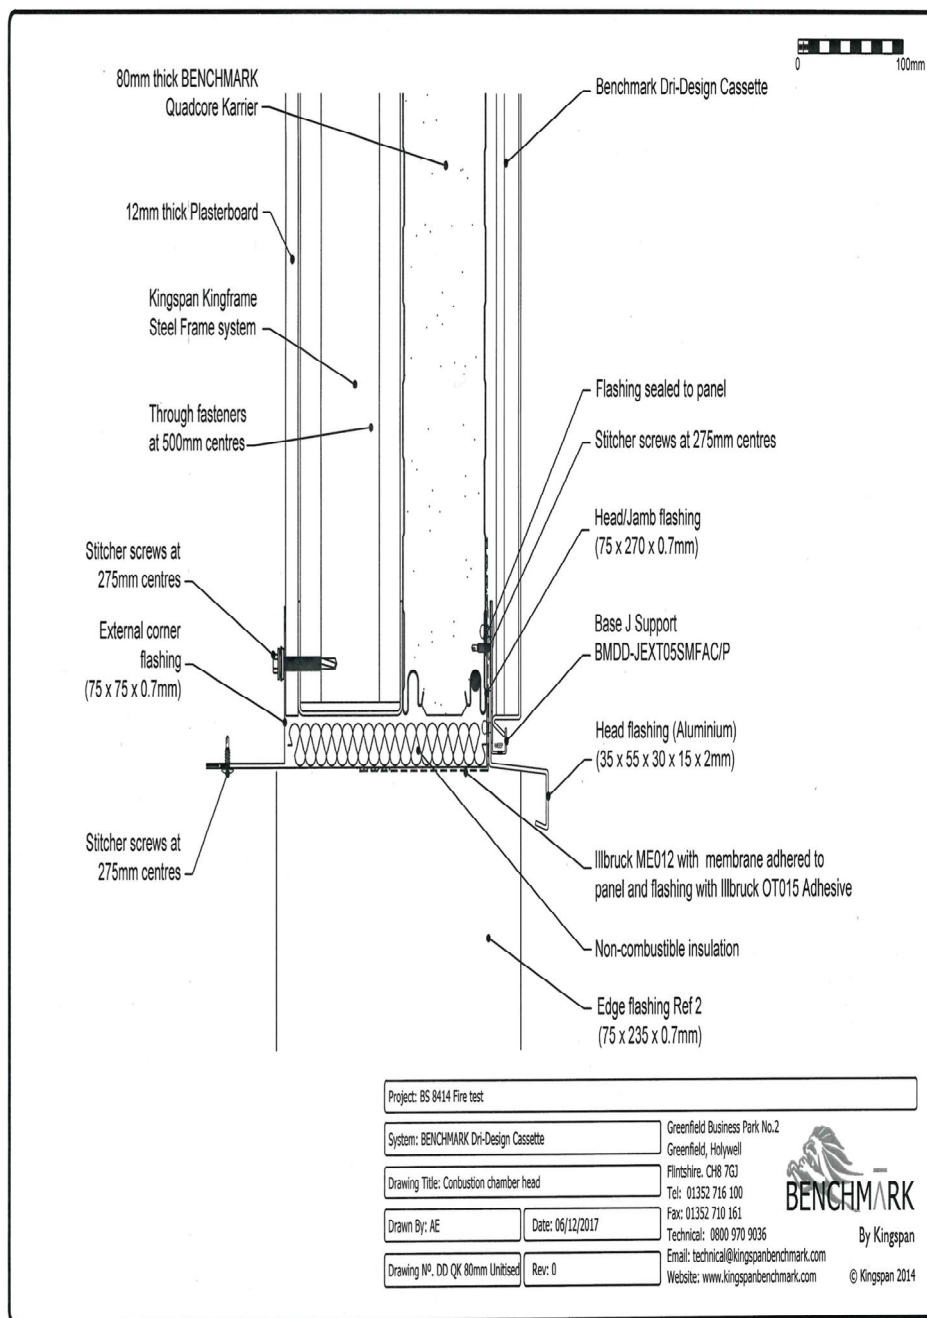
Figure 16. Client supplied drawing – Combustion chamber head

An aluminium head flashing (35x55 x 30 x 15 x 2) was placed in position across the top of the combustion chamber with the 'Base J Support' BMDD-JEXT05SMFAC/P in front. Both items were secured into place with a single rivet 'Omega Support-KSMR-ACM SSAL 4.8 x 18 x 16mm fixed every 275mm.

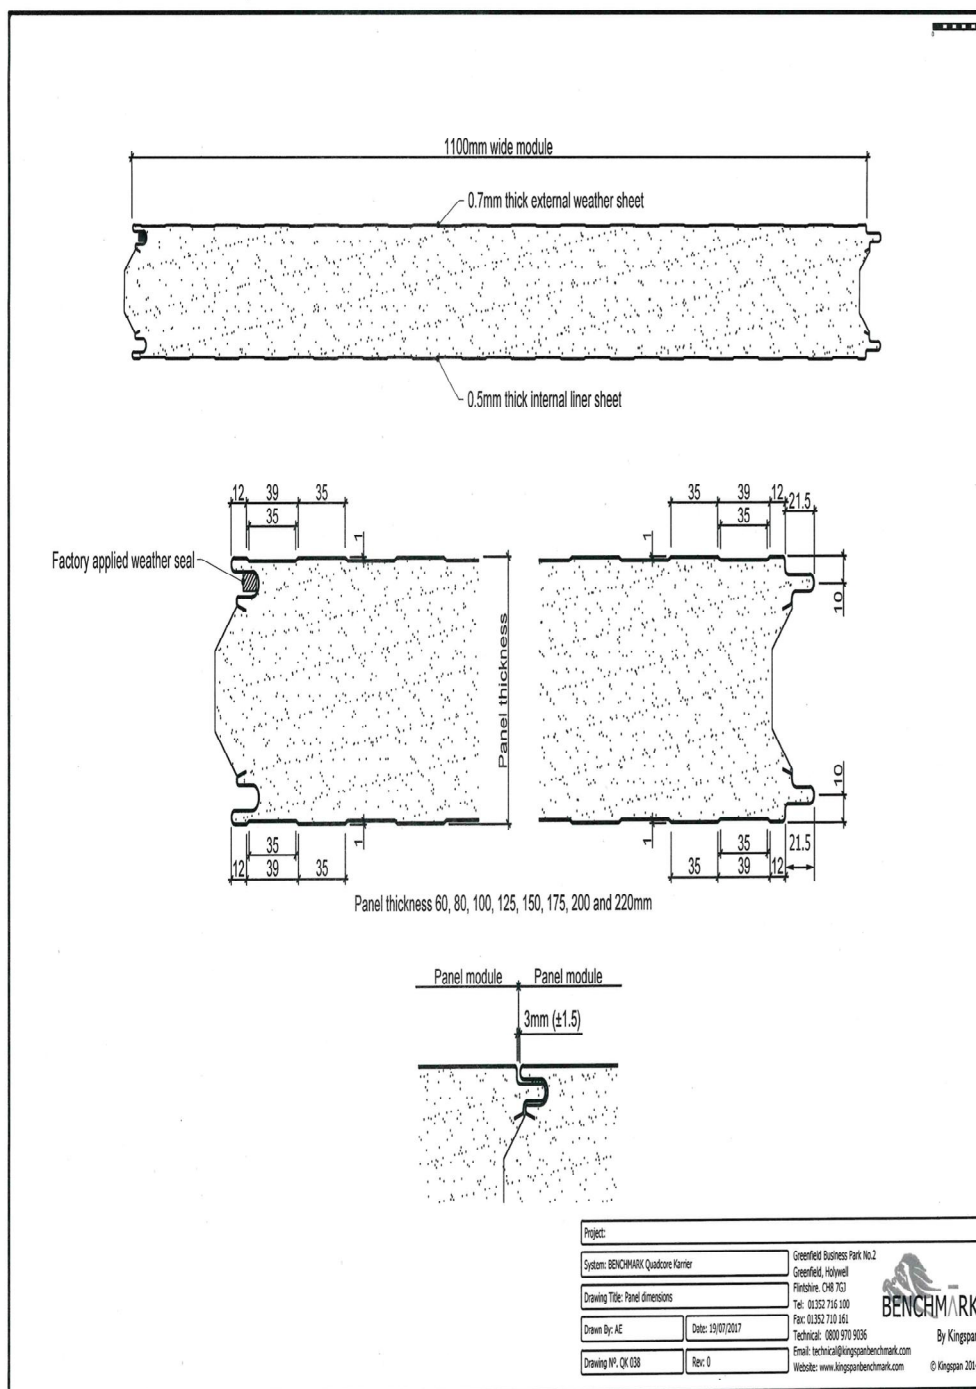
Figure 17. Client supplied drawing – Cross section of BENCHMARK QuadCore™ Karrier panel
