# Façade Fire Performance: Understanding large scale façade fire testing

New Zealand, December 2019 Edition

# Understanding large scale façade fire testing

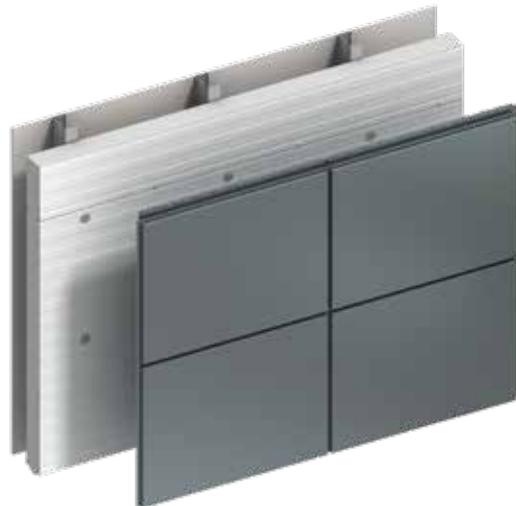
**Figure 1.** This photograph shows a recent successful BS 8414 test on a Kingspan system.

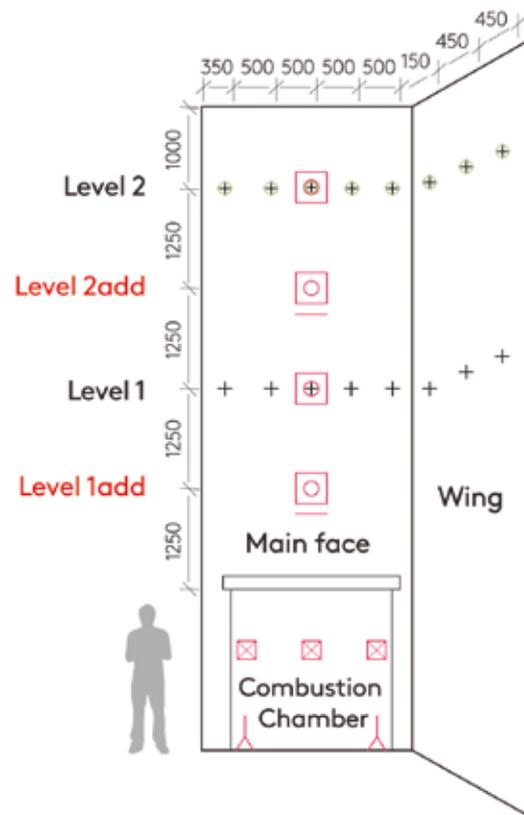
**Figure 2. BS8414 Test Setup.** This diagram shows level 1 and level 2 and the marks indicated in grey and green are thermocouples. During the test, temperature is measured through the thermocouples and there are levels that are not permitted to exceed. This measures fire propagating within the façade system.

During the test, temperature is measured through thermocouples to see whether fire is propagating within the façade system.

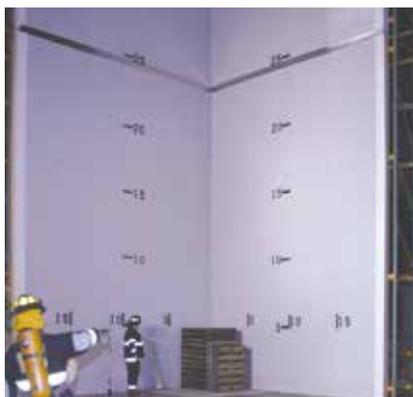
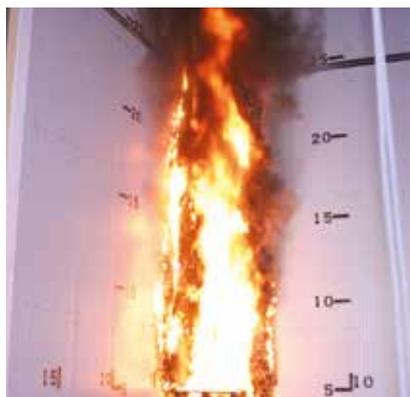
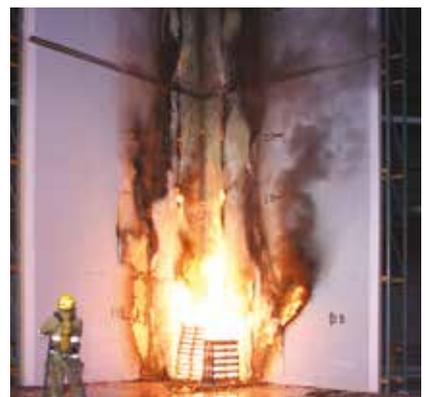
**Figure 3. FM 4880/FM 4881 Test.** The 50ft test shown below forms part of assessment requirements for approval to Class 1 internal wall and ceiling panels with no height restriction (FM 4880) and external walls with no height restriction (FM 4881).

Test set up

Fire development

End of test

The two wings/walls are 50 feet high and 20 feet in width.

Some way up the wall you can see a horizontal line indicating a failure point.

Similar to other reaction to fire tests, there are also thermocouples embedded within the insulation and used on the test rig.

344kg of dry oak makes up the fire ignition source.

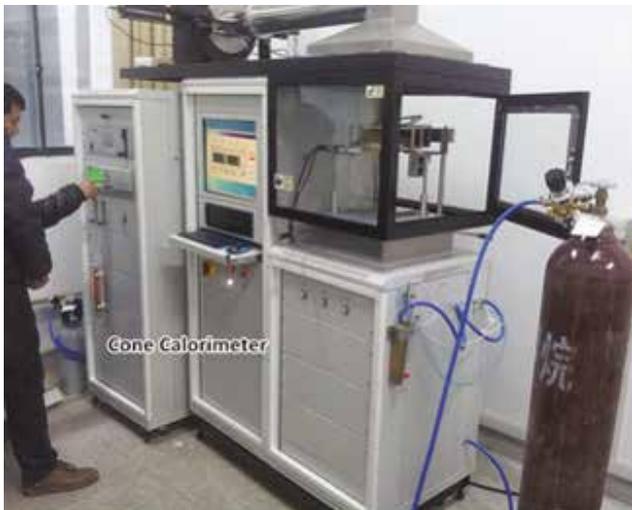
Figure 4. Cone Calorimeter Small Scale Test.

ISO 5660-1 is a small-scale radiant heat test (no direct flames).

The test results are given as Peak Heat Release Rate (PHR) in  $\text{kW/m}^2$  and Total Heat Released (THR) in  $\text{MJ/m}^2$ . The lower the values the better the performance.

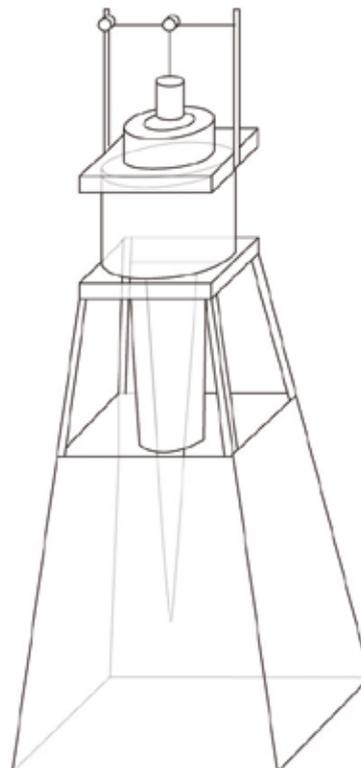
Figure 5. Non-Combustible Small Scale Test.

A small-scale test that is used to determine non-combustible status, AS1530.1 is a pass or fail test.

Sample size of  $45 \times 50\text{mm}$  is tested and failure occurs if:

- Any flaming of the specimen (5 seconds or more)
- Furnace temperature rises by more than  $50^\circ\text{C}$
- Specimen temperature rises by more than  $50^\circ\text{C}$ .

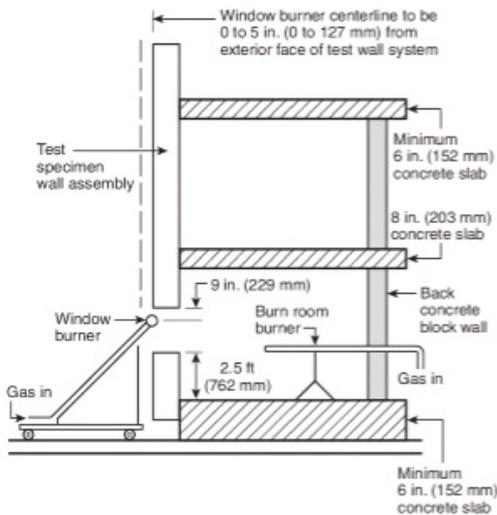
Figure 6. NFPA test: section view of burner placements for first-storey test room (not to scale)

One gas burner is placed inside the lower storey and provides a maximum heat output of 900kW after 30 minutes and a second smaller burner, placed near to the test wall is turned on after 5 minutes.

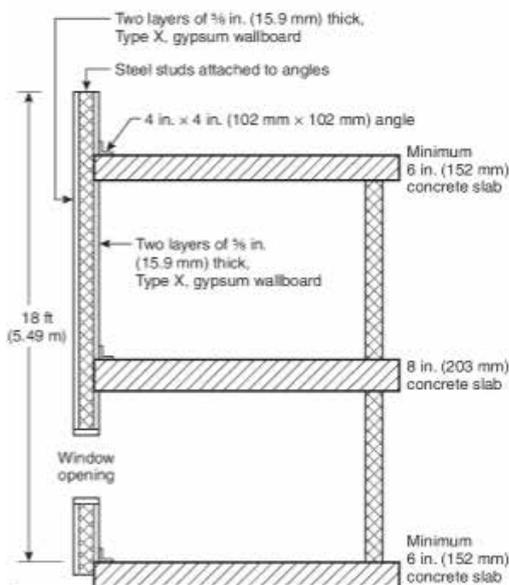
Figure 7. NFPA test: section view of calibration wall assembly (not to scale)

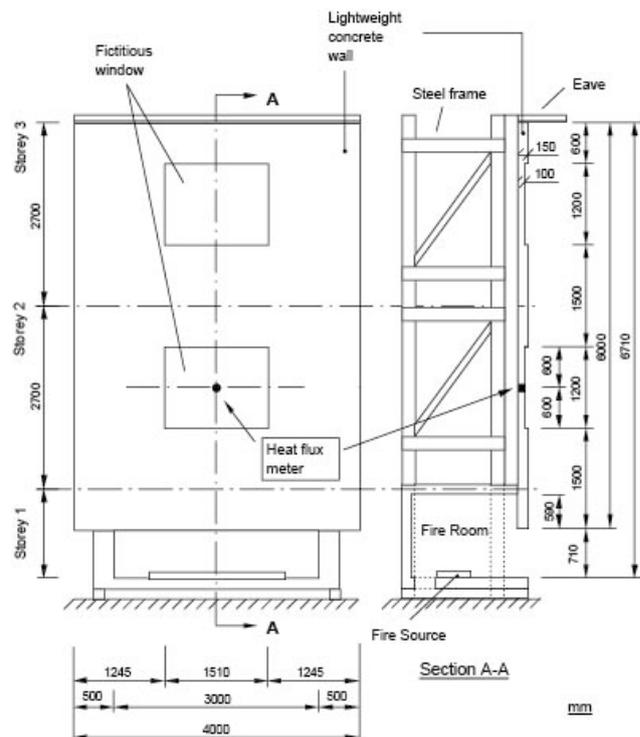
Figure 8. Test rig used in SP Fire 105.

The size of the test facade is 4m wide x 6m high, and the test configuration should represent the actual facade system as closely as possible. Any falling pieces or droplets are noted and assessed. The temperatures of the fire effluents above the eaves are measured, as is the heat flux at the center of the window on the first storey.

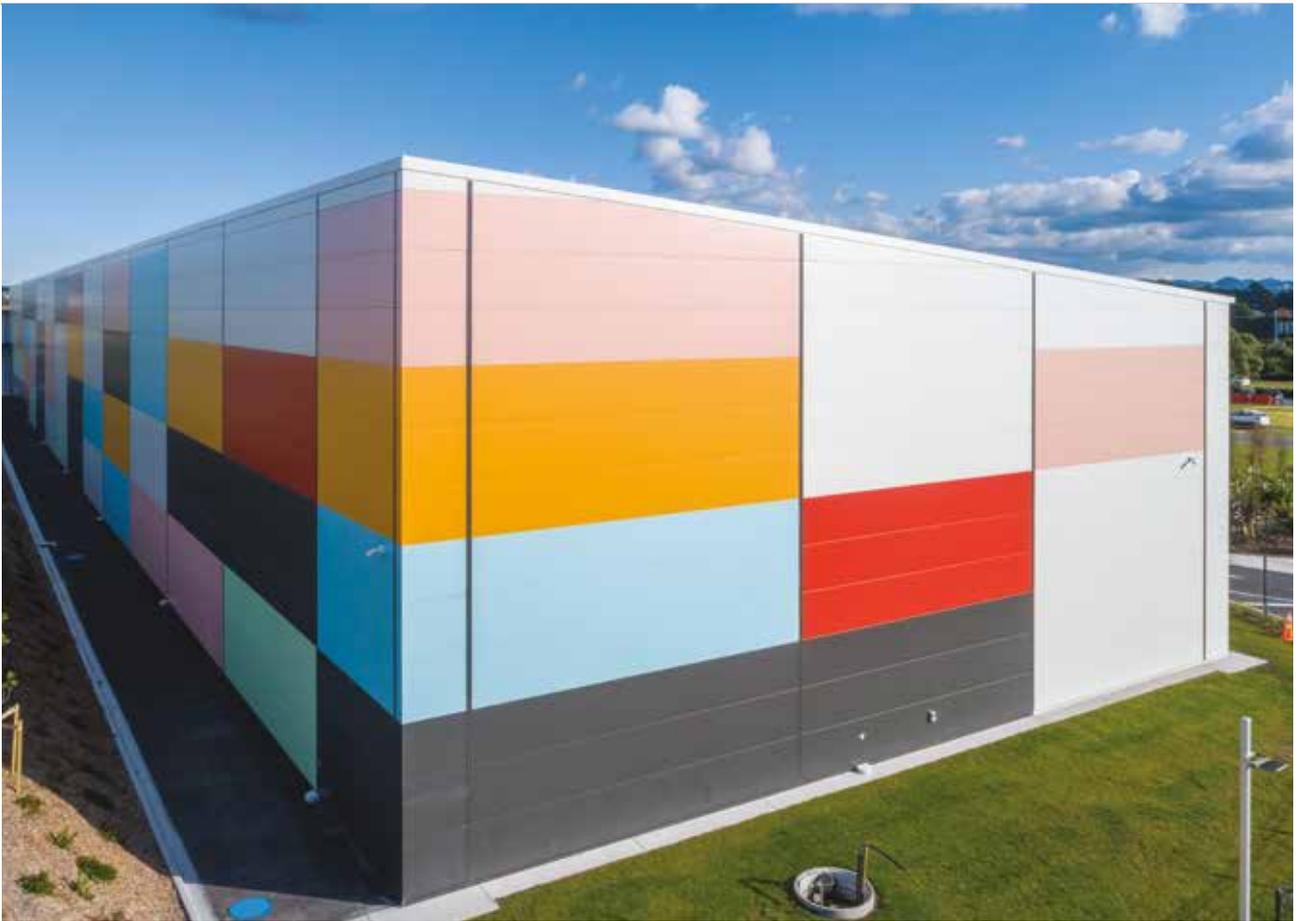
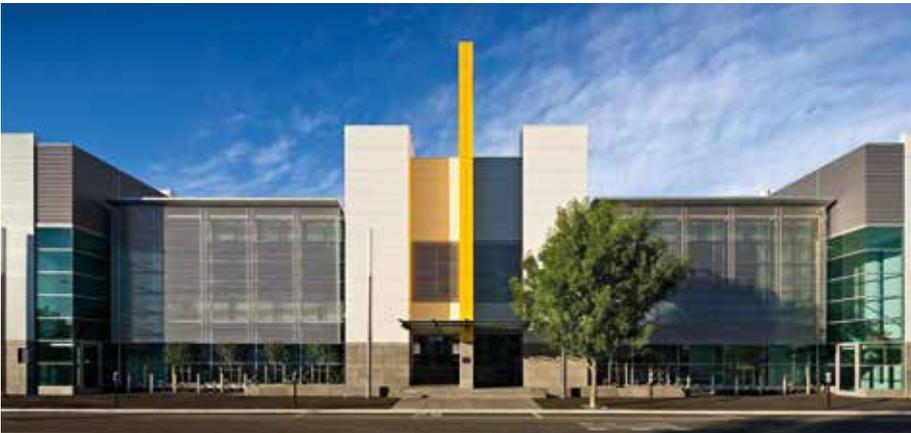
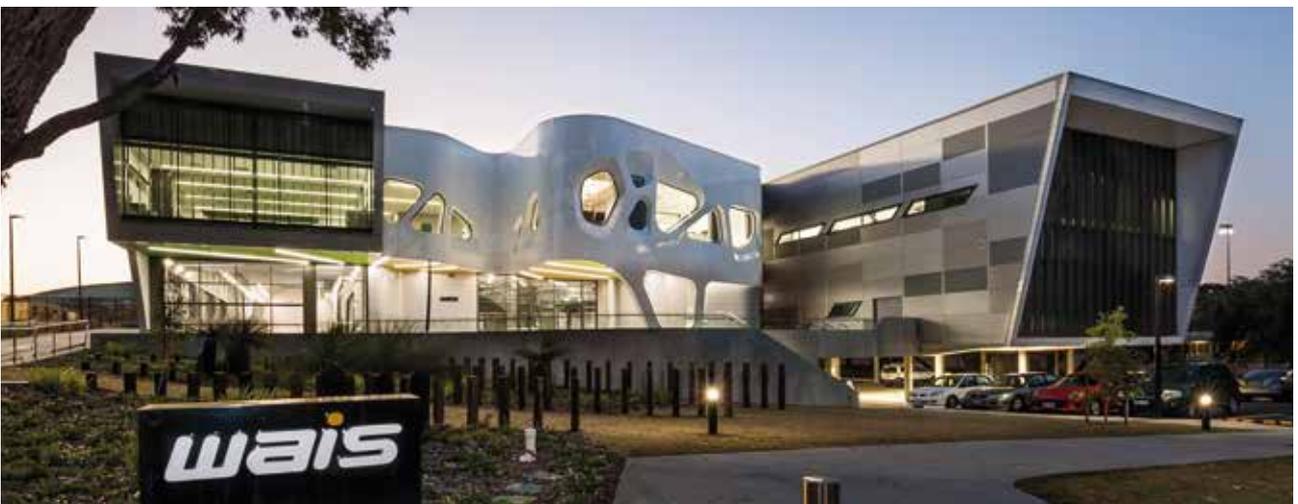
Used in Sweden and the Nordic countries to assess the fire performance of facade systems, SP 105 is intended to represent a scenario of a fire in a particular storey in a building, of which the window has failed. It aims to assess the impact of flames emanating from a window on the cladding system above.

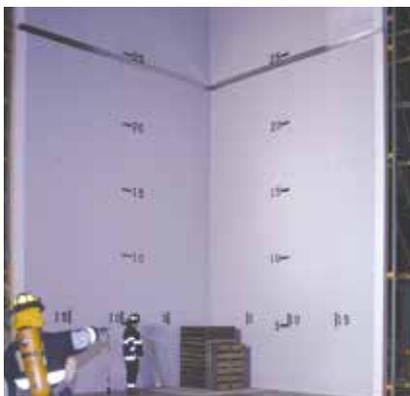
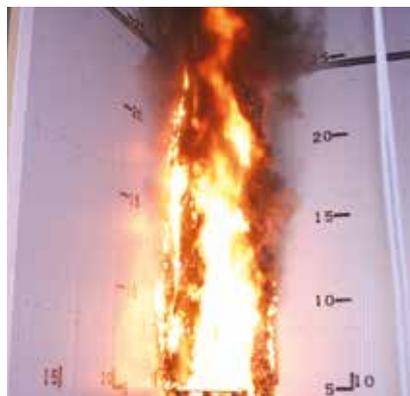
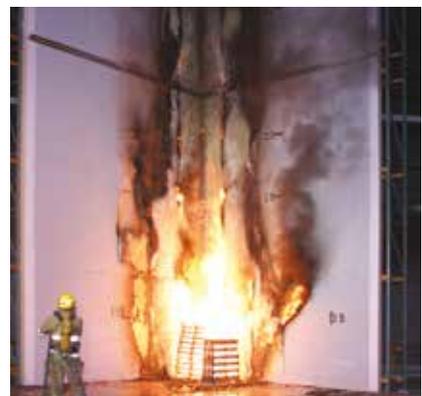
Test set up

Fire development

End of test

**Figure 9. FM 4880/FM 4881 Test.** The 50ft test shown below forms part of assessment requirements for approval to Class 1 internal wall and ceiling panels with no height restriction (FM 4880) and external walls with no height restriction (FM 4881).

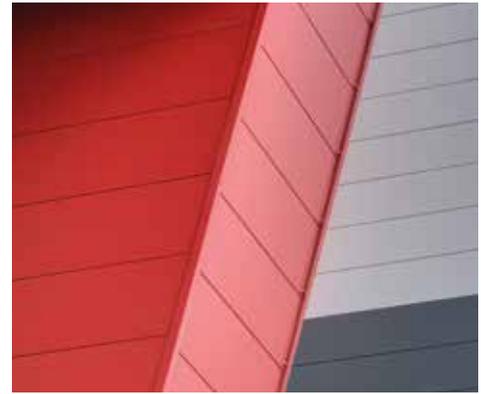
Substrate	Insulation	Fire Breaks / Cavity Barriers	External Finish	Generic Cladding Type
Lightweight Steel Frame	150mm Kingspan Evolution Wall Panel with ECOsafe PIR Insulation Core	No Cavity Barriers Used	150mm Kingspan Evolution Wall Panel with ECOsafe PIR Insulation Core	Insulated Sandwich Panel Facade System

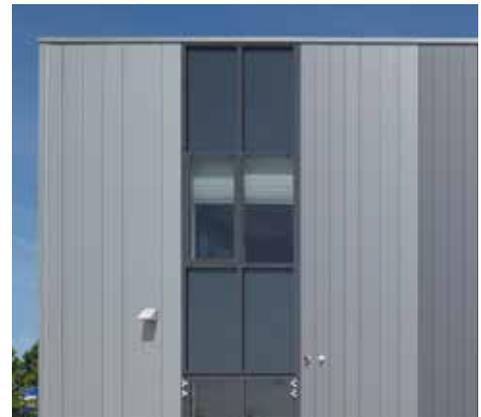
Substrate	Insulation	Fire Breaks / Cavity Barriers	External Finish	Generic Cladding Type
Lightweight Steel Frame	140mm steel-faced Architectural Wall Panel with PIR insulation core	No Cavity Barriers Used	140mm steel-faced Architectural Wall Panel with PIR insulation core	Insulated Sandwich Panel Facade System

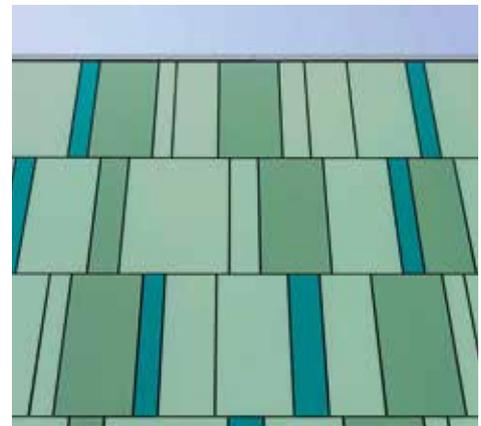
Substrate	Insulation	Fire Breaks / Cavity Barriers	External Finish	Generic Cladding Type
Lightweight Steel Frame	100mm steel-faced Wall Liner panel with PIR insulation core	Horizontal Intumescent Cavity Barriers	3 mm Aluminium Cassette System (Hook-on)	Aluminium Rainscreen Facade System

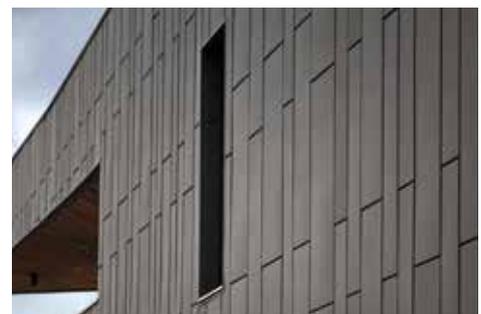
Substrate	Insulation	Fire Breaks / Cavity Barriers	External Finish	Generic Cladding Type
Lightweight Steel Frame	80mm QuadCore™ Insulation Core Karrier Panel  POWERED BY <b>QuadCore</b> TECHNOLOGY	No Cavity Barriers Used	Aluminium Dri-Design Cassette Facade System	Aluminium Rainscreen Facade System

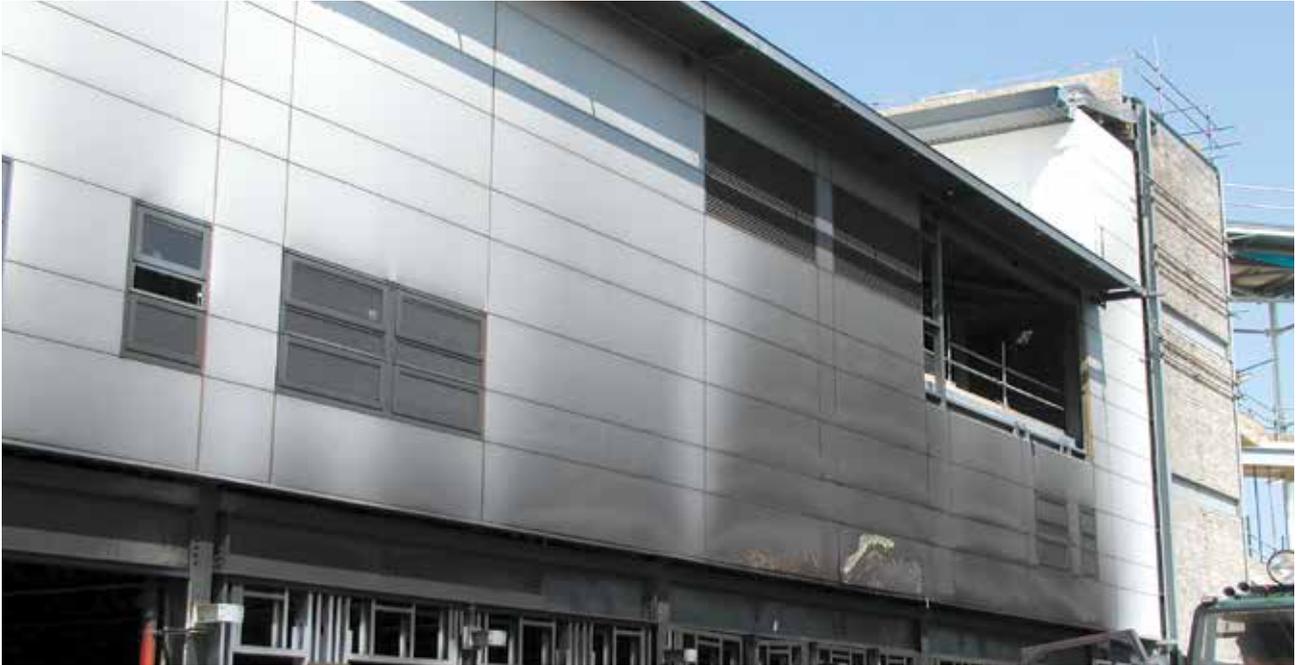
Photograph 1

It was thought that the fire was started deliberately by adhesive being poured over slabs of insulating material which were stored on the ground floor. *Photograph 1* shows the fire area.

The heat generated by the fire was significant, as evidenced by cracking of the concrete floor above the fire and the distortion of steel beams that had been protected by a fire resisting intumescent coating.

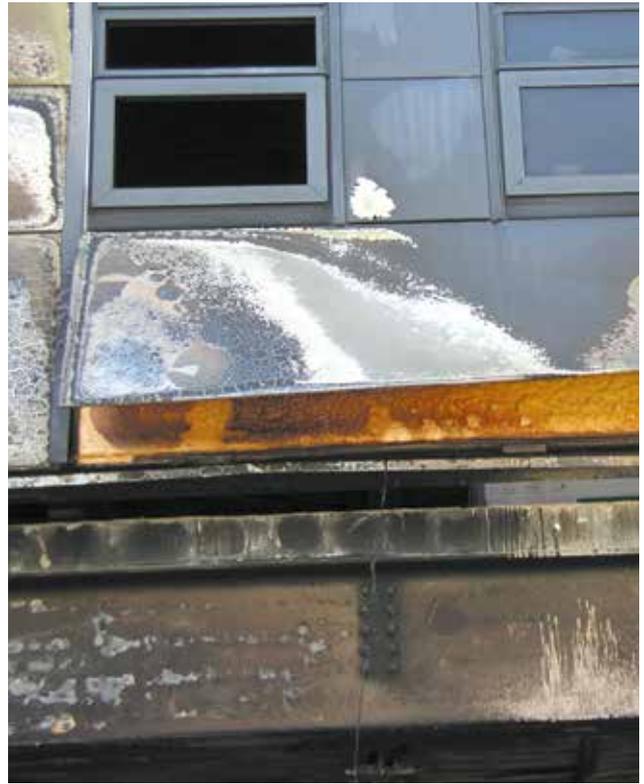
Photograph 2

The fire service found light smoke but no fire spread on the upper floors of the building. They also reported that although the joint between the floor and first floor walls had not been fire stopped there was no fire spread within the Kingspan ECOsafe PIR core material. *Photograph 2* shows where the flame damaged outer skin of the bottom panel has been lifted to inspect the slight charring of ECOsafe PIR core beneath.

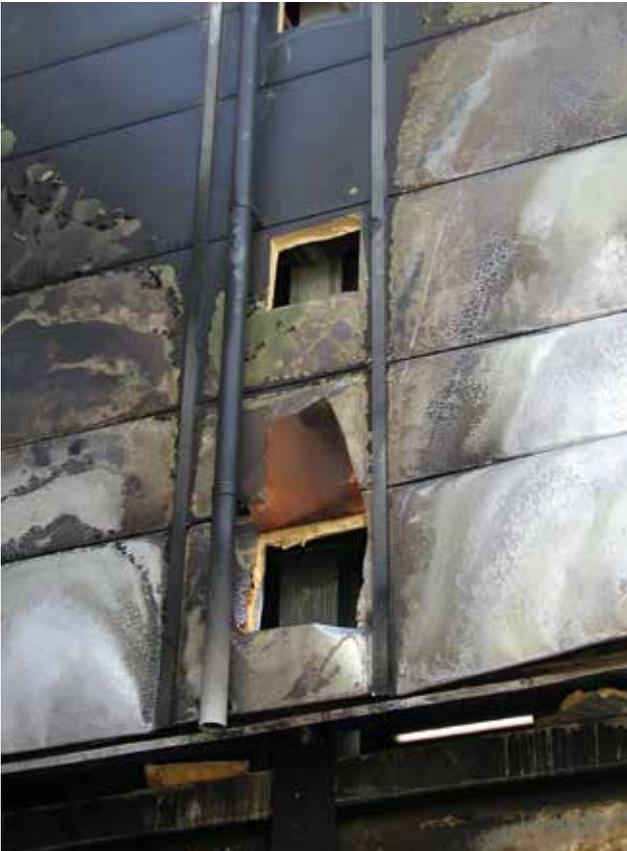
"[The fire service] reported that although the joint between the floor and first floor walls had not been fire stopped, there was no fire spread within the Kingspan ECOsafe PIR core material."

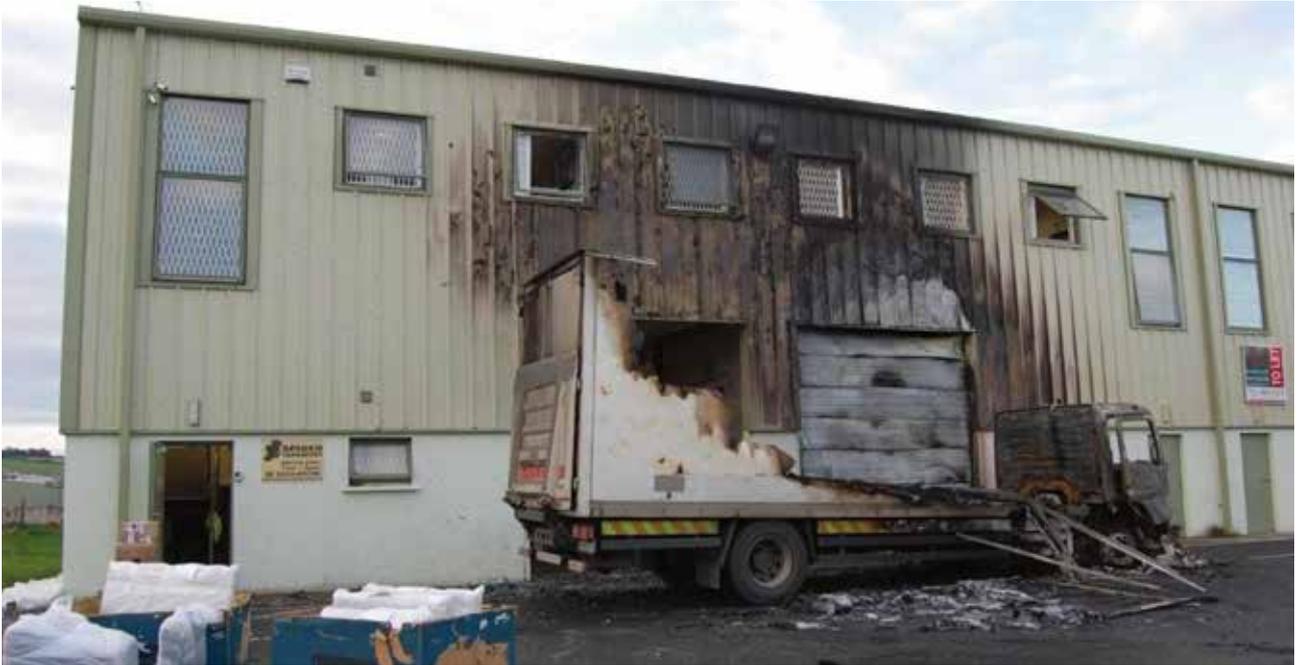
Photograph 1

The fire was started maliciously by two people pouring a flammable liquid over the interior of a vehicle parked across the front of the building. CCTV footage recorded the whole incident and clearly shows the intensity of the fire. Flames impinged on the building and there was an 'explosion' of debris from the sides and top of the vehicle causing a fireball and burning debris to be projected onto the cladding, as captured by the CCTV image (1:33:19 am, opposite page).

*Photograph 1* shows the aftermath of the fire. The upper parts of the external wall consisted of Kingspan Trapezoidal KS1000 RW insulated panels which complied with LPCB Grade EXT-B to LPS 1181 Part 1, whilst the lower parts were constructed of blockwork.

- The integrity of the Kingspan insulated panels was maintained, even immediately above the up and over door where the bottom of the insulating core was exposed to flame impingement and suffered severe charring.
- There were no signs of any spread of heat via the cores of the Kingspan insulated panels to any point within the building and no signs of spread within the cores of those panels.
- There is no indication that the Kingspan insulated panels contributed to the heat damage caused by the fire.

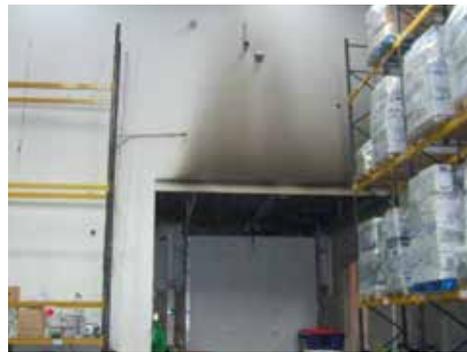
Photograph 2

Although the bottom of the insulating core of the Kingspan insulated panels was directly exposed to flame impingement above the up and over door, there was no delamination of the skins of the panels and the insulation remained in place.

The CCTV footage shows the duration and intensity of the truck fire. *Photograph 2* demonstrates that the fire did not get into the building.

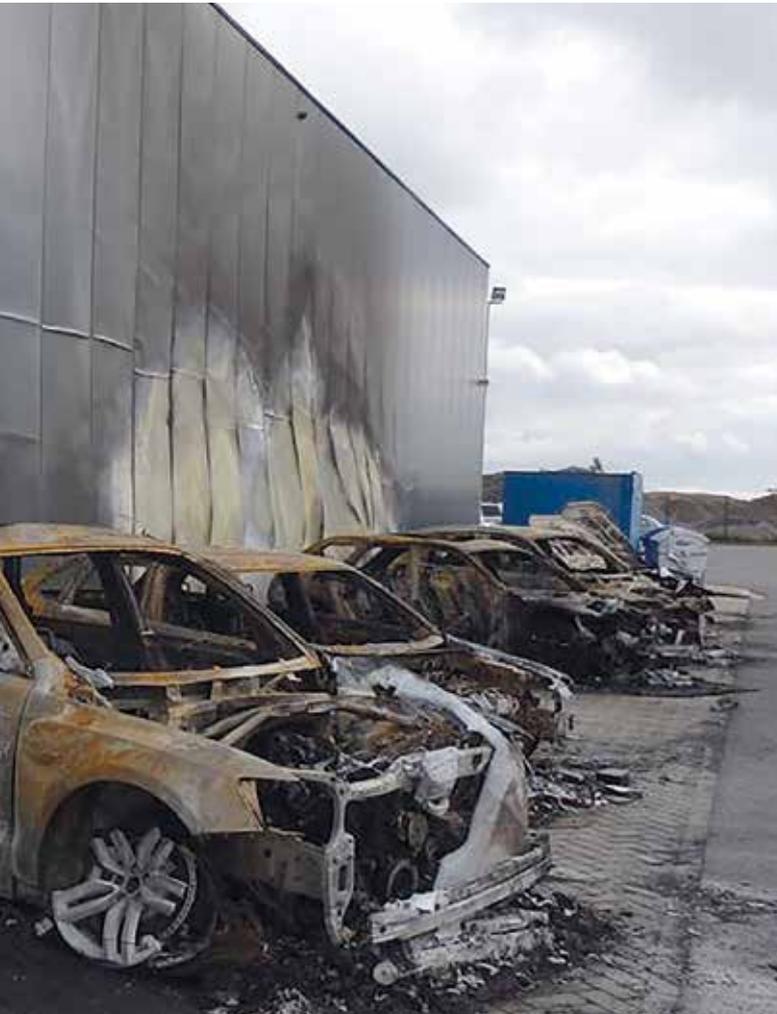
*Photograph 2* shows a sample of the ECOsafe PIR core material removed from the cladding panel at the location of predicted peak incident radiative heat flux of  $31.8\text{kW/m}^2$ . The photograph indicates that the ECOsafe PIR core had pyrolysed to a carbon char to a depth of about 40mm at this location. At locations remote from the area of peak incident radiative heat flux, the charring of the ECOsafe PIR core was significantly reduced, demonstrating that combustion had not been propagated by the ECOsafe PIR core material.

No evidence of fire penetration to interior of the workshop

- The ECOsafe PIR cored sandwich panels were subject to a fire likely to have lasted at least 15 minutes from ignition.
- It is likely that the cladding will have been subjected to peak incident radiative heat flux of at least  $31.8\text{kW/m}^2$  for a period of at least 10 minutes.
- The sandwich panels exposed to these conditions sustained damage in terms of delamination of the exposed steel skin of the panels away from the ECOsafe PIR core, removal of the paint coating and pyrolysis of the ECOsafe PIR core material to a depth of approximately 40mm.
- There was no evidence of fire propagation within the panels.

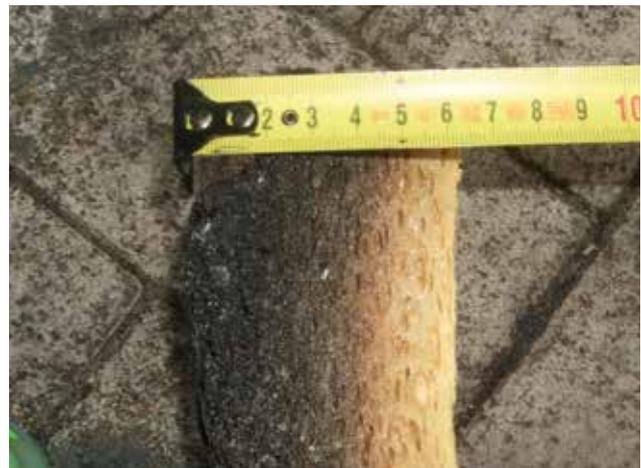
Photograph 2

The inside of the workshop showed no evidence of fire penetration in an area adjacent to the external fire attack.

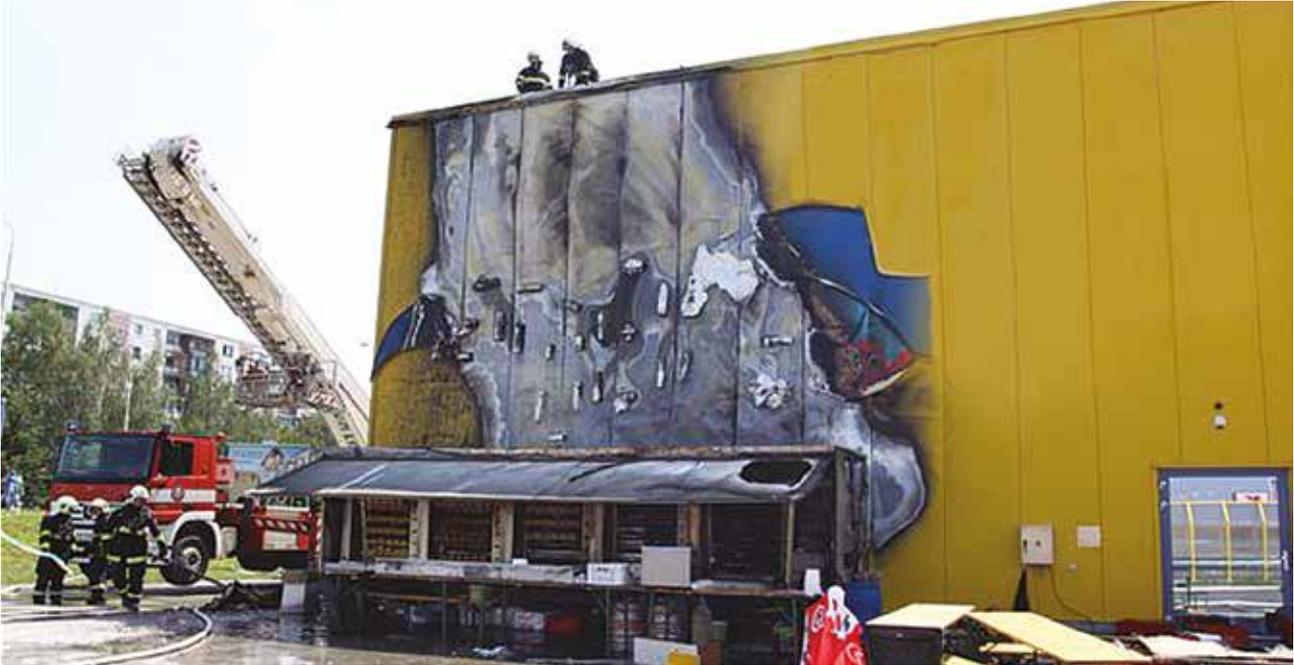
A large fire took place in a furniture store in Presov, Slovakia – a large flat roofed retail building constructed with a concrete frame and clad with Kingspan Insurer Approved ECOsafe PIR core wall panels.

The building measures approximately 100m by 40m with a height to the roof parapet of approximately 8.5m. The fire took place in a food cooking grill area located approximately 1.2m from an external wall. The fire involved the combustible contents of the grill and 5 propane gas cylinders – at the height of the blaze the flames were over 10m high and were impinging directly onto the surface of the panels.

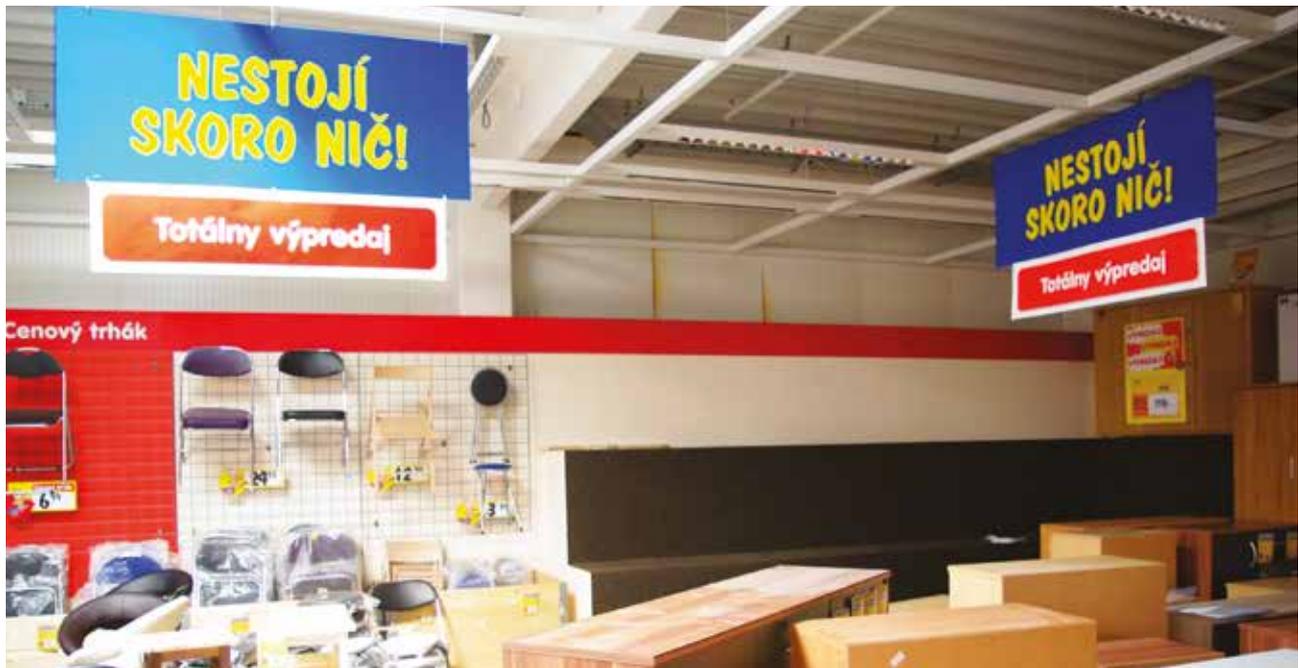
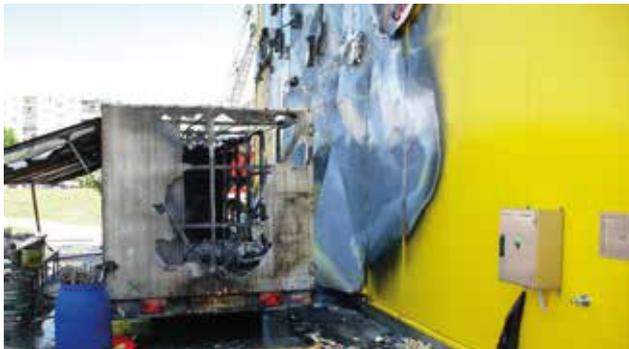
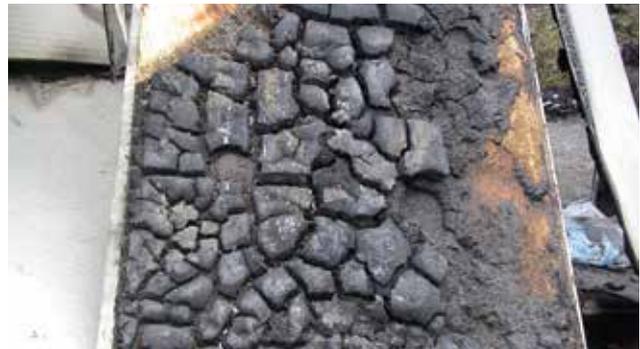
- The Kingspan Insurer Approved ECOsafe PIR core material of the external wall panels charred to a depth of about 10mm in the area directly impacted by the fire plume and the external skin of the panels delaminated from the core in these areas.

- Despite the intensity of the fire plume, the Kingspan Insurer Approved ECOsafe PIR core did not propagate the fire within the panel construction to areas within the core remote from the area of direct fire plume impingement.

- After extinguishing the fire on the outside of the wall panels, fire-fighters found no evidence of smouldering or flaming combustion inside the wall panels.

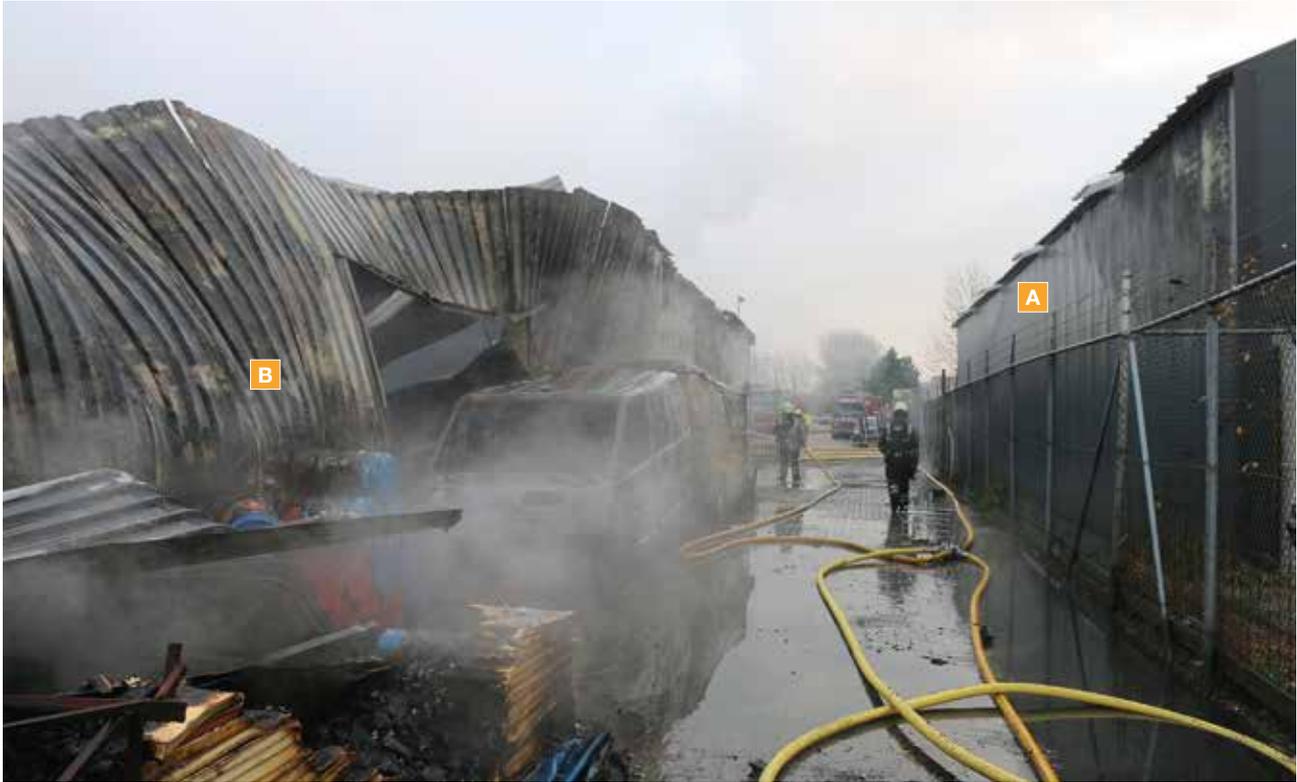
Photograph taken by fire-fighters immediately after the fire.

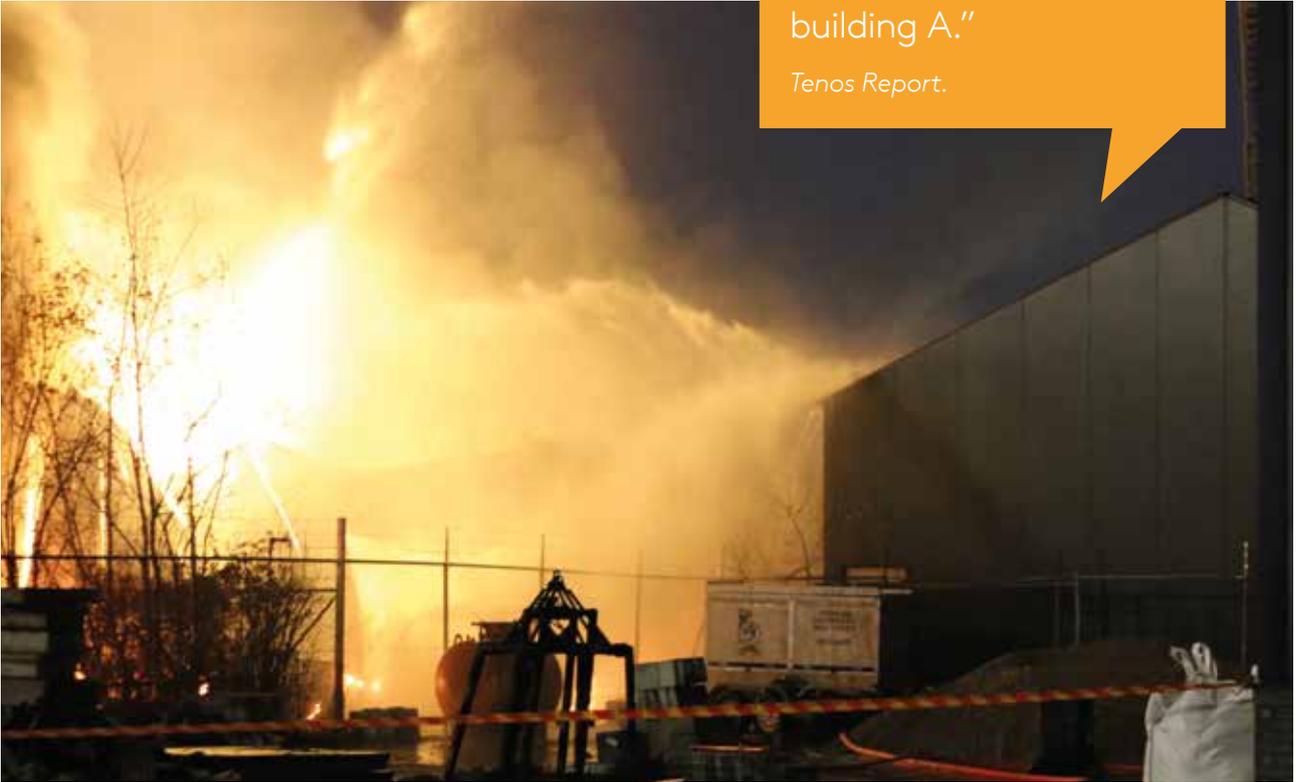
Photograph taken by fire-fighters of the western elevation of building A.

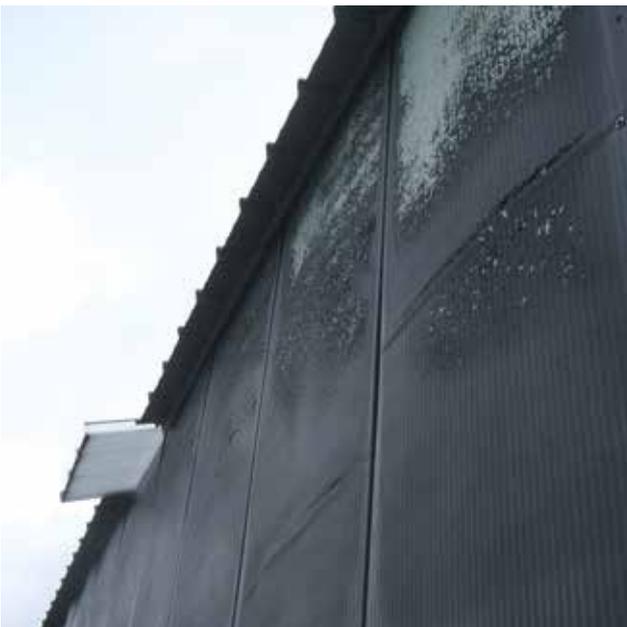
Close-up of damage to the Kingspan ECOsafe PIR wall cladding of building A.

- The fire in building B would have subjected the external facade of building A to levels of radiative heat flux sufficient to cause delamination of the ECOsafe PIR panels and charring of the ECOsafe PIR core.
- The level of fire damage actually sustained by the ECOsafe PIR core panels on building A indicates that the actions taken by firefighters to cool the external facade of building A using water jets had a significant effect in reducing the temperatures achieved by the exposed surfaces of the ECOsafe PIR panels.
- The behaviour of the ECOsafe PIR wall panels in this fire was commensurate with that observed in previous fire case studies.

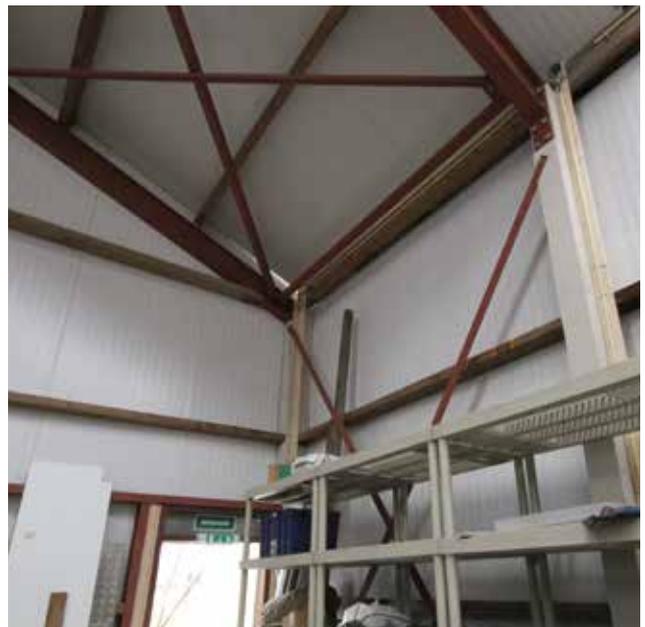
No heat transfer damage to interior of adjacent property (building A).

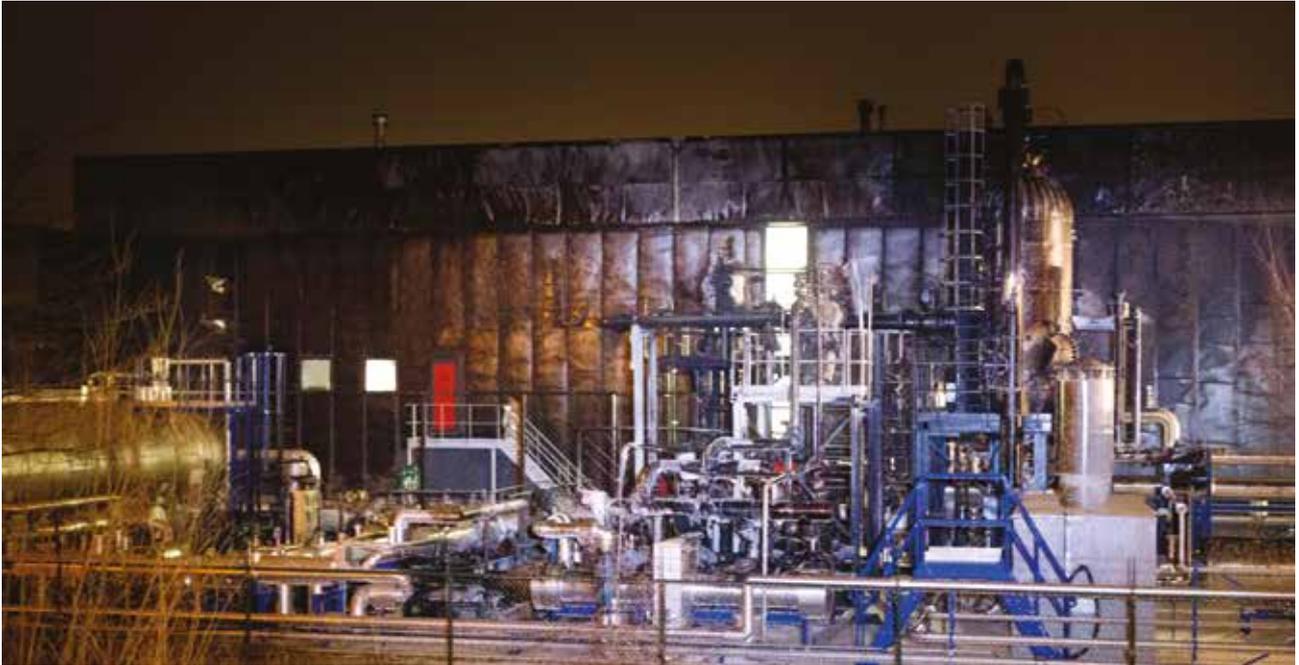
The facility at Arnhem in the Netherlands is used for the testing of equipment for the oil industry. On the 18th January 2013 a fire involving crude oil occurred in an external equipment testing area.

The fire started at about 5.00pm and continued to burn intensely for about 10 minutes with the flame plume, during this period, ranging from 10m to 30m high. After this initial period the fire died down significantly to form a number of smaller separate pool fires. The available video information ends after about 18 minutes of burning; at which time only small pools of flaming remained.

There appears to have been little or no direct flame impingement on the external cladding of the building. However, the building would have been subject to high levels of radiant heat flux from the fire plume and this has been estimated to be of the order of 24 kW/m<sup>2</sup>.

The intensity of radiation received by the panels caused some surface flaming but this ceased after approximately 30s (presumably after the surface coating had burned away). There was otherwise no evidence of self-sustaining flaming from the panel surface or at joints between panels.

As a result of the intensity of heat radiation the steel facing to the panels became rippled and delaminated from the foam core but there was only limited foam degradation at the core surface.

Despite the intensity of heat radiation being sufficient to cause ignition of the roofing system and being approximately double normal design values there was no evidence of any significant charring of the ECOsafe PIR panel cores or the promotion of fire spread via the panels.
