# BRE Global Test Report

**BS 8414-1:2015 + A1:2017 test on a ventilated façade system with Kingspan Kooltherm K15 insulation and Alpolic/fr panels.**

**Report Number:** P107017-1000 **Issue:** 1

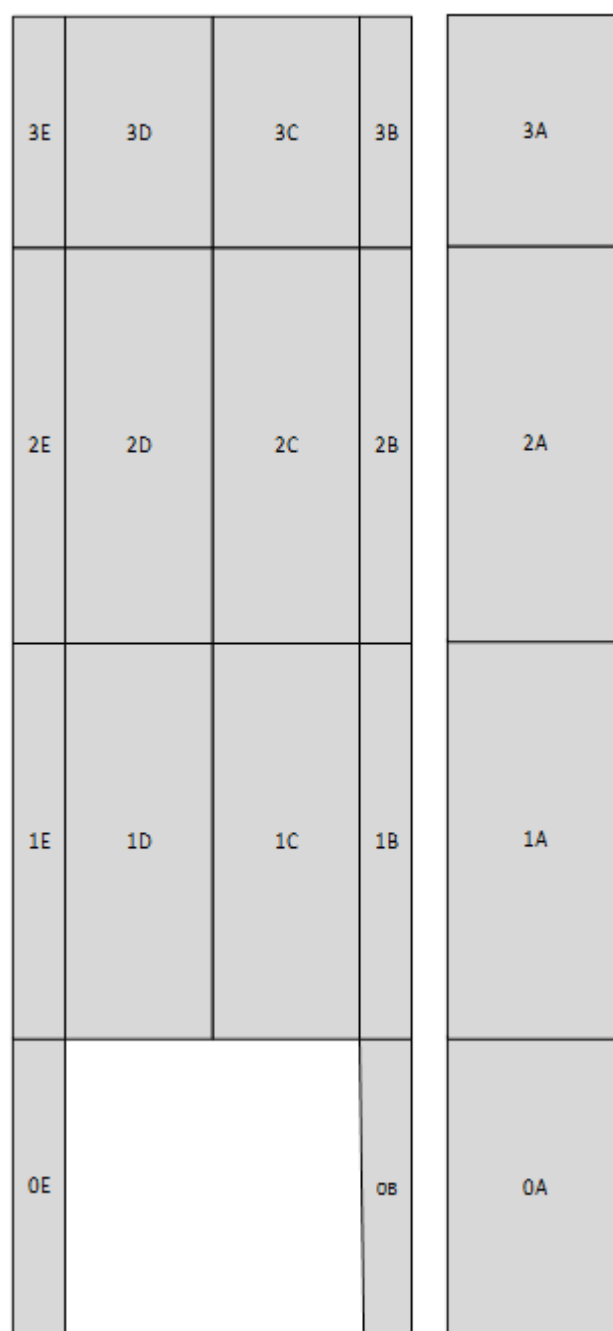
Figure 2. Layout of panels and numbering system used for reporting. Not to scale.

Row 0 – Panel 0A was significantly distorted and discoloured (approximately 70% panel coating removed, 25% dark discolouration). On panel 0B there was a small area (approximately 300mmx150mm) of dark discolouration in the top left hand corner of the panel (adjacent to the combustion chamber). Panel 0E was not visibly damaged.

Row 2 – Panel 2A was distorted and discoloured (<10% panel coating removed, 50% dark discolouration). Panel 2B was distorted and discoloured at the base of the panel (small areas of panel coating removed, 40% dark discolouration). Panels 2C and 2D were damaged across the full panel surface: panel consumed (55% and 40% respectively), distorted and discoloured across the remaining panel. An area approximately 1500mm x 400mm of panel 2D remained loosely attached with consumption of the panel core. Small holes approximately 50mm x 300mm and 50mm x 50mm were observed in panel 2D approximately 3750mm above combustion chamber. Panel 2E was distorted and slightly discoloured.

Row 3 – Panels 3A&3B had minor distortion. Panel 3C was distorted and discoloured (small areas of panel coating removed, approximately 30% dark discolouration). Panel 3D was distorted and discoloured (small areas of panel coating removed, approximately 25% dark discolouration). Panel 3E had minimal visible damage.

- 2D. Damage to the insulation was similar to that observed beneath panel 2C, however; a band of significant insulation consumption and detachment extended from approximately mid-height to approximately 300mm below the third cavity barrier. The blockwork was exposed in an approximately 300mm-width which would have been directly below the damaged edge of the remains of panel 2D.
- 2E. Insulation appeared to be undamaged.
- 3B. Insulation appeared to be undamaged.
- 3C&3D. Discolouration of the foil facing most pronounced along centre line of combustion chamber opening.
- 3E. Insulation appeared to be undamaged.

- 0A. The foil facing on the insulation remained intact.
- 1A. Blistering and slight discolouration of the foil facing up to mid-width adjacent to the main wall. Minimal damage from outside edge of wing wall to mid-width.
- 2A. Minor blistering and discolouration was observed in patches directly adjacent to the main wall
- 3A. Insulation appeared to be undamaged.
