Fire Performance Testing of an External Cladding System BS 8414-1:2015 + A1:2017

Test Report

Prepared for : Kingspan Insulation Ltd.
Project : System Development
Report No. : DLR1453 Rev.0
Sample : Kooltherm K15 –Alpolic/fr - BML100

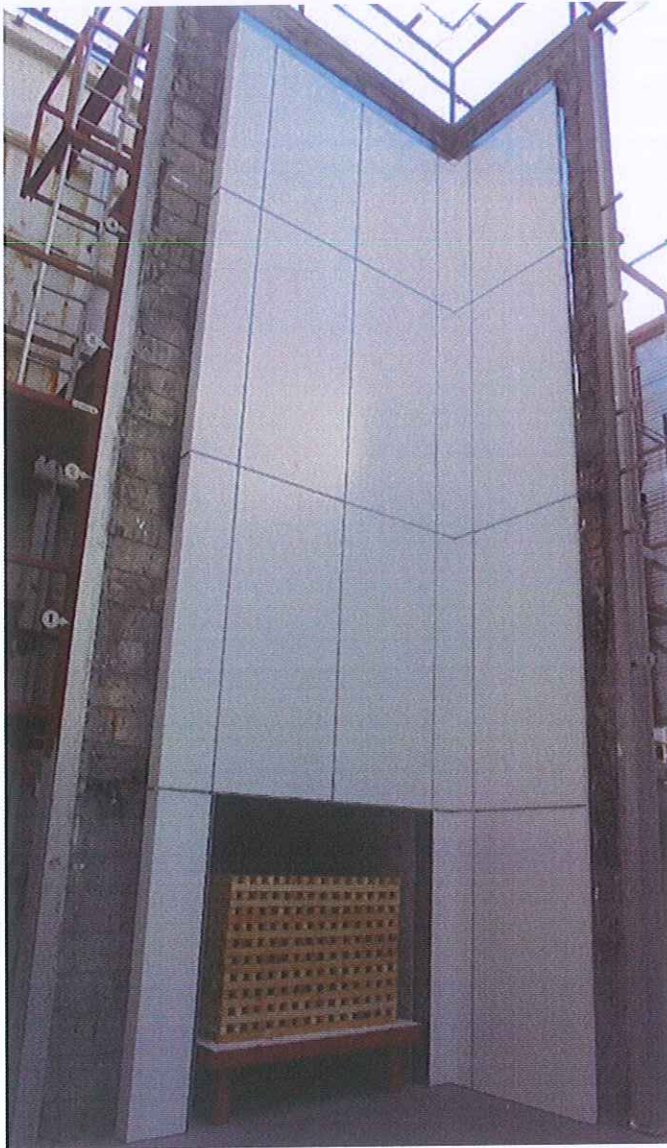
Figure 1 Photo DLP C2753C/7259 External View of the Test Sample

Photo DLP C2753C/7259 shows an external view of the sample.
