**BS 8414-2:2005 test on a
150mm BENCHMARK
Evolution Panel.**

Prepared for:
Kingspan Ltd
Greenfield Business Park No 2,
Holywell,
Flintshire.
CH8 7GJ.

15th May 2014

Test report number 293939

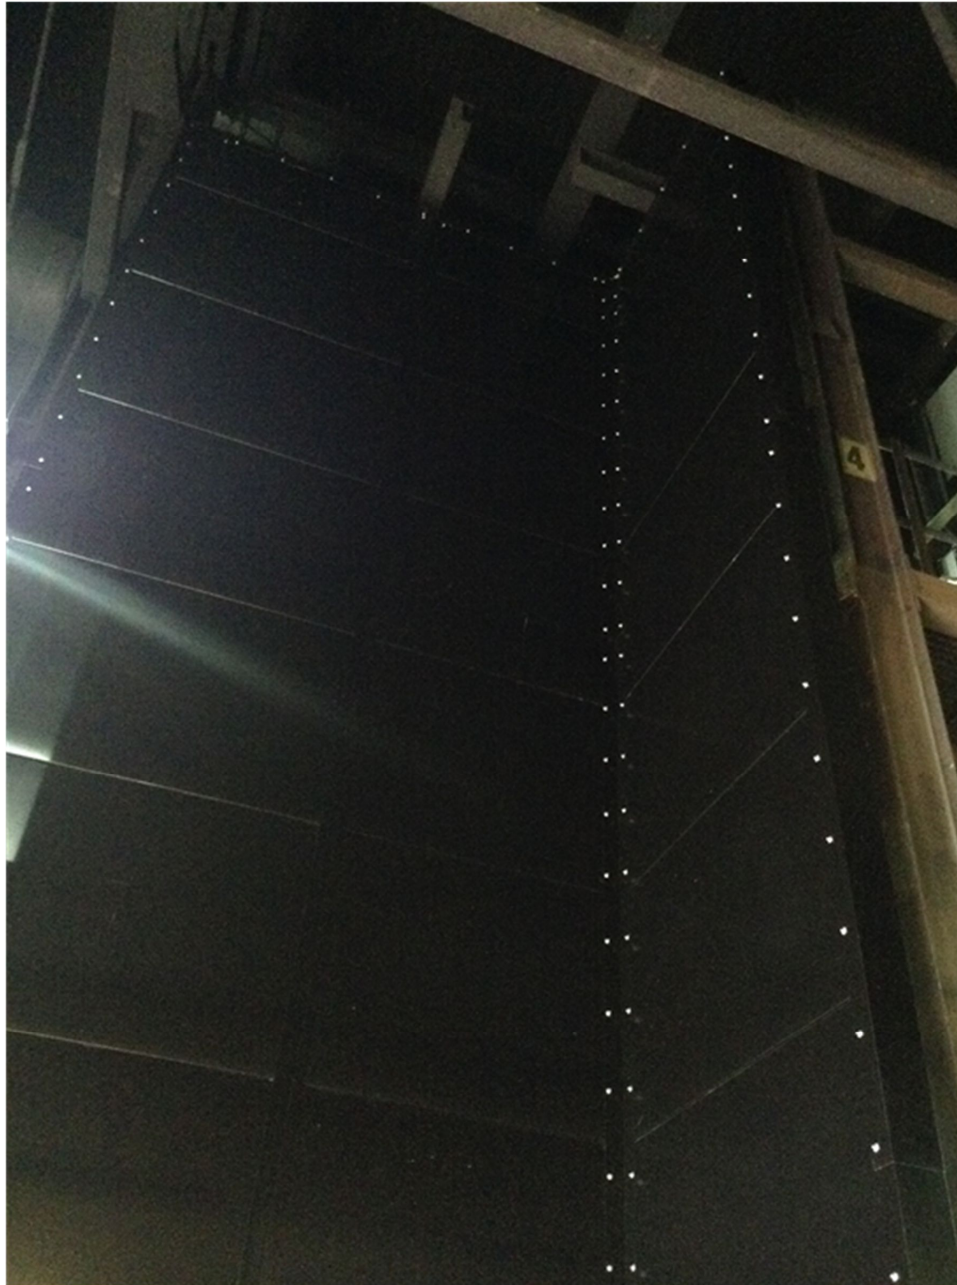
Figure 1. Photograph of the system.

Figure 1 shows the system during construction. The system prior to test is shown in Figure 1. Full details of the system specification and installation details have been provided by the client and are summarised in the following section. The system, as tested, comprised of:

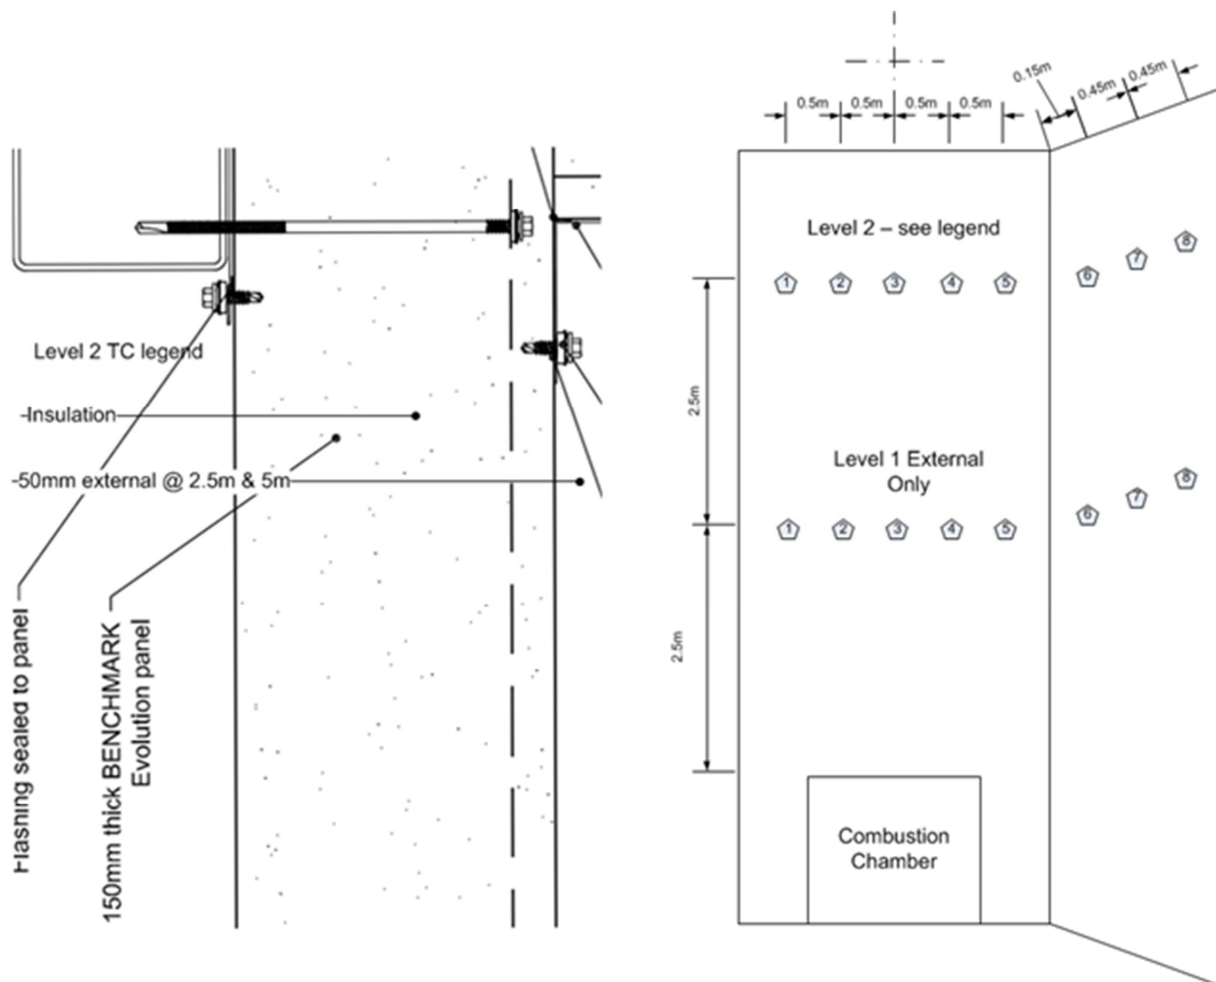
Figure 9. Location and identification numbers of thermocouples used (schematic only)

Figure 9 shows the locations and identification numbers of the thermocouples for the test specimen and also the face references used to describe the system.

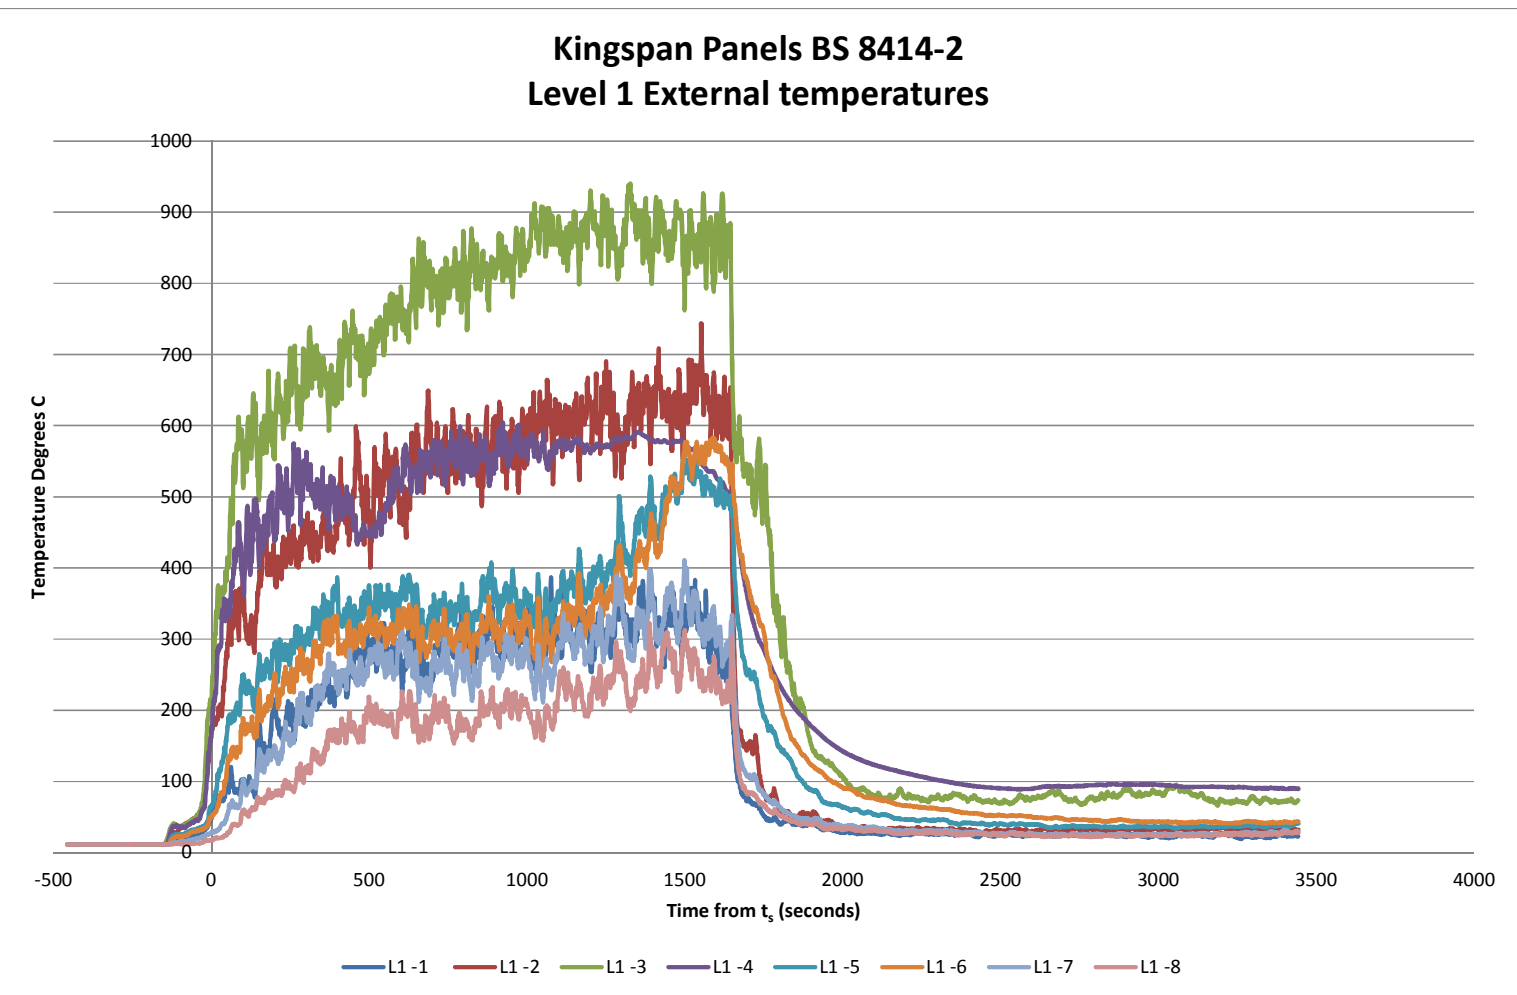
Figure 10. Temperatures Level 1 External

Parameter	Result
T _s , Start Temperature	211.5 °C
t _s , Start time	2:37 mins : secs after ignition of the crib
Peak temperature/time at Level 2, 50mm external	521°C at 20:42 mins : secs after t _s
Peak temperature/time at Level 2, Insulation layer	245°C at 24:05 mins : secs after t _s
