Fire Performance Testing of an External Cladding System BS 8414-1:2015 + A1:2017

Test Report

Prepared for : Kingspan Insulation Ltd.
Project : System Development
Report No. : DLR1516 Rev.0
Sample : Vitracore G2 Composite Panel With 180mm Rockwool Duo Slab Insulation

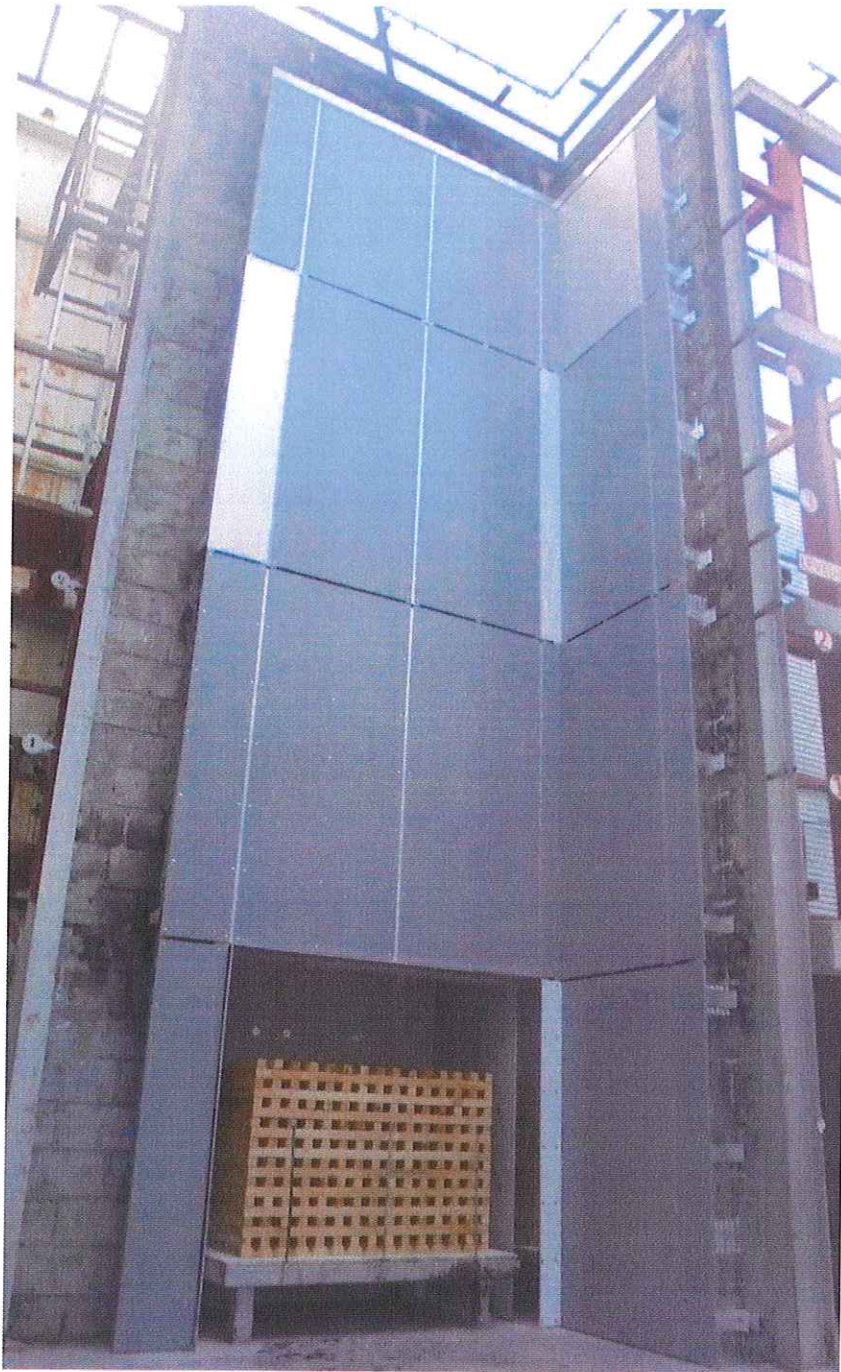
Figure 1 Photo DLP C2753H/1593 External View of the Test Sample

Photo DLP C2753H/1593 shows an external view of the sample.
