## Fire Performance Testing of an External Cladding System BS 8414-2:2015 + A1:2017

### Test Report

Prepared for : Kingspan Insulation Ltd.  
Project : System Development  
Report No. : DLR1515 Rev.0  
Sample : 100mm Kingspan Kooltherm K15 - Alpollic A2 ACM -  
BML400

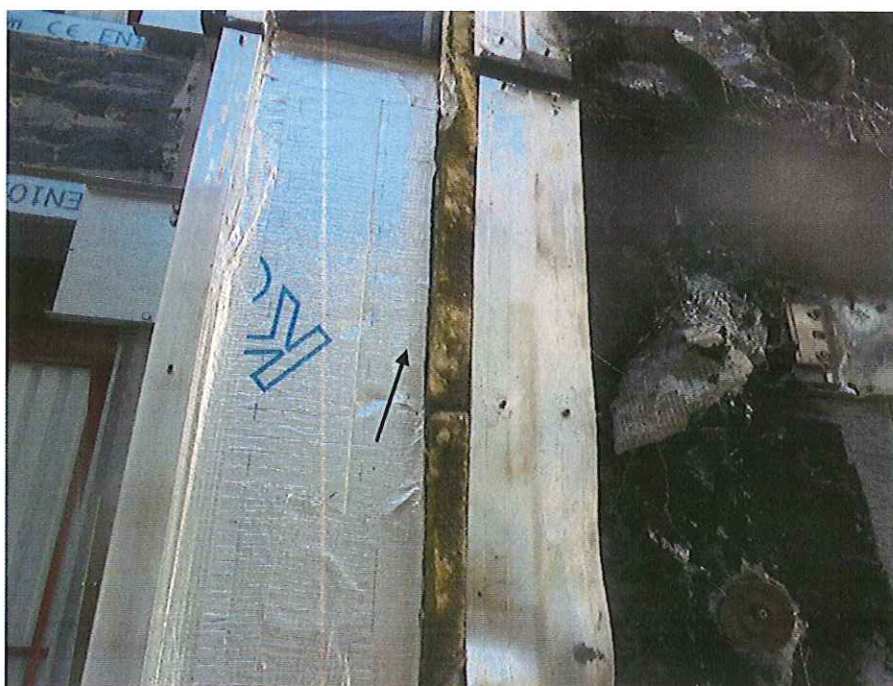
DLP C2753E/0017 Vertical cavity barrier

Sl. No.	Components	Observation	Photo Reference
3.	Cavity barrier	<p><b>Horizontal intumescent cavity barrier:</b></p> <p>Main wall:</p> <p>The 1<sup>st</sup> horizontal cavity barrier at 25mm above the combustion chamber was activated and consumed except the cavity barrier behind panels M5 &amp; M8.</p> <p>The 2<sup>nd</sup> horizontal cavity barrier at 2375mm above the combustion chamber was activated except the cavity barrier behind panels M13 &amp; M16. Intumescent layer was not present during dismantling. Cavity barrier was in place and material loss observed.</p> <p>The 3<sup>rd</sup> horizontal cavity barrier at 4725mm above the combustion chamber was activated except the cavity barrier behind panels M21 &amp; M24. Intumescent layer was partially present during dismantling. Cavity barrier was in place and minor material loss observed.</p> <p>The 4<sup>th</sup> horizontal cavity barrier at 6395mm above the combustion chamber was activated except the cavity barrier behind panels M24 &amp; M28. Intumescent layer was partially present during dismantling. Cavity barrier was in place and minor material loss observed.</p> <p>Wing wall:</p> <p>The 1<sup>st</sup> horizontal cavity barrier at 2025mm above the combustion chamber was not activated. No material loss observed.</p> <p>The 2<sup>nd</sup> horizontal cavity barrier at 4375mm above the combustion chamber was activated. Intumescent layer was not present during dismantling. Cavity barrier was in place and no material loss observed.</p> <p>The 3<sup>rd</sup> horizontal cavity barrier at 6725mm above the combustion chamber was activated. Intumescent layer was not present during dismantling. Cavity barrier was in place and no material loss observed.</p> <p>The 4<sup>th</sup> horizontal cavity barrier at 8395mm above the combustion chamber was activated. Intumescent layer was not present during dismantling. Cavity barrier was in place and no material loss observed.</p> <p><b>Vertical cavity barrier:</b></p> <p>Buckling and discoloration on the vertical cavity barrier on the main wall.</p> <p>No significant changes on the vertical cavity barrier on wing wall.</p>	DLP C2753E/0012, DLP C2753E/0016 & DLP C2753E/0018.
