**Fire Performance Testing of an External Cladding System**  
**BS 8414-2:2015 + A1:2017**

**Test Report**

**Prepared for : Kingspan Insulation Ltd.**  
**Project : System Development**  
**Report No. : DLR1567 Rev.0**  
**Sample : 160mm Kingspan Kooltherm K15 - Alpolic A2 ACM**  
**Cassette Panel– BML100**

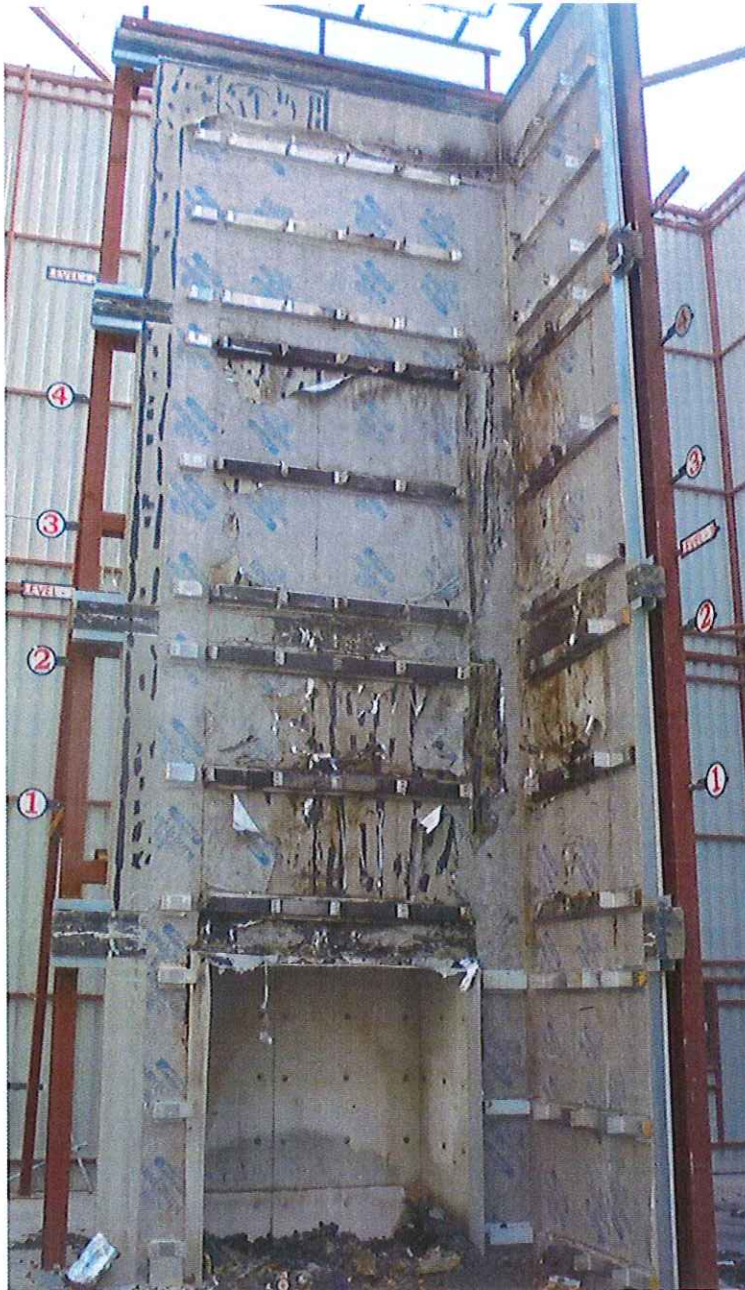
DLP C2753I/0017

3	Kingspan Kooltherm K15 insulation	<p>Insulations behind the panels M4, M5, M6, M8, M9, M10, M13, M14, W3, W4, W5, W6 &amp; W7 panels were burned. Approximately 60% of the burned insulations fell off and remaining left as char.</p> <p>Minor discoloration on the insulations behind the panels M12 &amp; W8.</p> <p>All other insulations were in place and no significant changes observed.</p>	DLP C27531 / 0016, DLP C27531 / 0020 & DLP C27531 / 0021.
4	Carrier railings	<p>Railings behind the panels M4, M5, M6, M8, M9, M10, W3, W4 &amp; W5 were melted.</p> <p>Railings behind the panels M12, M13, M14, W6, W7 &amp; W8 were discoloured.</p> <p>All other railings were in place and no damage was observed.</p>	DLP C27531 / 0016 & DLP C27531 / 0021.

Brackets and Nilvent breather membrane

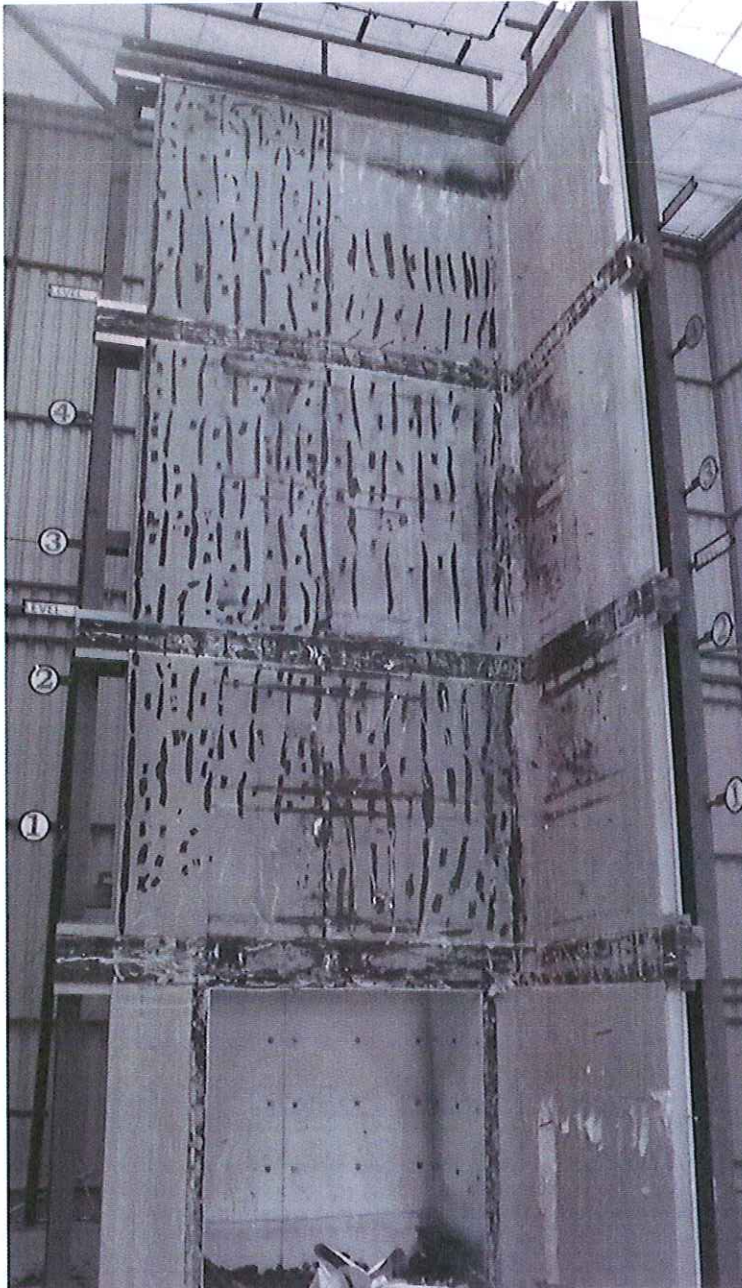
DLP C2753I/0018

Sl. No.	Components	Observation	Photo Reference
5	Brackets and Nilvent breather membrane	<p>Top Hat bracket:</p> <p>Discoloration on the brackets behind the panels M4, M5, M8, M9, W3, W4 &amp; W5. No significant changes on the remaining brackets.</p> <p>Helping hand bracket:</p> <p>Approximately 10% of the Helping hand brackets were partially melted. All other brackets were in place and no significant changes observed.</p> <p>Breather membrane:</p> <p>Minor material loss and discoloration on the Nilvent breather membrane observed.</p>	DLP C2753I / 0017 & DLP C2753I / 0022.
6	12mm Versapanel cement particle board	Minor discolouration on the cement particle boards behind the panels M4, M5, M8, M9, W3 & W5. No significant changes on the remaining boards.	DLP C2753I / 0018.
7	SFS and plaster boards	No significant changes.	DLP C2753I / 0019.

Brackets
