# BRE Global Test Report

**BS 8414-1:2015 + A1:2017 Test on Eternit Equitone Natura panel ventilated rainscreen system with Kingspan K15 insulation.**

**Prepared for:** Kingspan Insulation  
**Date:** 7<sup>th</sup> February 2020  
**Report Number:** P114679-1000 **Issue:** 1

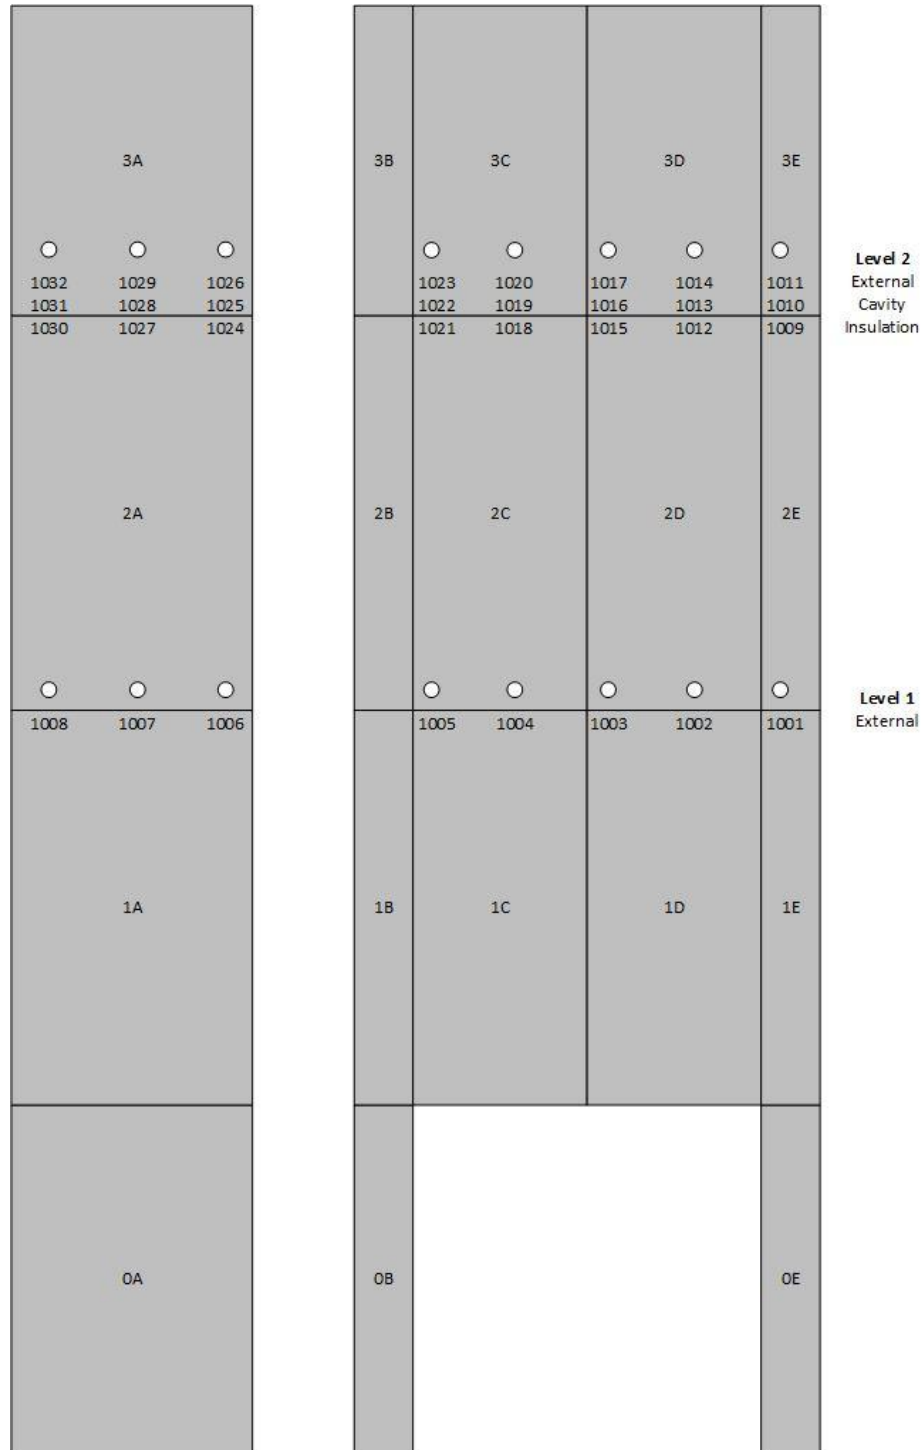
Figure 2. Layout of panels, TC positions and panel numbering (0A – 3E). Not to scale.

With reference to *Figure 2 & 19*, panel damage was as follows:
