## Fire Performance Testing of an External Cladding System

### BS 8414-1:2015 + A1:2017

Sample : 10mm Trespa Meteon FR Panel with 100mm Kingspan  
Kooltherm K15 Insulation

Report No. : DLR1709 Rev.0

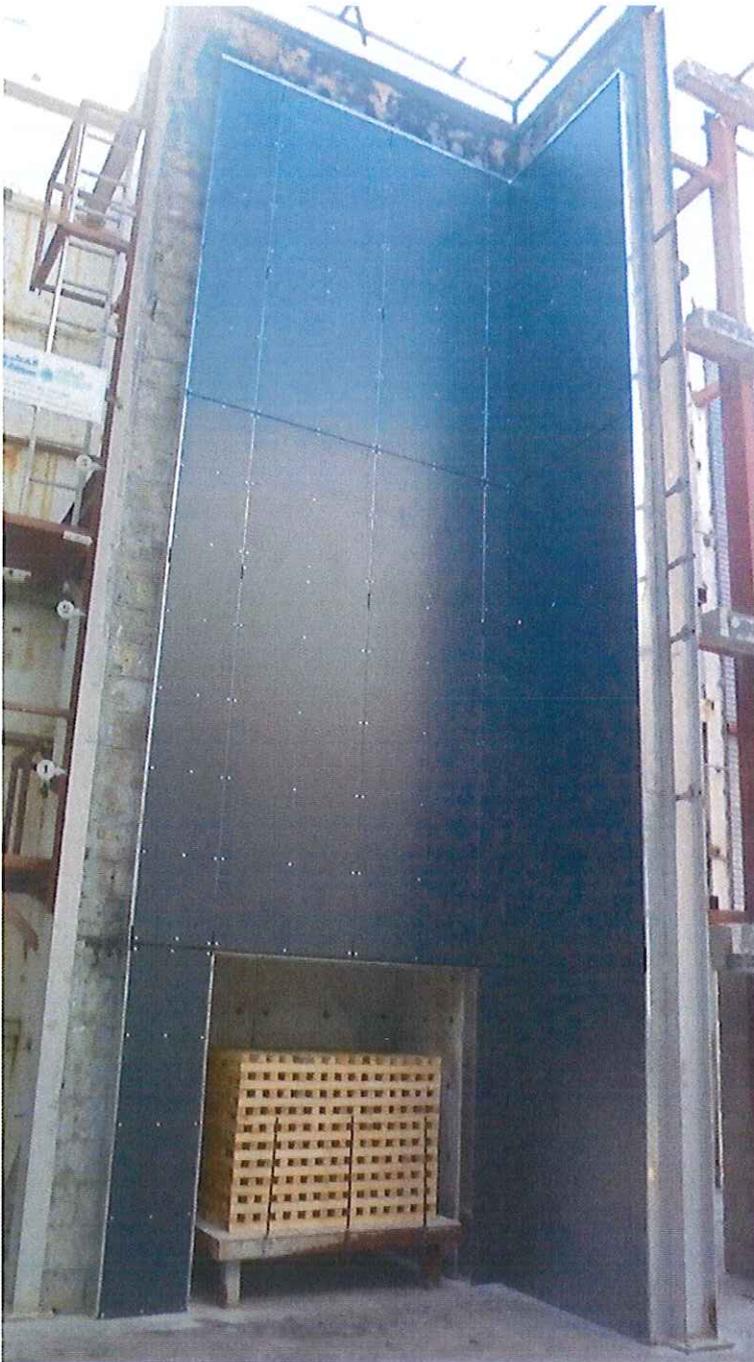
It was noted that no horizontal joint was provided (2400±100) mm above the combustion chamber opening which is a deviation from the test standard requirement.

The photograph below shows an external view of the sample.

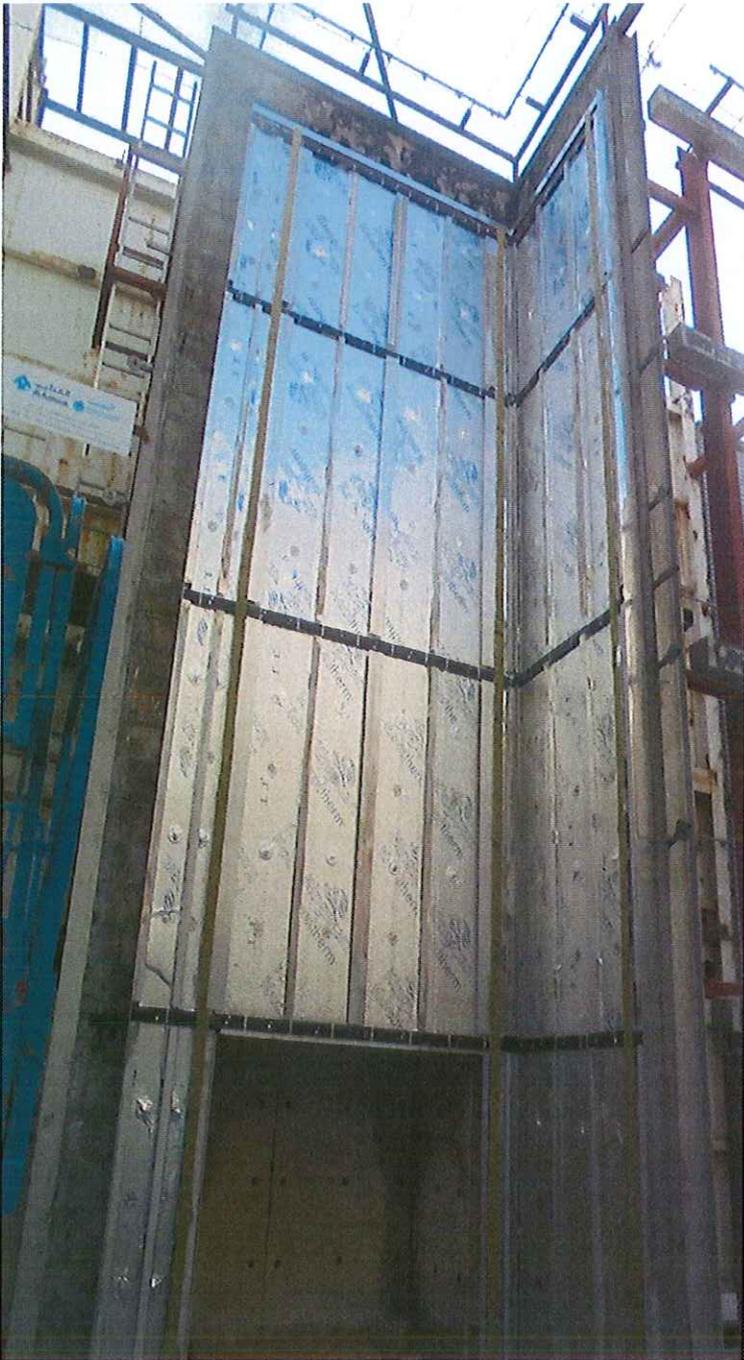
Photo 2 Cavity barriers, Kingspan Kooltherm K15 insulation and railings

Insulation	100mm Kingspan Kooltherm K15 insulation (Batch number: 8100342740). See Photos 2 & 5 in Section 4.3 below.	Insulation was fixed to the masonry wall with Ejot steel and plastic pins.
Railing	125x60x2mm Aluminium 'T' rail 60x40x2mm Aluminium 'L' rail See Photos 2 & 5 in Section 4.3 below.	Railings were fixed to the Helping Hand brackets with Ejot JT4-4-4.8x19mm screws.
Panel	Trespa Meteon FR panel, 10mm thick. See Photo 6 in Section 4.3 below.	Trespa FR panels were fixed to the railings with stainless rivets 16mm dia head.  10mm joints were provided between the panels. Aluminium bird peak profile was placed at the panel joints.

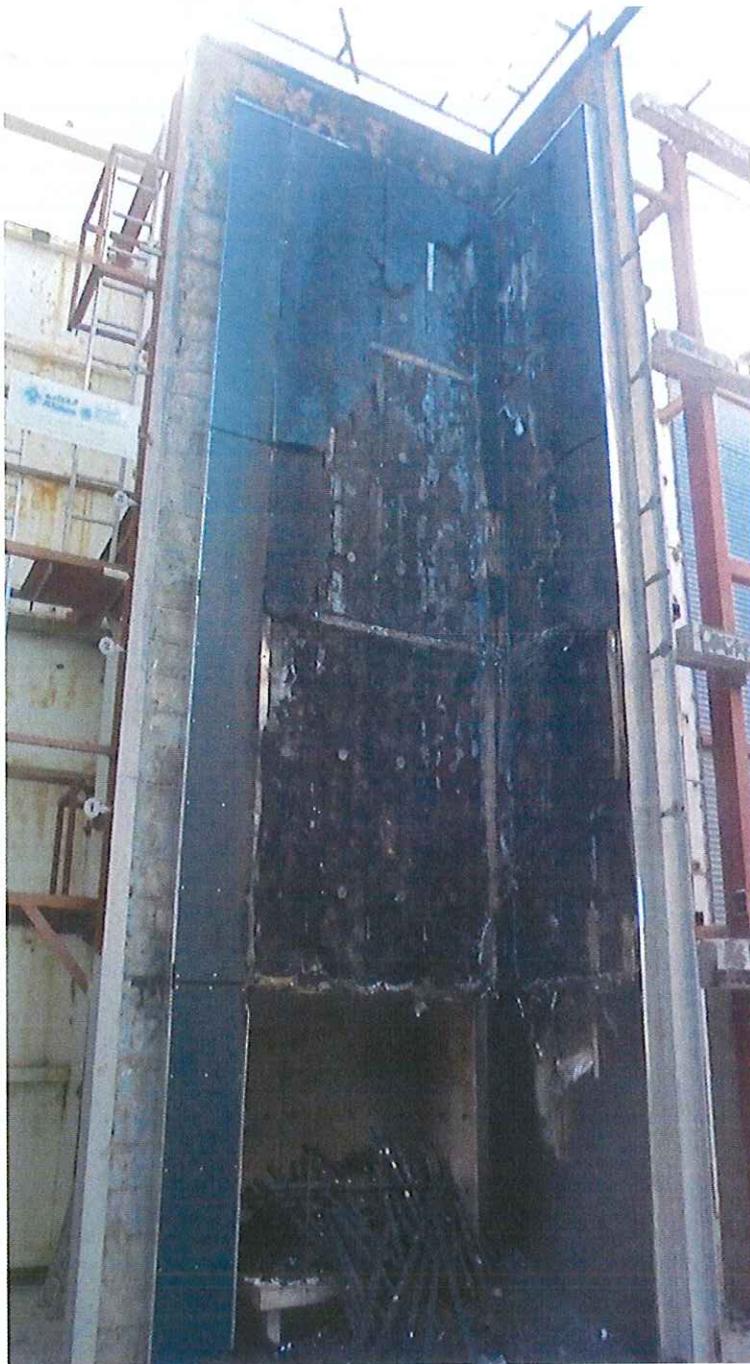
Component	Observation	Photo Ref. (Section 6.4)
Trespa Meteor FR Panel	<p>Panels M1, M3 &amp; M7 – Minor discoloration and buckling on the panels.</p> <p>Panels M2 &amp; M10 – Panel was burned and left as char.</p> <p>Panels M5 &amp; M6 - 100% of the panel was consumed.</p> <p>Panels M4 &amp; M9 – Approximately 75% of the panel was consumed and remaining area was burned.</p> <p>Panels M8– Approximately 25% of the panel was consumed and remaining area was burned.</p> <p>Panel W1– Approximately 25% of the panel was consumed and remaining area was burned.</p> <p>Panel W2 – Approximately 90% of the panel was consumed and remaining area was burned.</p> <p>Panel W3 – Approximately 50% of the panel was consumed and remaining area was burned.</p>	Photo 16
Cavity barrier	<p><b>Horizontal intumescent cavity barrier:</b></p> <p>Main wall:</p> <p>The 1<sup>st</sup> horizontal cavity barrier at 65mm above the combustion chamber was activated except the cavity behind Panel M3. Material loss and damage were observed.</p> <p>The 2<sup>nd</sup> horizontal cavity barrier at 2455mm above the combustion chamber was activated except the cavity behind Panel M3. Material loss and damage were observed.</p> <p>The 3<sup>rd</sup> horizontal cavity barrier at 4785mm above the combustion chamber was activated except the cavity behind Panel M7. Material loss and damage were observed.</p> <p>The 4<sup>th</sup> horizontal cavity barrier at 6420mm above the combustion chamber was activated except the cavity behind Panel M7. Cavity barrier was intact and no material loss observed.</p> <p>Wing wall:</p> <p>The 1<sup>st</sup> horizontal cavity barrier at 2065mm above the ground level was activated. Material loss and damage were observed.</p> <p>The 2<sup>nd</sup> horizontal cavity barrier at 4455mm above the ground level was activated. Material loss and damage were observed.</p>	Photos 17, 19, 20 & 21

Photo 16 View of the sample after the test
