Fire Performance of
Insurer Certified PIR Core
Sandwich Panels

Real Fire Case Studies

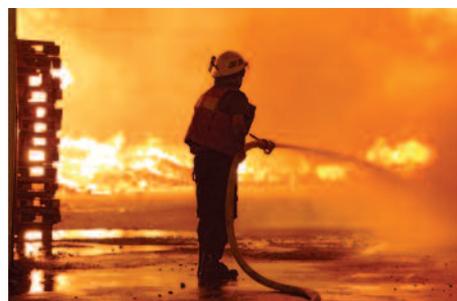
In January 2010, a large fire occurred at the site of a major food processing factory, south of Melbourne. The fire started in a staging area for plastic packaging trays, and despite the area being attended and the presence of automatic smoke detection, the fire quickly spread to the EPS (expanded polystyrene) sandwich panel ceiling causing total loss.

An interesting footnote to this fire was the performance of approved PIR sandwich panels. A new extension to the existing EPS cold store had been constructed from PIR. The fire burnt up to the PIR wall but did not penetrate, the PIR section was left largely intact. This tends to confirm a number of insurer's and experts recommendations of approved alternative panels, be they PIR or Phenolic resin matrix.

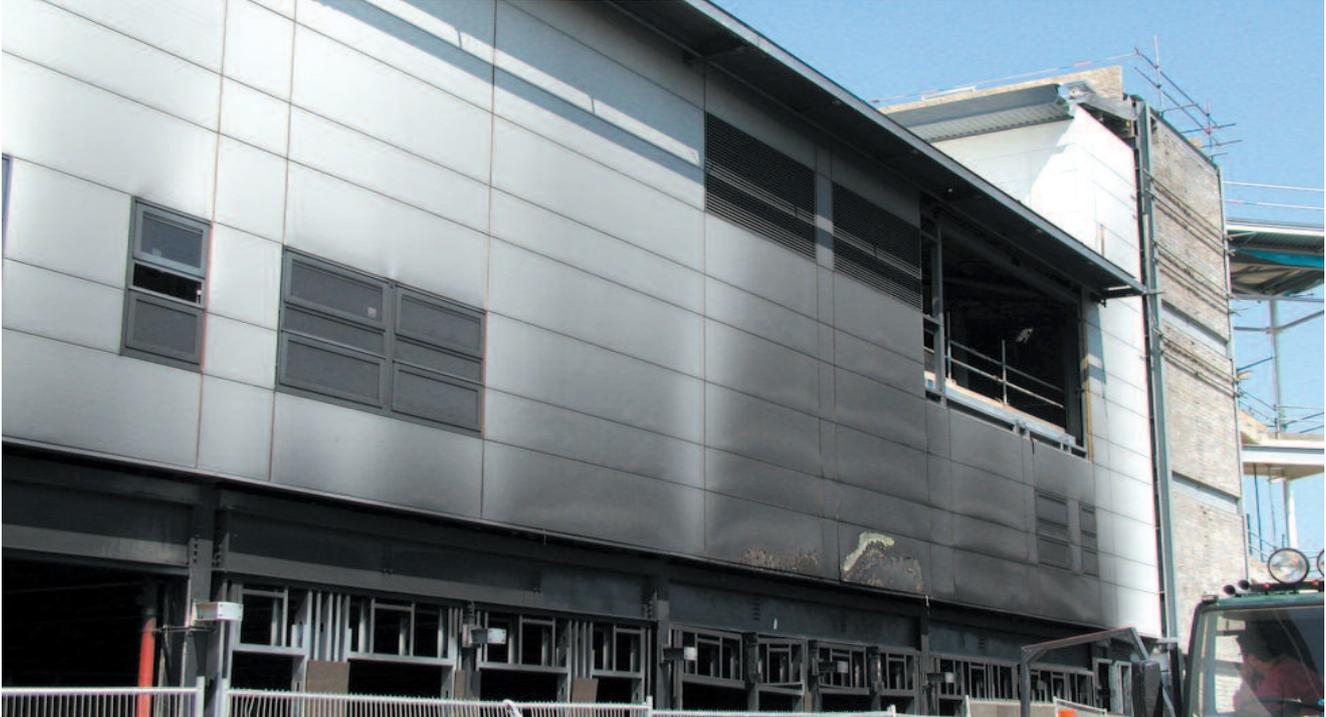
Wharfedale Hospital, UK

The main image above shows where the insulated cladding panels on the external face of the building had been attacked by flames.

A fire occurred at a hospital under construction during the summer of 2003. The building was steel framed with concrete floors. The first and second floors were clad with Kingspan PIR insulated panels approved by LPCB to EXT-B of LPS 1181 Part 1. At the date of the fire, the ground floor cladding had not yet been installed and the ground level was open sided.

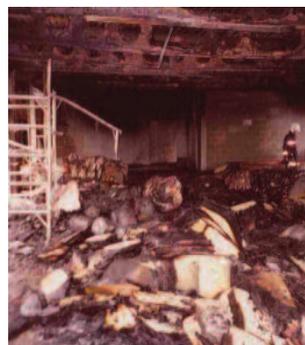
Photograph 1

It was thought that the fire was started deliberately by adhesive being poured over slabs of insulating material which were stored on the ground floor. *Photograph 1* shows the fire area.

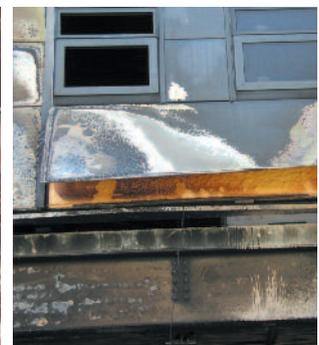
Photograph 2

The fire service found light smoke but no fire spread on the upper floors of the building. They also reported that although the joint between the floor and first floor walls had not been fire stopped there was no fire spread within the PIR core material. *Photograph 2* shows where the flame damaged outer skin of the bottom panel has been lifted to inspect the slight charring of PIR core beneath.

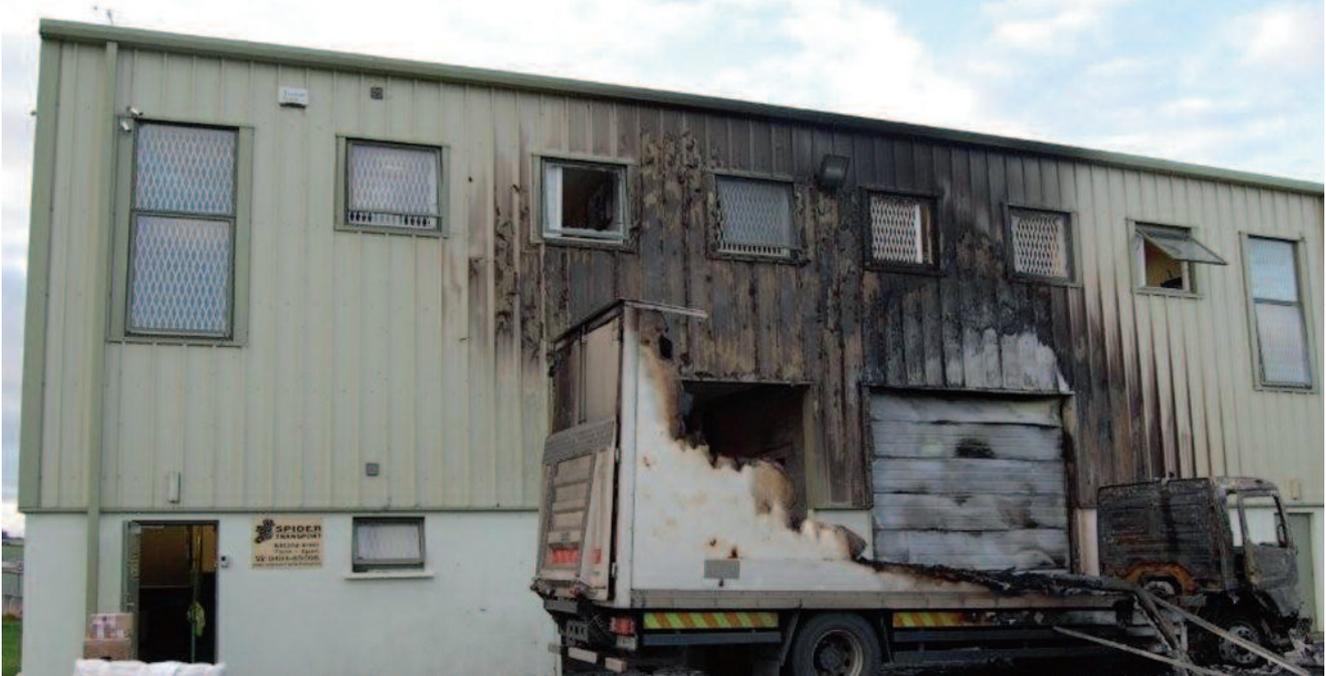
Spider Transport, Ireland

The main image above shows the aftermath of the fire. The upper parts of the external wall consisted of Kingspan Trapezoidal KS1000 RW insulated panels which complied with LPCB Grade EXT-B to LPS 1181 Part 1, whilst the lower parts were constructed of blockwork.

Although the bottom of the insulating core of the Kingspan insulated panels was directly exposed to flame impingement above the up and over door, there was no delamination of the skins of the panels and the insulation remained in place.

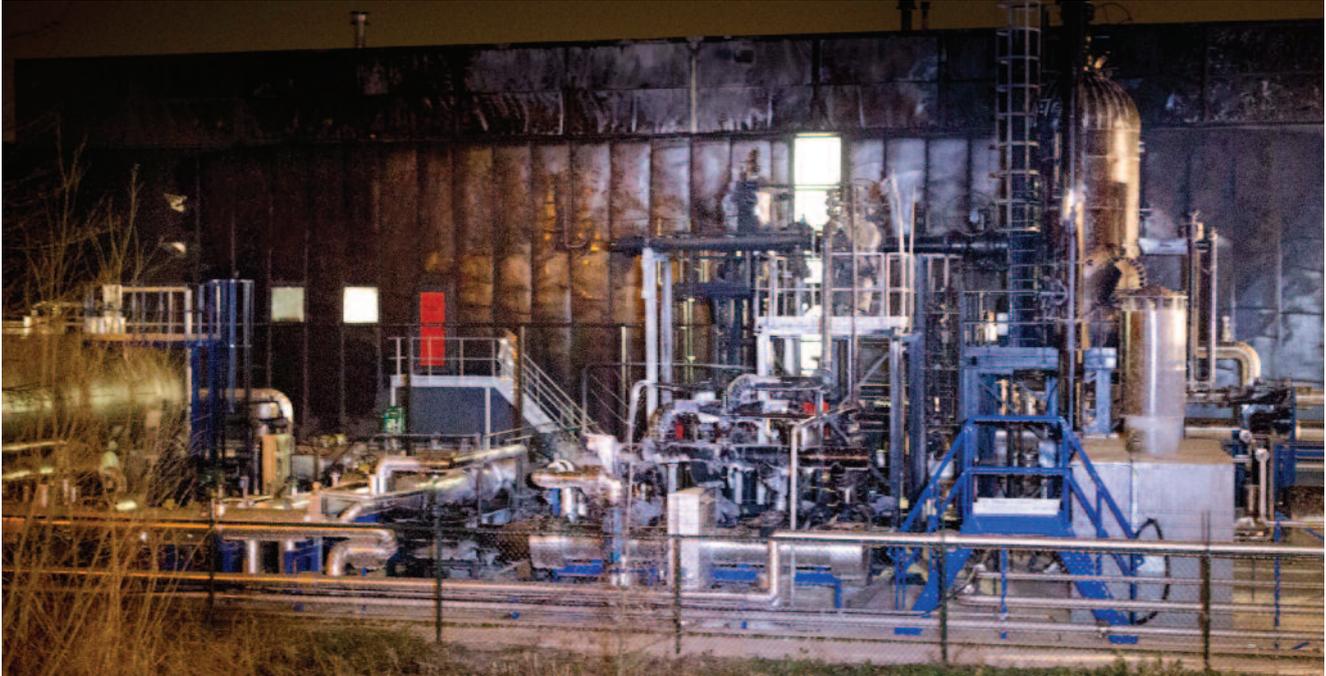
Crude Oil Pool Fire, Netherlands

The facility at Arnhem in the Netherlands is used for the testing of equipment for the oil industry. On the 18th January 2013 a fire involving crude oil occurred in an external equipment testing area. The test site was located adjacent to the main test building which was clad with Kingspan Insurer Certified PIR insulated wall panels up to a parapet wall which was constructed from polyurethane core panels.

There appears to have been little or no direct flame impingement on the external cladding of the building. However, the building would have been subject to high levels of radiant heat flux from the fire plume and this has been estimated to be of the order of 24kW/m².

The intensity of radiation received by the panels caused some surface flaming but this ceased after approximately 30s (presumably after the surface coating had burned away). There was otherwise no evidence of self-sustaining flaming from the panel surface or at joints between panels.

As a result of the intensity of heat radiation the steel facing to the panels became rippled and delaminated from the foam core but there was only limited foam degradation at the core surface.

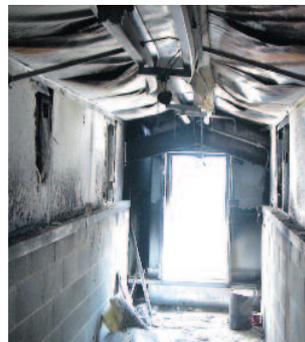
Photograph 1 shows the area where the fire started, in an enclosed passageway linking two open air plant areas on the roof. There was scaffolding at the rear of the premises which gave access to the roof and the fire was thought to have been caused by the accidental or malicious ignition of roof sealant.

Photograph 1 also shows the empty drum thought to have contained the roof sealant, and holes made in the partition system by the fire service to check that the fire had been completely extinguished. The plastic and glass components of the fire alarm and light fittings had shattered / melted and although delamination of the inner skin of the insulated panels occurred, the core and outer skin remained undistorted.

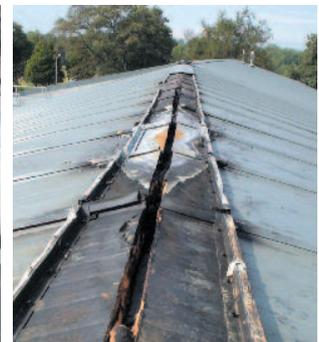
Photograph 2 shows the apex of the roof, with some discolouration in the area subject to direct flame attack, but no evidence of fire spread.

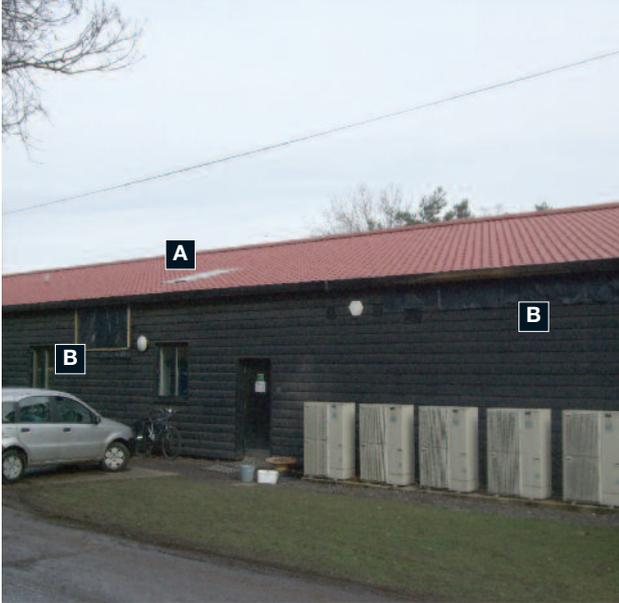
A: Vent cut in roof by fire service. B: Vents cut in wall by fire service.

On locating the area of the fire the attending fire service cut a hole through the roof construction directly above the fire and in the location of the damage shown in the above image to ventilate the area. The images show the hole which was cut (which has been temporarily re-covered). The effect of the heat of the fire on the PIR core can be seen showing delamination of the exposed steel skin of the sandwich panel from the core, the formation of a carbon char layer and unaffected material at greater depth in the section which has been insulated from the fire.

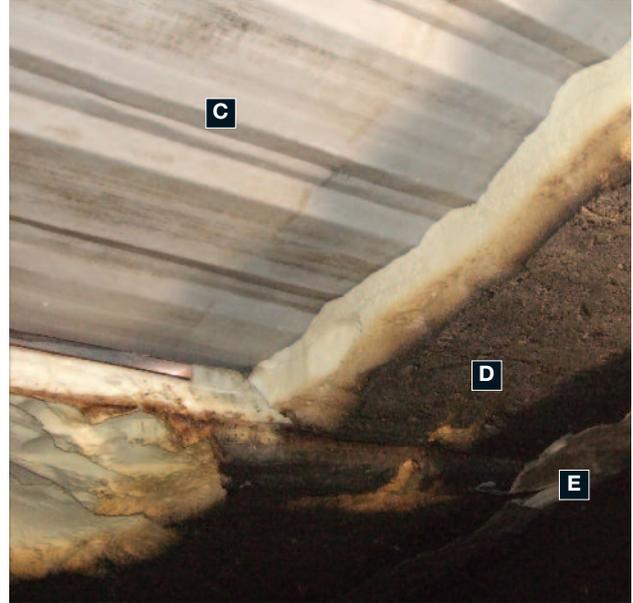
C: Temporary roof covering over hole in roof. D: PIR core showing delaminated lower surface and extent of through-thickness charring. E: Cut edge of lower steel skin of sandwich panel.

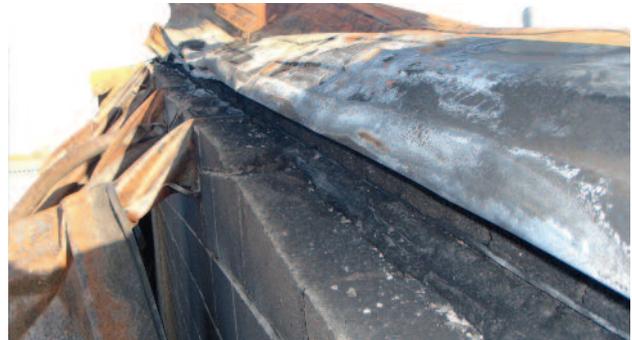
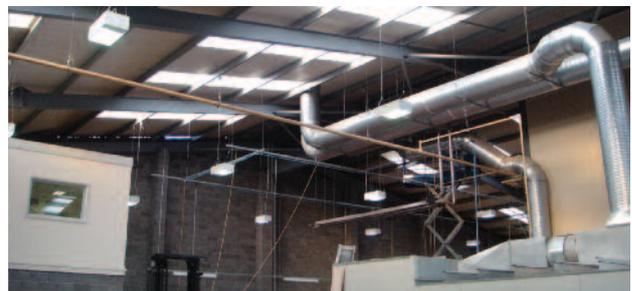
The charring exhibited by the Kingspan Insurer Certified PIR core material indicated the formation of a sufficiently stable char within the panel to provide an effective fire stop between the steel skins of the cladding panels at the head of the compartment party wall.

The findings of the site inspection provide evidence that the Insurer Certified PIR core of the Kingspan Trapezoidal KS1000 RW panel can provide sufficient resistance to fire propagation and erosion to such an extent that the functional requirement of the UK Building Regulations (Regulation B3) can be satisfied without providing a 300mm wide band of limited combustibility material to replace the PIR core where the panel passes over a compartment wall.
